## OWNER-ENGINEER AGREEMENT

**Re: Proposal for the Brookside Road Bridge over the Housatonic River  
Superstructure Replacement**

| CITY/TOWN<br><b>GREAT BARRINGTON</b> | B.I.N.<br><b>04K</b> | BR. DEPT. NO.<br><b>G-11-008</b> | 8.-STRUCTURE NO.<br><b>G11008-04K-MUN-NBI</b> | INSPECTION DATE<br><b>JUN 8, 2021</b> |

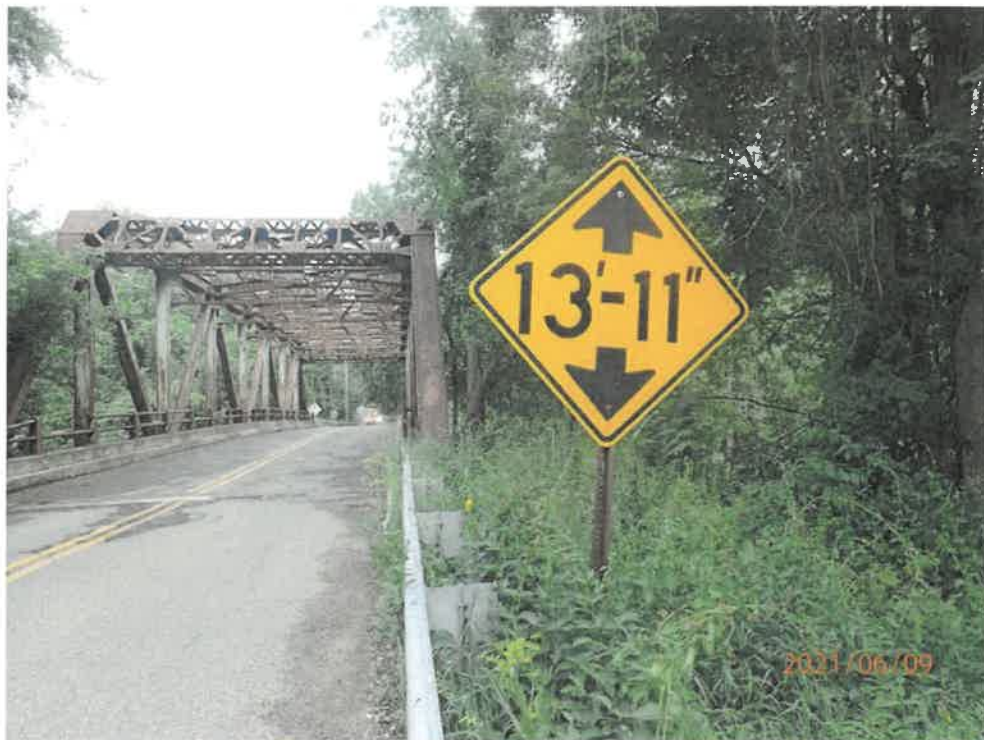
The minimum vertical clearance of 14'-2" was measured at Panel Point U6 over the double yellow lines. There are At-Bridge and Advance clearance posting signs of 13'-11" located along both bounds (**see Photos 1 and 2**).

**Photo 2: East Approach At-Bridge Clearance Posting**

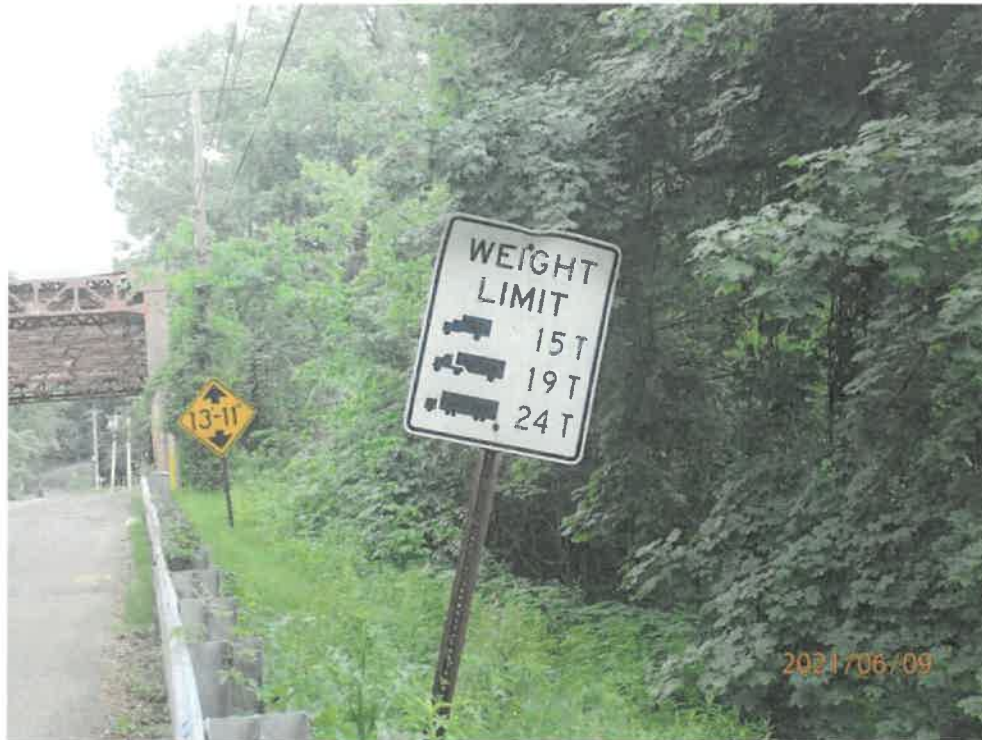
The bridge has a posted weight restriction for 15 tons on two axles, 19 tons on three axles and 24 tons on five axles. There are At-Bridge and Advance weight posting signs located along both bounds (**see Photos 3 and 4**).

Photo 3: West Approach At-Bridge Weight Posting

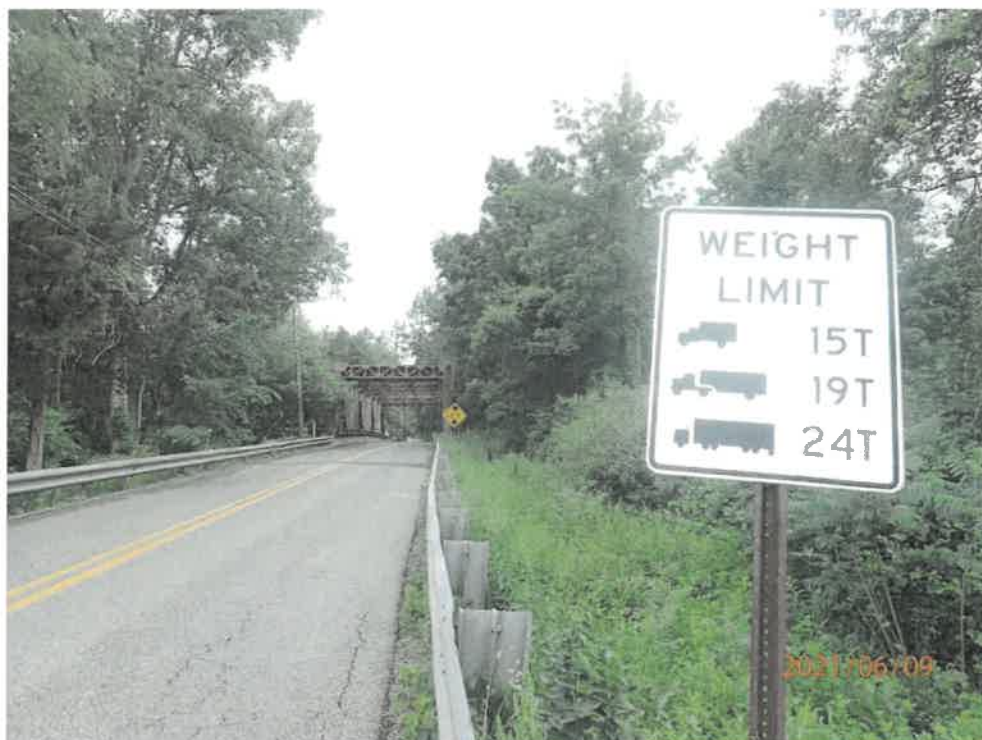
Photo 4: East Approach At-Bridge Weight Posting

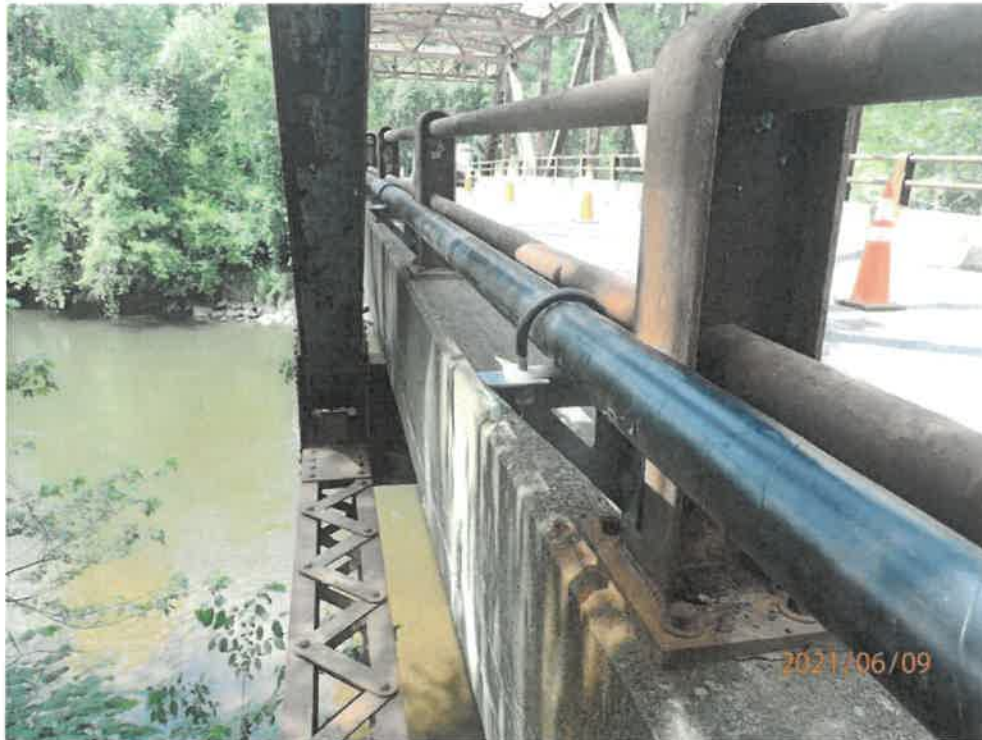
There is a gas main that has been relocated to the south side of the bridge behind the railing (see Photo 15). There are power lines located along the south side of the bridge.

**Photo 15: Gas main at South side of bridge**
