School District of Bloomer Facility Audit

June
2019

BLOOMER HIGH SCHOOL

FACILITY ANALYSIS

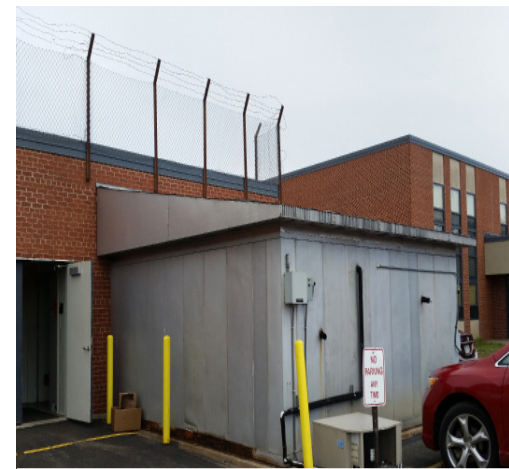
- Lack of an auditorium or another large presentation area
- Attached add-on food service refrigeration building
- Add-on extended greenhouse
- A patchwork of additions and corridors from past expansion
- Limited space in classrooms
- Inadequate storage space for adjacent areas of use
- Inappropriate storage in mechanical areas
- Outbuilding

Bump-out refrigeration unit

The first recommendation is to consider building a new high school. This option allows for the existing site and building to be used while the new construction is completed. The planning and design for the new building can remedy all of the space concerns while also improving the educational delivery and operational efficiencies. Identification of the funding for this option is a priority for the capital costs to complete.

The second recommendation in lieu of the first is to plan, design, and engineer in detail another renovation and remodel of the building and site. This option requires a large amount of transitional space for construction work to be completed or a long construction schedule with multiple phases over several years to complete. As with the other option, identification of funding for all phases to complete the renovation and remodel is a priority.

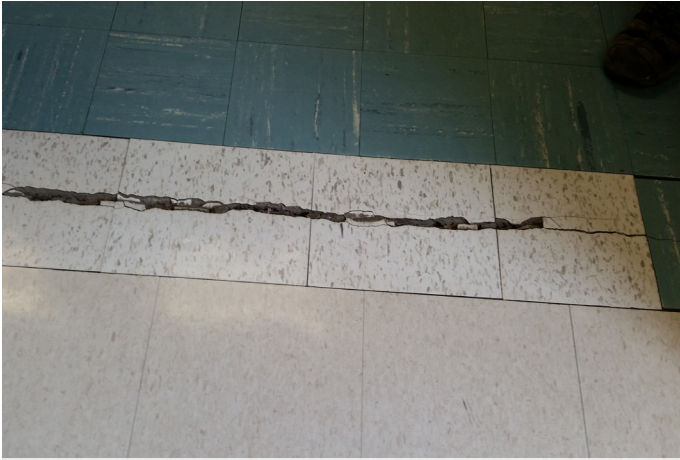
Patched asbestos tile

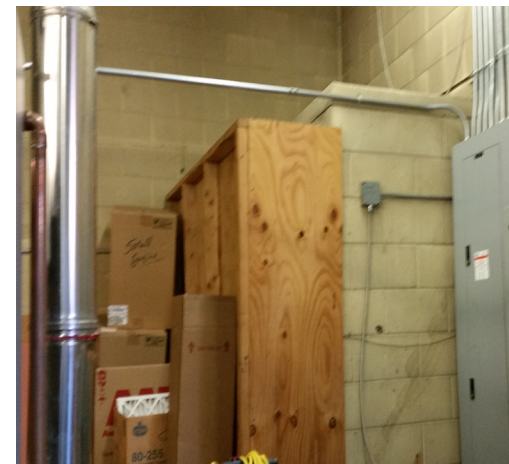
Boiler wood make-up air cover

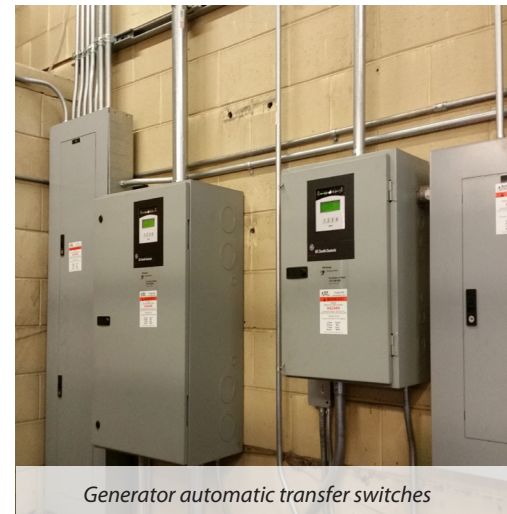
Emergency egress lighting is supported by the on-site electric emergency generator. The emergency generator is an eighty kW power back-up generator approximately twenty years old. The two generators automatic transfer switches separate emergency and other designated standby loads. A documented full load and automatic transfer switch testing have not been completed recently.

Generator automatic transfer switches

A full load and transfer switches testing along with frequent run tests and comprehensive annual preventive maintenance are recommended for the electrical generator and automatic transfer switches to verify load coverage, code compliance, and operation when needed.

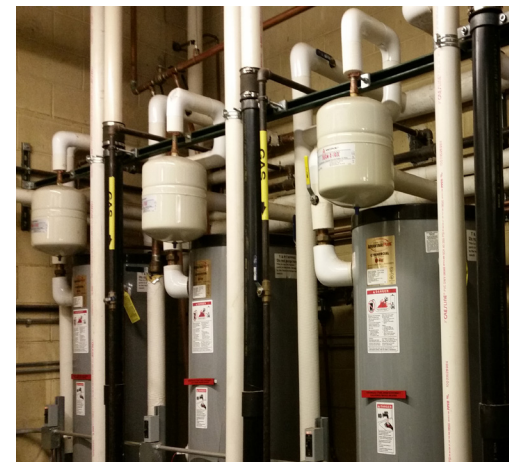
Central domestic water heating

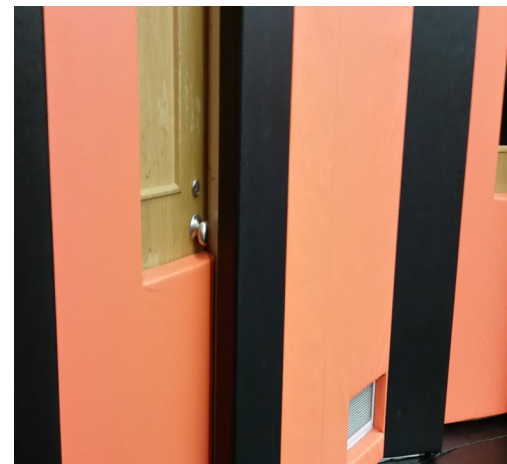
The door security system is adequate. The interior room doors rooms 160 and 160 A-E are not ADA compliant. The clock system is battery operated, and the data and phone systems are adequate.

Non-ADA compliant door hardware

The door hardware for rooms 160 and 160A through 160E should be replaced with ADA compliant door hardware. The fire alarm system is near the end of its expected life and should be upgraded or replaced. Especially if additional building space is constructed and infrastructure systems are to be replaced. The addition of more building space and replacement of infrastructure systems would also warrant adding more fire suppression coverage for the larger building.
