# Summary Report for Incident on 10-7-17

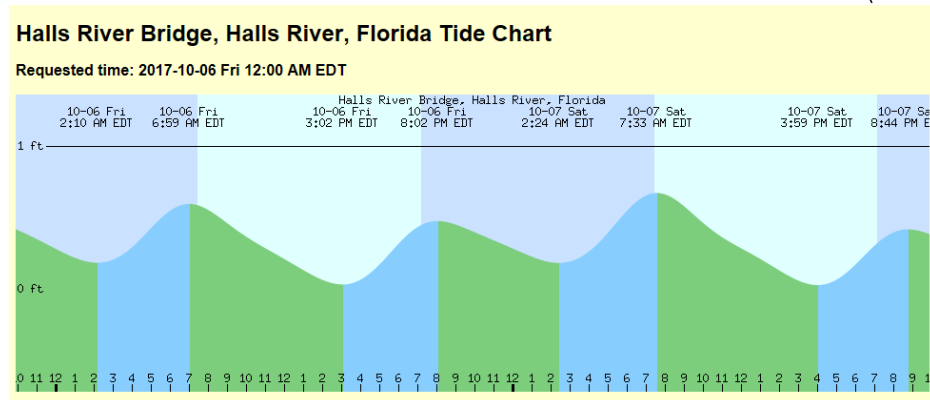
Water level difference from Hurricane Flooding. Picture.

Photo was not taken at highest tide. Water level would have been higher (see Tide Chart).
