RE: Corrective Action Plan for Rock Spillage at Snyder  
Quarry.

Your file NO.: M-77-210

## CORRECTIVE ACTION PLAN

### SNYDER QUARRY

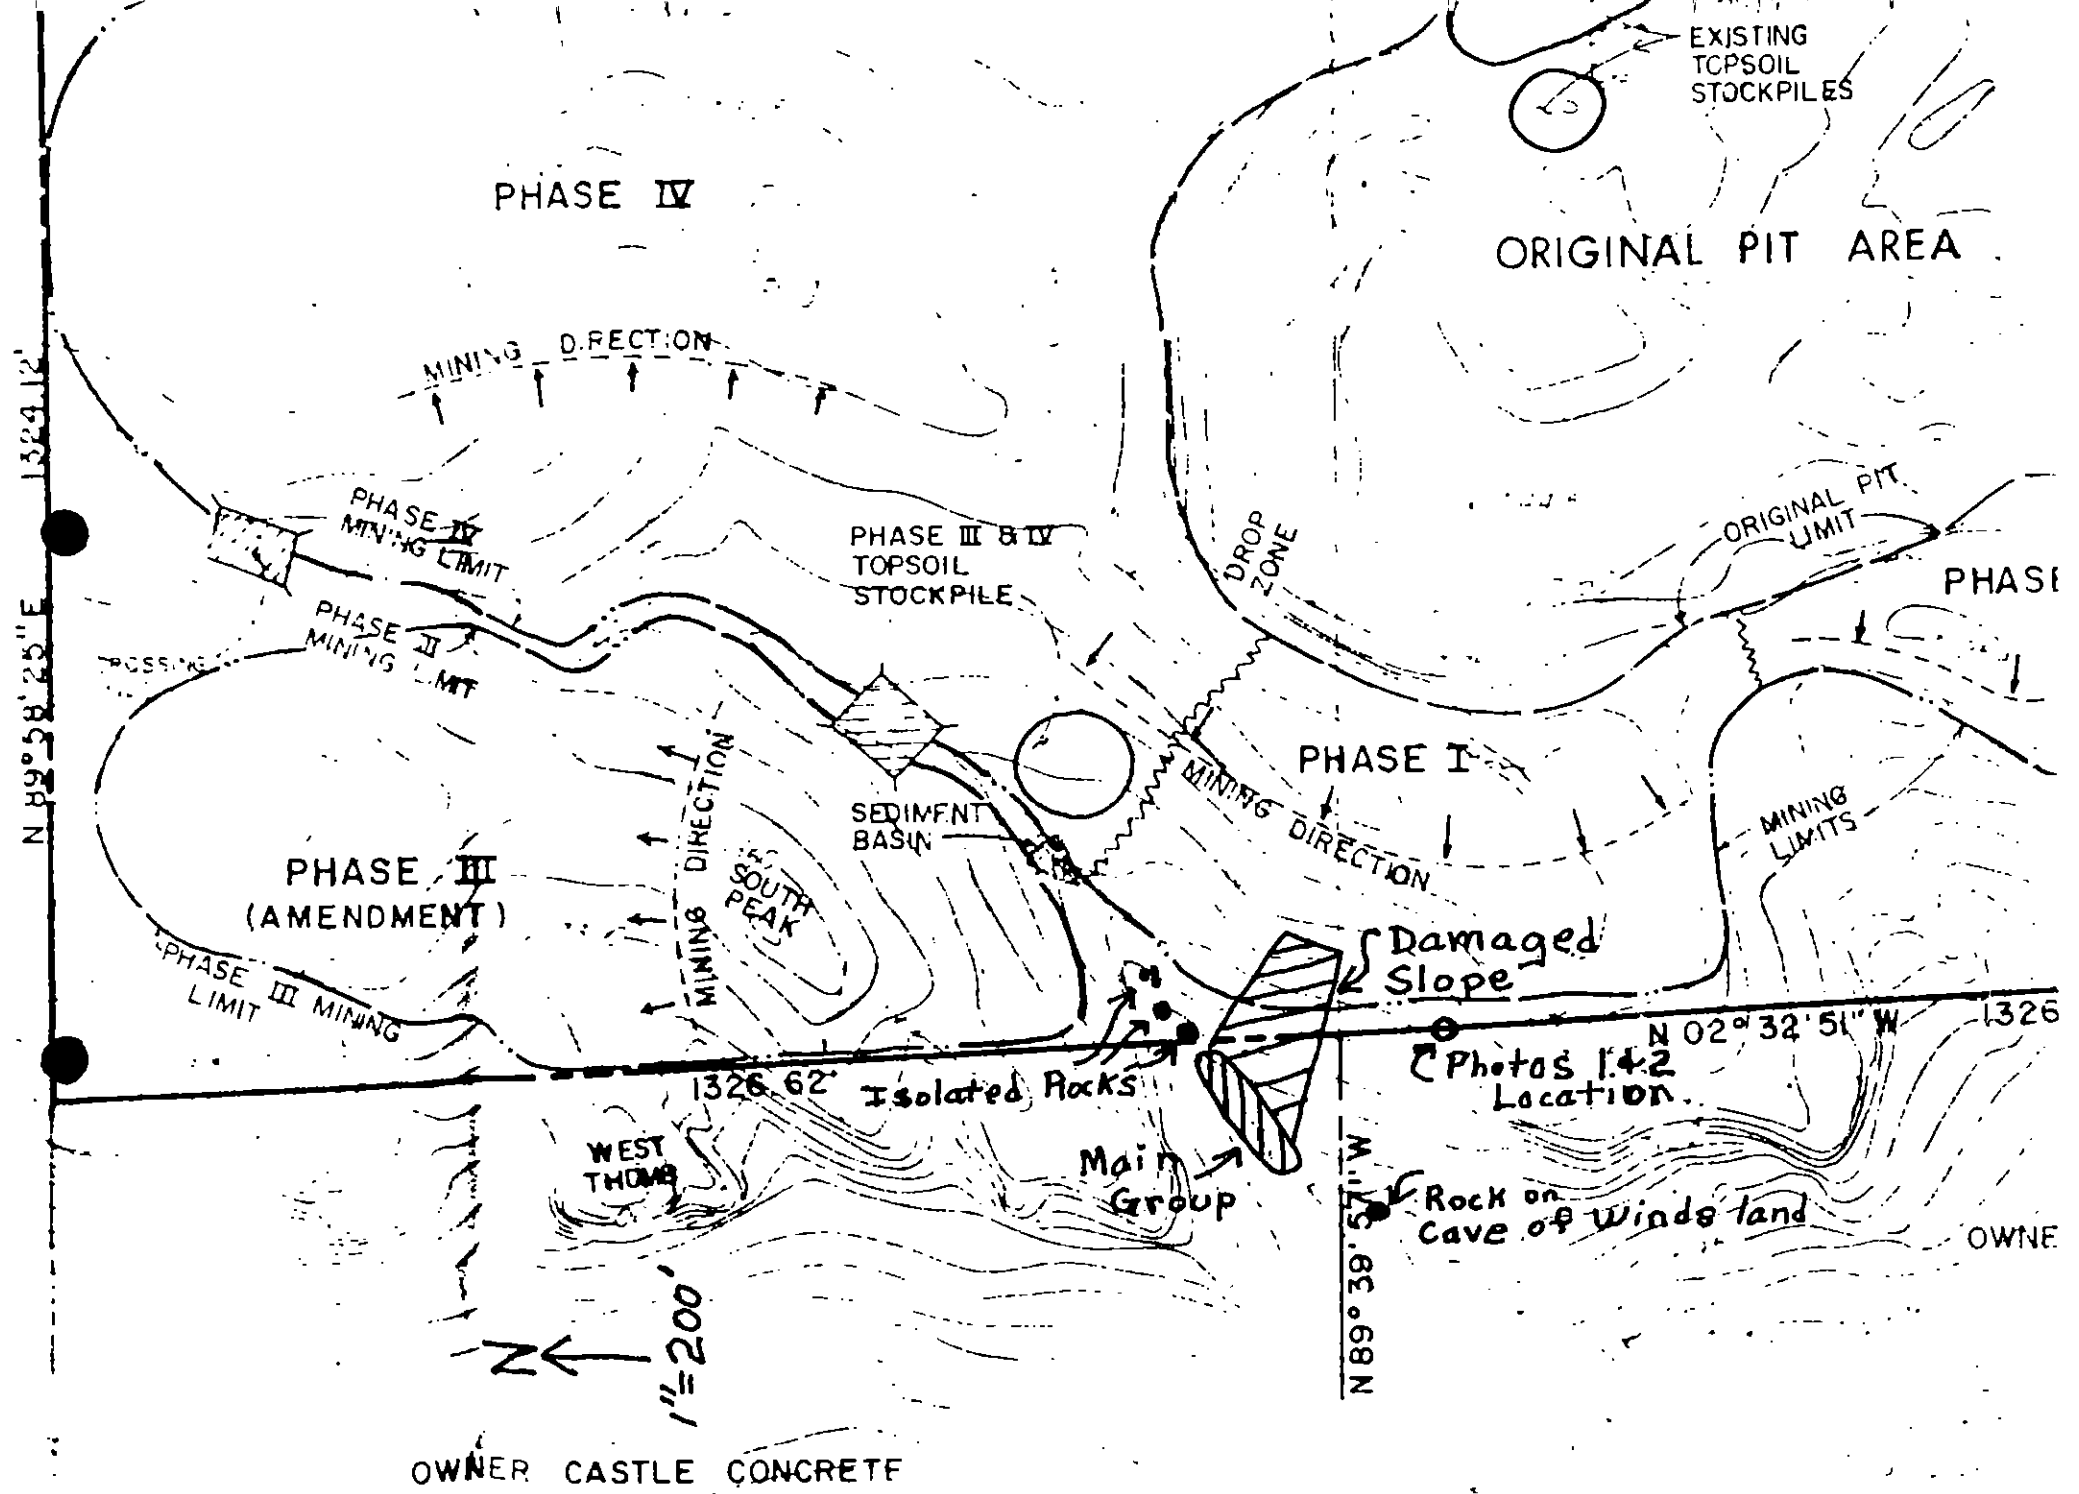
PHOTO 1: A VIEW OF SLOPE AND MAIN BODY  
OF ROCKS IN DRAINAGE BELOW PHASE 1.  
SOLID DARK LINE ALONG RIGHT SIDE  
INDICATES LOCATION OF PERMIT BOUNDARY.  
PERMIT IS TO RIGHT OF BOUNDARY LINE.  
PHOTO LOCATION IS SHOWN ON MAP.
