FORCON INTERNATIONAL - NC, LTD.
1730 Mt. Vernon Road, Suite H, Atlanta, GA 30338
770/390-0980 • 770/390-0981 FAX • www.forcon.com
Firm License #: C-1617

RE: City of Hickory (Plaintiff) vs. Neill Grading and Construction Company, Inc., Dane Construction, Inc., and Western Wood Structures, Inc.
Preliminary Report – **Attorney Work Product**
CASE #: 22-CVS-804 (North Carolina, Catawba County, Superior Court)
FORCON CASE #: NC22003-1

As Counsel for Neill Grading and Construction Company, Inc. (Neill), you have requested that I (Dara Thomas, P.E., a FORCON International Corporation (FORCON) Professional Forensic Structural Engineer), provide services as an Expert and prepare a Preliminary Report on this matter. **The purpose of the report is to express my opinions, to-date, about the catastrophic failure of the Iconic Arches at the City Walk Project, Hickory, NC.**

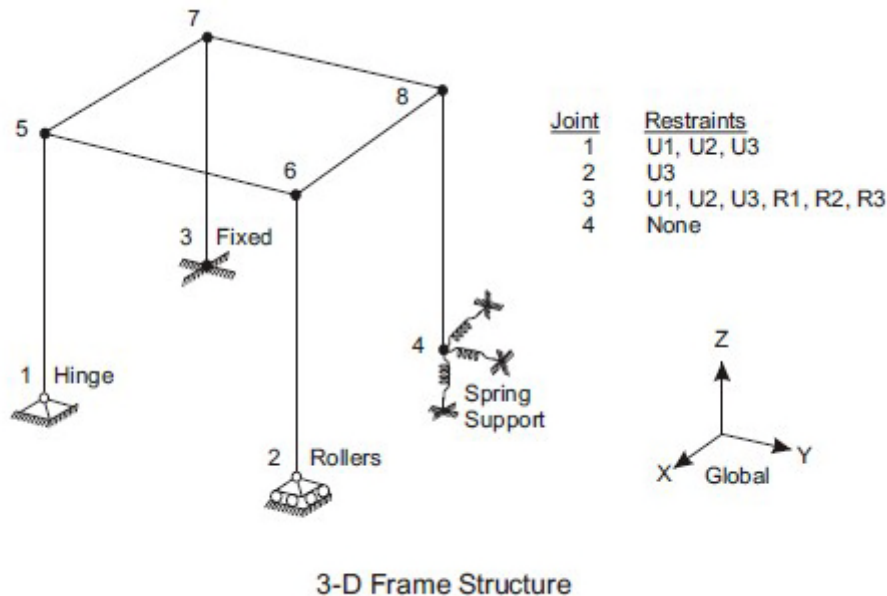
As we can see from the diagram, in order to create a *fixed* node (node 3 in the diagram) in the frame analysis computer model, we must restrain all six degrees of freedom. And we can see in the calculations from Western Wood that the EOR of the timber structure only restrained the x, y, and z movements (U1, U2, U3). The rotation degrees of freedom (R1, R2, R3) were not restrained in the computer model by Western Wood. This means that the eight base plates were allowed to freely pivot/rotate once the arches began to fall over. They offered no assistance in resisting the collapse.
