**NORTH MEDFORD GYM COLLAPSE
MEDFORD, OR
STRUCTURAL EVALUATION**

KPFF PROJECT No. 10022500117

DATE
MAY 5, 2025

NORTH MEDFORD GYM COLLAPSE STRUCTURAL EVALUATION

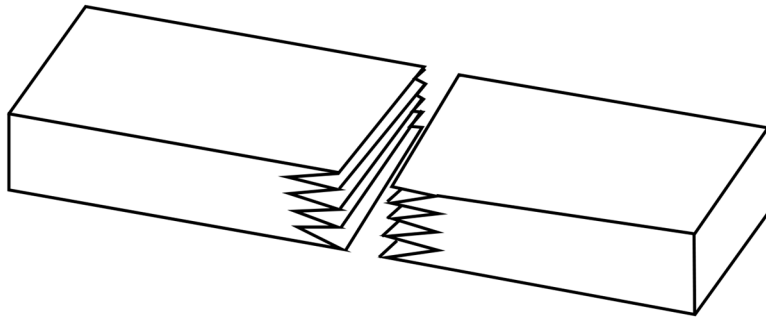
Figure 4 – Finger Joint

Current code glulam manufacturing standards utilize finger joints for the lamination end joint. Finger joints were first introduced in 1962 and by the 1970s were the more common end joint in glulam timber structural members. See Figure 4.
