# Aviation Investigation Preliminary Report

| <b>Location:</b> | Moab, UT | <b>Accident Number:</b> | DCA26LA012 |
| <b>Date &amp; Time:</b> | October 16, 2025, 06:43 Local | <b>Registration:</b> | N17327 |
| <b>Aircraft:</b> | Boeing 737 | <b>Injuries:</b> | 1 Minor, 111 None |

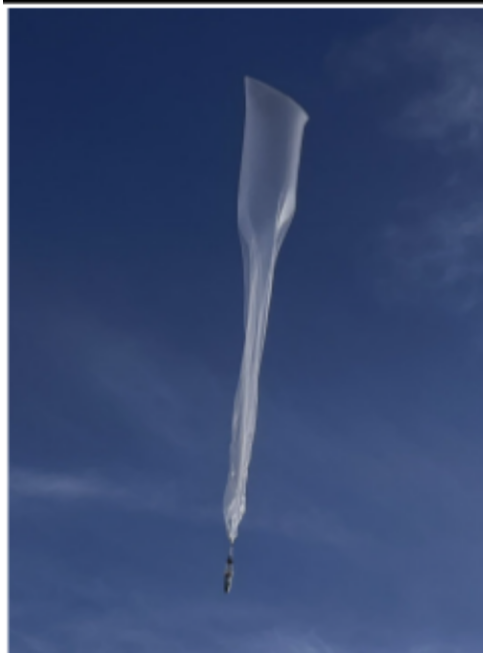
**Figure 3.** WindBorne GSB in flight. (Source: WindBorne)

The GSB system consists of a balloon envelope filled with lift gas, an avionics package for flight control, communications, and sensing, and a ballast system for altitude control. According to Windborne the GSBs are designed with the intent to minimize harm in the event of an impact during flight or landing. No large metal or high-stiffness structural elements are employed. The balloon envelope and the ballast container are a thin, low tensile strength, plastic film. The silica ballast is relatively low density and low grain-size.
