# ECRI

November 16, 2022

Re: Investigation of a Fire within an Ambulance

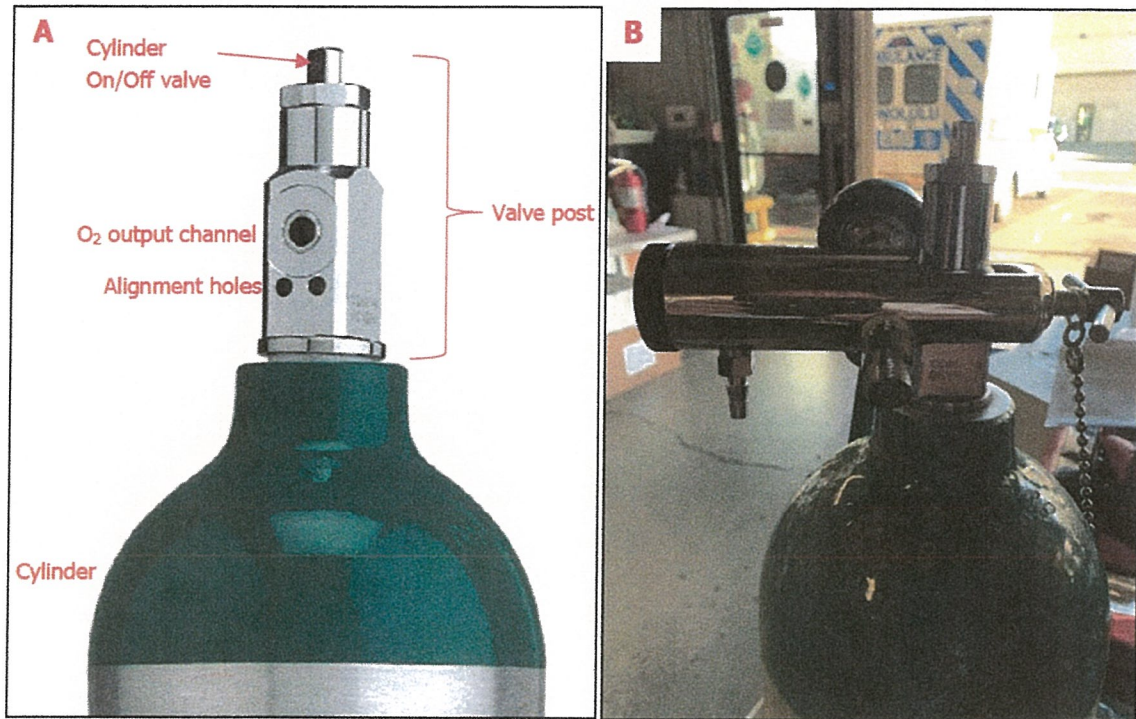
Figures 2 and 3 illustrate the different components of a medical O<sub>2</sub> cylinder and regulator. The depicted devices are the same manufacturer and model as the equipment involved in this ambulance fire. The O<sub>2</sub> cylinder is a size jumbo-D, and the regulator is a Cramer Decker AREG8725-B2D, which is a fixed pressure, variable flow regulator with two diameter-safety system (DISS) threaded connectors operating at 50 psi and one nipple adapter with flow rates that can be adjusted by the flow regulator knob (0 lpm to 25 lpm). The regulator has an aluminum body, a brass core, and chrome plated brass bodies. As of 2021, Cramer Decker rebranded to ProRack Gas Control Products.

**Figure 2A)** Medical O<sub>2</sub> jumbo-D cylinder and valve post **2B)** Assembled cylinder and regulator

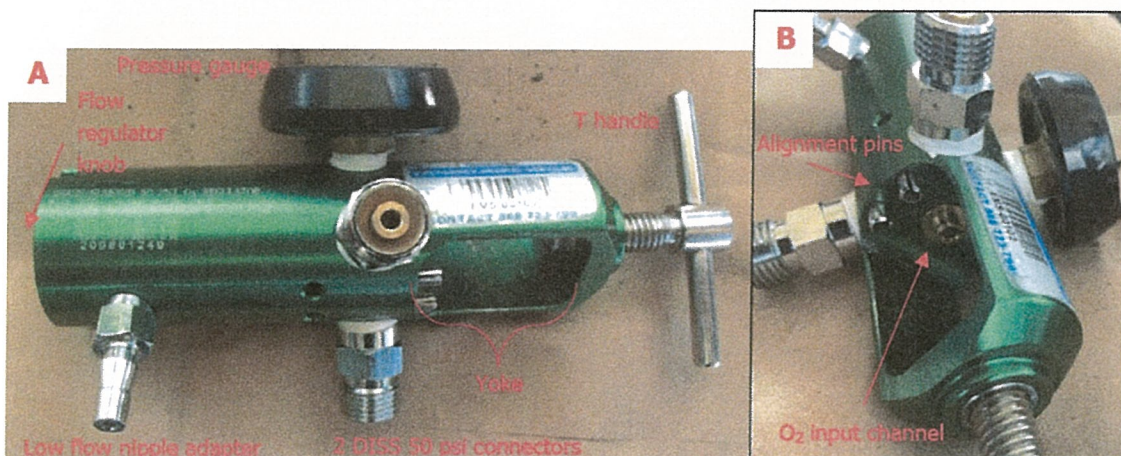
**Figure 3A) and 3B)** Different components of an O<sub>2</sub> regulator
