02/22/2019

# ROUTE 66 GASCONADE RIVER BRIDGE | STRUCTURAL EVALUATION

Prepared for the Gasconade River Bridge Guardians

SPARKS ENGINEERING, INC.

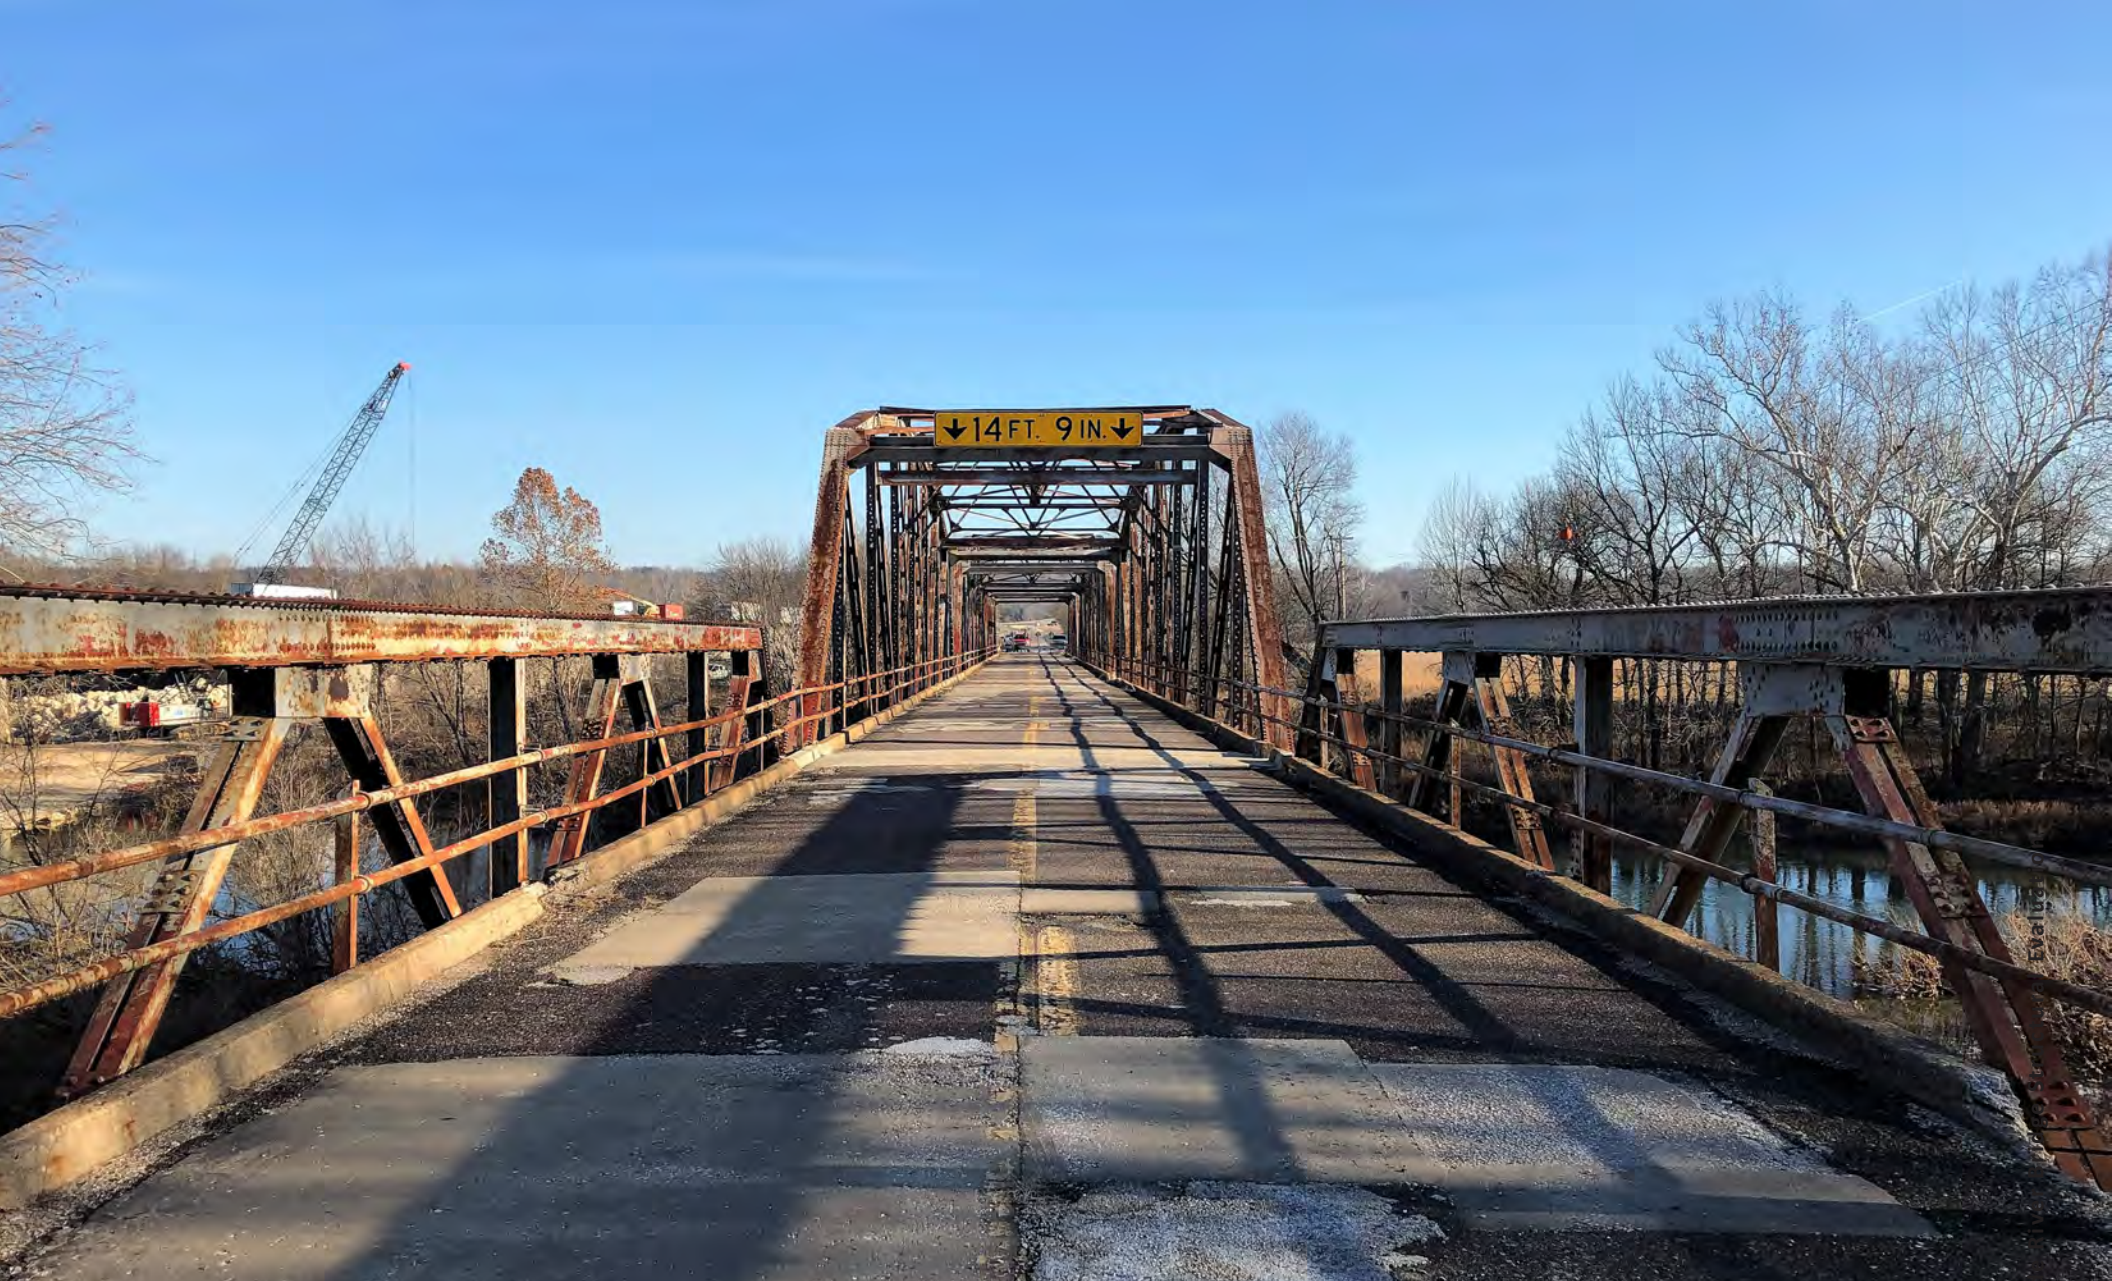
The existing pipe railings are generally sound with some isolated damage; however, the railing does not meet current codes requirements. Replacement is required if the bridge is rehabilitated.
