April 3, 2017

# Facility Condition Assessment

Nissan Stadium

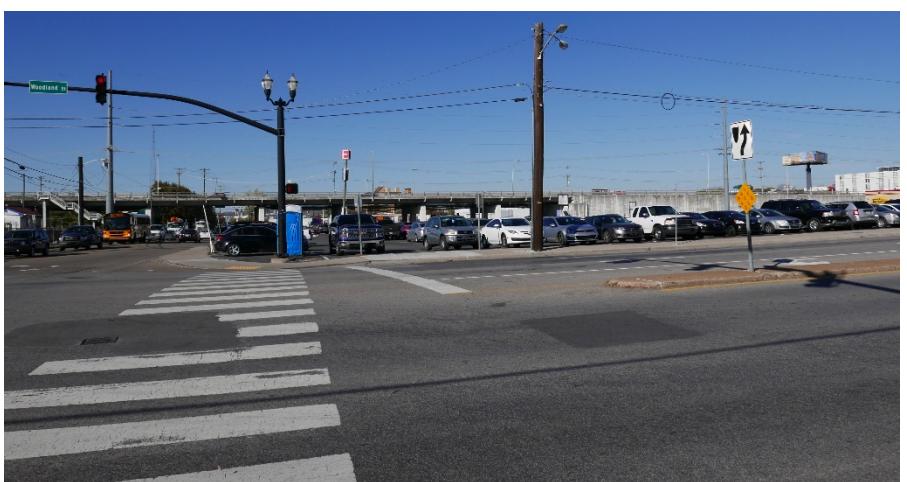
Parking Lot F

Lot F is located north of the stadium, across Woodland Street, which is a very busy street on event days. Lot F is characterized by insufficient landscaping and a poor pedestrian route to the stadium. The entry to lot F is not aligned with Lot E across 1<sup>st</sup> Street, which can lead to traffic congestion.

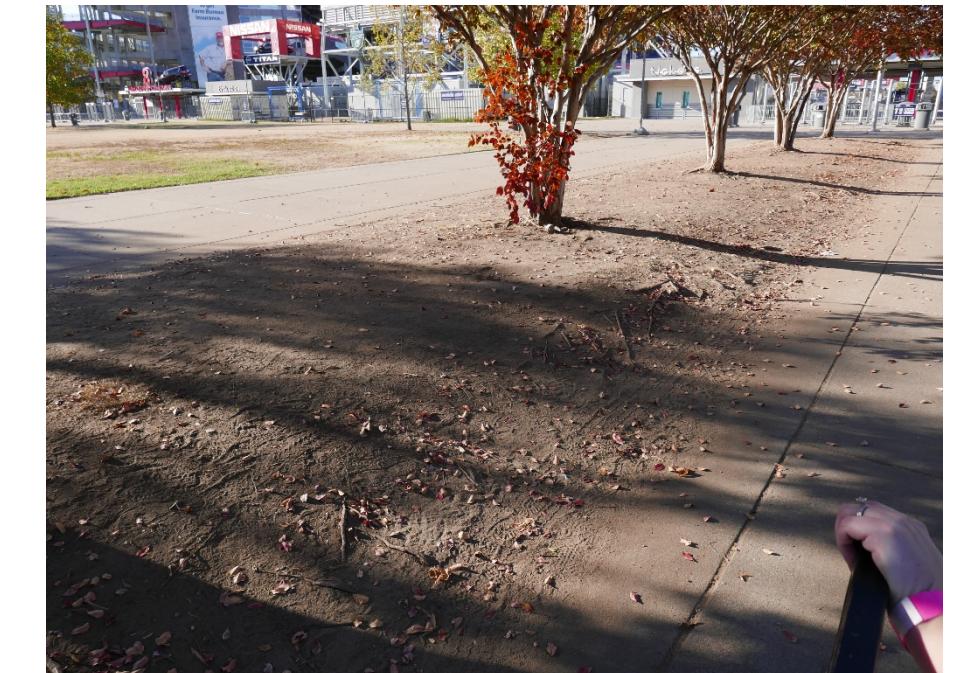
Parking Lot K

Lot K is a very small parking lot located immediately south of the stadium. Paving, striping and pedestrian features appear to be in good condition. Landscaping adjacent to Lot J has excessive wear from pedestrian traffic.

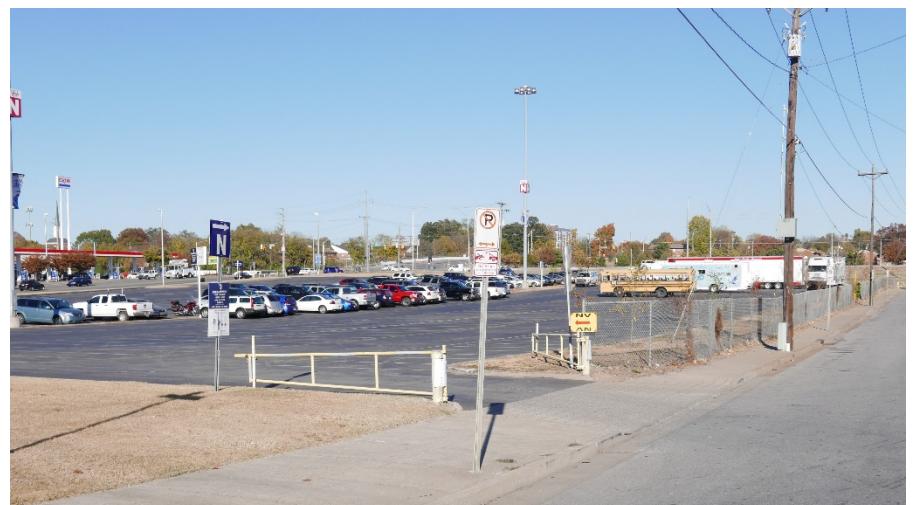
#### Parking Lot R

Lot R is two parking lots separated by the ramp to the old Shelby Street Bridge. Paving, striping and pedestrian features appear to be in fair condition—several drive lanes have deteriorated and are in need of repaving. Landscaping is very sparse in the portion of Lot R south of Korean Veterans Boulevard.

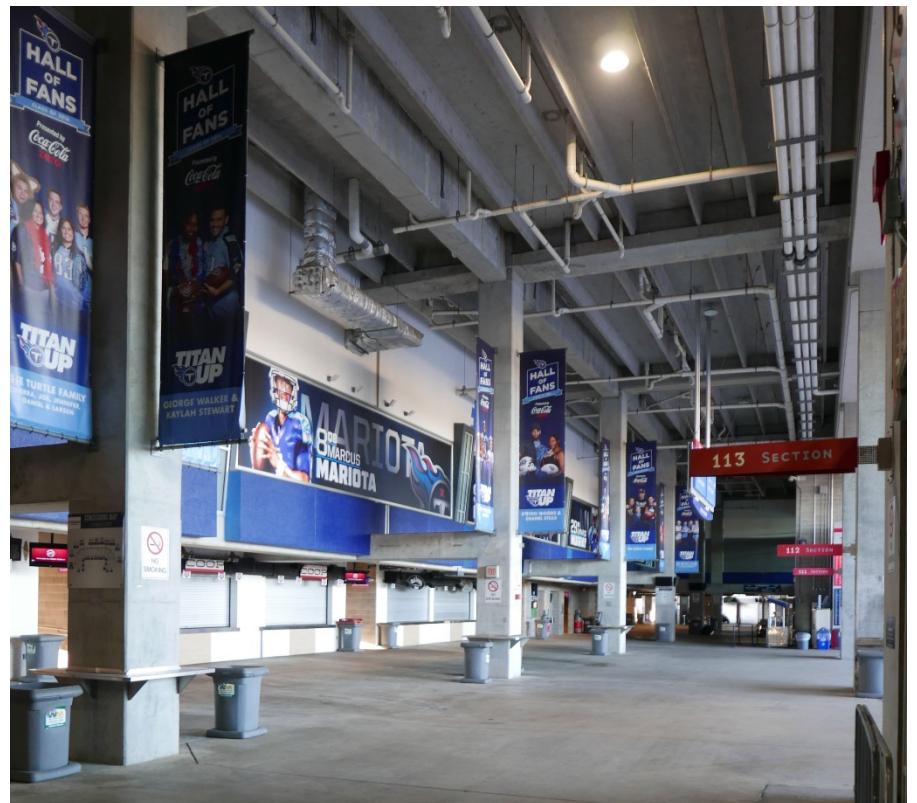
The overall impression of the main concourse is of unfinished or under finished space. This is primarily due to the extensive use of exposed unpainted concrete masonry units (of no special color) to construct many of the walls at this level. While colored CMU is often used to create durable and economical concourse walls, plain CMU is seldom used because of this unfinished effect. The floor finish in the concourse is generally plain concrete. Visible cracking in the concourse floor was limited.

Some doors and frames in high traffic areas are showing signs of wear and should be refurbished as part of routine maintenance.

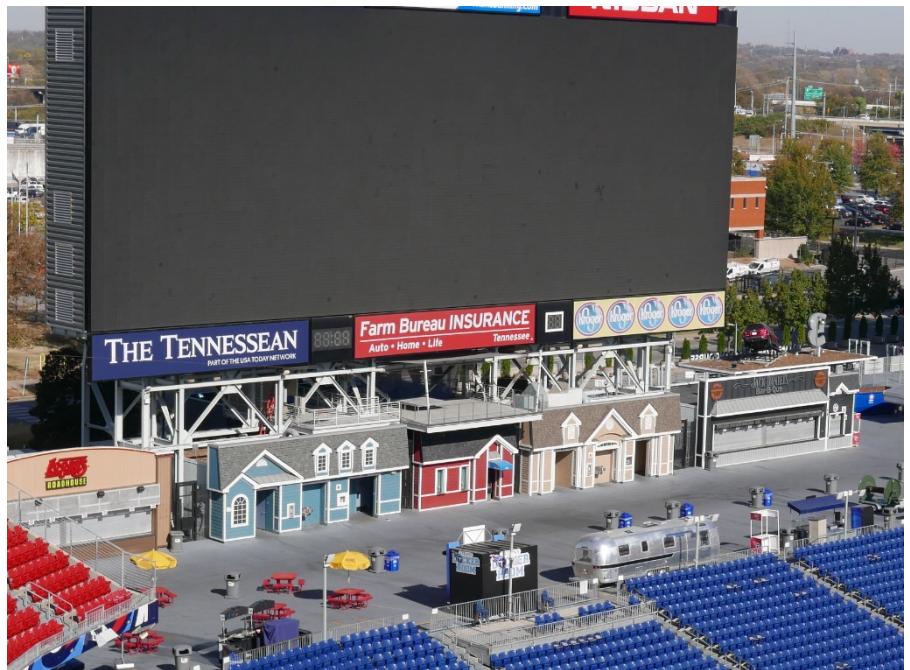
A collection of themed storefronts line the concession areas in each end zone under the scoreboard. While vaguely reminiscent of the scenic design of the Grand Ole Opry, these themed areas seem out of place at the otherwise starkly contemporary Nissan Stadium, and have proven difficult to repurpose without significant investment. The entrance to the Mother's Lounge is especially forbidding and should be reworked.

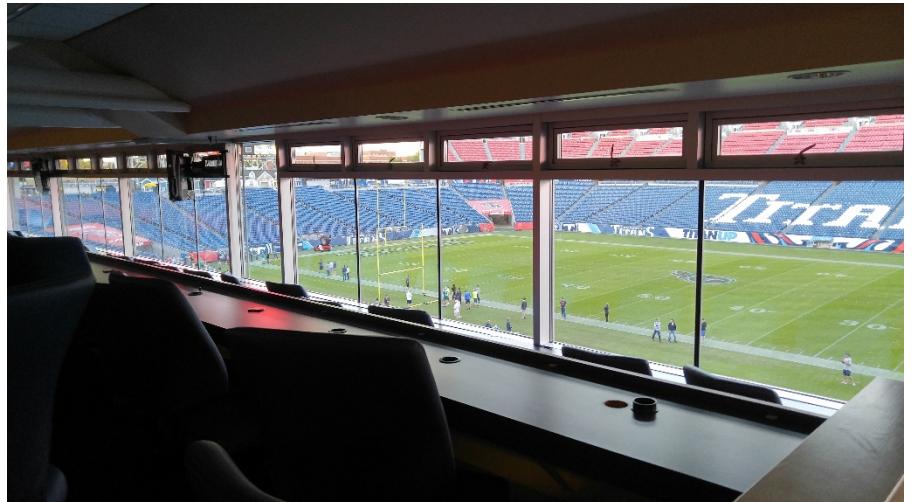
The writing press window to the field uses a curtainwall glazing system with vertical mullions that create partial obstruction of views of the playing field. Replacement of this glazing with fully butt-glazed insulated glass should be considered in the future. Chairs for the writing press are too large for the space available and should be replaced with smaller (though not necessarily narrower) chairs.

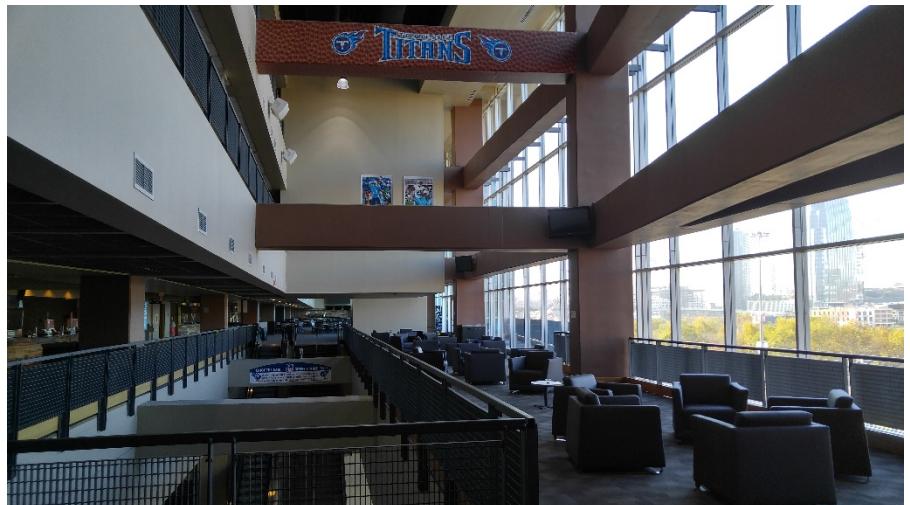
Printed sign at team store is not appropriate for upscale club lounge area. Likewise, some of the wayfinding signage (e.g., for restrooms) appears amateurish and not appropriate for the upscale environment. Concession areas lack overhead signage.

27. Replace printed retail signage on club level with dimensional signs. Replace wayfinding signage with appropriately designed dimensional signage system. Add overhead dimensional signage at headers above concession stands.

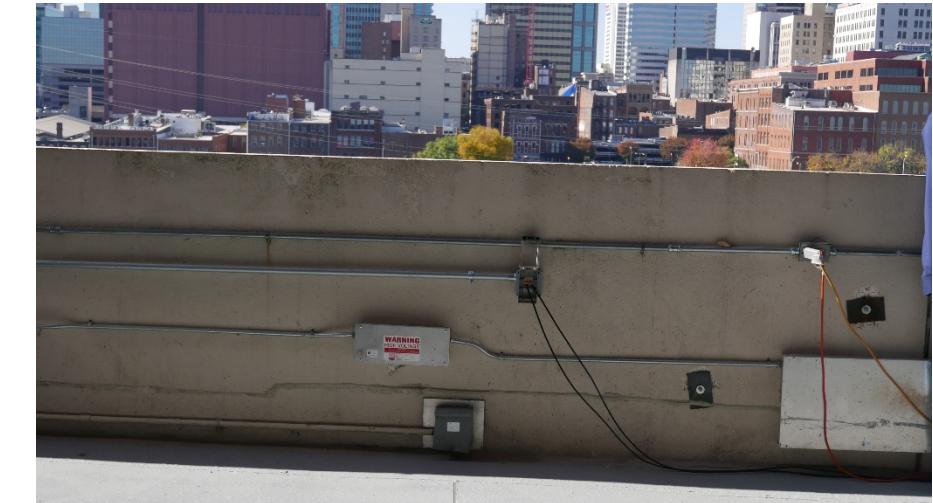
Some parts of the guardrail at the upper concourse are flat on top, allowing guests to rest food and drinks on it. Some portions of the guardrail effectively form a wall preventing views to spectators on the concourse. In some locations, concrete guardrail has accumulated an undesirable accretion of electrical conduit in a disorganized pattern.

46. Add angled trim to flat guardrail tops to discourage resting food or drinks on guardrail. Lower height of precast cladding from approximately 10 feet to 4 feet (with sloped top) where spectator views are possible. Replace electrical conduit on precast guardrail to minimize visual impact.

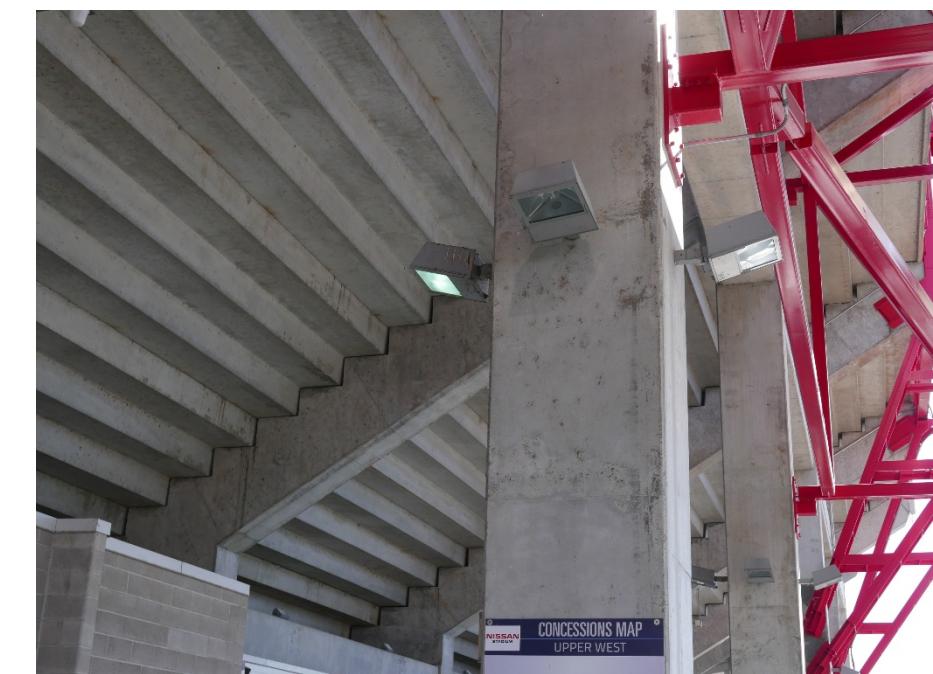
Lighting at the upper concourse is via HID floodlights. While efficient from a lumen per watt viewpoint, this lighting contributes to a lowest-cost ambience.

47. Replace HID floodlights at upper concourse with a decorative light fixture with similar output characteristics.

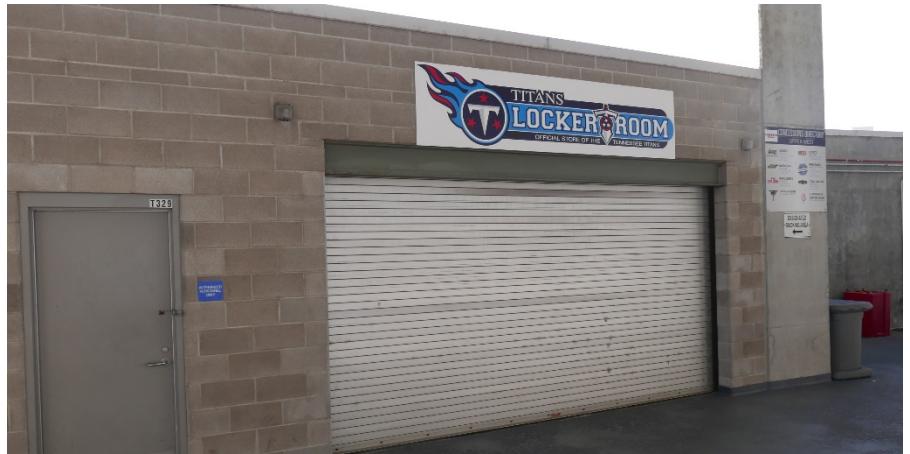
Retail signage is flat, inexpensively printed signs.

48. Replace printed signage at any retail area on the upper concourse with dimensional signage similar to permanent concession stands.

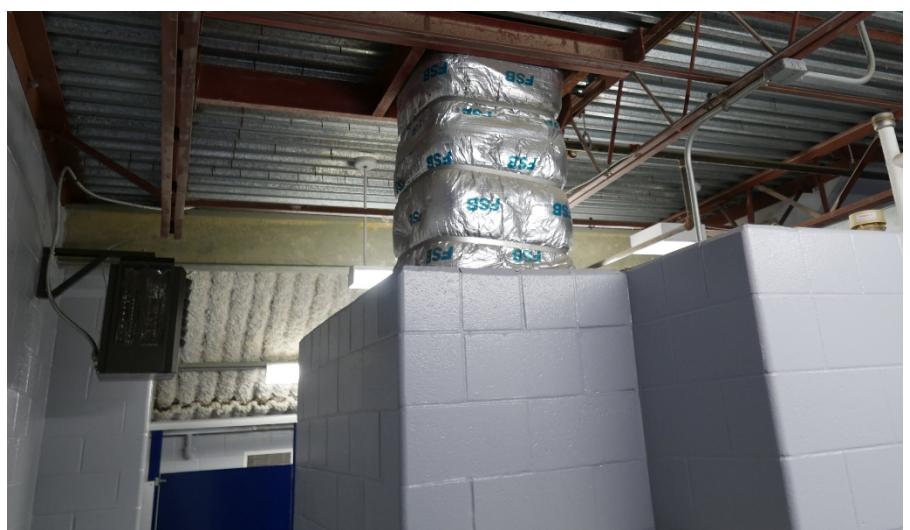
The restrooms have been updated as on the upper concourse; however, exposed fireproofing on the sloped ceilings detracts considerably from their appeal. The roof deck and structure within restrooms were never painted.

49. Add permanent, moisture-resistant surface at sloped ceiling area of upper concourse restrooms. Paint inside roof deck and all visible roof structure of restrooms.

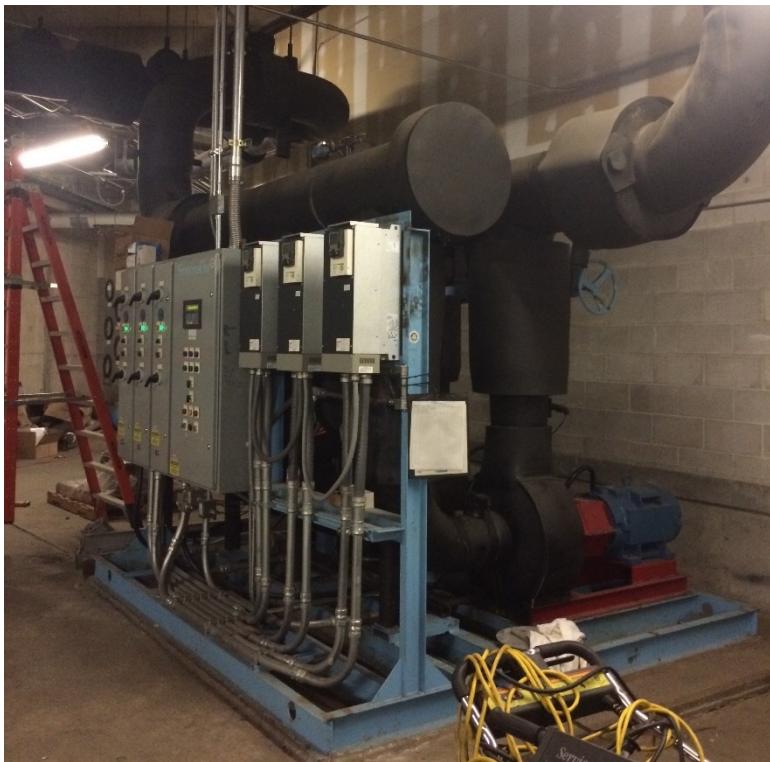
*Primary Chilled Water Pump Skid*

The chilled water system is original to the building and appears to be in moderate working condition considering its age. Purchased, district chilled water is supplied to the stadium by NDES for all cooling requirements. The chilled water system is not decoupled from the district loop system, meaning there are no heat exchangers that separate the building from the city loop. Because there are no heat exchangers, there is no equipment that requires maintenance or replacement other than pumps. The chilled water pumping system is served by three (3) variable-speed primary pumps sized for what appears to be 50% of the total flow for full redundancy. The pumps are each 50 HP end suction type. While the system may be sized for full redundancy at 3,600 gpm, the pumps are only able to produce on a peak day around 2,300 gpm. This in large part due to the additional scale build-up within the pipes from corrosion.

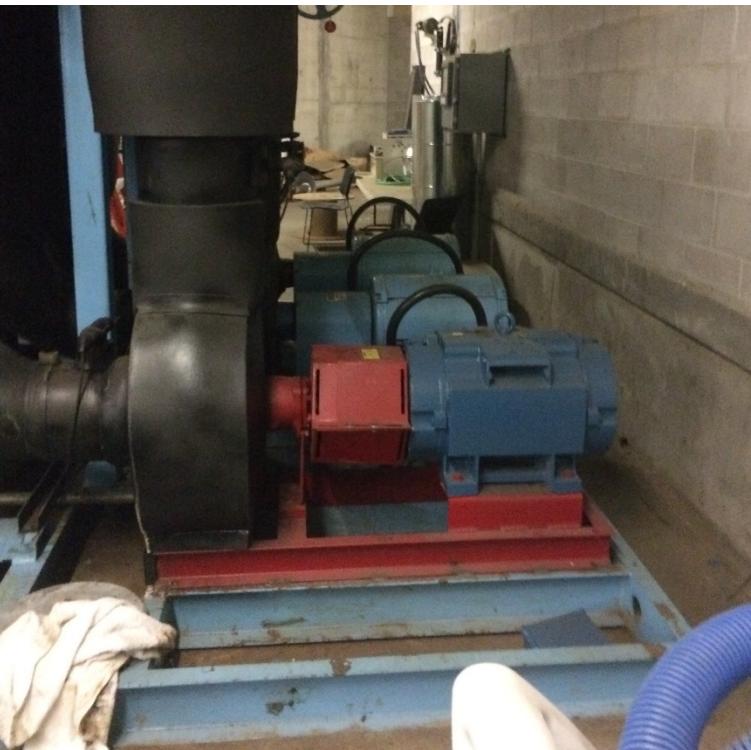
*Primary Chilled Water Pumps*

The chilled water system was designed to maintain a temperature difference between the supply and return lines of 14 degrees; however due to the restrictions, the system is only able to maintain around a 20 to 25-degree temperature rise. All the pumps appear to be in fair condition, given their age. The pumps are showing signs of wear. Pump condition is as follows:

- Chilled Water Pump, P-1: Motor replaced 1 year ago
- Chilled Water Pump, P-2: Bearings and seals replaced four years ago
- Chilled Water Pump, P-3: Bearings and seals replaced three years ago

The median useful life of the chilled water pumps is between 20 and 21 years. All of this equipment may outlive, or already has outlived its useful life due to maintenance, but should be considered for replacement soon.

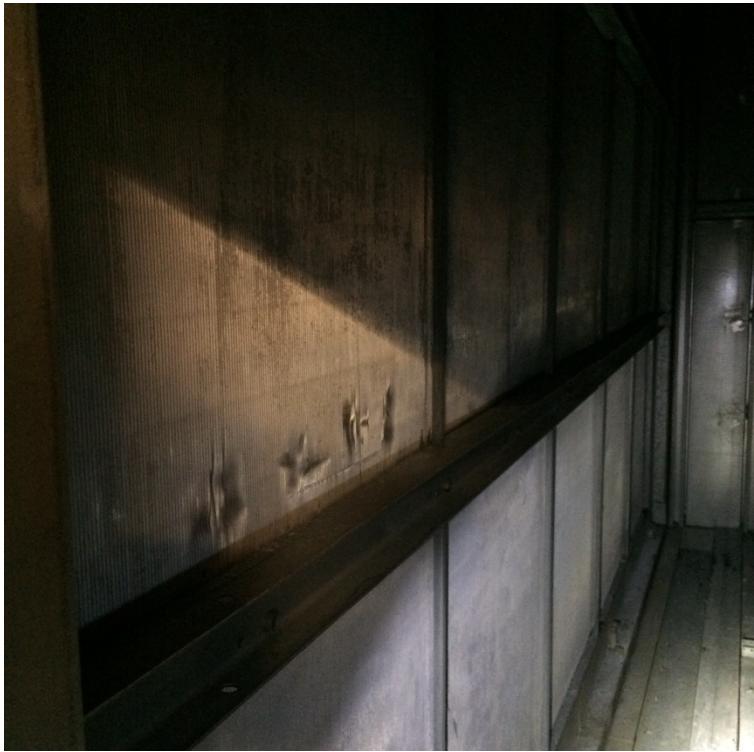
Club AHU Cooling Coil

The club level air handlers and their associated components appear to be in generally good condition considering their age and runtime. However, one of the air handlers apparently has a leak in the condensate drain pan that is getting onto the floor. The air handler on Level 3 Sector B has a buckled, return air mixing box plenum due to a restriction within the ductwork at one point in time. While this is not a replacement issue, it should be reviewed and confirmed there is no leakage of airflow through the buckled seam. The coils are original to the unit and need to be cleaned. The unit with the leak may require replacement of the coil in the immediate future due to rust spreading up the coil.

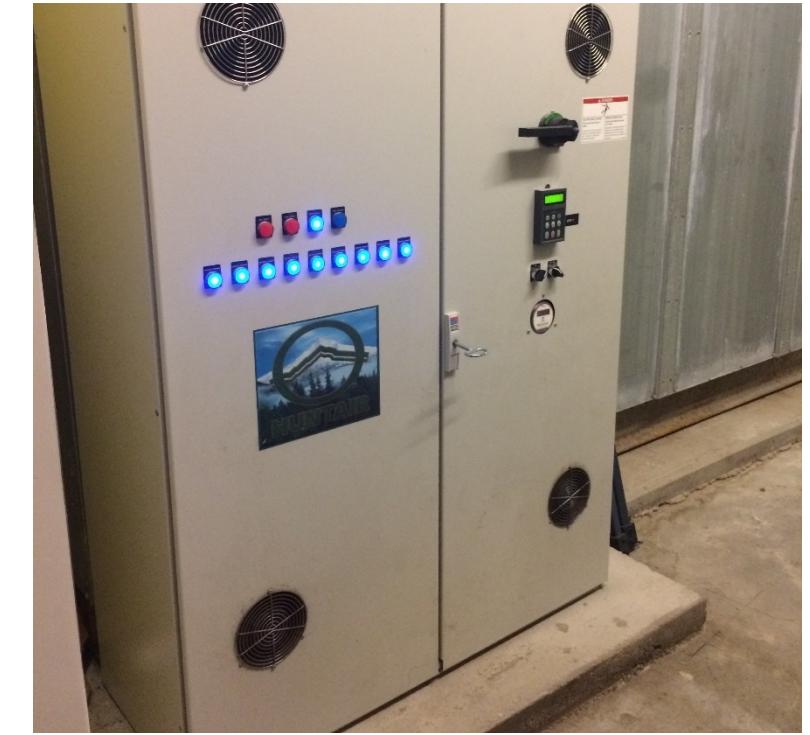
Club AHU Supply Fan Array VFD

Typical life span for a custom air handler is around 15-20 years. Hydronic coils are expected to last about 15 years, and fans reach their end of life around year 25. All this equipment may outlive, or already has outlived its useful life due to its good maintenance, but should be considered for replacement soon.

6. Based on the condition of the custom built-up air handlers in the club areas, it is recommended to stage replacement beginning within five (5) years. Each year replacing one (1) air handler with a standard custom air handling unit. It would be recommended to utilize a panelized knock down type construction for ease of placement and constructability.

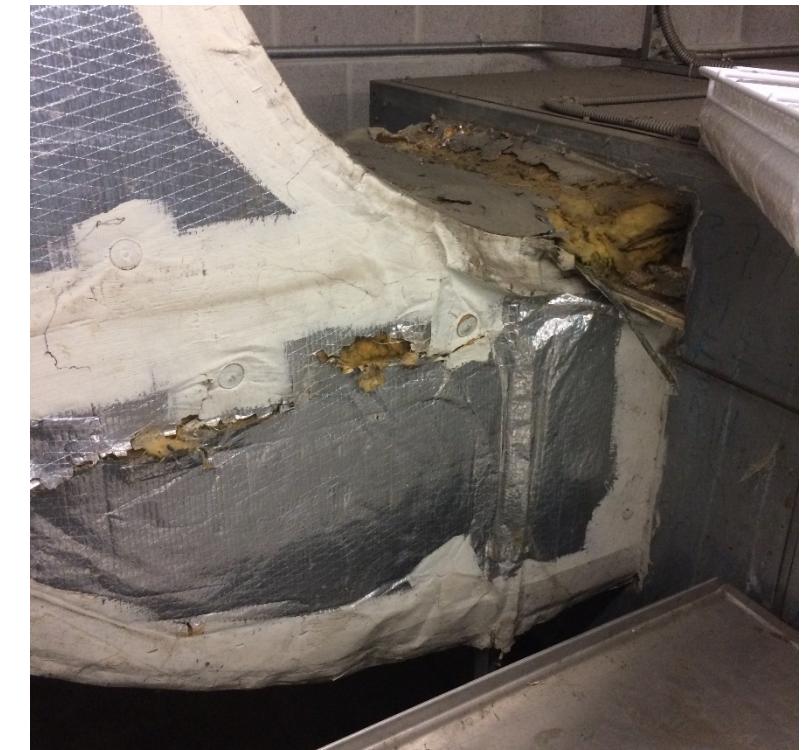
*Air Handling Supply Ductwork Insulation*

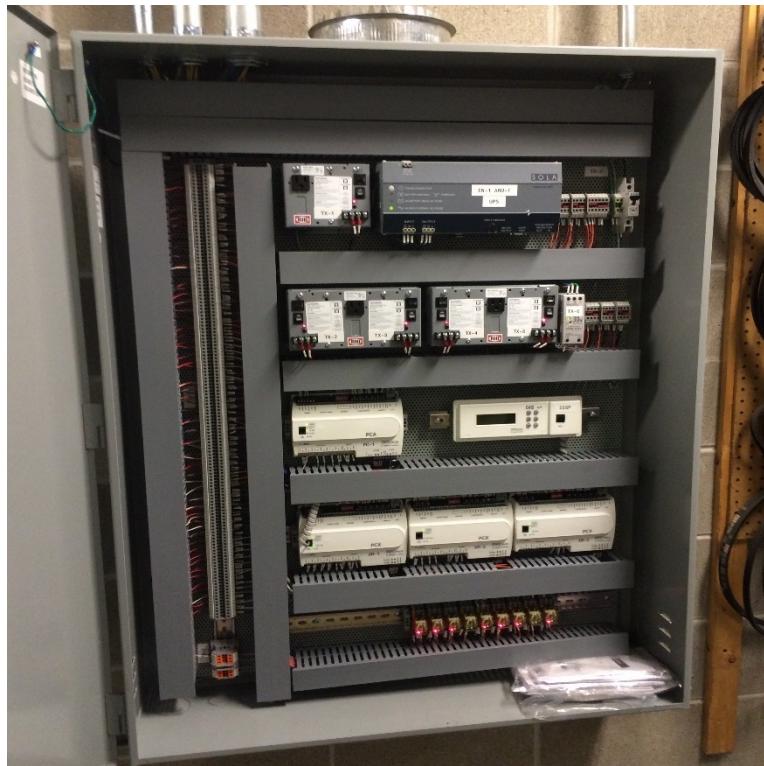
This system is the original BAS system with minor upgrades to the system, other than software updates. Most control issues are being addressed by maintenance staff. The software updates have ended, therefore causing the control system to be out of date. All building automation system components appear to be in good working order given the age of the system.

*Siemens Control Panel*

12. A complete replacement of the BAS system should be planned within the next two (2) years to allow the staff to properly operate and monitor equipment throughout the building.

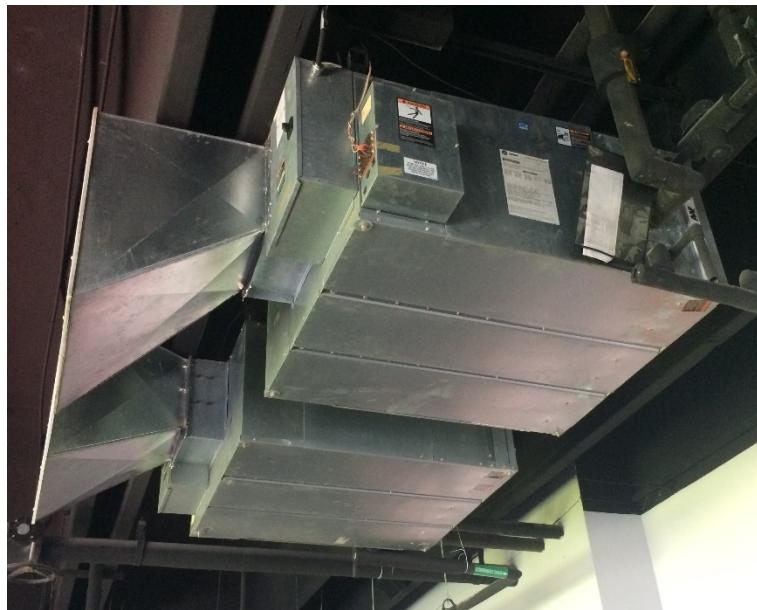
*Fan Coil Unit in Suite*

One of the major concerns is that all FCUs are provided with an isolation valve on the chilled water supply line but no isolation valve on the return line. This prevents the staff from replacing units without shutting down the entire chilled water system. Considering the location of most FCUs and the age of the equipment, this is a major problem.

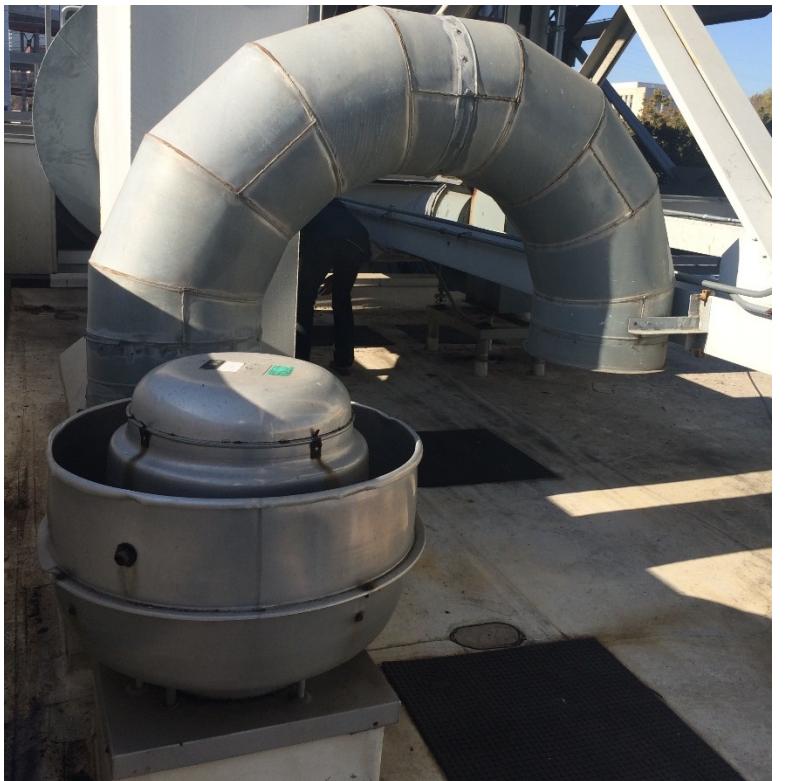
All equipment appears to be in a reasonable working condition, considering almost all exhaust fans are original to the building. The life span of a general exhaust system should be between 15 and 30 years. depending on the frequency of use and preventative maintenance.

*General Exhaust Fan on Low Roof*

15. We recommend adding all the building exhaust fans, including those for restrooms and cooking, to the BAS for enable/disable and status monitoring.

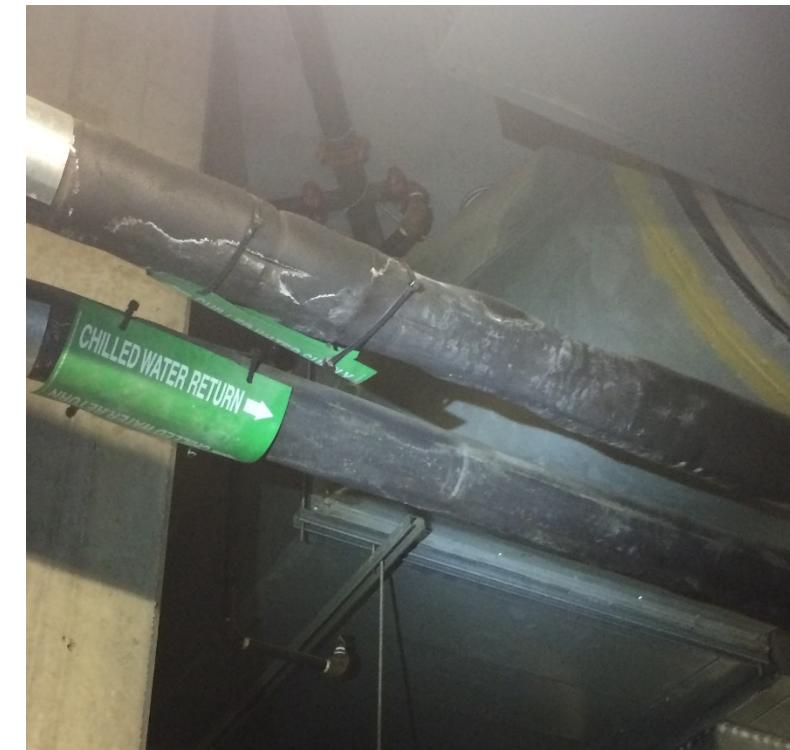
The chilled water insulation is showing signs of water damage in certain areas of the facility. Most of the chilled water piping serving the facility is insulated with a closed cell, fiber-free elastomeric thermal insulation.

*Chilled Water Insulation*

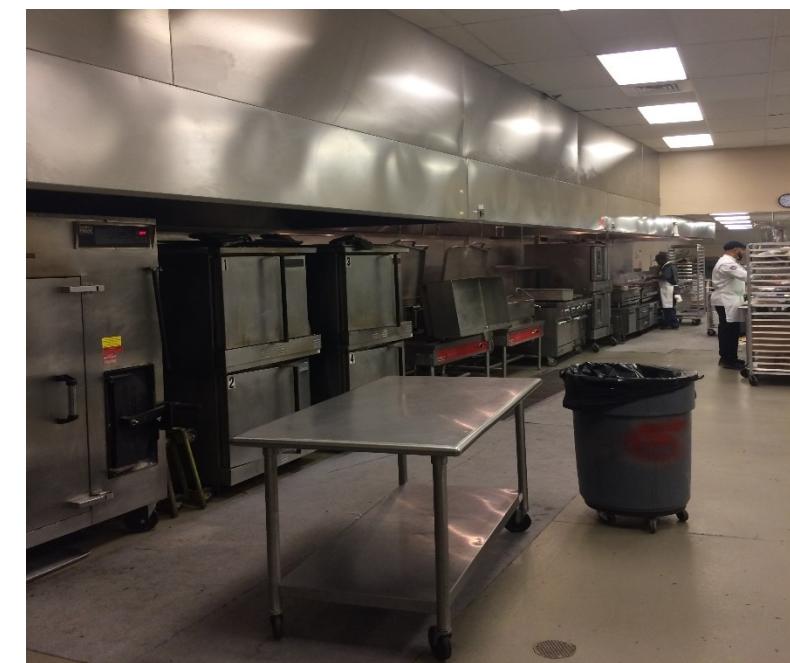
The grease fans during a full cooking mode are not able to eliminate all the smoke produced under the kitchen hood; this can be caused by the kitchen hood not being properly cleaned or a grease build up the ductwork which creates a low flow situation.

*Main Kitchen Exhaust Hood*

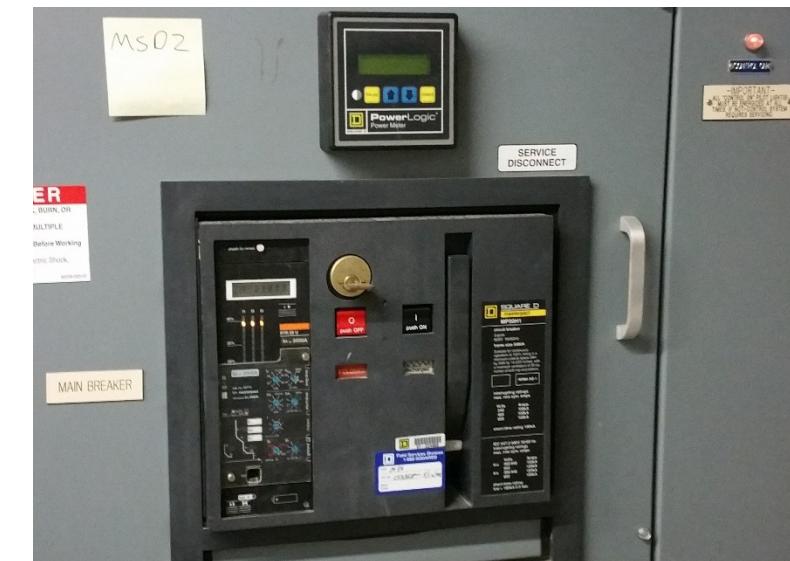
The main switchgear analog meter was observed to be turned 'OFF' on some of the main switchgear and is not connected to the stadium's central building monitoring system.

*Main Breaker and Analog Meter*

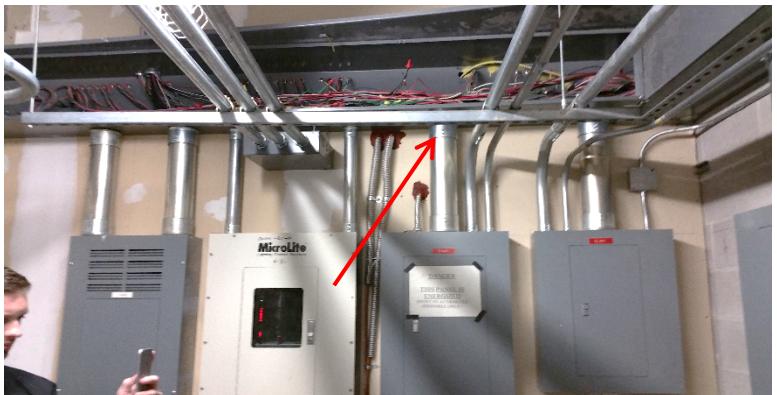
Several junction boxes and wireways were observed to be open and missing covers completely.

*Normal and Emergency Circuits run in the same wireway which is missing the cover*

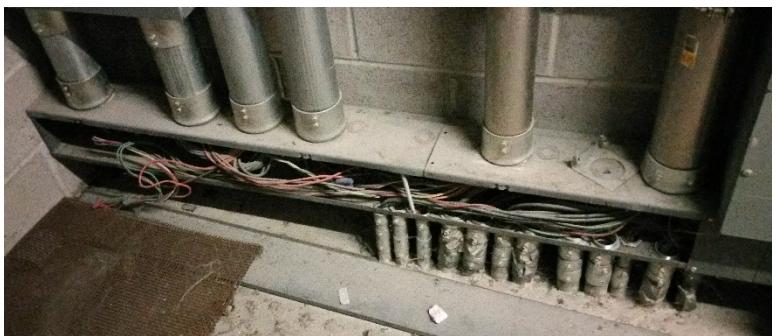
*Open Wireway*

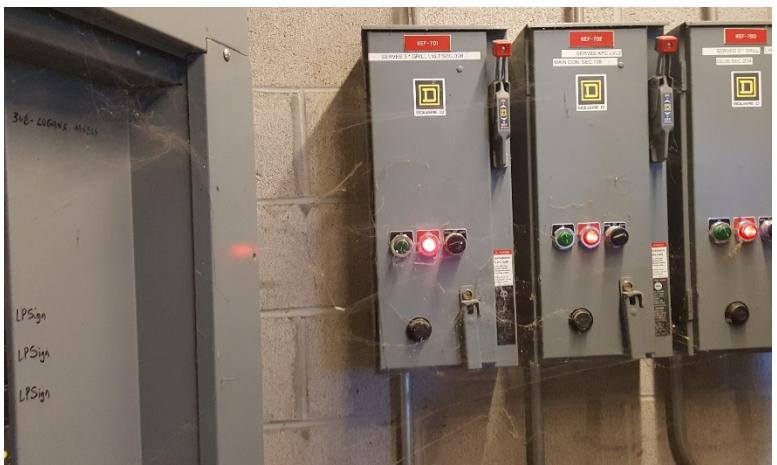
The riser electrical rooms on the upper concourse were extremely dusty at the time of the walk-through.

*Cobwebs in Upper Concourse Electrical Room*

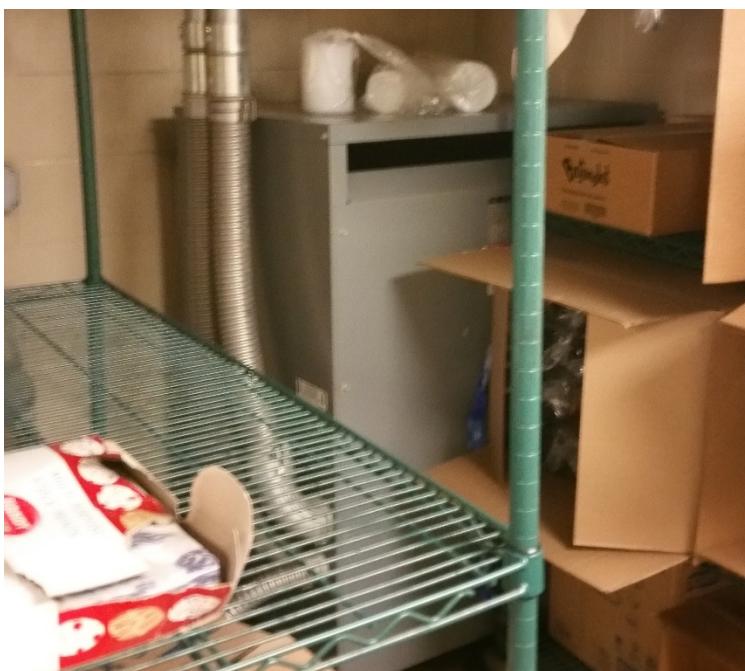
The concession transformers were observed to not have adequately maintained clearances or were being utilized for shelving.

*Concession Transformer with Improper Clearance*

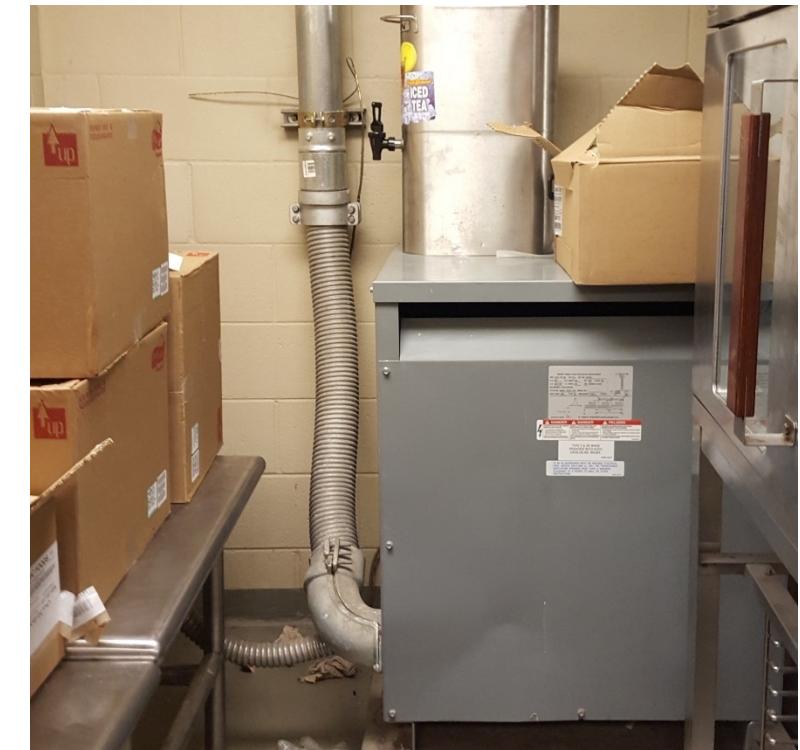
*Concession Transformers*

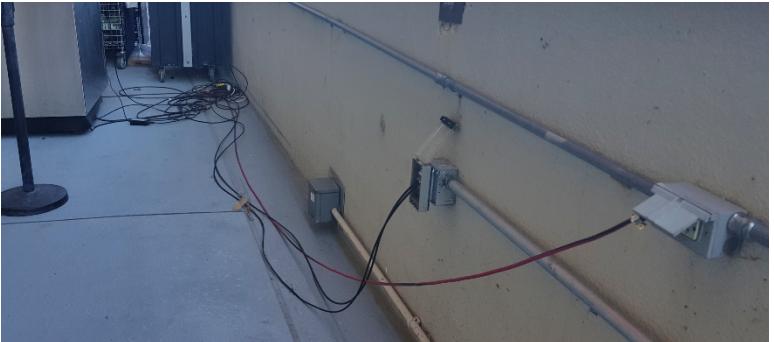
The main concourse portable cart power at each end zone and the upper concourse appeared to not have an adequate quantity of power connections for the current portable concessions

needs. During the assessment, multiple extension cords were observed being utilized to distribute power to multiple carts, which is shown.

*Upper Concourse Portable Carts Serviced by Extension Cords*

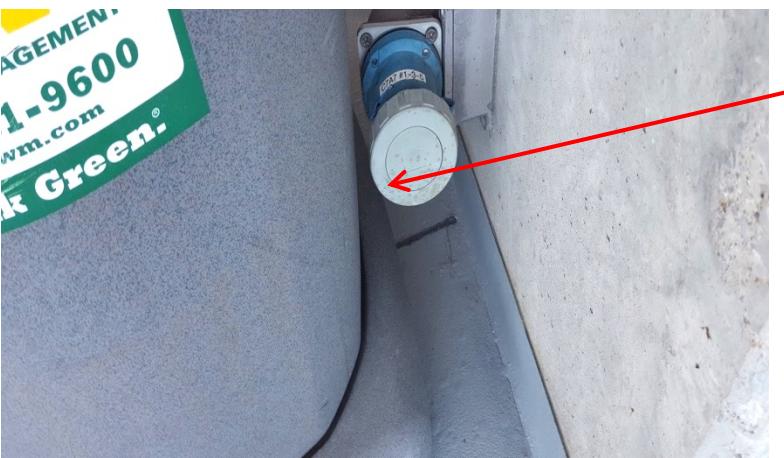
*Damaged Portable Cart Connection*

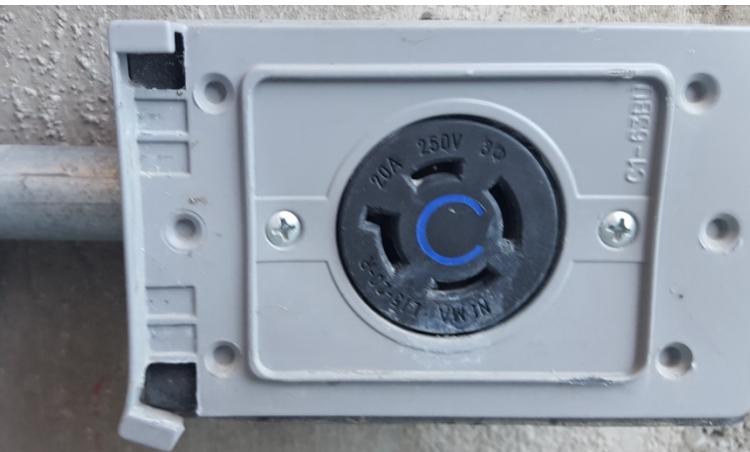
*Upper Concourse Cart Receptacle Missing Cover*

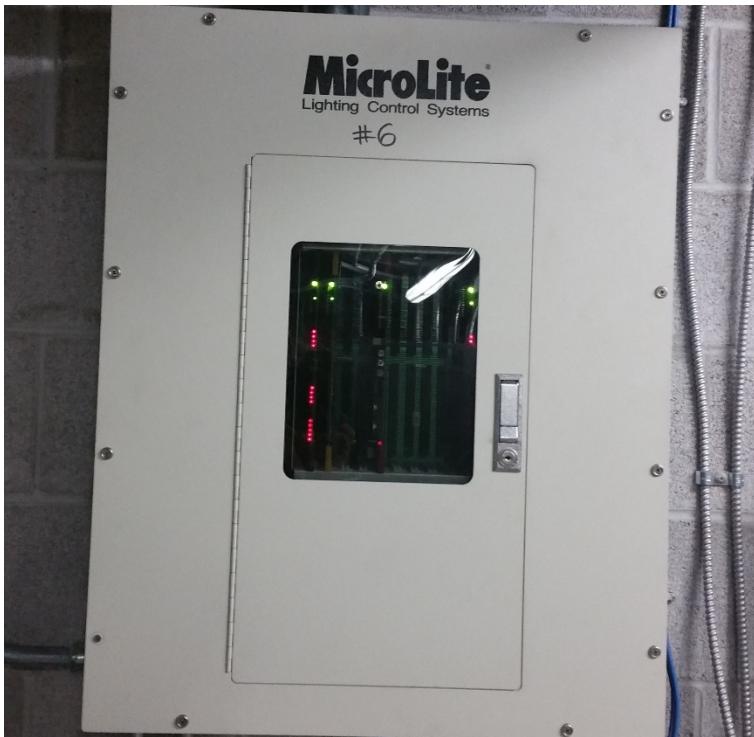
The original MicroLite main control touchscreen panel located above the PC screen was observed to be no longer functional. The maintenance staff is having difficulty finding replacement parts for the system since the product is no longer manufactured.

Existing MicroLite Relay Panel

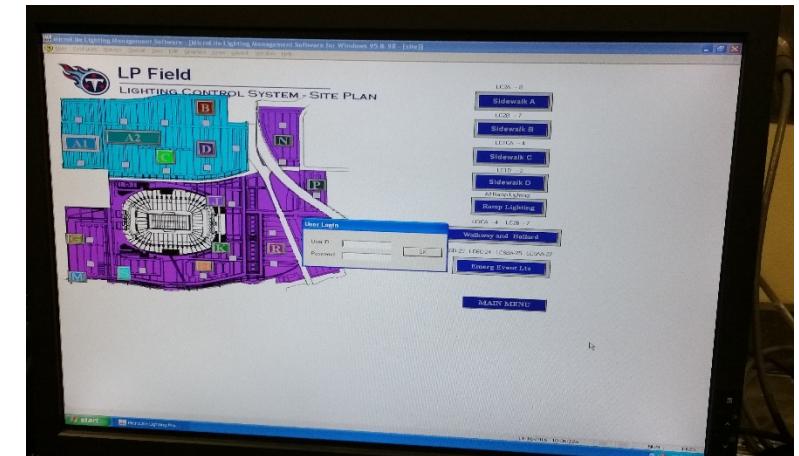
MicroLite Lighting Control Master Station

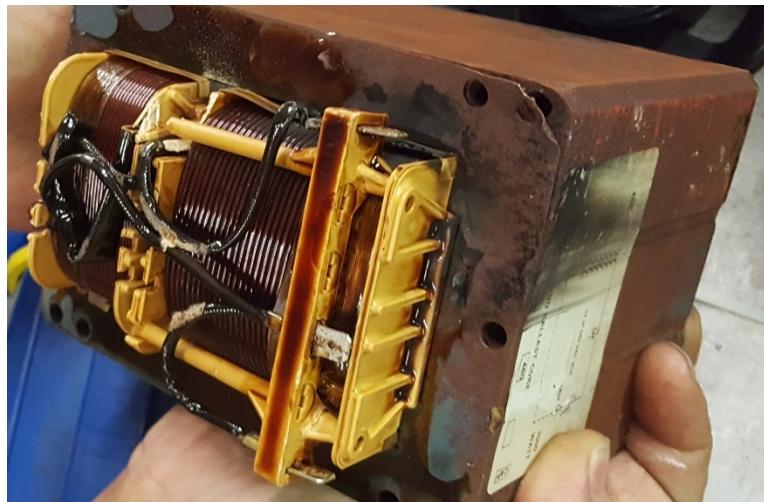
It was noted that the sports lighting ballasts have started to fail on a more regular basis.

*Failed Sports Lighting Ballast*

26. Replace existing sports lighting fixtures with LED fixtures, which in the next few years will become more prominent within stadiums of this size and usage. Advantages of LED sports light fixtures include the ability to instantly turn fixtures ON/OFF and much greater flexibility within the control system, including various scene settings. LED source also allows for better control

27. Institute a program of group re-lamping of existing sports lighting fixtures to maintain proper lumen output. The re-lamping time should be based on the lamp manufacturer's recommendation, but in general, it is approximately at 75% of lamp life. Metal halide lamps in this type of application typically have a life span of approximately 10,000 – 12,000 hours.
28. Replace the existing head-end fire alarm control panel and have the system recertified.
29. Continue to implement the existing preventative maintenance plan and service records for the fire alarm system in accordance with the NFPA-72 and the local A.H.J. requirements.

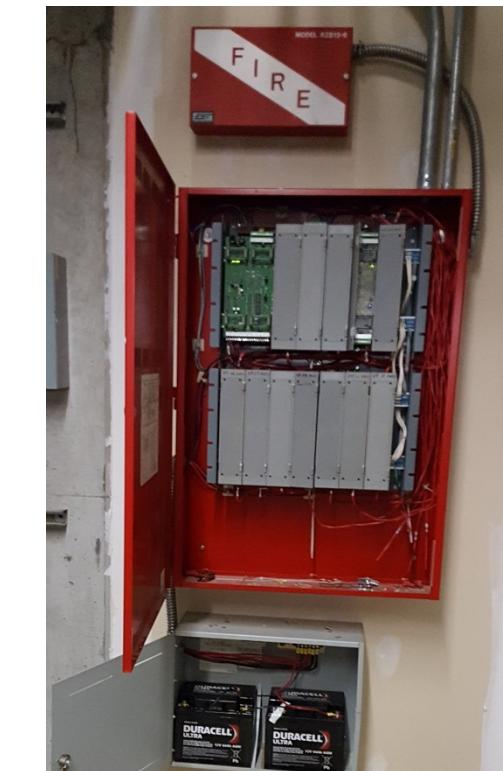
The fire alarm riser panels located in the electrical riser rooms were observed to be in excellent condition.

*Fire Alarm Riser Panel*

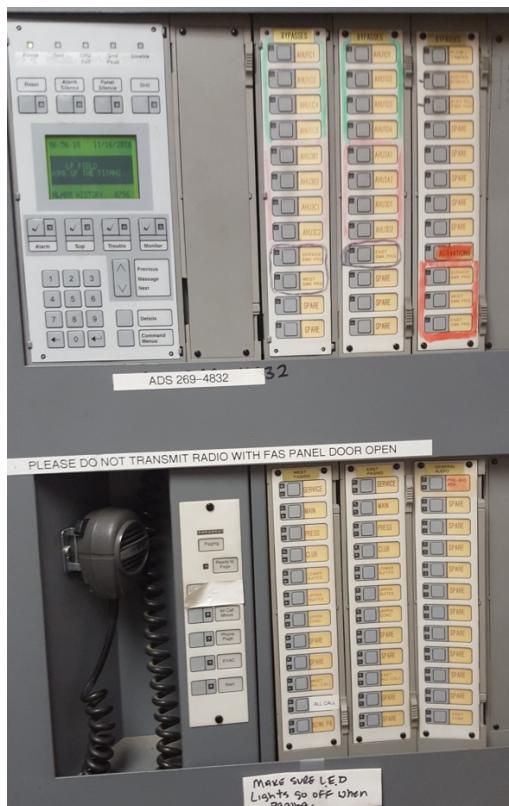
Maintenance staff noted that strobe synchronization has not been able to be accomplished with the existing fire alarm panel.

**Fire Alarm Control Panel**

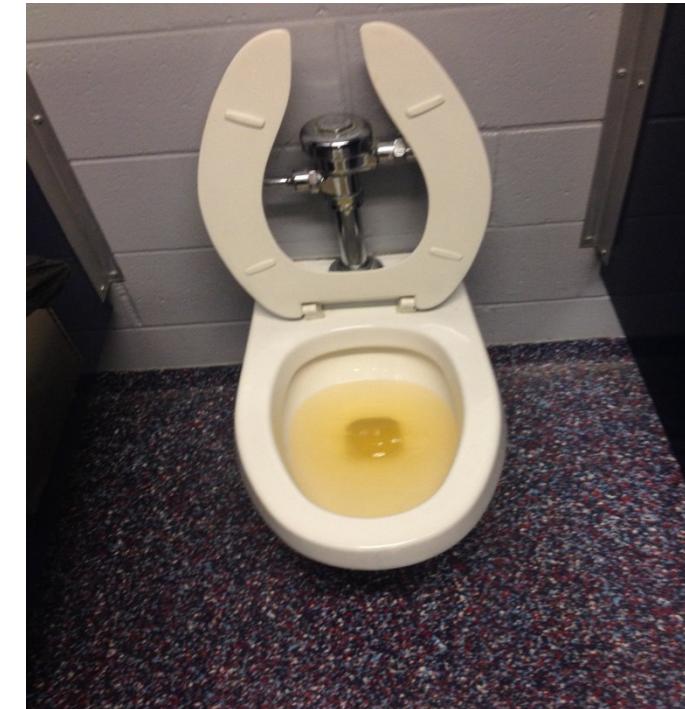
The galvanized coating inside all of the cold water piping has deteriorated over the years, and now the piping is oxidizing at an accelerated rate. Currently the maintenance staff is flushing the entire cold water piping system four (4) days before an event. (Example: Flush Thursday before a Sunday Titans game.) The staff has installed flushing ports at the event level and upper concourse level. These flushing ports consist of a 2 ½-inch valved hose connection. There are four (4) on the low-pressure zone system at the event level and six (6) on the high-pressure zone system at the upper concourse level.

Water Closet Upper Concourse – Discolored Water from Corrosion

This observation was performed Wednesday and Thursday after a Titans game on the previous Sunday afternoon. After flushing the water closets and urinals in one of the men's restrooms on the upper concourse for approximately 5 minutes, we began to see evidence of additional buildup of corrosion in the domestic cold water main. The flushing procedure requires two (2) technicians dedicated to this effort for 8 hours each time. As the corrosion continues, more time may be necessary to flush the system until clear water is present in all fixtures at all levels of the stadium.

1. The galvanized cold water pipe and fittings should be replaced. In addition to the ongoing cost for regular flushing, the condition of the inner wall is a potential breeding ground for bacteria and viruses such as legionella. Suggested replacement piping materials would be type "L" copper, stainless steel, Schedule 80 CPVC or Aquatherm. Victaulic type fittings could be used for either copper or stainless steel.

2. An option for consideration would be to replace the larger main sizes that are 4-inches through 12-inches with one of the suggested piping materials. There are contractors that specialize in lining existing piping within existing walls and chases. This is usually limited to pipe sizes 3-inches and smaller. The liner is typically an epoxy, plastic or glass product and would need to be NSF approved. The lining is applied after the interior wall of the existing piping has been cleaned/prepped for the application of the liner. This method minimizes demolition and rebuilding of wall cavities and chase walls.

3. We wouldn't recommend draining the cold water system down in the future until the piping could be replaced as previously discussed. Several maintenance issues occur during the refilling of the system that requires replacement of flush valve diaphragms, removal of some water closets to remove debris from the rim water supply channel, and replacement of lavatory faucet "O" rings and aerators. Draining the system allows more oxygen into the piping system. This only promotes increased oxidation.

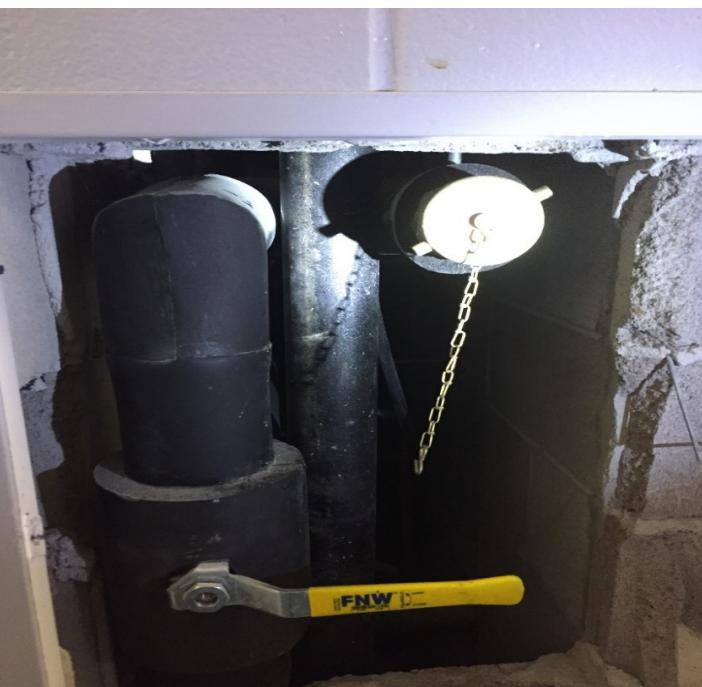
Domestic Water Flushing Port – Upper Concourse
