April 3, 2017

# Facility Condition Assessment

Nissan Stadium

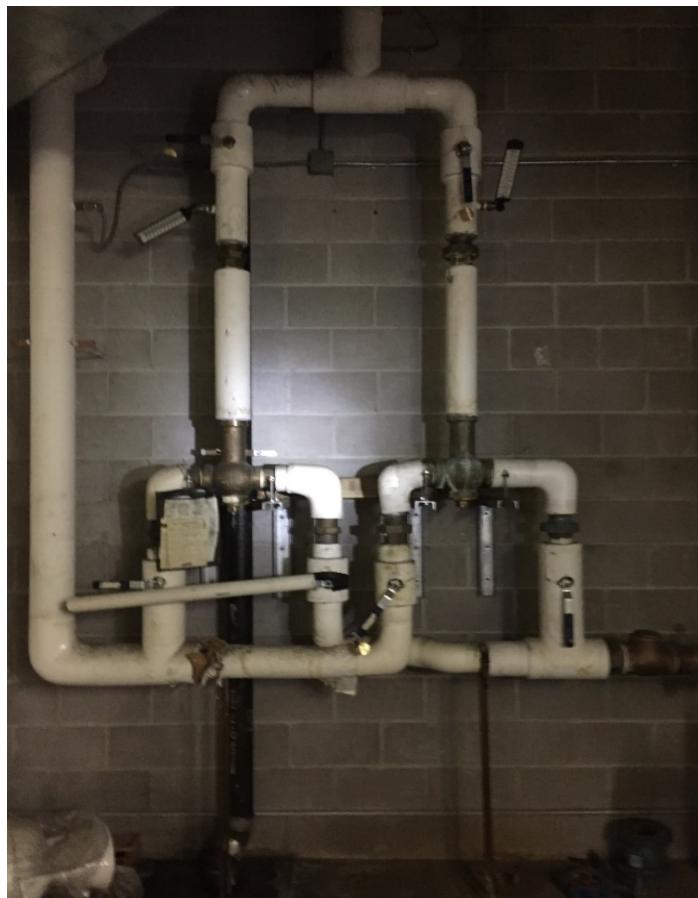
*Holby Mixing Valve Station*

5. The existing Holby mixing valve station is near the end of its expected service life. There are two (2) valves at this location. The piping was originally designed incorrectly to allow for operation of both valves. After one valve was isolated with the remaining valve in service, it was discovered that only one valve is required to satisfy the hot water load. We recommend replacing with newer technology that allows for variable flow conditions and a system that can communicate with the building automation system.

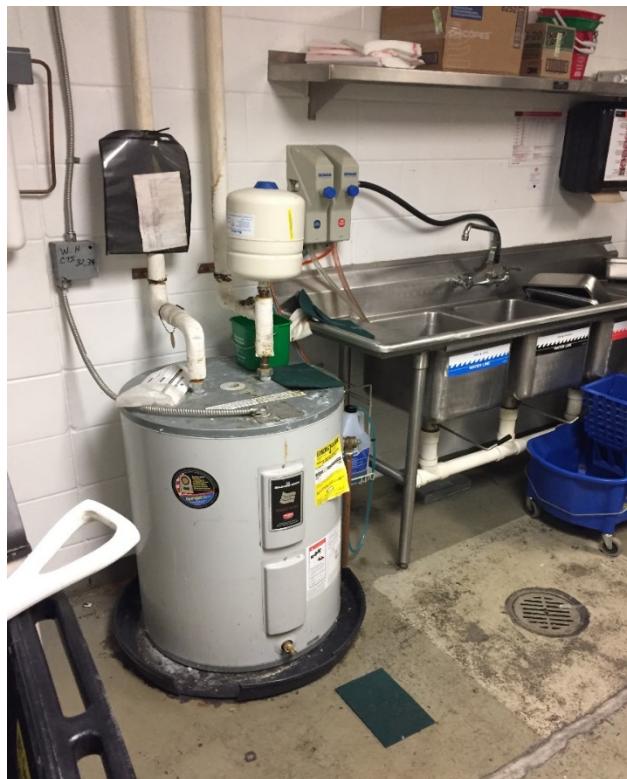
The electric heaters provided in the concession stands appear to be undersized. Typically, a 40 or 50-gallon heater has been provided. The 3-compartment sink in the concessions is the hot water user in the concession stands. This fixture will use all the available hot water to fill all three compartments when a 50-gallon heater is used, leaving no hot water for hand washing until the electric heater has recovered.

*Concession Water Heater*

6. Replacement of the existing multiple electric water heaters should be on an as needed basis. Consideration should be given to increasing the size of the heaters in the concessions to provide adequate hot water quantities at temperatures the health department may require.

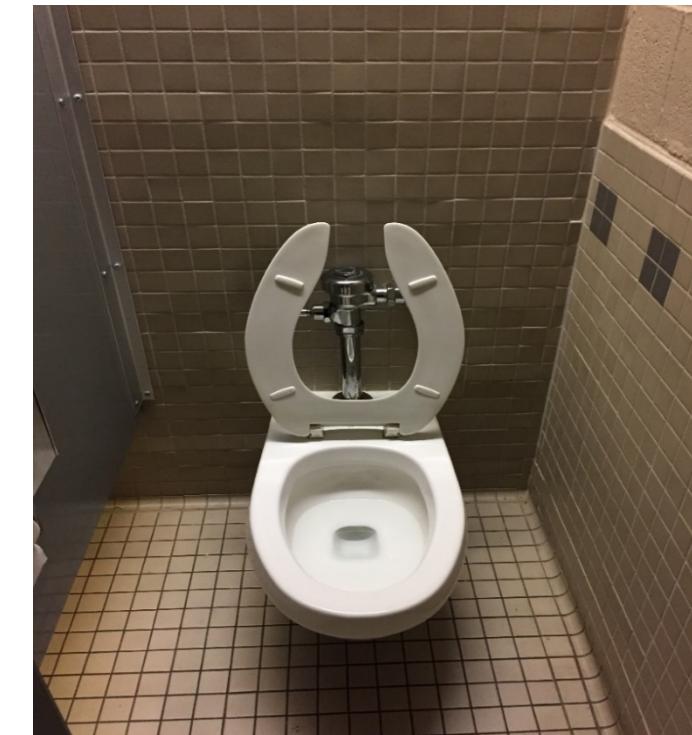
Water closets are 3.5 Gallons Per Flush (GPF). They are wall hung type but use a 3-bolt pattern wall carrier. Currently there are only two (2) fixture manufacturers, Kohler and American Standard, that still can provide fixtures with this bolt pattern.

*Typical Flush Valve Water Closet*

7. The three bolt water closet carriers are going to present a problem. As manufacturers phase out this product, the stadium will need to begin a program of replacement. This will involve demolition and rebuild of the chase walls where the fixtures are installed. When the fixtures are replaced, we would recommend replacement with a 1.28 GPF fixture as this uses 64% less water than the current water closets. There are 772 water closets in the stadium.

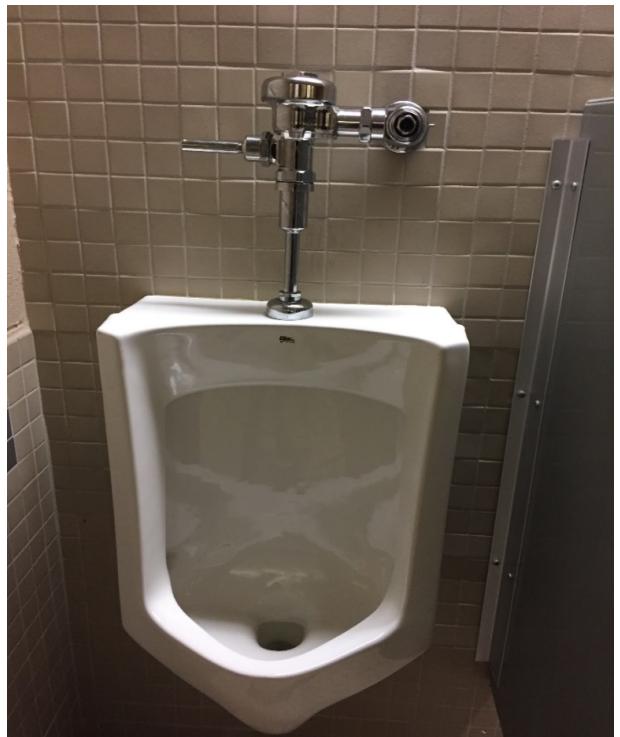
Flush valve urinals are 1.0 GPF. Lavatory faucets are currently being replaced and are assumed to be units that allow for only 0.5 GPM flow rated. Original faucets remaining in service are assumed to be 2.0 GPM each.

*Typical Flush Valve Urinal*

8. We recommend replacement of the existing 1.0 GPF urinals with pint flush urinals. Each urinal will save 7 pints of water each time the fixture valve is operated. There are 346 urinals. If all 346 urinals were flushed at the same time, they would use 346 gallons of water. If they are replaced with pint flush urinals, only 43 gallons of water is used to flush all 346 urinals.

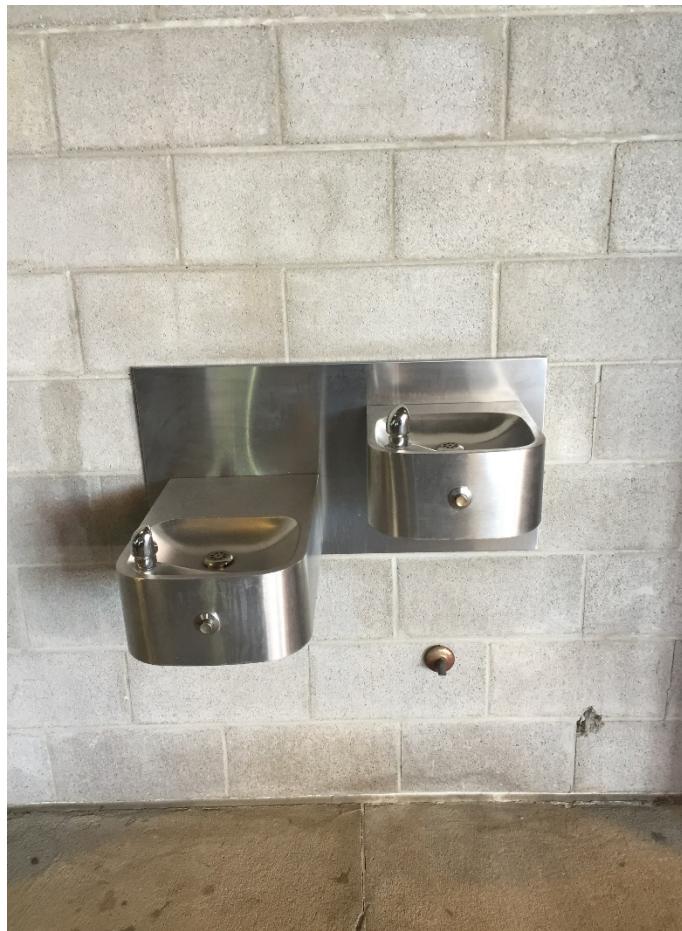
Electric water coolers are provided along the main and upper concourses. The refrigeration units serving these fountains are manufactured by Halsey Taylor or Sunroc and located in a closet behind the fountains. Parts are becoming scarce for these units. The fountain is a stainless-steel product and appears to be in good condition.

*Stainless Steel Drinking Fountain*

9. We recommend continued replacement of lavatory faucets. Replacement units should include 0.5 GPM aerators.
10. We recommend replacing all refrigeration units with a manufacturer that can provide replacement parts in the future; removing the refrigeration feature to convert the electric water coolers to non-refrigerated drinking fountains; or replacing the existing fountains with new drinking fountains. The plumbing code doesn't require public drinking water to be refrigerated.

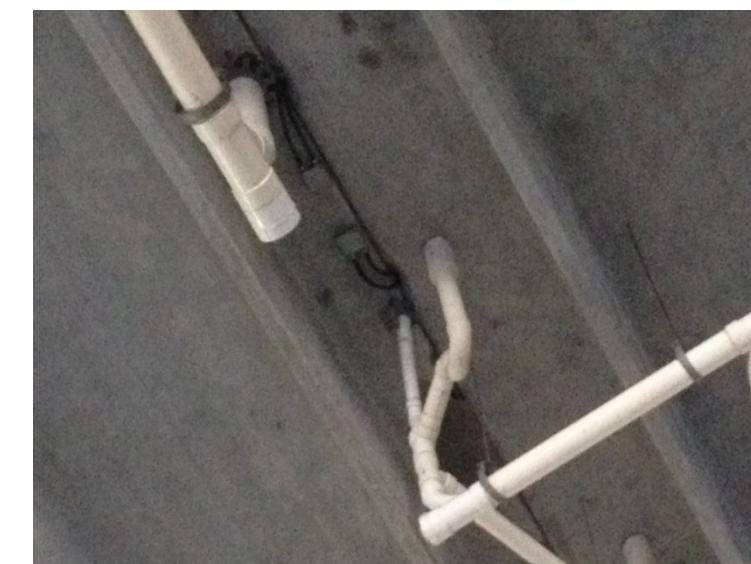
*Exposed Floor Drain Trap*

11. Shower valves could be rebuilt as a minimum but should be considered for replacement due to length of existing service.
12. Add heat trace cable and insulation on exposed floor drain traps to reduce maintenance, and trap replacement should be considered.

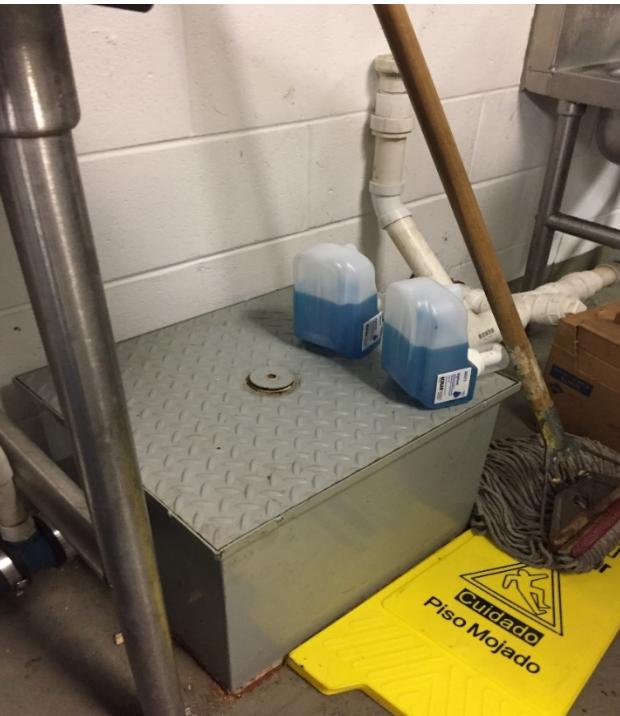
Local grease traps are used at the 3-compartment sinks in the concessions. Testing proved the existing selection was adequate for the sink size provided.

*Local Grease Trap*

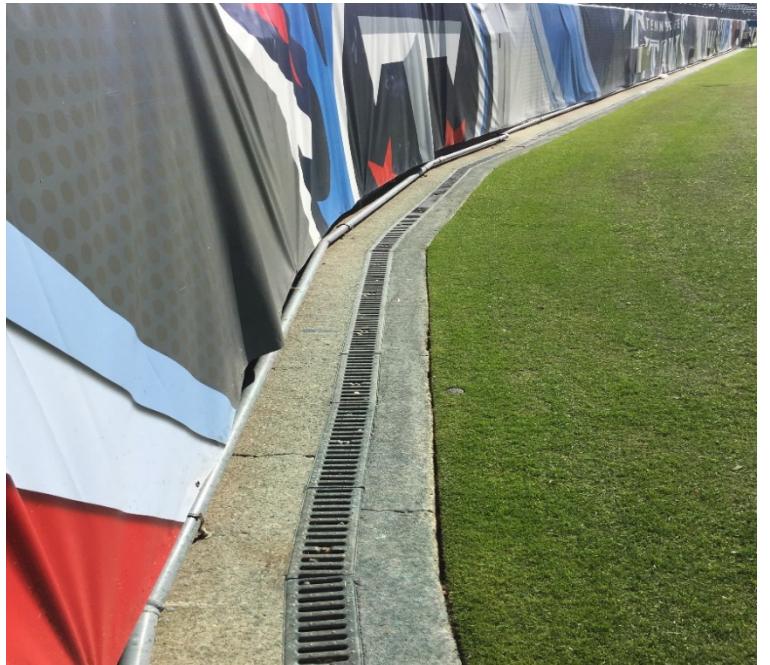
Playing Field Trench Drain

13. The existing sewage pumps are original, and a phased replacement of the pumps, valves, controls and control panels is recommended.
14. Debris including cigarette butts, peanut shells and paper should be cleaned from all drain locations. Several cigarette butts and peanut shells were noted in the trench drain system serving the playing field.

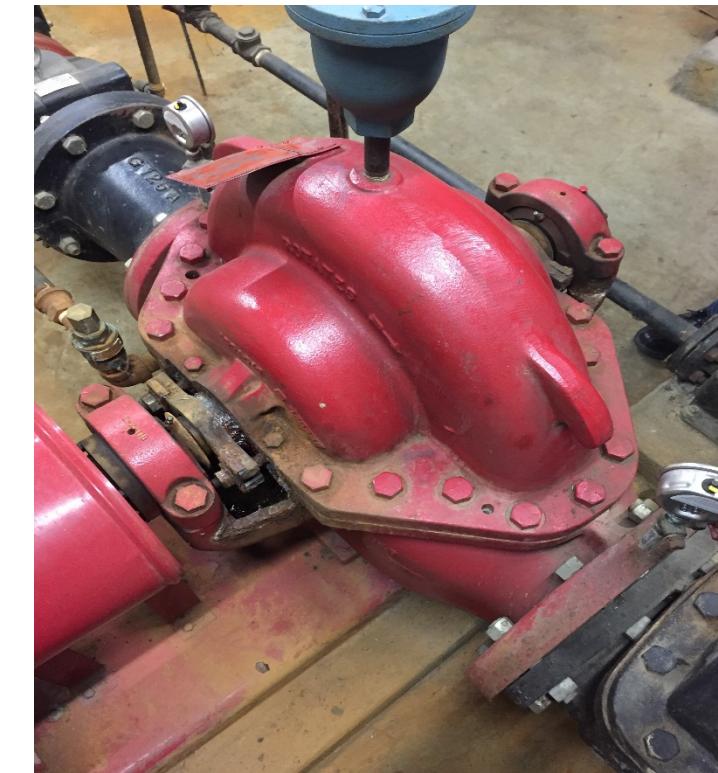
It was observed that the fire pump casing is showing only minimal amount of corrosion build up for the age of the pump.

Fire Pump Casing

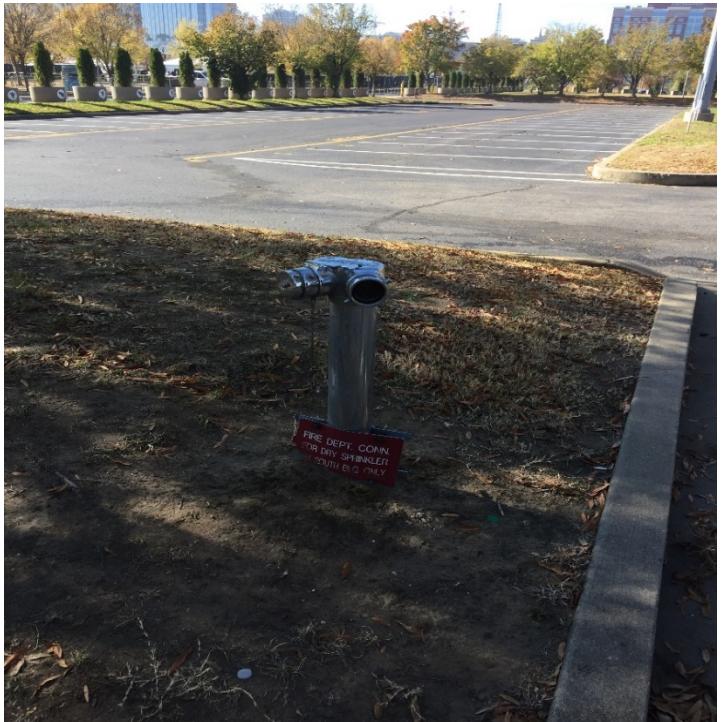
Caps with chains are missing from both fire department connections. The missing caps and chains should be replaced to prevent intrusion of foreign materials. Both fire department connections are within the acceptable distance from a city fire hydrant.

*Fire Department Connection South End Zone Missing Caps and Chains*

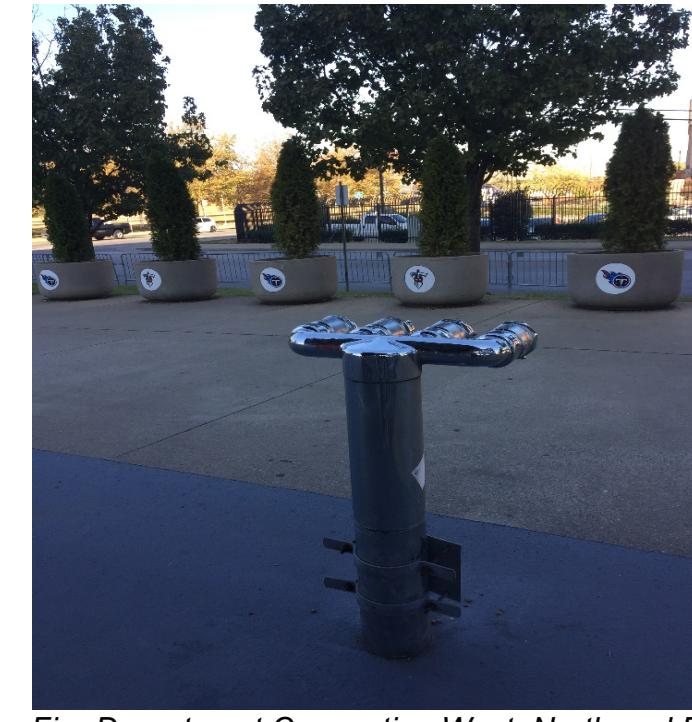
*Fire Department Connection West, North and East Sides Missing Caps and Chains*

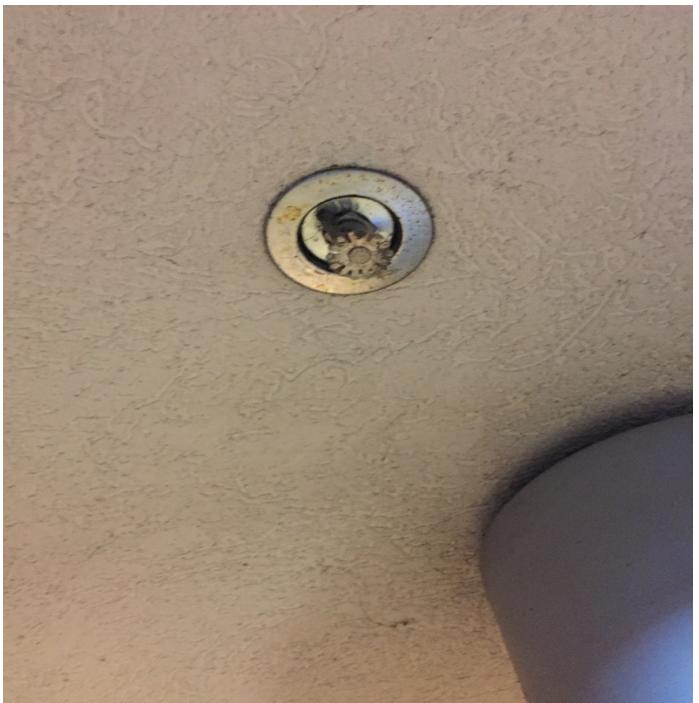
There are multiple dry pipe systems that serve exterior spaces and concessions on both concourse levels. We noted several sprinkler heads located in exterior areas where rust is beginning to accumulate. The sprinkler operation or performance shouldn't be affected; however, the 2008 Edition of NFPA 25 Standard for the Inspection, Testing and Maintenance of Water-Based Fire Protection Systems states that dry pipe sprinklers that have been in service for 10 years shall be replaced, or representative samples shall be tested every 10 years (5.3.1.1.1.5). Paragraph 5.3.1.2 outlines an acceptable test procedure.

*Automatic Sprinkler Head Corrosion*

4. NFPA 25 also outlines that sprinklers manufactured using fast-response elements that have been in service for 20 years should be replaced, or representative samples should be tested. If tested, they should be re-tested every 10 years (5.3.1.1.2).

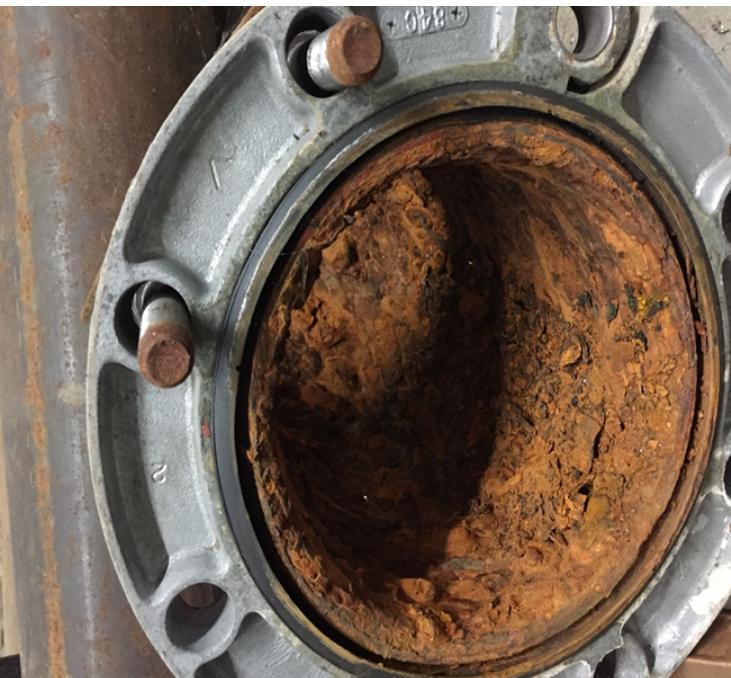
We observed interior corrosion of fire protection piping sections that had previously developed leaks and required replacement. Buildup of corrosion appears to be acceptable for the age of the piping.

*Interior Pipe Corrosion*

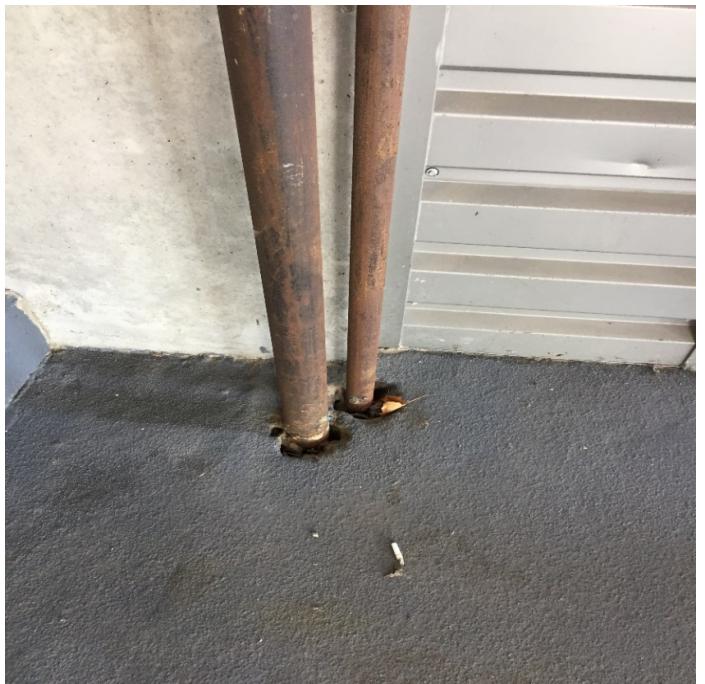
*Piping Missing Floor Supports*

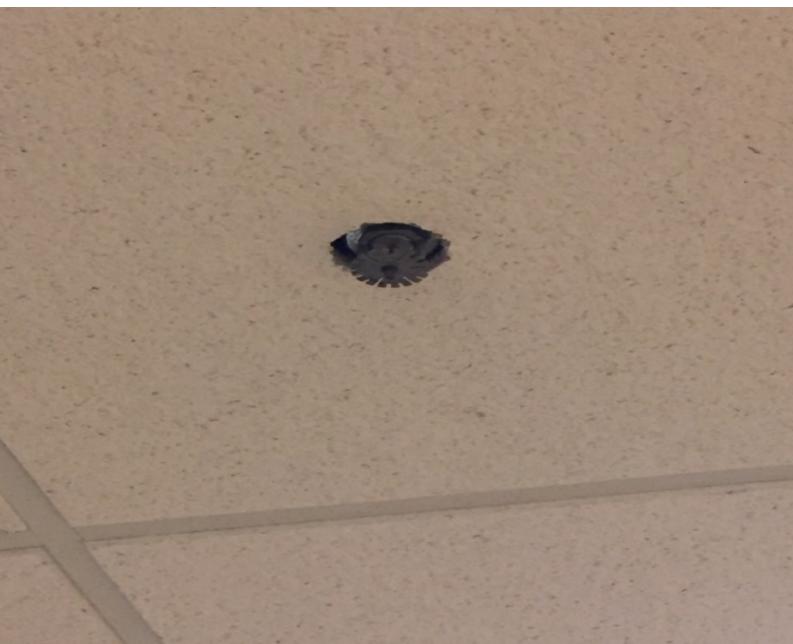
We noted that interior sprinkler head trim rings were missing in a few locations.

*Interior Automatic Sprinkler Head Missing Trim*

5. The exterior surfaces of the existing piping and fittings should be cleaned and painted to extend the remaining life of the piping or replaced with new pipe and fittings. At this point in the life of this piping, this comment is a cosmetic type recommendation to clean up the appearance of the stadium.
6. We recommend that expanded foam insulation be provided around the valve stem and fire hose connection inside the freeze-proof fire hose cabinets. Split ring chrome plated escutcheon rings should also be provided to conceal the insulation at the valve stem and fire hose connection.
7. Missing sprinkler trim rings should be replaced to match the finish of the existing head and should be provided by the same sprinkler head manufacturer.

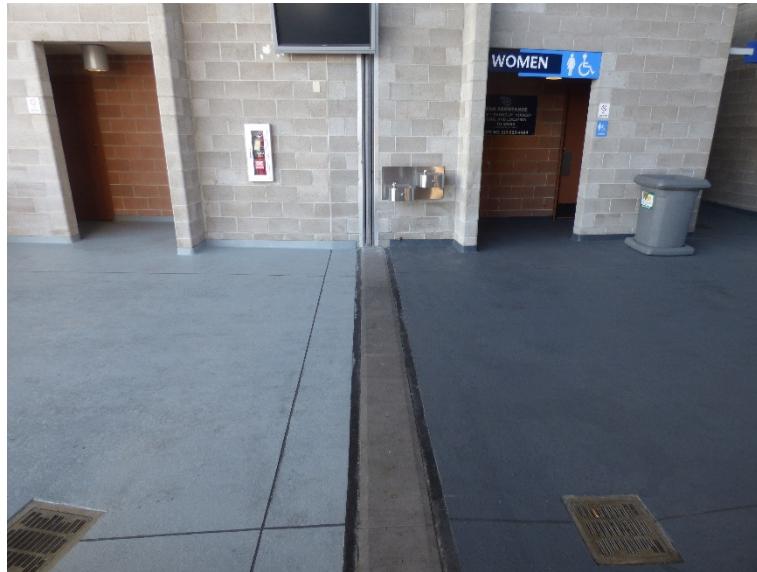
Expansion Joints: The header material on the new expansion joints installed on the upper level concourse on the East side of the stadium exhibited minor damage.

Overall view of new expansion joint on upper concourse

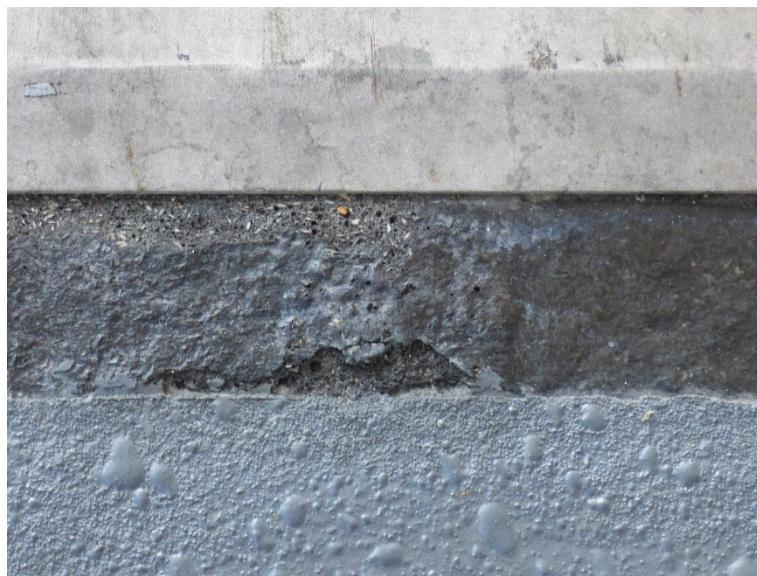
Damage of header material for expansion joint

1. Replace damaged header material on new expansion joints installed on upper concourse.
2. Replace failed sealants at older expansion joints that have failed.

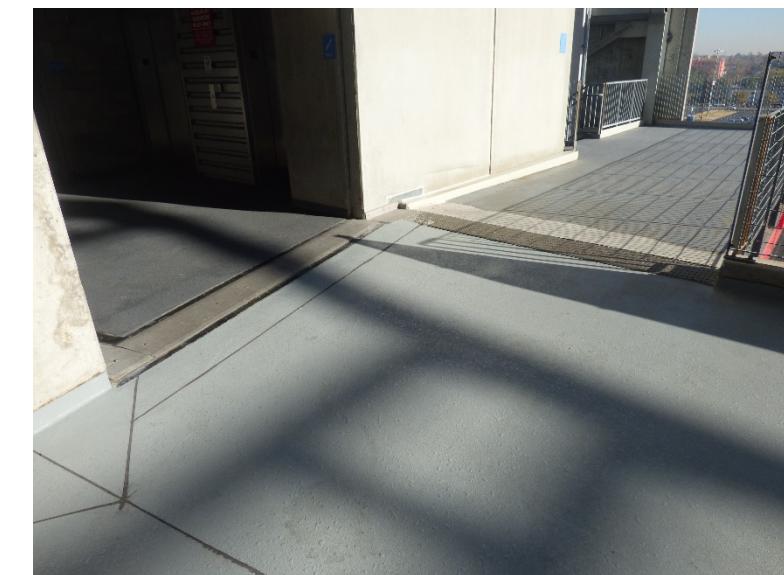
Sealants at older expansion joints, the joints between concourse perimeter walls, and the joints in the topping slab on the main concourse slab appear to have reached the end of their service life and had failed.

Overview of older expansion joints

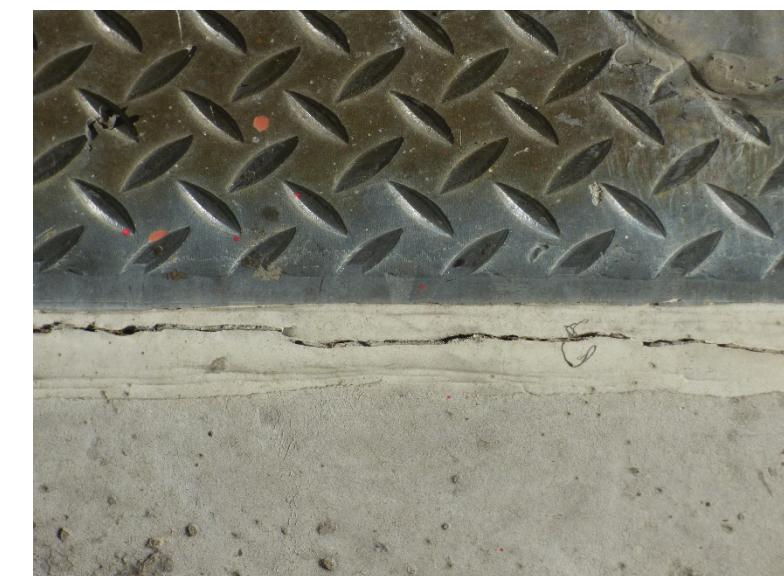
Failed sealant on perimeter of plates over older expansion joints

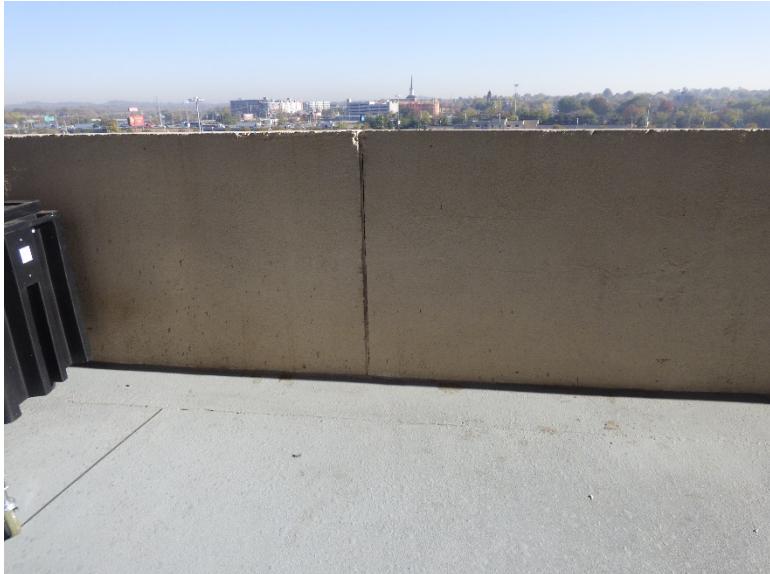
Vertical joint between concrete perimeter walls

10. Replace deteriorated concrete steps.
11. Replace failed expansion joints.
12. Replace all failed sealants.
13. Perform concrete repairs per ICRI guidelines and replace deteriorated coating in seating areas.

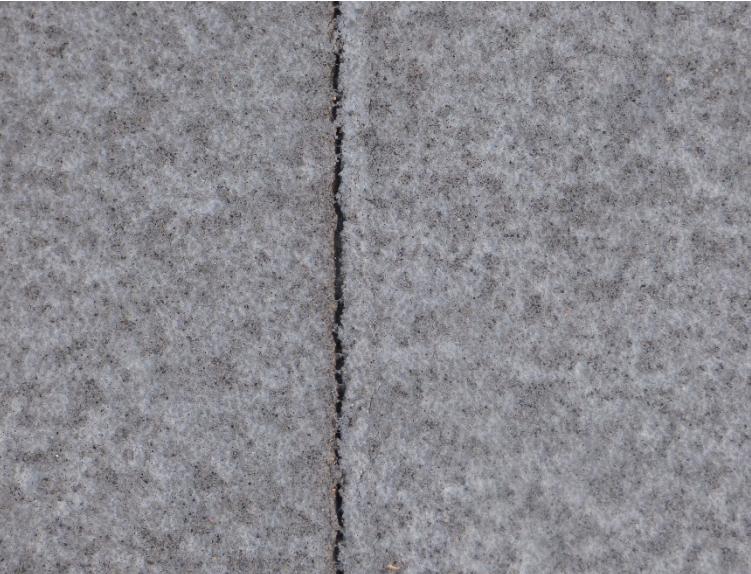
Failed sealant at topping slab joints in the Main Level concourse

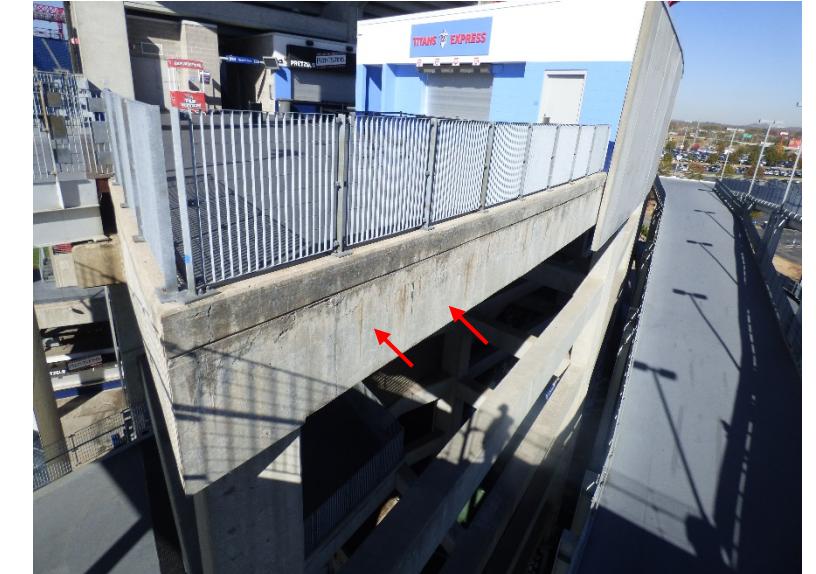
Concrete spalls and delamination on face of beam and slab

Concrete spalls and delaminations on face of slab and beam on southeast corner of upper concourse level, on the flanges and stems of double tees at various locations throughout the stadium, and on one column on the Main Level concourse. The delaminations and spalls do not appear to be caused by overloading of the structure, but rather by either corrosion of the reinforcing steel, reinforcing steel with low concrete cover, or damage during construction in the case of precast members.

3. Replace missing nuts and bolts on railing in club level seating.
4. Repair concrete spalls following ICRC guidelines.
5. Replace broken CMU blocks and repoint cracked joints.

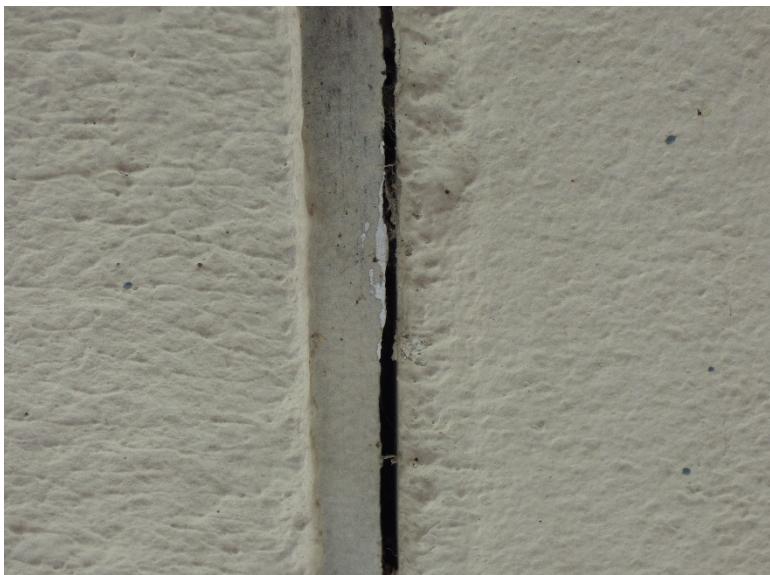
Failed sealant at joint between perimeter walls

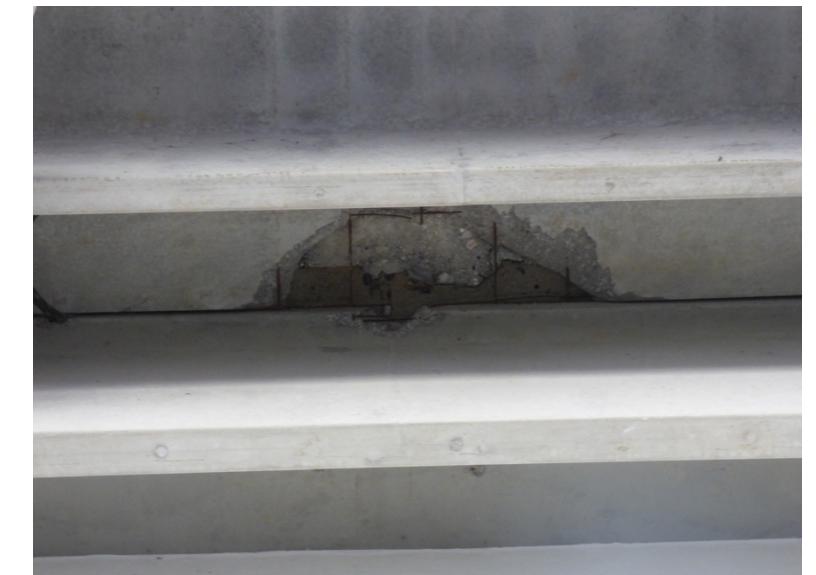
Concrete spall on double-tee flange on the underside of press level, southwest corner of stadium

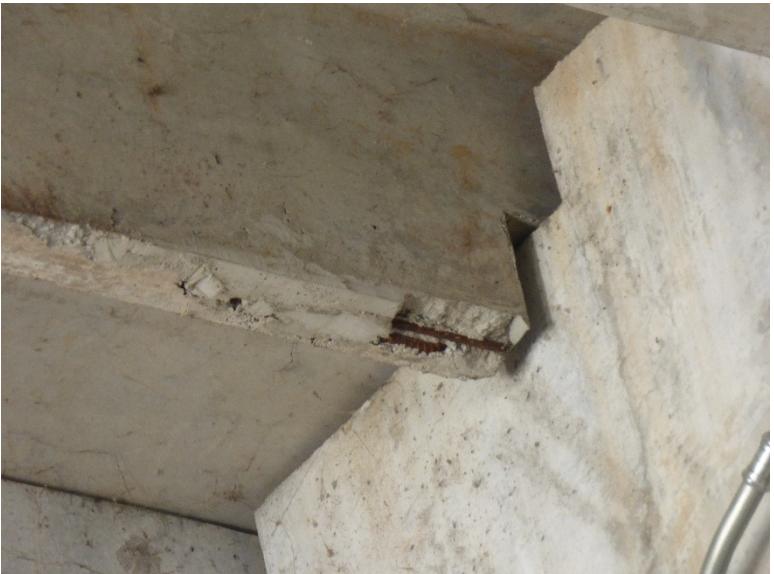
*Concrete spall on double-tee stem*

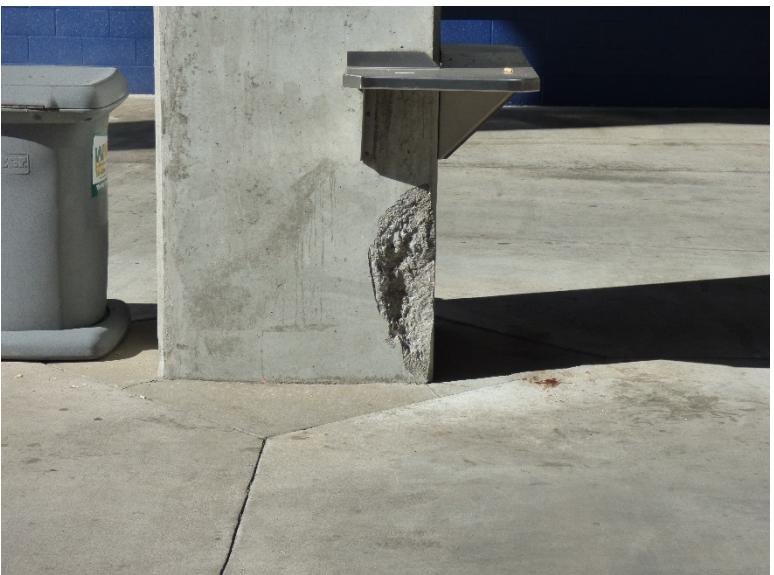
*Concrete spall on column at Gridline 10 on main concourse level*

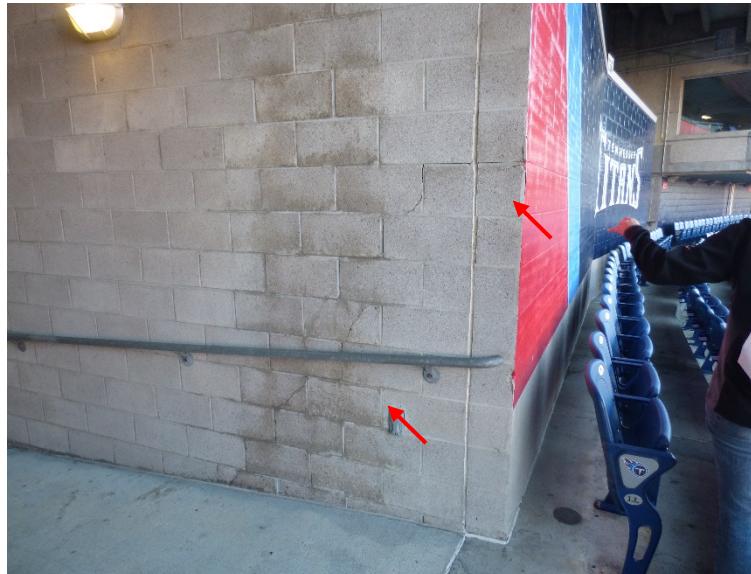
Cracking of concrete masonry units (CMU) at two locations on the stadium. The CMU walls are not part of the main structural system for the stadium, but are part of the bathroom and concession facilities. Cracking does not appear to be of structural concern, but repairs are recommended to prevent further deterioration.

*Cracks in concrete masonry units (CMU)*

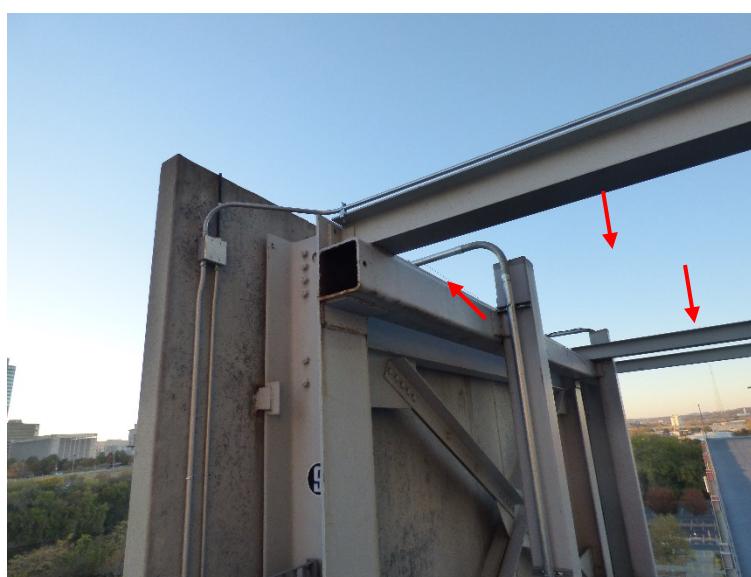
The ends of vertical and horizontal tubes at the east and west stair towers are unsealed, allowing water inside the tubes, which has resulted in corrosion of the interior of the tubes and in rust staining on stair surfaces below. The corrosion inside the tubes appeared to be limited to surface corrosion with no apparent section loss of the tube.

*Open ends of steel tubes*

6. Seal the ends (top and sides) of the tubes with a steel cap plate. Bottom end of the tubes shall remain open to allow water to exit the tube.
7. Repair deteriorated concrete and perform localized subgrade replacement, if required.

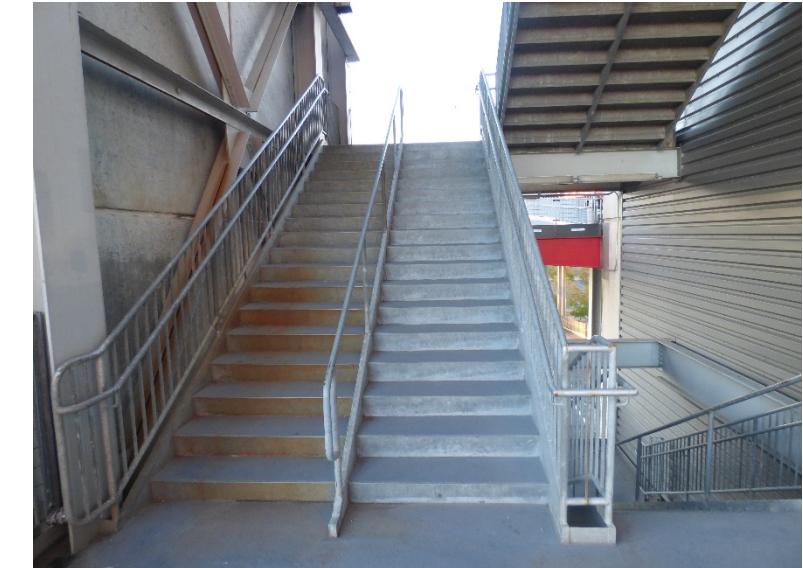
*Rust staining of horizontal surfaces below open-ended tubes*

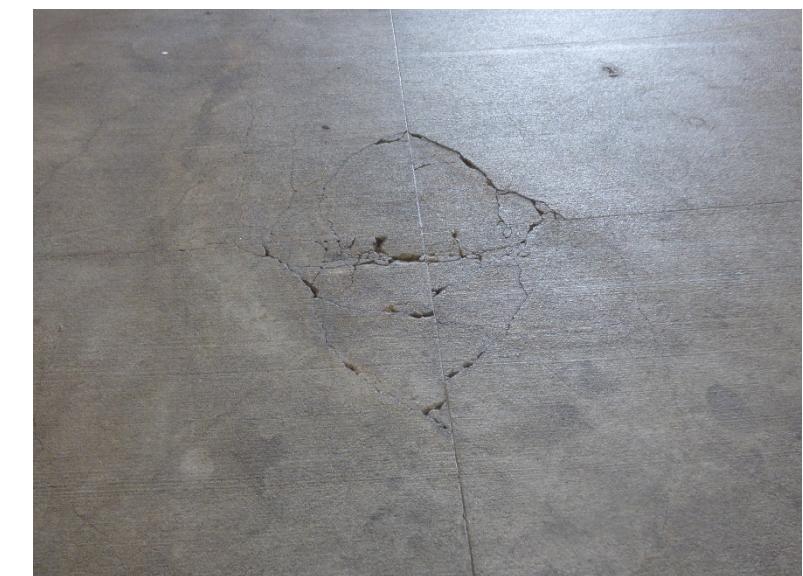
Cracks and spalls on slab-on-grade at service level. Typical cracking on slab-on-grade is of no structural concern. Cracks could be a result of localized overload or localized failure of the subgrade which resulted in loss of support of the slab.

*Concrete spalls on slab-on-grade*

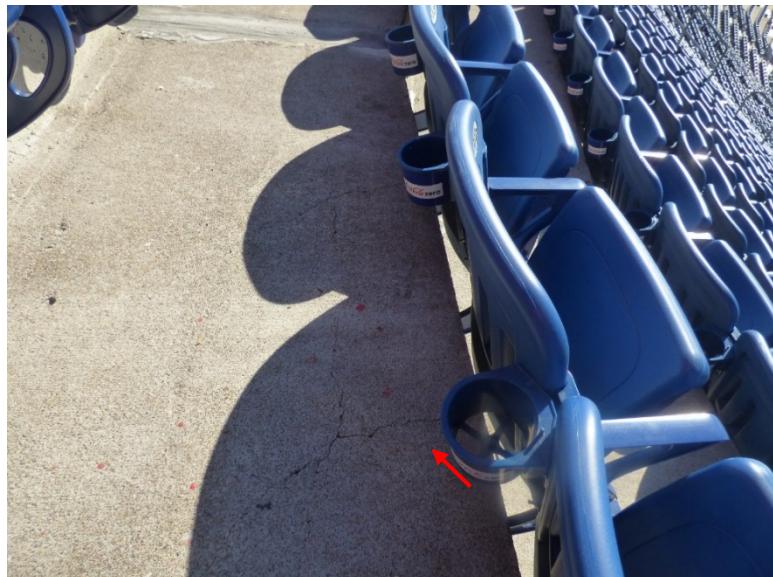
Cracks on top surface of precast seating risers do not appear to be caused by overloading of the structure but rather by volumetric changes due to shrinkage of the concrete or expansion/contraction due to changes in temperature.

Cracks on seating risers

8. Cracks greater than 1/32-inch should be routed and sealed to prevent moisture intrusion that could lead to corrosion of the reinforcing steel.
9. Remove delaminated patches and install approved concrete repair material following ICRI guidelines.

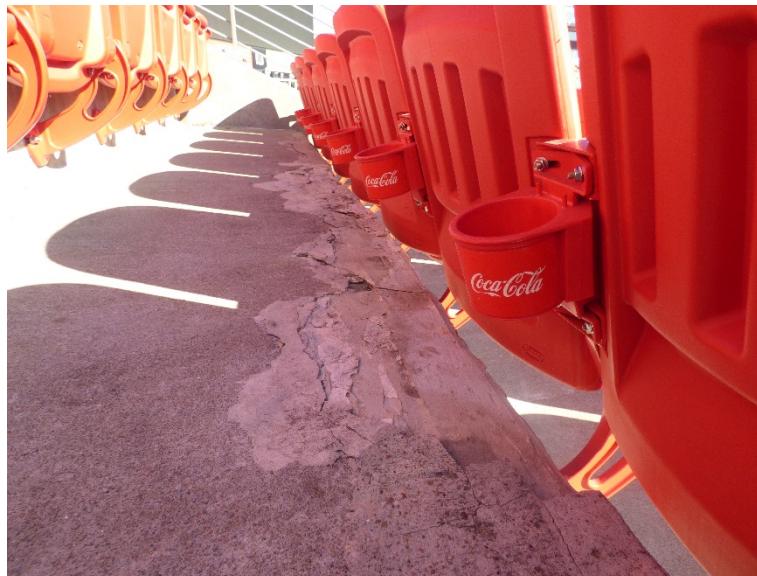
Failed concrete patches on west club level seating risers. The concrete repairs do not appear to have been performed following ICRI criteria.

Failed concrete patches on seating risers

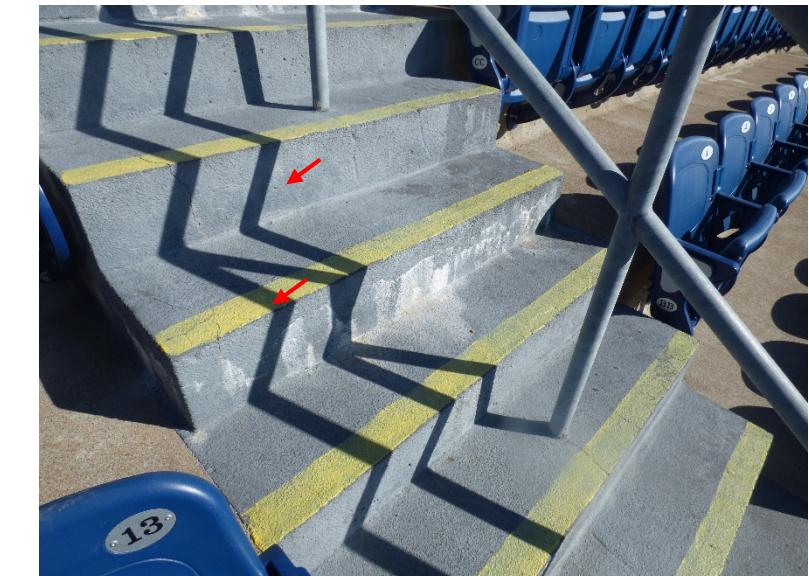
Cracking and leaching on concrete steps was evident, and it appears that some of the cracks had been sealed prior to the application of the waterproofing membrane; however, additional cracks have formed since then and are reflecting through the existing waterproofing membrane. It is our understanding that testing has been performed on the steps and that evidence of alkali-silica reaction was found which explains the leaching observed. Replacement of steps on the lower rows of the Upper Level had been recently completed.

Cracks and leaching in concrete steps

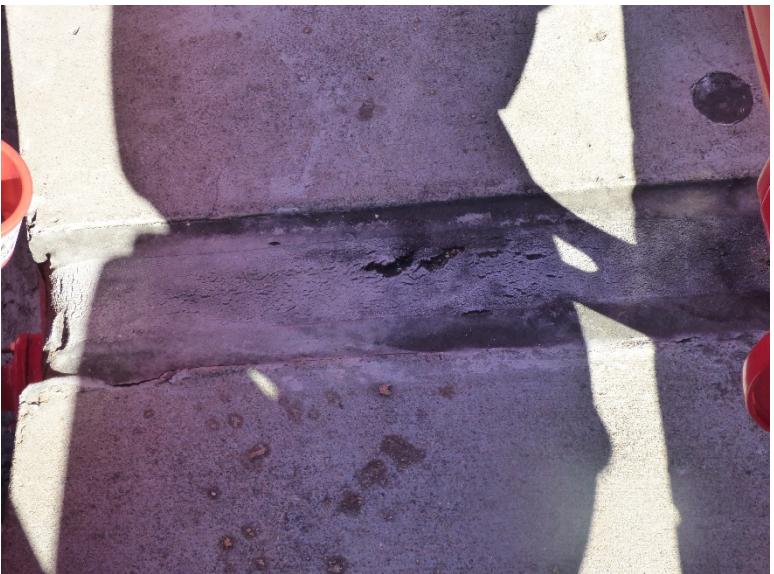
Failed expansion joint covers on seating areas. The existing expansion joint covers appear to be a premolded joint. In areas above occupied space, the joints have been covered with sealant to prevent water intrusion into the occupied space below. It is our understanding that the expansion joints have been recently replaced in the lower rows on the upper level and are currently scheduled for replacement on the east side of the club level.

*Failed expansion joint on seating areas*

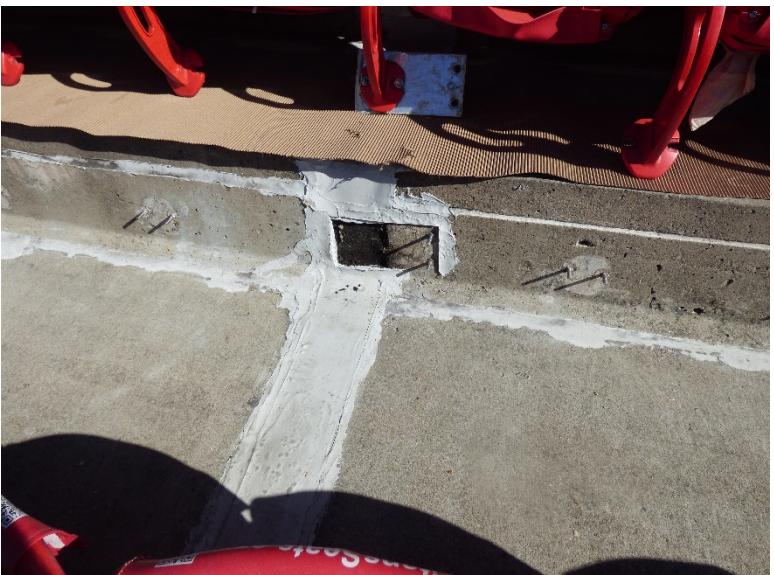
*Expansion joint covered with sealant*

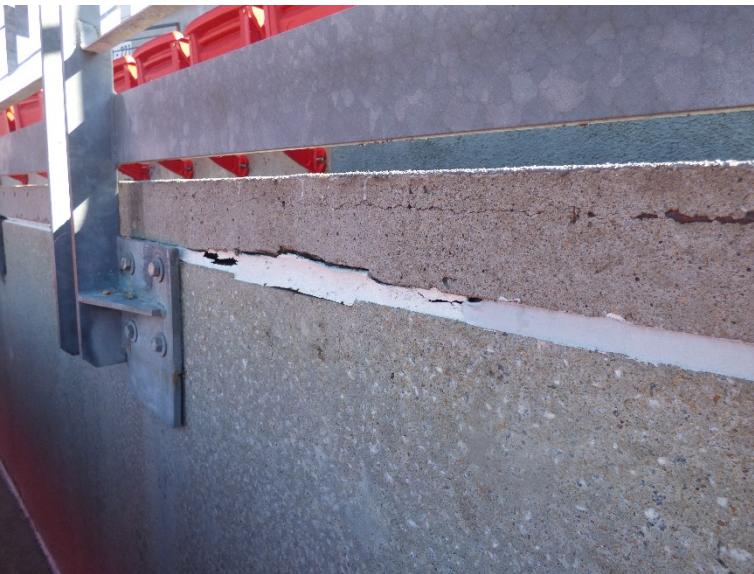
Failed sealant at horizontal joints on precast seating risers. Sealant had been recently replaced on the lower rows on the upper concourse level and was in the process of being replaced on the east side of the club level.

*Failed horizontal sealant on precast seating riser*

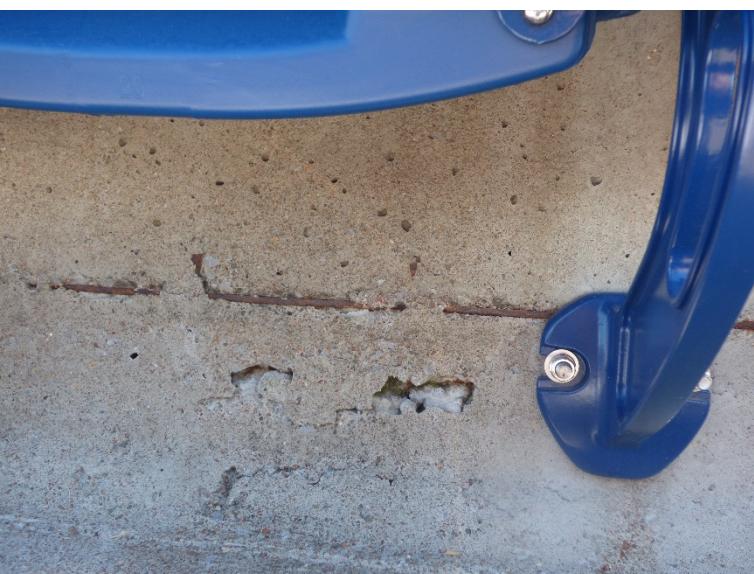
Exposed wire mesh on precast seating risers, which appears to be a result of very low concrete cover and inadequate consolidation of the concrete. The exposed wire mesh is not of structural concern and does not appear to be negatively affecting the structural member. At this time, no correction measures are recommended.

*Exposed wire mesh on precast seating riser*

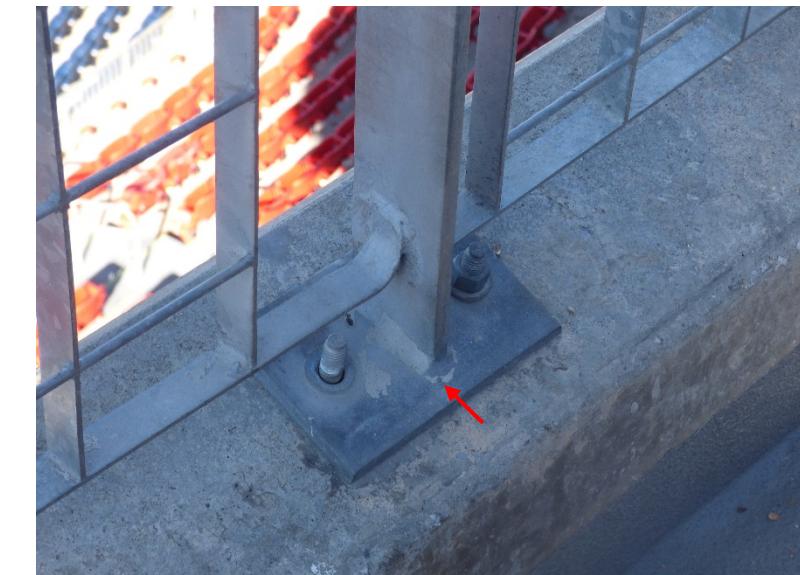
Missing nuts on the base plates for the guardrails on the seating areas were observed at two locations. Missing anchors on the guardrail attachments were noted in two locations at the club level.

*Missing nut on handrail base plate on club level*

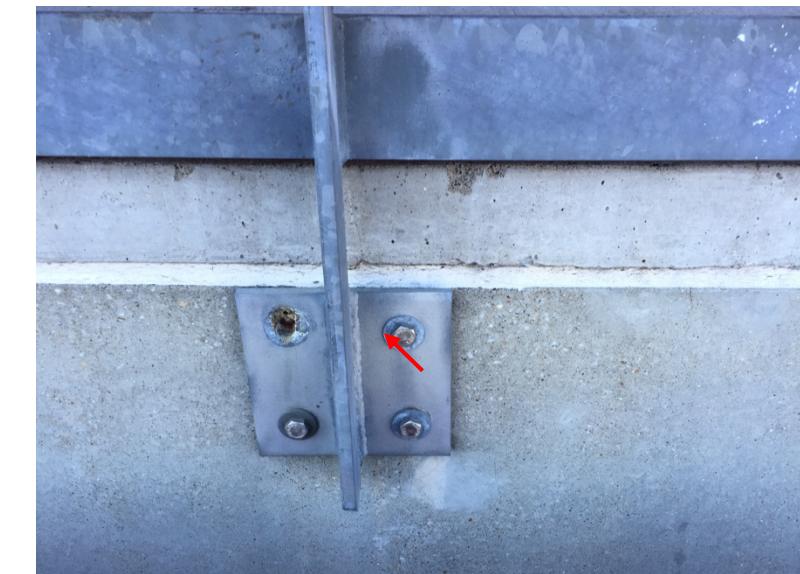
*Missing bolt on handrail anchorage plate in club level*

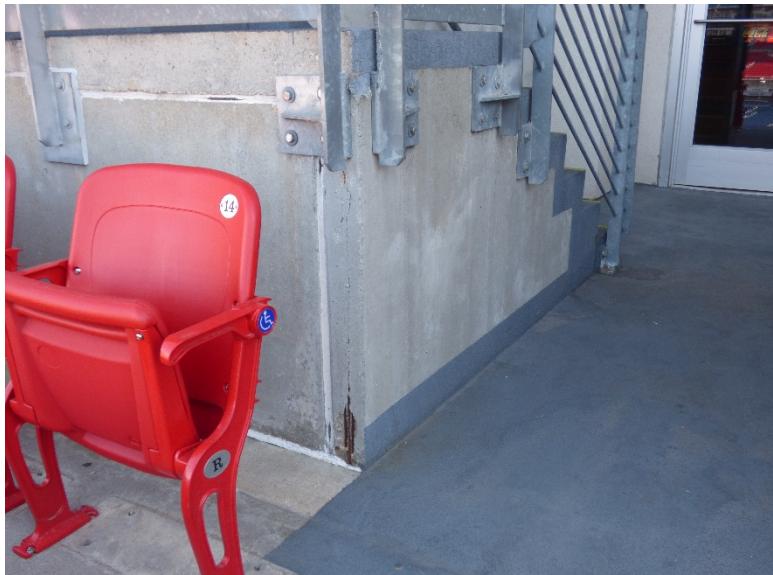
Cracks and spalls were observed at the corner of precast concrete stairs on the club level. In some cases, corroded reinforcing steel was also observed. In the cases where the reinforcing steel was visible, it appeared to have very low concrete cover which might have led to cracking of the concrete and subsequent corrosion of the steel, which resulted in the concrete spalls.

Cracks and spalls at corner of precast stairs
