April 3, 2017

# Facility Condition Assessment

Nissan Stadium

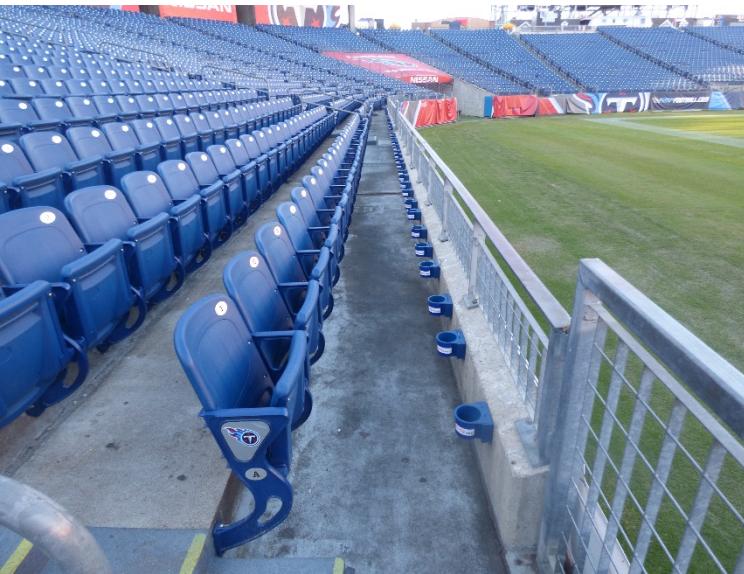
Deteriorated coating and concrete delaminations on the first row of the Lower Level seating areas.

Deteriorated traffic coating

10. Replace deteriorated concrete steps.
11. Replace failed expansion joints.
12. Replace all failed sealants.
13. Perform concrete repairs per ICRI guidelines and replace deteriorated coating in seating areas.

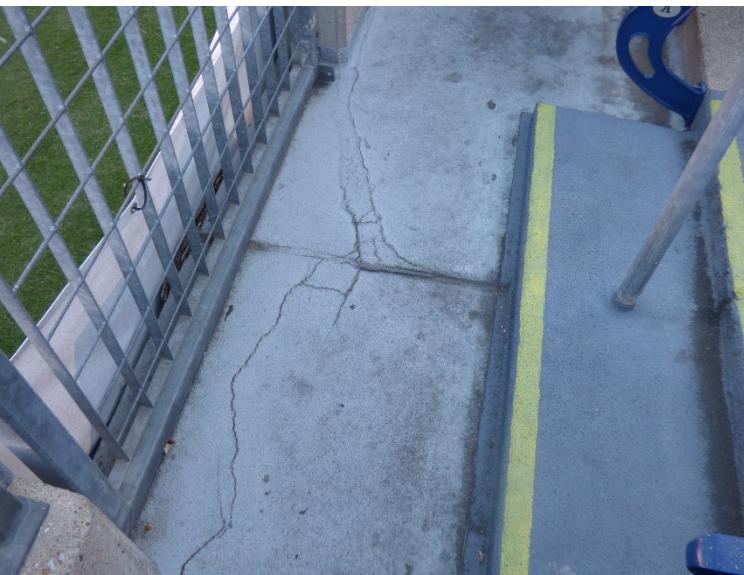
Concrete delaminations on first row of lower level seating area

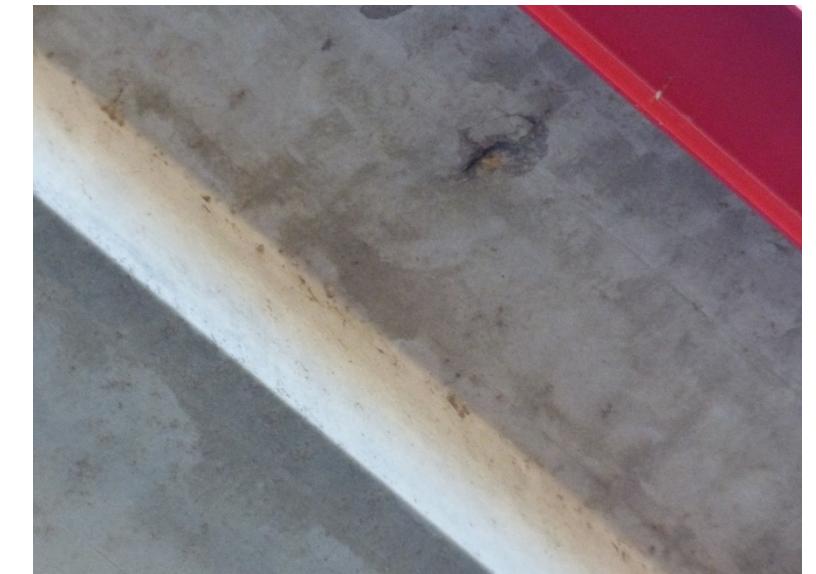
Spalls on underside of precast seating risers. The spalls appear to be a result of low concrete cover, and in some cases, corrosion of the embedded reinforcing steel.

Concrete spall on underside of seating riser.

3. Replace missing nuts and bolts on railing in club level seating.
4. Repair concrete spalls following ICRC guidelines.
5. Replace broken CMU blocks and repoint cracked joints.

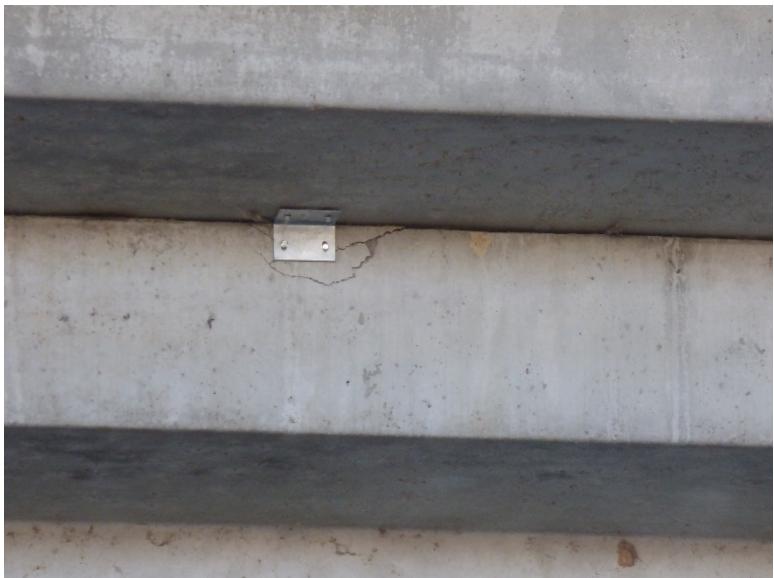
Delaminations at clip angles on the underside of precast seating risers. It is our understanding that as part of a recent renovation, these clip angles were installed at locations where concrete had spalled at locations of welded connections between precast seating risers. The welds were ground off, and the new clips were installed. The documented delaminations may be caused by differential movement between the precast seating risers that causes stresses at the connection points.

*Concrete delamination at clip angle location*

14. Review deterioration at clip angles between precast seating risers by original designer.
15. Replace broken connection on ribbon board.

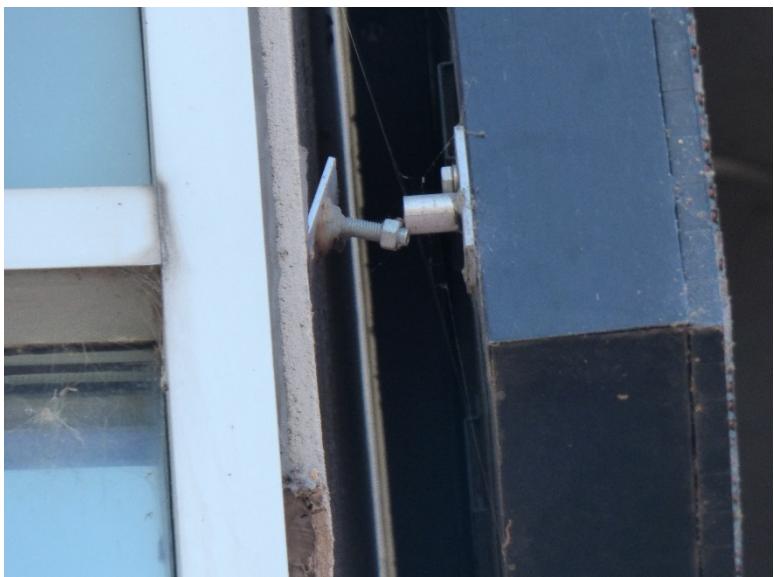
One of the connections of the ribbon board on the northeast corner of the club level seating area had failed.

*Loose connection of ribbon board*

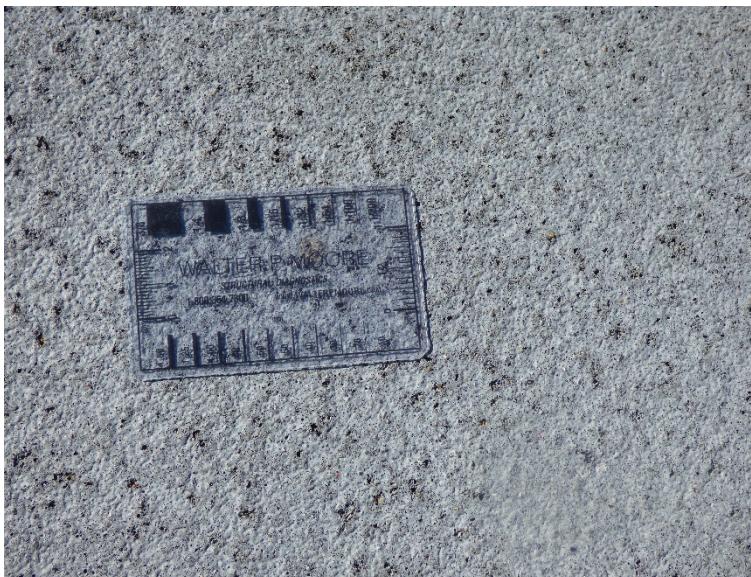
The traffic coating on the pedestrian ramps that provide access to the upper levels is aged and has been damaged by vehicles and other equipment. Traffic coatings typically require recoating every 5 years, and replacement once the base coat shows excessive deterioration.

*Aged traffic coating on pedestrian ramps*

16. Recoat traffic coating with replacement at isolated locations on pedestrian ramps.
17. On pedestrian ramps, remove all corrosion products and coat with a high-performance coating. At isolated locations, installation of supplementary sections of deck may be required.

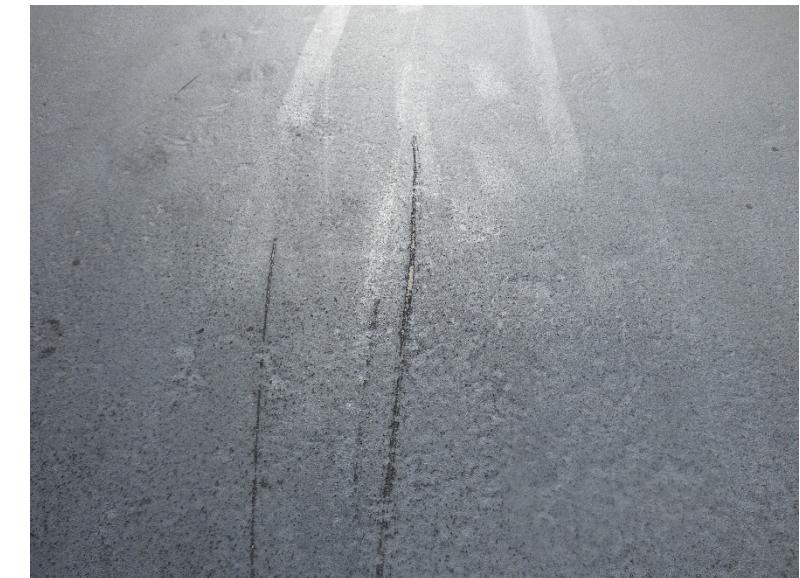
*Damaged traffic coating on ramp*

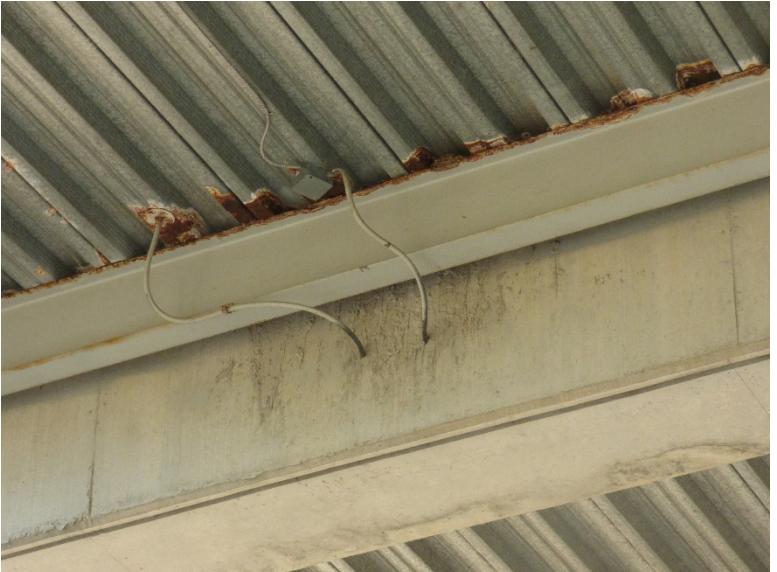
Corrosion of the metal deck and structural steel beams on the pedestrian ramps. It appears that the corrosion is a result of water intrusion from the top of the ramps through the side, which did not have cove sealant originally. Cove sealant appears to have been installed along with the traffic coating on the top surface of the ramps. However, significant corrosion of the metal deck and minor corrosion of the top of the beams has occurred. In one area, the corroded metal deck had been coated; however, it appears that the corrosion products were not removed prior to coating.

*Corrosion of metal deck on pedestrian ramp*

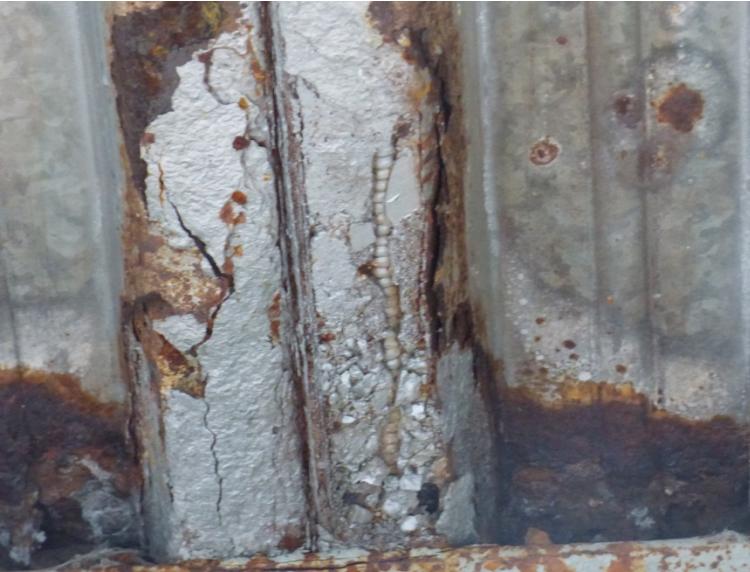
*Corroded metal deck which has been painted over at exterior, visible from exterior of stadium sidewalk*

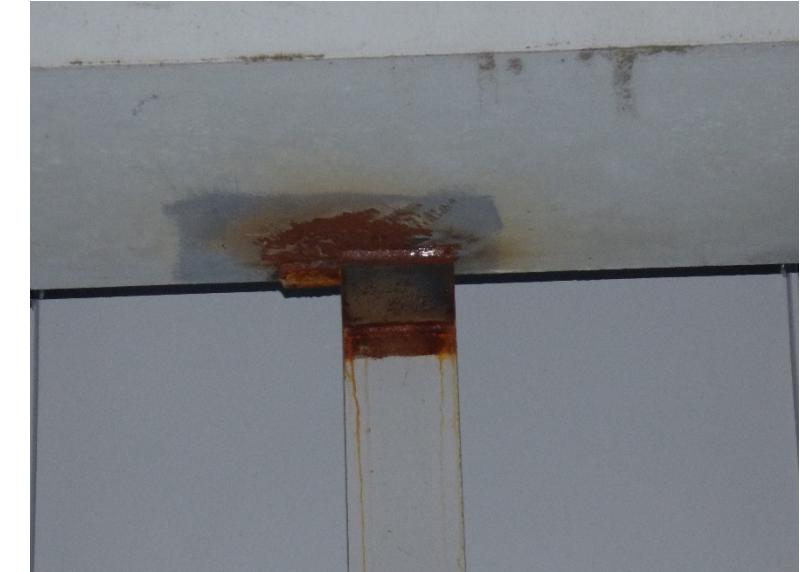
*Corrosion of clip angle*

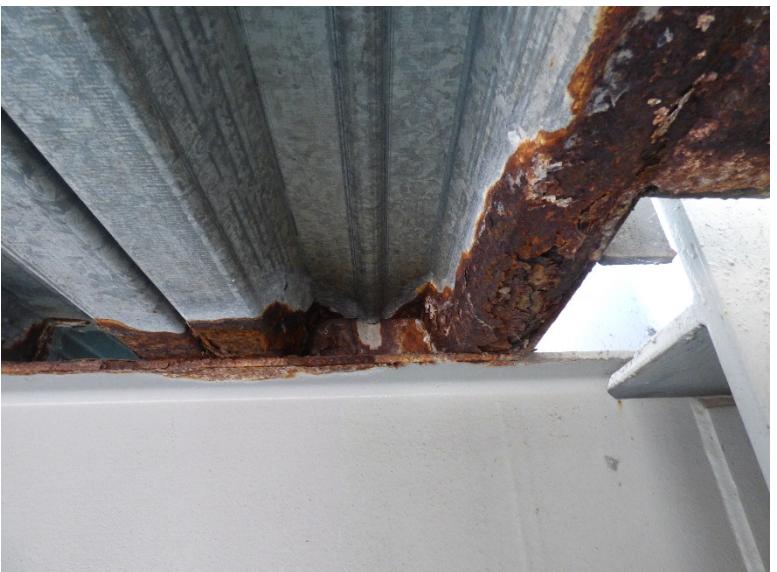
*Close up of metal deck damage due to corrosion*

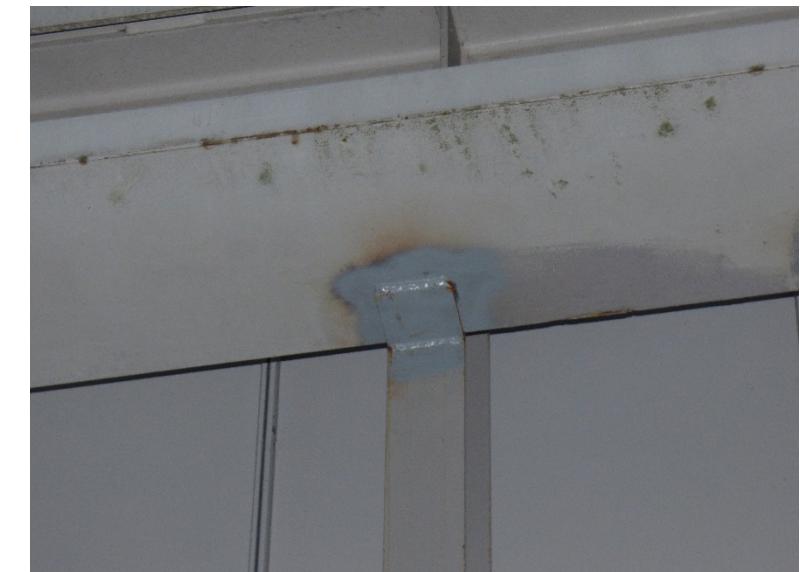
Corrosion of clip angles and structural steel beams on scoreboard structures. Some of the clip angles had been previously recoated; however, evidence of rust was also observed on these angles as shown. Some of the structural steel I-beams had been installed with the web at a slight angle from the horizontal direction which causes water ponding on top of the web. Even though holes had been drilled on the web, they were not located in the low spot.

*Evidence of rust on previously coated clip angle*

18. Remove all corrosion products on scoreboard structures and coat with a high-performance coating. On the structural steel beams, add holes at the low spots to prevent water ponding, or install caps over the beams.

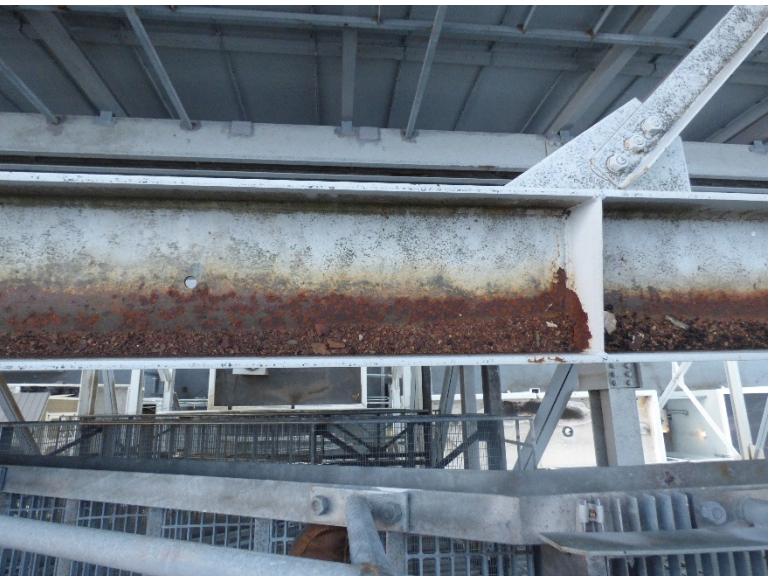
Corrosion of web on structural steel beam. View looking down.

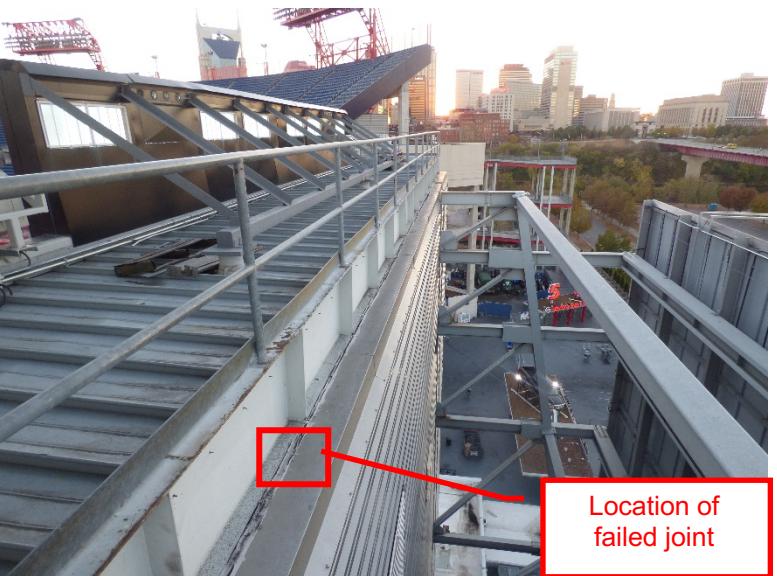
Failed sealant at joints between exterior elements of scoreboard structure

View of back side of scoreboard

19. Replace failed sealants on exterior of scoreboard structures.
20. Repair deteriorated exterior concrete and perform localized subgrade replacement, if required.

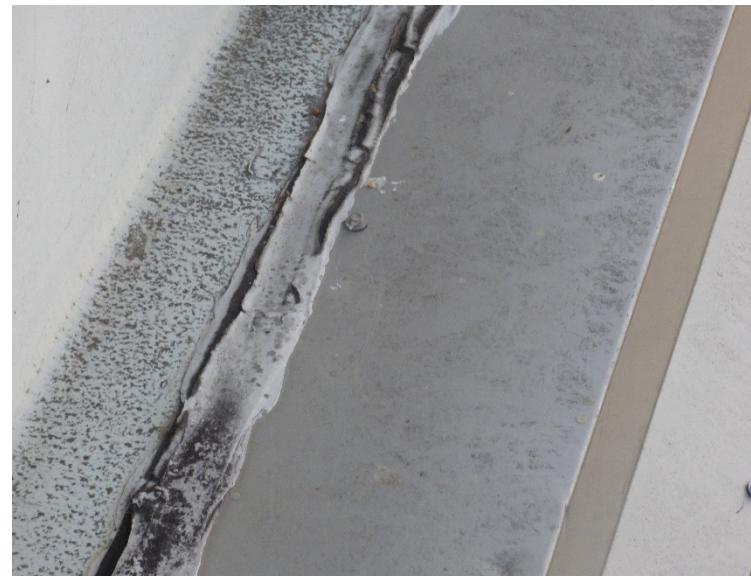
Deteriorated sealant at joint on scoreboard elements

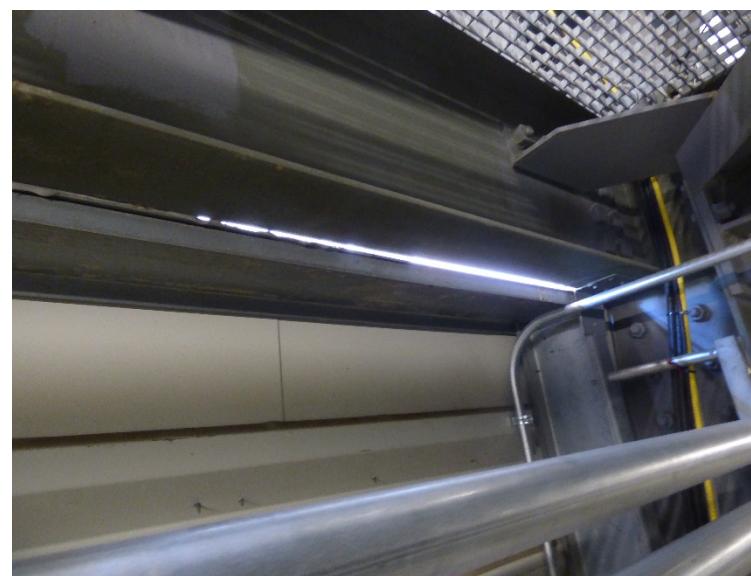
Evidence of failed sealant between elements of scoreboard elements (notice daylight through joint)

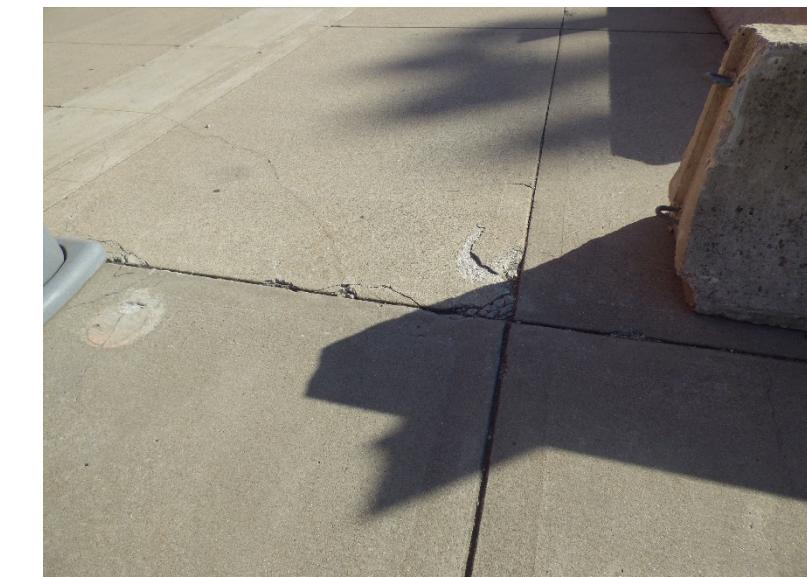
Concrete cracks and spalls on slab-on-grade. Typical cracking on slab-on-grade is of no structural concern. Concrete damage could be a result of localized overload or localized failure of the subgrade which resulted in loss of support of the slab.

Delaminated concrete in slab-on-grade

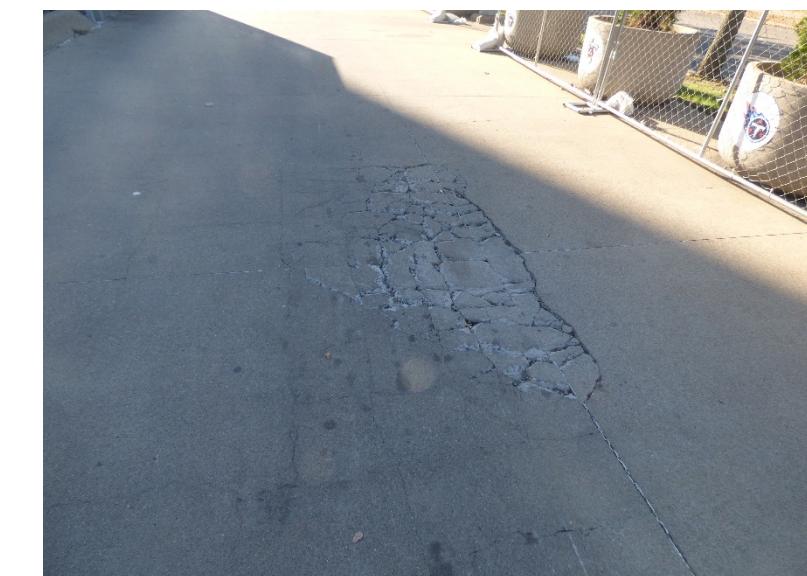
Severely damaged concrete in slab-on-grade

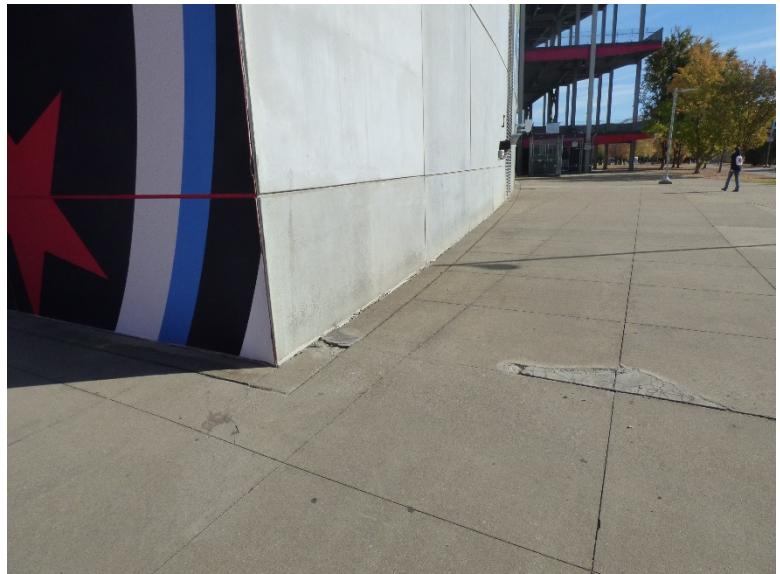
Failed cove sealant along the perimeter of the building. The sealant appears to have reached the end of its service life and requires replacement.

*View of exterior wall location of failed cove sealant*

21. Replace failed cove sealant along perimeter of stadium.
22. Repair spalled concrete on the perimeter per ICRI guidelines.
23. Install grout at base of precast concrete walls.

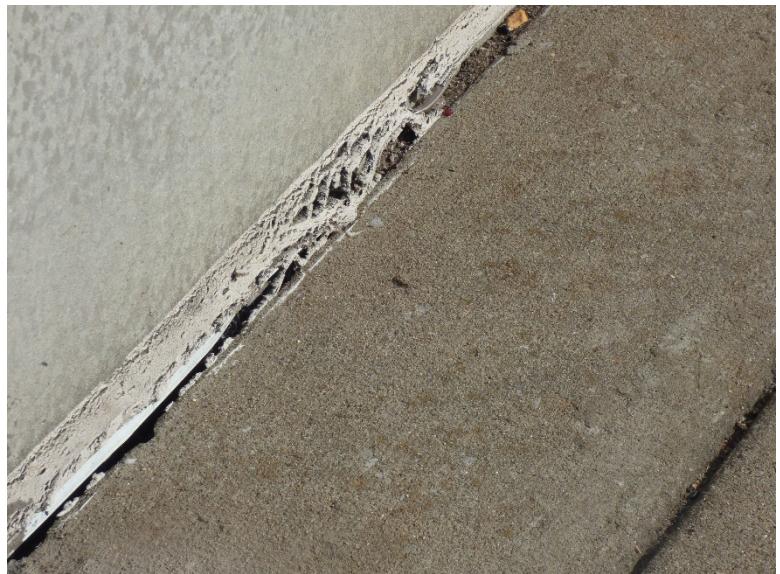
*Failed cove sealant at exterior wall*

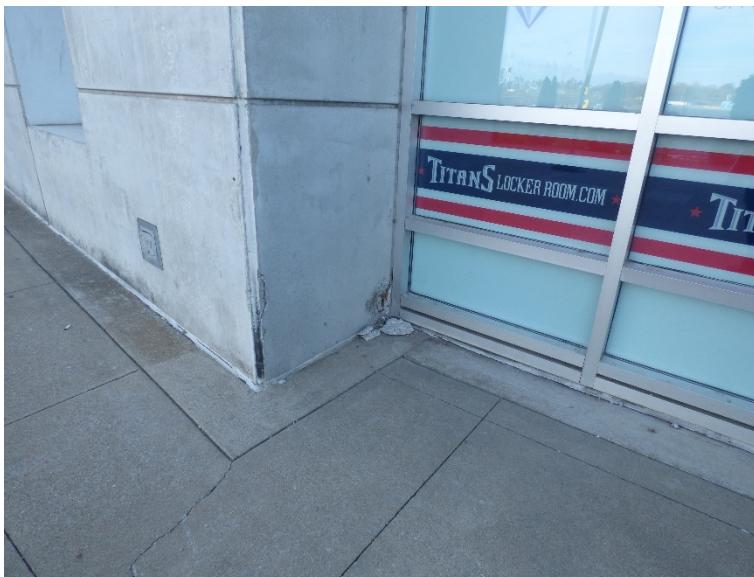
Concrete spall on precast concrete wall panel. The spall was observed on one of the exterior wall panels but does not appear to be of structural concern. Spall may have been caused by minor damage during construction that with time resulted in the spall observed.

*Concrete spall on precast wall element*

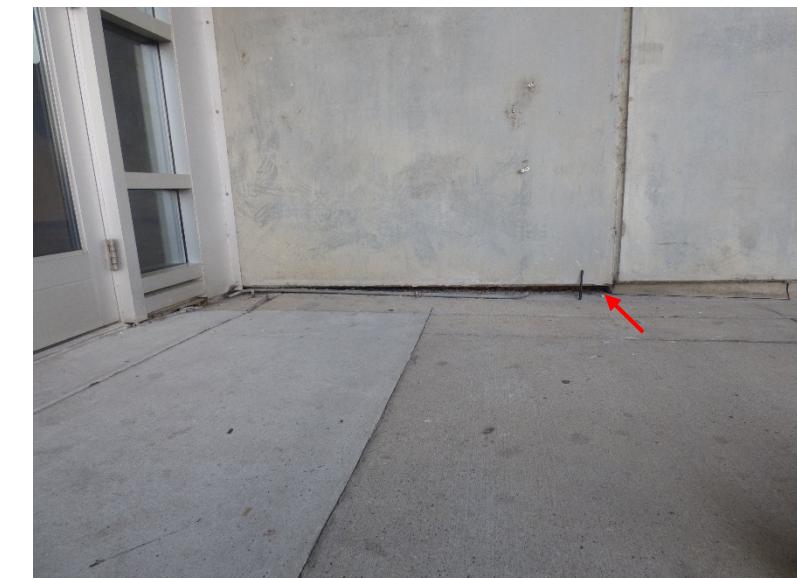
Missing or loose grout at base of precast concrete walls. The grout originally placed at the base of precast concrete walls on the perimeter of the building was either missing or completely loose and could be removed by hand. It does not appear that the grout is used to support the walls, as they are typically attached directly to the columns. However, the grout will prevent water from penetrating into the structure.

*Missing grout below exterior precast wall panel*

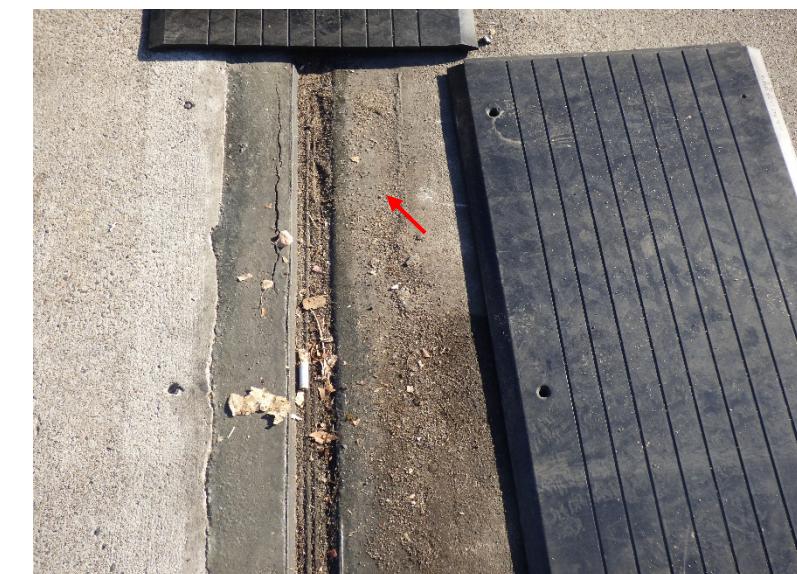
Damage to header material on exterior expansion joint located over loading dock.

*Damage to header material on exterior expansion joint over loading dock*

24. Replace deteriorated header material on exterior expansion joint cover.
25. In surface parking lots, seal cracks and replace pavement in heavily damaged areas. In areas with severe weathering, an overlay will be required. In areas with minor weathering, we recommend application of a seal coat.

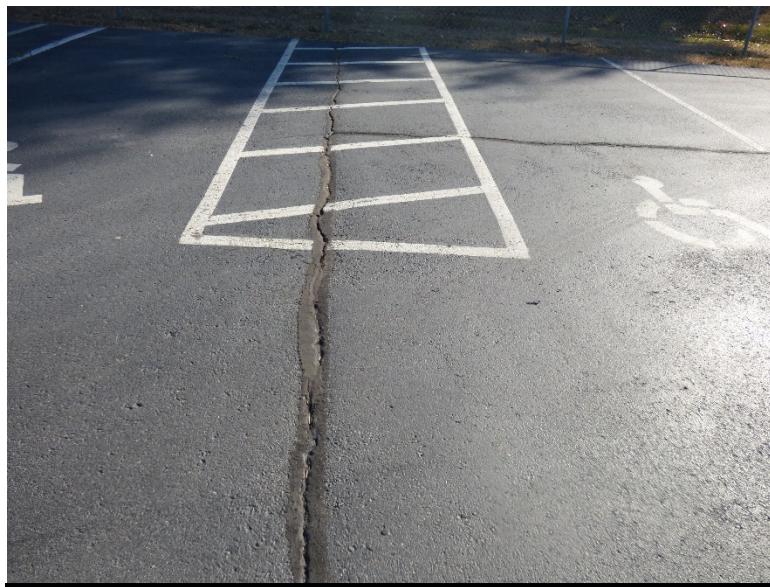
The surface parking lots were in fair condition. We observed cracks in the pavement. Some of the cracks had been previously sealed but had cracked again. We also documented isolated locations of significant pavement distress which could have been caused by overload or subgrade deterioration. The degree of weathering of the pavement varied throughout the different lots.

*Previously sealed pavement crack*

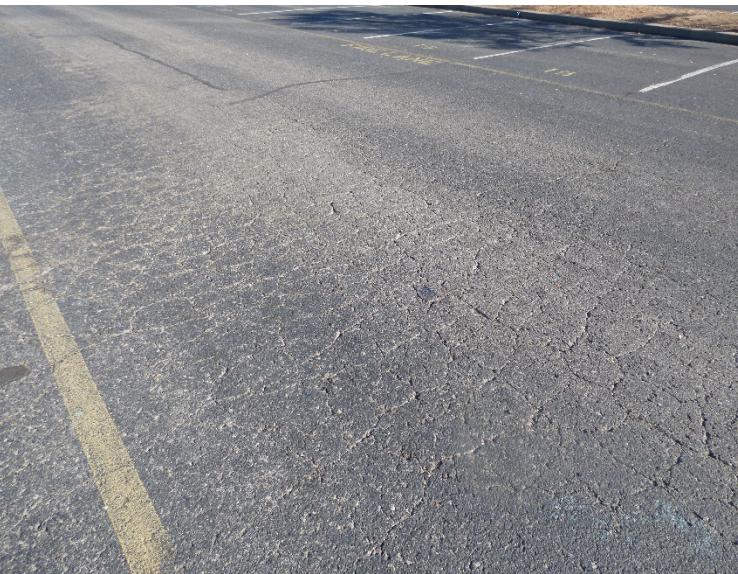
*Severe pavement deterioration*

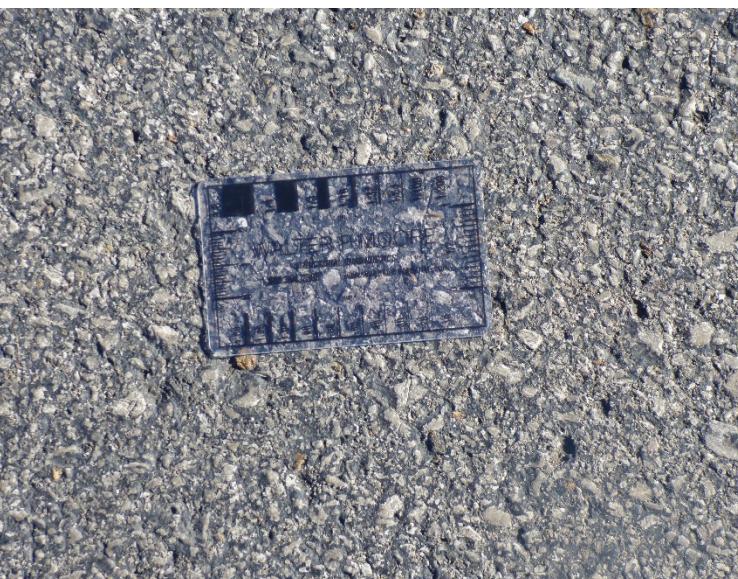
*Weathering of pavement*

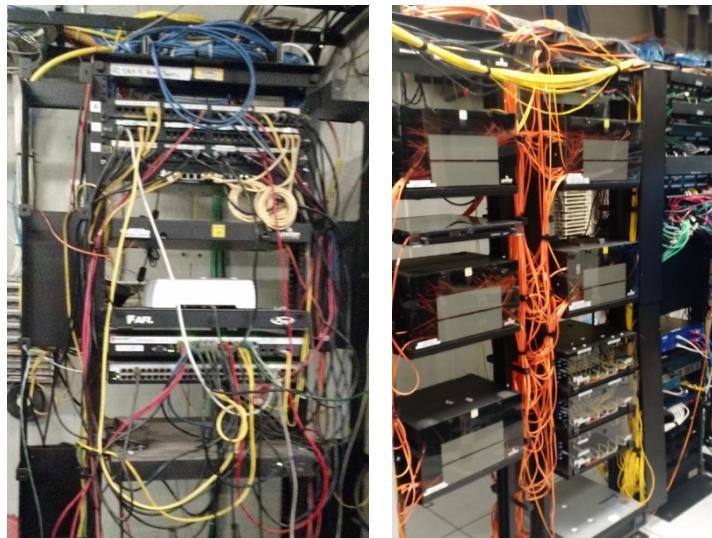
Telecom Spaces - Cabling Management

The structured cabling system infrastructure, spaces and pathways, are primarily the results of the initial construction of the stadium and are generally in accordance with current guidelines and standards: Building Industry Consulting Service International (“BICSI”), American National Standards Institute (“ANSI”) and Telecommunications Industry Association (“TIA”). To further achieve compliance with published guidelines and standards, minor housekeeping is recommended to address cable management/routing/support issues in the IDFs (intermediate distribution frame/telecom room).

1. To further achieve compliance with Structured Cabling System guidelines and standards, minor housekeeping effort is recommended to address cable management/routing/support issues in the IDFs and IT Main Equipment Room.

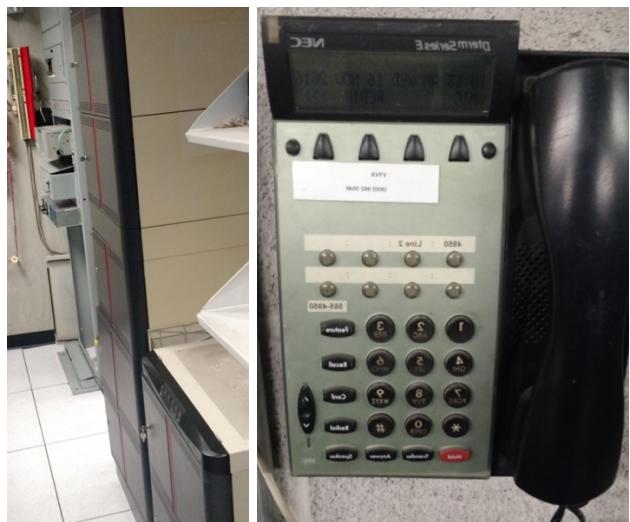
Legacy Phone System

The phone system is a legacy phone PBX, NEC NEAX 2400 IMS. The manufacturer announced End of Support of the PBX as of March 31, 2014. Support and refurbished parts availability is becoming more difficult to obtain. We recommend upgrading the PBX within the next 1-2 years to an enterprise Voice-over-IP (VoIP) PBX solution.

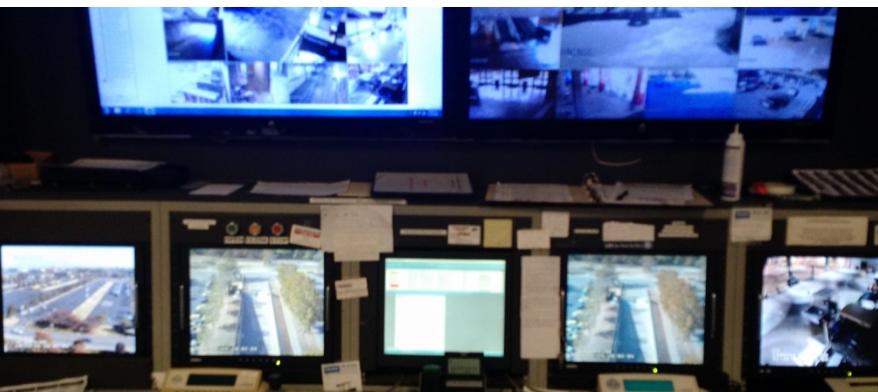
**Security Control Room**

The security technology in the control room includes some upgraded components, and many outdated components. It is recommended that the viewing monitors be upgraded when the video management system (VMS) is upgraded.

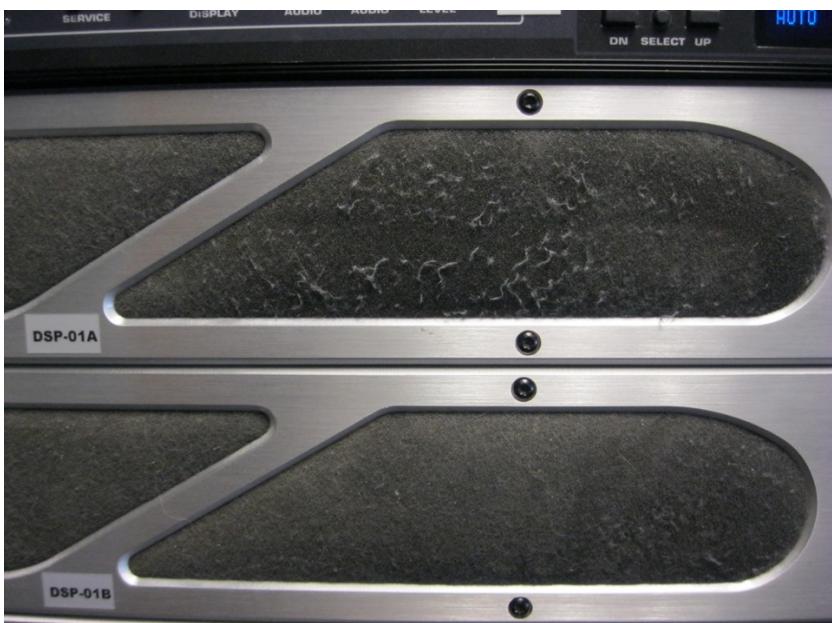
General cleaning of amplifier and processor air intake filters is recommended as many are loaded with dust. This is a time consuming task, but easily accomplished.

*Dirty processor filters*

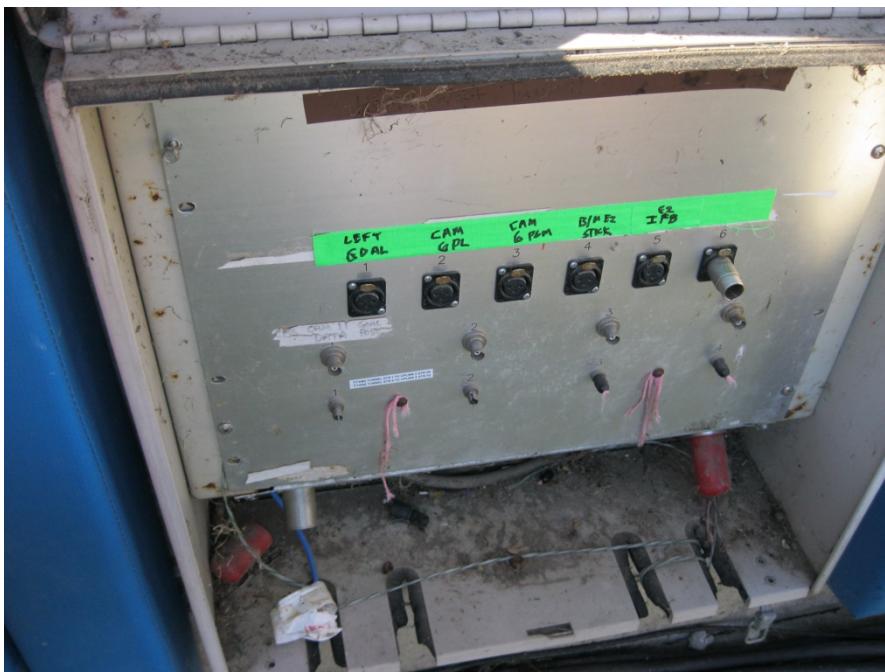
*Field wall panel example*

**Field Audio Cabling and Panels** – The audio cabling routed to the field wall is original to the building except for the portion damaged in the 2010 flooding. The original design as well as common practice is to route this cabling from origin to destination without splices. The flood remediation work installed splice points in the field cabling which eventually will lead to service issues due to corrosion or failing contacts. The connectors at the field wall panels show considerable corrosion and should be replaced. It would also be prudent to replace and upgrade the field wall enclosures to stainless steel when any cabling and panel repairs are made.

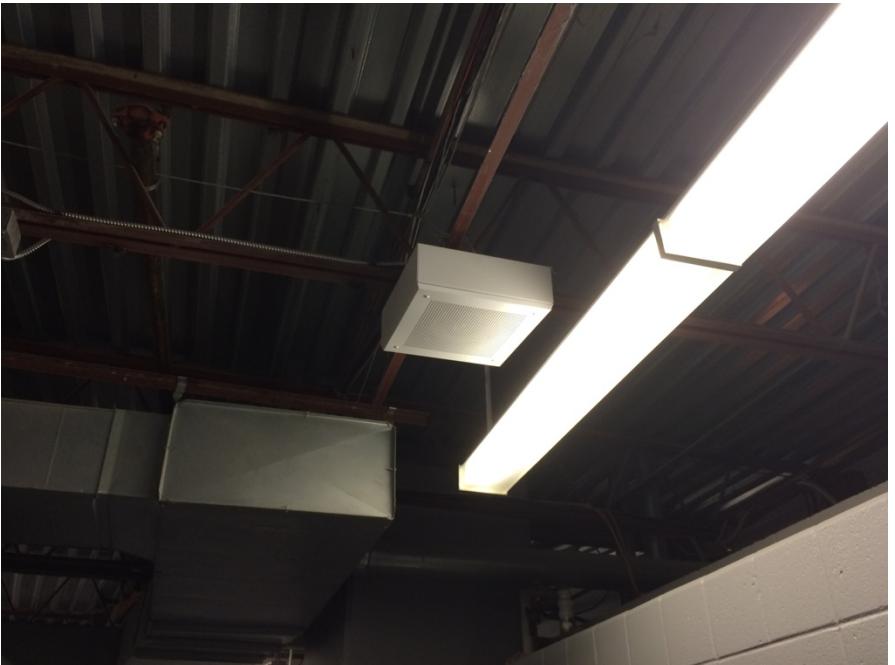
Typical Restroom Speaker

There are two restroom zones on the upper concourse level and in the North end zone of the main concourse where the speakers are not operating properly and need to be serviced as soon as possible. This is likely a wiring issue caused by construction work conducted over the years and not associated with the sound system.

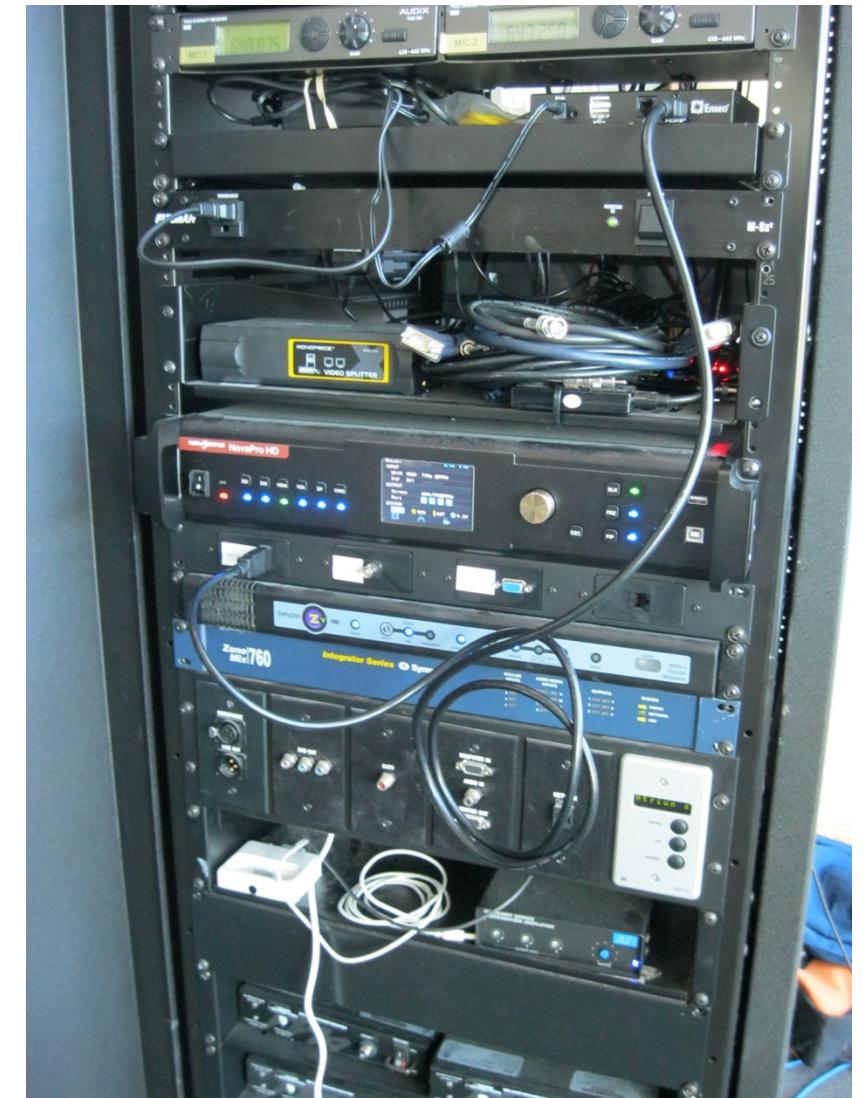
Club spaces in the stadium are equipped with sound systems to play background music and audio reinforcement. These systems have been partially upgraded over the years, although some equipment dates to the original installation. Local AV racks in each space provide control and interfacing with the stadium's sound and TV distribution systems as connections to allow. Poor installation practices were observed for some of the upgrades as seen in the AV rack photos below. It should also be noted that a large percentage of the audio equipment housed within the club AV rack is obsolete, no longer manufactured, and in most cases, not even serviceable.

*Existing club rack*

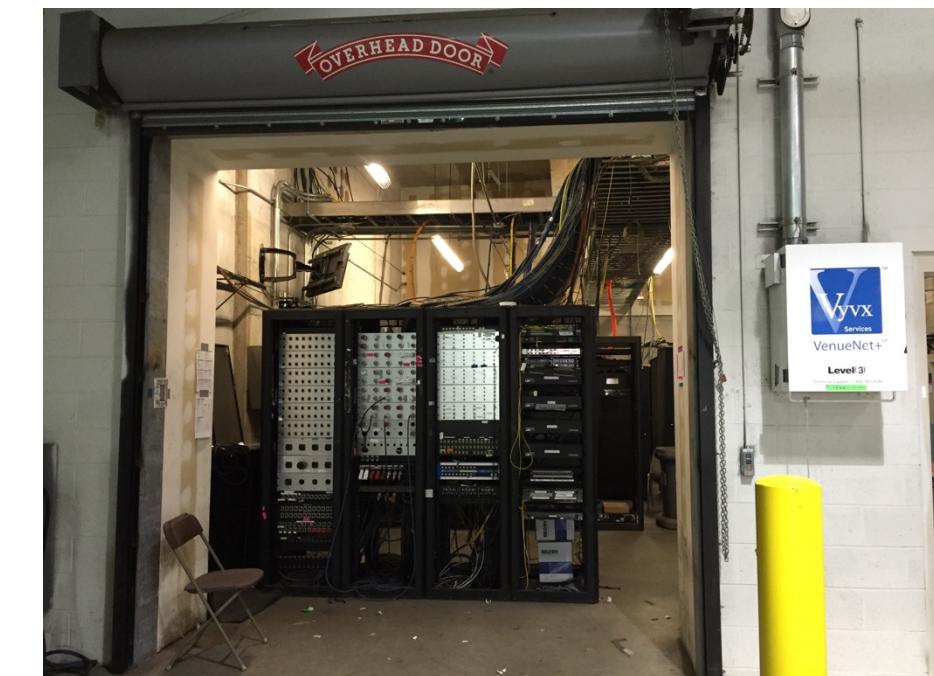
TV Truck Connection Area

The overall system is in poor condition, thus causing the facility to be inadequate for today's NFL broadcasting requirements. Many of the issues have to do with the following:

- Most broadcast box connectors are rusted or corroded.
- Certain broadcast boxes have non-functional electrical outlets.
- The single mode fiber quantities are light
- Drains in some of the camera wells are clogged, letting water pool up to the electrical outlets and connectors
- Most coaxial connections are not useable.

1. Replace entire broadcast cabling plant to meet current TV broadcast requirements.
2. With the facility being short on broadcast fiber optic cabling, it is recommended that single-mode fiber optic cable gets added to meet current TV broadcast requirements. This fiber cabling could be installed separately, although it would be most practical to install fiber while replacing other damaged cabling.
3. Since the overall broadcast cabling plant has damage to it and does not align with systems being installed currently, full replacement is recommended. At a minimum, sweep tests

should be conducted of all connection points and connectors or cabling repaired or replaced at deficient locations.

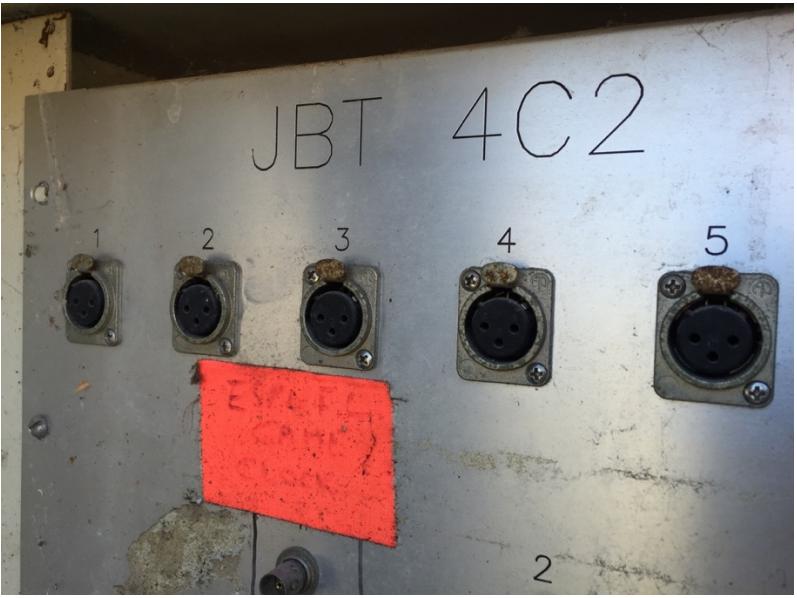
- At the TV truck connection, there are 50 triax camera connectors of which eight were observed to be labelled as unusable.
- Corrosion was observed on most the panel mounted connections at the field wall.

*Close Up of Corroded XLR Connectors (Typical of Most)*

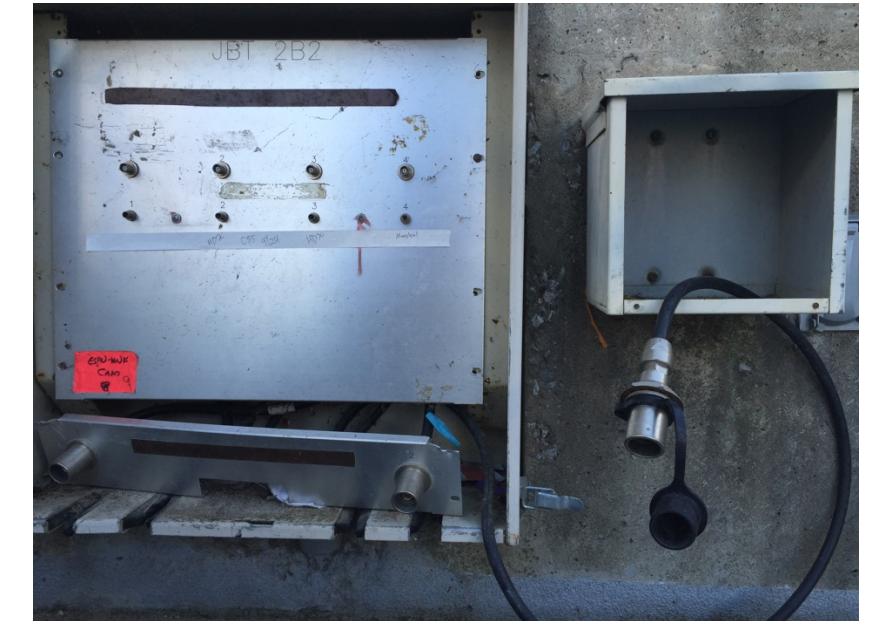
*Triax with panel mount connector but not connected to panel*

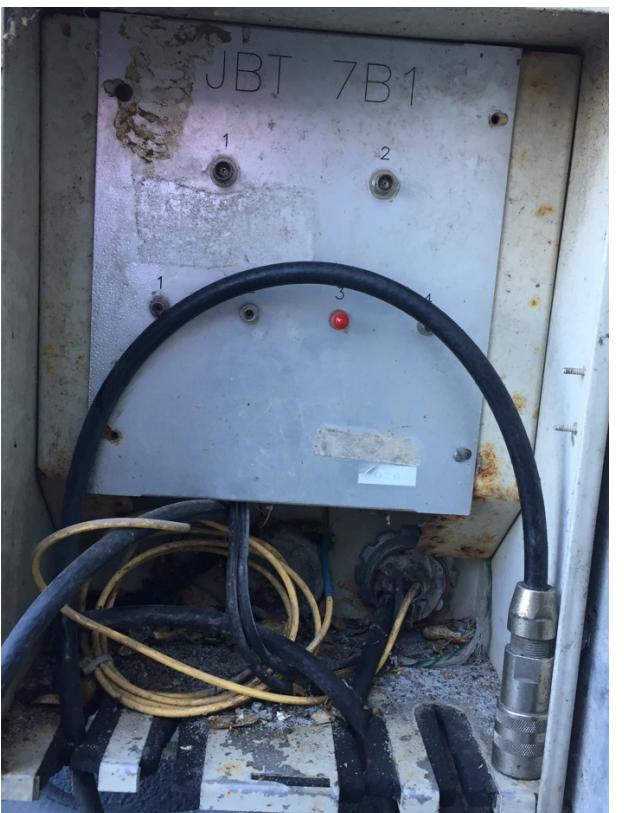
*Close Up of Corroded Coax and Fiber Connectors and non-panel terminated triax.*

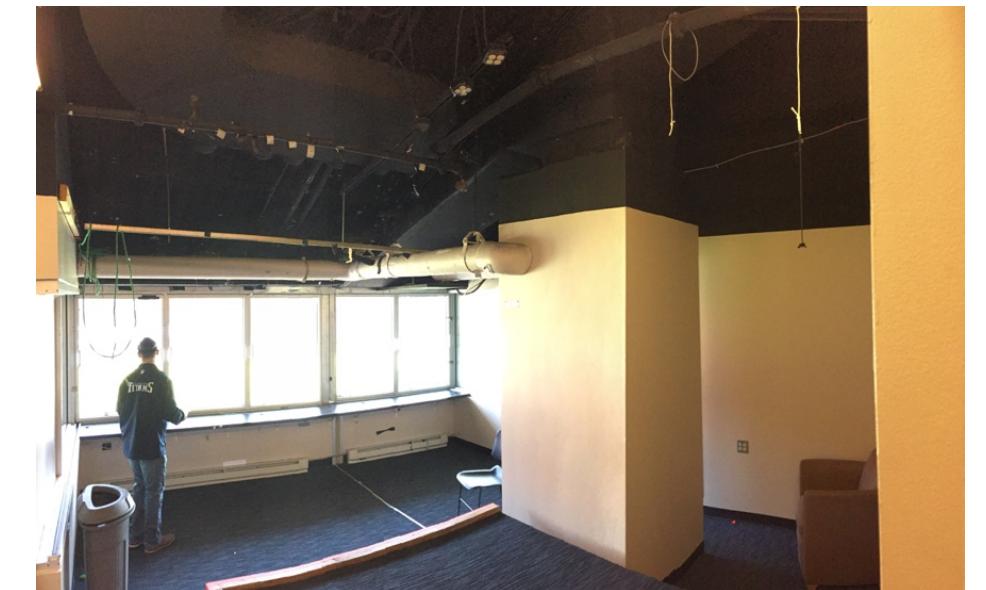
Main TV Broadcast Booth

- The Main TV Broadcast booth is deficient on the following:
    - Lack of useable lighting grid.
    - A stage/platform that is configurable. It needs to be in smaller pieces in order to fit the size of the room. Now, it is not able to breakdown at all.

- Fiber to the TV truck
    - Audio to PR/Writing Press
  - TVs are set on the counters, taking away counter space from the talent. Most facilities have these mounted to the ceiling corners.

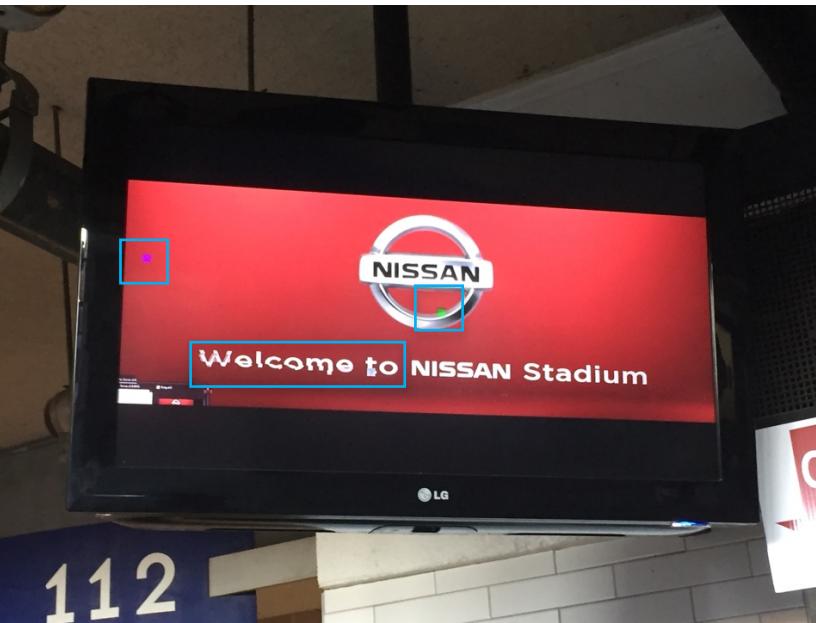
Certain TV locations are experiencing artifacts in some of the content. We believe this is a product that the distance limitations of the coaxial based trunk and tap system have.

Example of TV Location with Artifacts

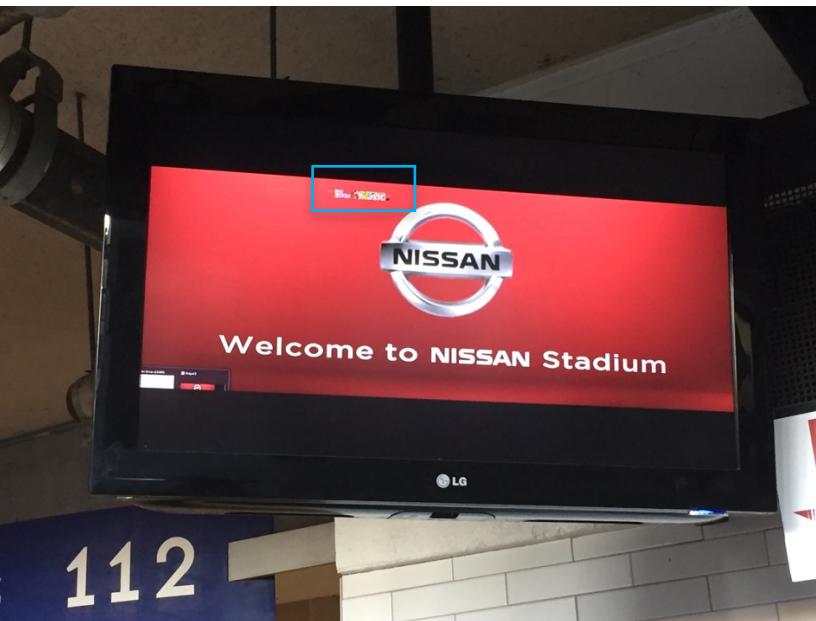
Example of Same TV Location with Different Artifacts

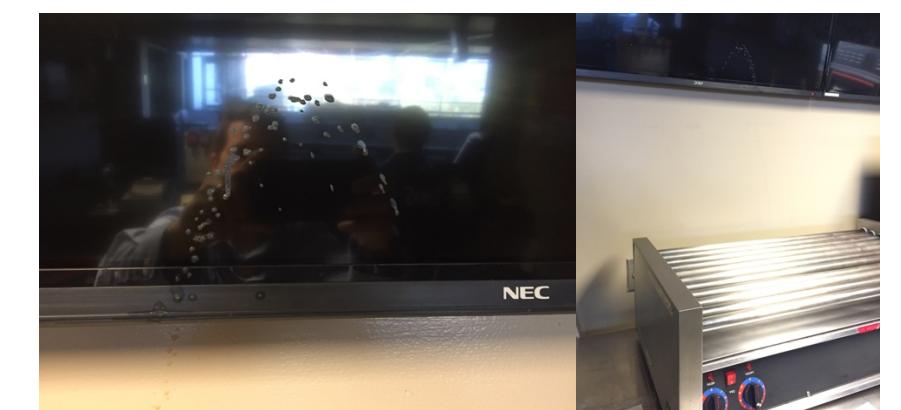
The location of some of the concession televisions can cause damage due to the food prep equipment as shown in the photo below.

Concession Location with TV Damage from oil splatter

2. Television replacement is typically served by a repair or replace as needed on an occurrence basis. The televisions past the typical 8-year life span should be considered for replacement.
