April 3, 2017

# Facility Condition Assessment

Nissan Stadium

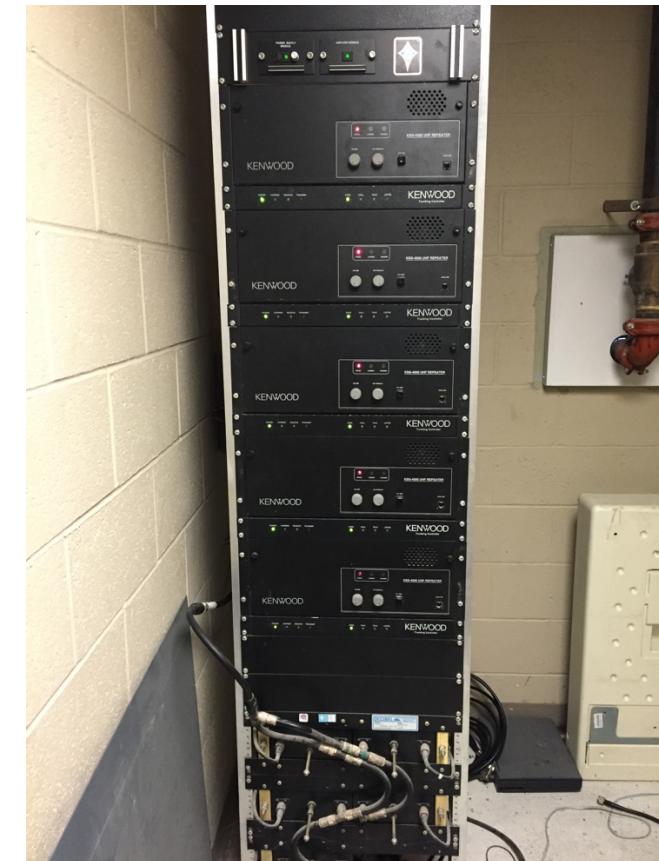
Repeater System in Room 7.56.03

At 20 years, the system is quite out of date and lacking the features required in a modern system. Parts are also unavailable. Some of the features of new systems:

1. Due to age, the radio repeater system should be planned for replacement.

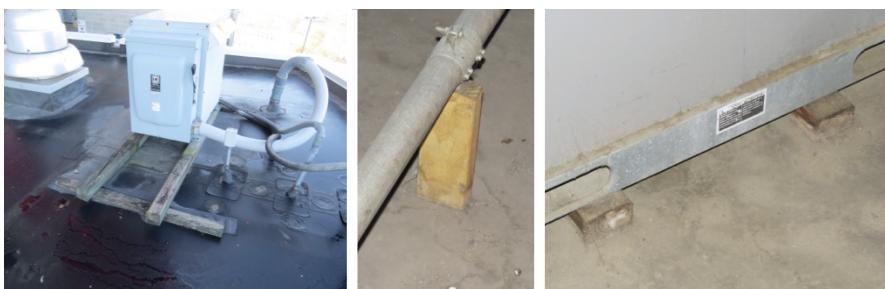
Several heavy electrical transformers, as well as other rooftop equipment are installed on wood sleepers, some of which rest directly on the (unprotected) EPDM roof membrane (above, and below left). The weight of such equipment can cause damage to the roof membrane, and may potentially puncture the thin membrane, causing leakage/damage. A blister in the EPDM roof membrane was noted on one upper roof area (below center). Blisters occur when air becomes trapped between the EPDM roof membrane and underlying roof insulation. An open hole was also noted on an upper roof area (below right). This hole is non-watertight and appears to have resulted from a heavy object falling onto the roof surface, or from damage caused by workmen on the roof.

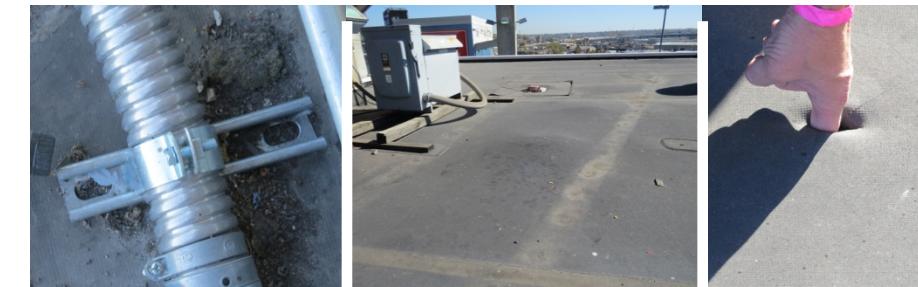
During our inspection, we noted a hole of approximately 1½ inches in diameter through the EPDM roof membrane. The puncture appears to have been caused either by falling debris or possibly by workmen on the roof. The puncture is wide open to moisture infiltration/damage.

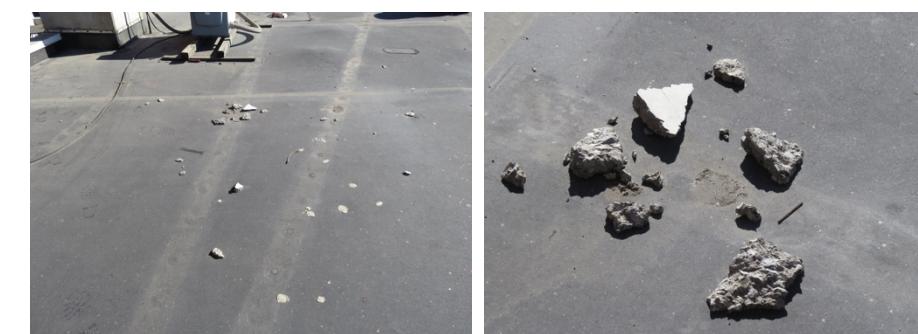
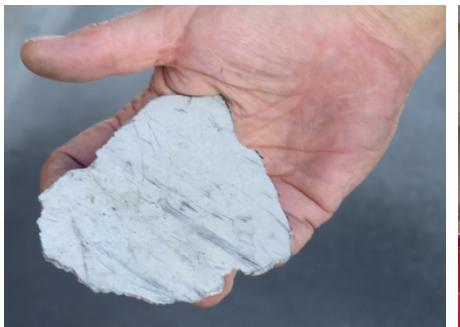
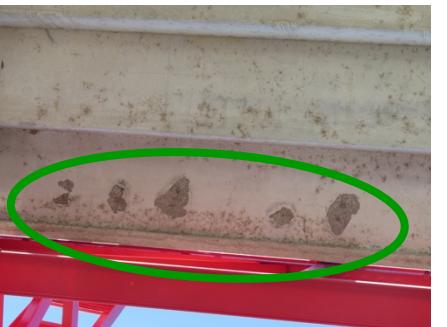
Fragments of concrete were found lying on the roof surface in many areas (photos above and at top left of next column), having spalled and fallen onto the roof from the underside of precast concrete sections of the upper seating bowl (photo at top right of next column). In some areas, the concrete fragments may have fallen up to 40 feet directly onto the thin, vulnerable EPDM roof membrane. The jagged/sharp-edged concrete fragments may damage/puncture the roof membrane, causing leakage/moisture damage. This condition was noted in several areas around the stadium beneath the upper seating bowl.

During our inspection, we also noted several areas where fragments of concrete, from the precast seating bowl structures above the roofs, are spalled and falling directly onto the unprotected roof membrane, potentially damaging/puncturing the roof membrane. We noted more than 25 such fragments of spalled/ fallen concrete throughout the facility.

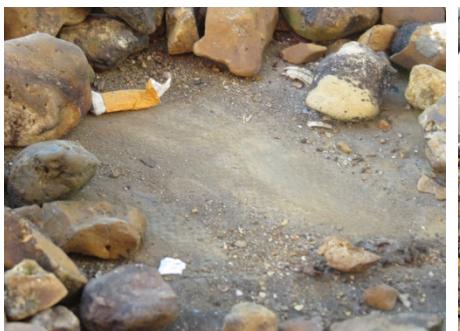
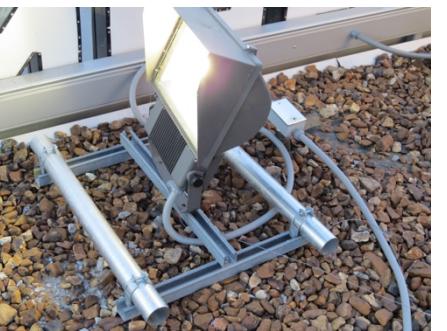
Several roof areas utilize EPDM single-ply membrane roof covering systems on which the roof membrane and underlying roof insulation are loose-laid atop the metal roof deck and ballasted with washed river stone (above). On only a couple of these areas, a ply of polyester filter fabric is installed atop the EPDM roof membrane beneath the stone ballast (above left). The fabric helps protect the roof membrane from damage/abrasion by the stone ballast and fines in the stone. In several places, equipment is installed directly atop the stone ballast (above right); additional weight atop the stone may cause damage to the underlying EPDM roof membrane.

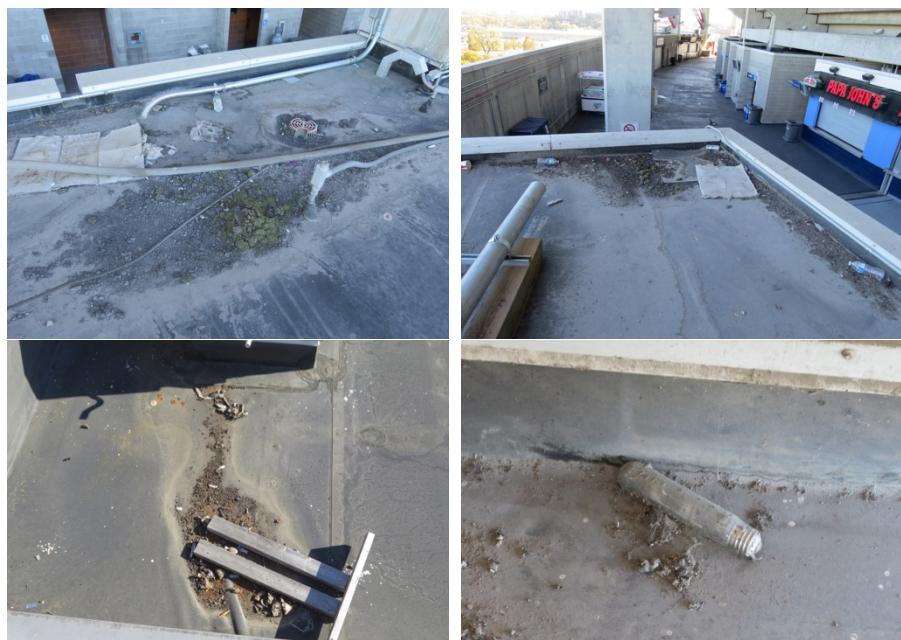
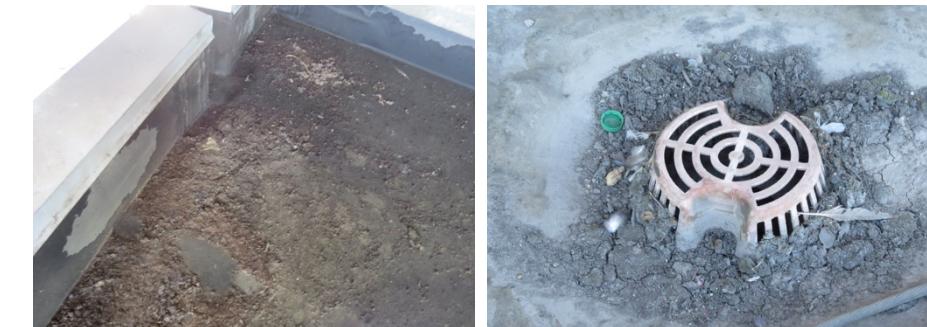
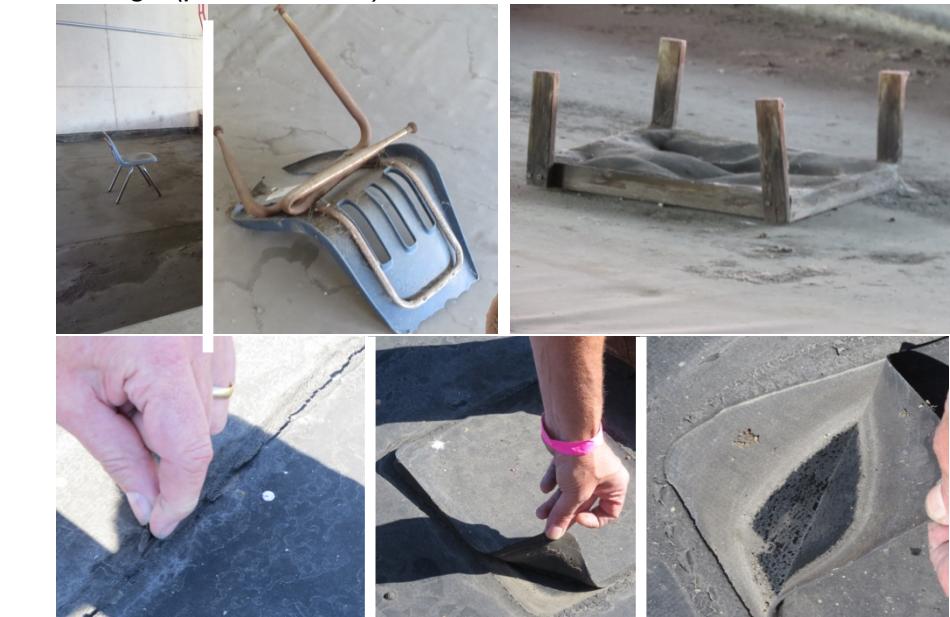
There are numerous areas with excess accumulated dirt/debris on the roof surfaces. Debris on the roofs, if stepped upon, may potentially damage/puncture the thin EPDM roof membrane, causing leakage and moisture damage. We noted at least one instance of a chair with thin metal legs sitting directly on the EPDM roof membrane, and the chair legs may easily puncture the membrane if a heavy person sits on the chair as it is.

Loose dirt/debris was also noted in the drainage elements in several areas; dirt/silt/debris can potentially clog drainage elements and/or storm drainage plumbing, and may result in retention of water on the roofs. It generally appears as if the roofs have not been thoroughly cleaned for at least several years.

Debris is accumulated on roof surfaces in many areas throughout the facility. Debris on the roofs may cause damage to the EPDM roof membrane (particularly if sharp-edged debris or broken glass is stepped upon), and dirt/silt/debris may clog roof drains and/or storm drainage plumbing (photos above). Pieces of broken furniture on the roofs can also cause cuts, punctures, or other damage to the roof membrane, causing leakage (photos below).

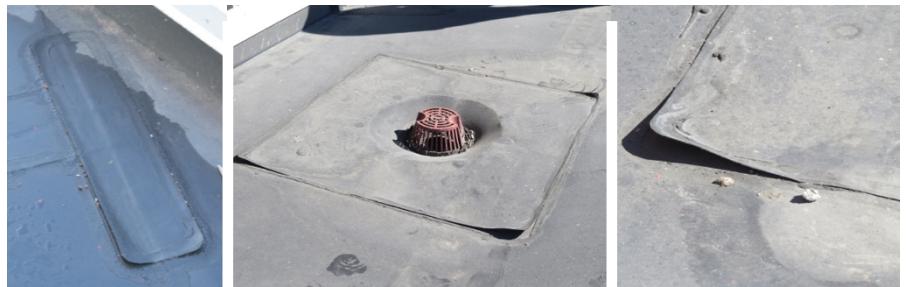
Lap seams in the roofing/flashng membrane are failing, delaminating, and non-watertight in many places throughout the facility. This condition was more common in areas with more exposure to the elements. It appears that adhesives utilized in the seams are badly deteriorated, and many patches and sections of flashing membrane are delaminating, particularly at outside corners in the membrane.

**Membrane Seam Failure:** Throughout the facility, many lap seams in the roofing/flashng membrane are failing, and more frequently on roof areas with direct exposure to the elements. Dozens of lap seams are delaminated, particularly at outside corners of patches/flashng membrane; many corners are upturned, allowing moisture infiltration into the seam. Moisture enters beneath open membrane seams and freezes/expands, further delaminating the seam until, eventually, the seam will leak.

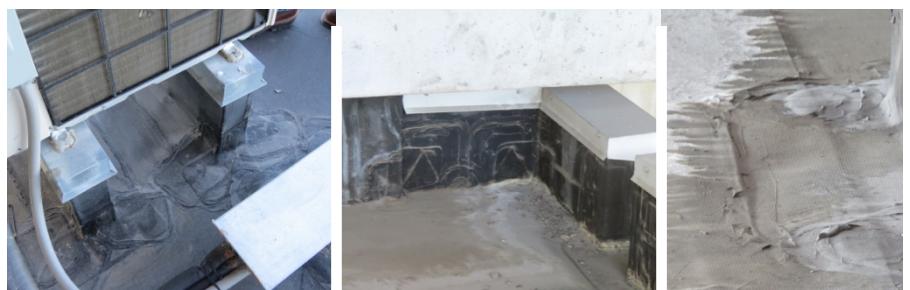
*The existing EPDM-covered roof covering systems appear to have been repaired in very few locations. Most of the repairs appear to have been properly installed and tied-into the existing EPDM roofing/flashng membrane (above left and center); however, one poorly installed patch that was noted does not appear to be properly tied-into the existing membrane system, and is dependent upon sealant for water tightness (above right). The sealant utilized around the repair/patch is poorly installed.*

**Membrane Repairs:** There are very few visible repairs/patches on the existing EPDM membrane throughout the facility. Generally, the membrane patches/repairs that we noted appear to be properly installed, functional, and watertight; however, we saw one patch that was poorly installed, and is dependent upon sealant for watertightness.

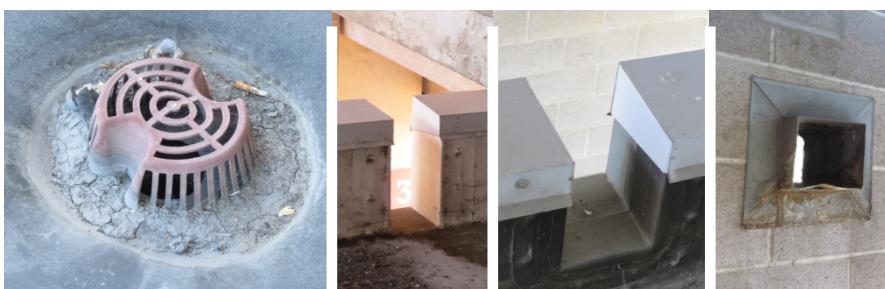
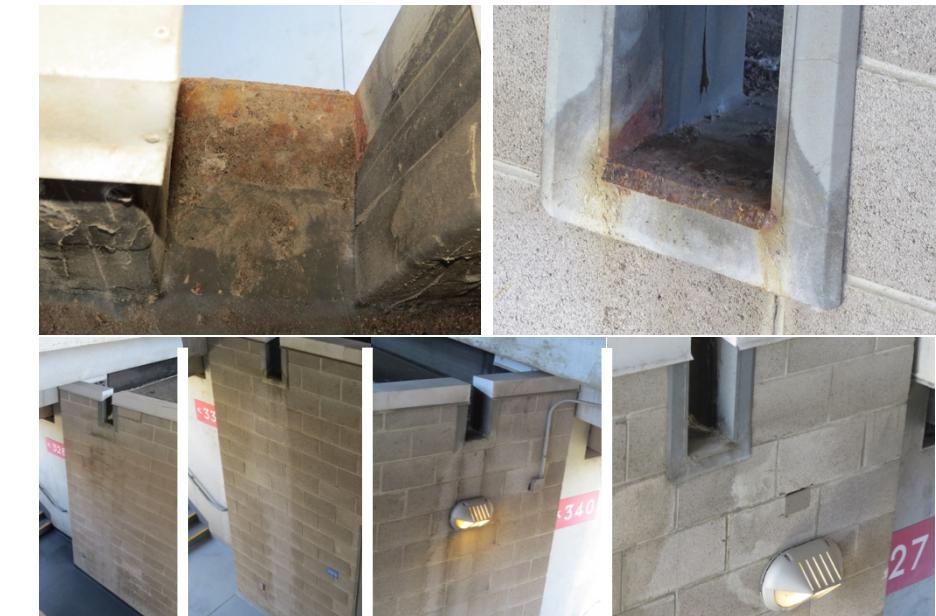
*Water is removed from most low-slope roof areas via interior roof drains (above left) or open-cut through-wall scuppers (2<sup>nd</sup> photo above). Many areas also utilize open-cut overflow scuppers (3<sup>rd</sup> photo above) functioning as “secondary” (overflow) drainage elements. The interior roof drains are connected to the storm drainage system, but most scuppers allow water to simply cascade down the exterior face of CMU walls (photos below). As a result, there are moisture stains on the CMU walls beneath many through-wall scuppers (photos far below). A few metal scupper liners are badly rusted (photos above right and immediately below); leakage/damage may occur if a scupper liner were to become rusted completely through. Many scupper openings are poorly located, being placed nearly or directly above wall-mounted electrical boxes and/or light fixtures (3<sup>rd</sup> and 4<sup>th</sup> photos far below). Water effluent from the scuppers could damage the electrical system and/or cause electrical hazards.*

**Drainage Elements:** Roof drainage on this facility is rather simplistic; some roof areas utilize interior roof drains that are connected to the storm drainage system. The roof drains appear to be in fair condition; however, a few roof drains are badly clogged with silt/debris, mostly due to the lack of periodic cleaning/maintenance of the roofs and drainage elements. Clogged drainage elements can cause water retention on the roofs, often resulting in shortened service life.

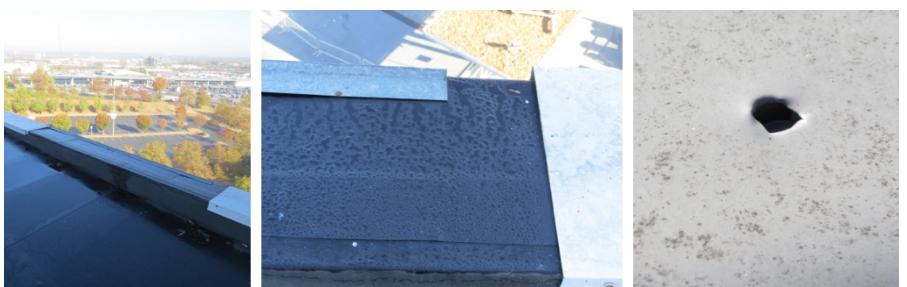
**Perimeter Flashing Conditions:** Most of the roof perimeters utilize elevated parapets with sheet metal copings. The metal copings are generally intact, but one missing section was noted. Some joints in the metal copings do not appear to be watertight; however, the missing section of coping showed that the EPDM membrane flashings are extended up and across the top of the parapet. One instance was noted of a hole punched through the metal coping and underlying membrane flashing.

Perimeters of the EPDM membrane roof atop the video camera booth, at the very top of the upper seating bowl, utilize metal edge flashings along the flush roof edges. The EPDM membrane strip-flashings along the edge flashings are poorly installed and do not appear to be watertight.

A section of metal coping is missing from the parapet (above left and center); it should be noted that the EPDM flashing membrane is (properly) extended atop the parapet, helping to protect the parapet structure from moisture infiltration. A joint between two sections of metal edge flashings is poorly flashed

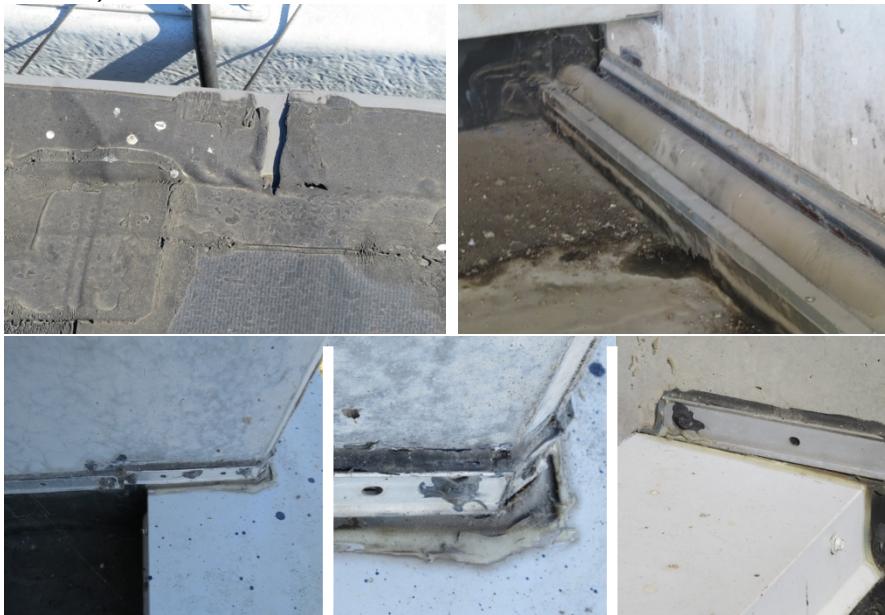
A few junctions between metal copings and concrete walls or columns are dependent upon caulk/sealant for water tightness. The sealant joints along some junctions are cracked/deteriorated, and do not appear to be watertight.

with membrane and does not appear to be watertight (photo immediately below left). Expansion joints that intersect roofs are flashed with pre-manufactured EPDM/metal expansion joint flashings (photo immediately below right). Junctions between parapets and vertical walls/columns are flashed with EPDM membrane that is extended above the metal coping and terminated with a metal termination bar. The existing sealant along some junctions between parapets and walls/columns is deteriorated and does not appear to be watertight (photos at bottom).

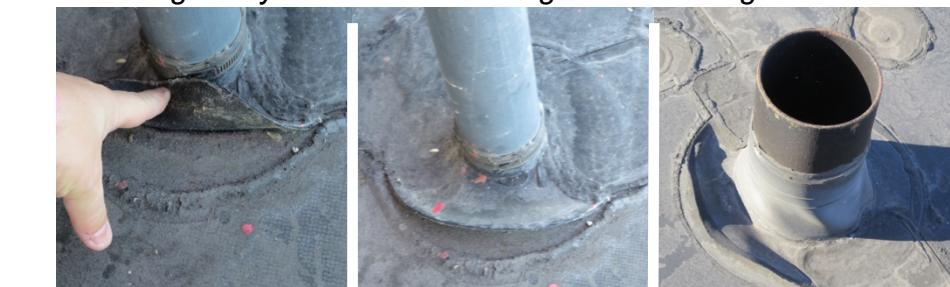
Flashings for numerous small roof penetrations (pipes, vent stacks, conduits, equipment supports, etc.) are in very poor/failing condition, and many are non-watertight. Some small roof penetrations are flashed with pre-manufactured EPDM flashing boots, while others are flashed with a “field-wrap” of EPDM sheet membrane. Adhesives, utilized to adhere the membrane flashings to the EPDM roof membrane, are failing, rendering many membrane flashings non-watertight.

**Roof Penetrations/Flashings:** Most small items penetrating the roof (vent stacks, pipes, conduits, etc.) are flashed with pre-manufactured EPDM flashing boots that are adhered to the EPDM roof membrane with adhesive. The adhesive utilized to secure many such flashing boots is failing, and many of the EPDM flashing boots are detached and non-watertight. It appears that none of the EPDM flashing boots have ever been repaired or replaced since original construction.

Several penetrations for pipes/conduits appear to have been installed more recently. Some of the penetrations are flashed with a “field-wrap” of EPDM membrane (which is an acceptable method of flashing penetrations); however, the flashing membrane lacks proper termination along the top edge (such as elastomeric sealant). One roof penetration for a new non-watertight flexible electrical conduit is simply caulked with silicone sealant; this type of detail does not meet minimum industry standards, and is not watertight.

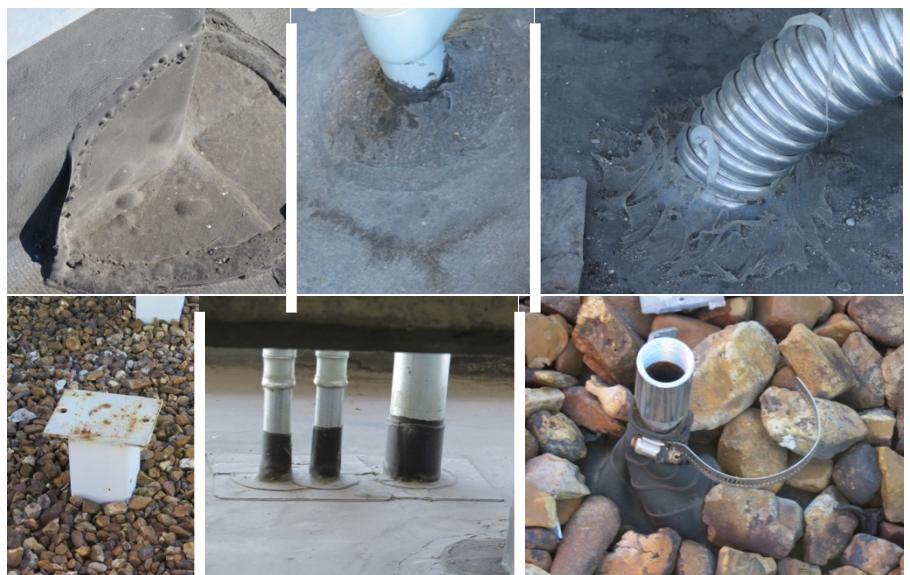
EPDM membrane patches, generally applied over corners of roofing/flashing membrane, are delaminated in many places (top left), potentially allowing moisture infiltration into the roof covering system. A few roof penetrations were noted that are not properly flashed in accordance with industry standards (top center and right). These penetrations have only a poorly-installed application of elastomeric sealant; this type of detail does not meet minimum industry standards, and these penetrations do not appear to be watertight. Several roof penetrations for steel supports, pipes, and conduits are flashed with EPDM membrane; however, the membrane on some penetrations is not properly extended up onto the penetration min. 8 inches (photo immediately above left), as compared with other pipes that appear to be properly flashed (photo immediately above center). Another roof penetration for a conduit appears to be properly flashed (photo immediately

above right); however, the unused conduit is open on top, potentially allowing moisture into the electrical system. Another conduit exiting the roof is missing a cover on the LB (angle) fitting (below left). Open pitch pocket flashings are utilized for flashing some irregularly-shaped/angled roof penetrations (below center and right). The filler material in many open pitch pocket flashings on this project is shrunken, cracked/split/deteriorated, retains water on top, and in some pitch pockets, does not appear to be watertight. Pitch pocket flashings typically require regular maintenance/refilling.

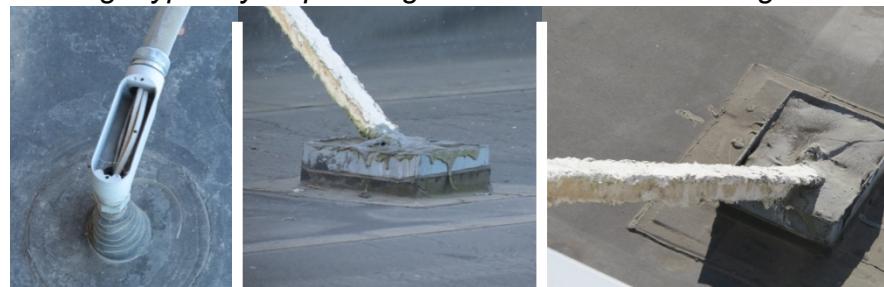
It appears that additional roof penetrations and structural members were recently constructed on the eight canopy roofs above entry gates (end zones) to display vehicles atop the roofs. The square steel tube supports are flashed with EPDM membrane, but the membrane flashings are not properly terminated along the top edge. Some roof penetrations (such as electrical conduits) on other roof areas are also more recently installed, and EPDM flashing membrane surrounding such penetrations is not properly terminated at the top. Current industry standards generally require a metal draw band and sealant to terminate the flashing membrane around the top edge.

Roof curbs for mechanical equipment are flashed with EPDM membrane (sheet membrane) that is also adhered (with adhesive) atop the roof membrane, and the adhesives are failing in many areas. Edges of EPDM sheet membrane flashings are loose/delaminated in many areas, allowing moisture infiltration and potentially larger areas of damage.

many of these pitch pockets is shrunken (retaining water on top), and/or cracked/split/deteriorated, and some are non-watertight. In our opinion, open pitch pocket flashings are not the best design choices for roof penetrations; while they are not always avoidable, when they are utilized, open pitch pockets require regular inspection/repair/refilling.

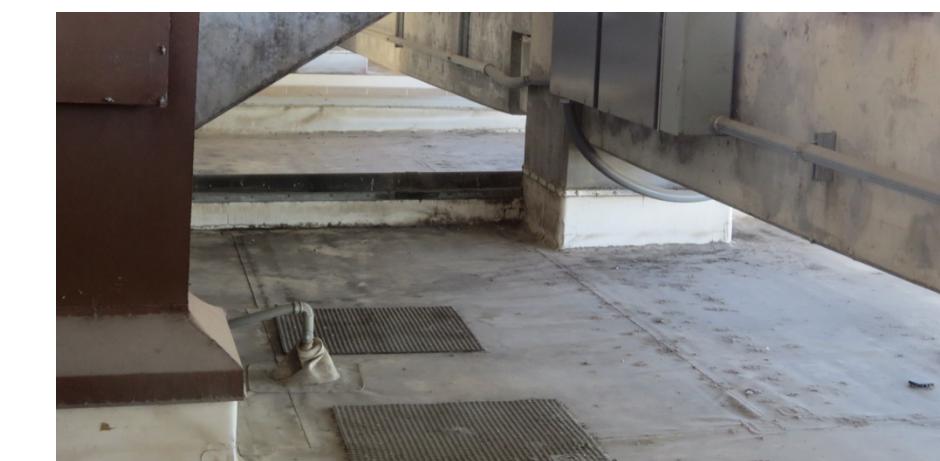
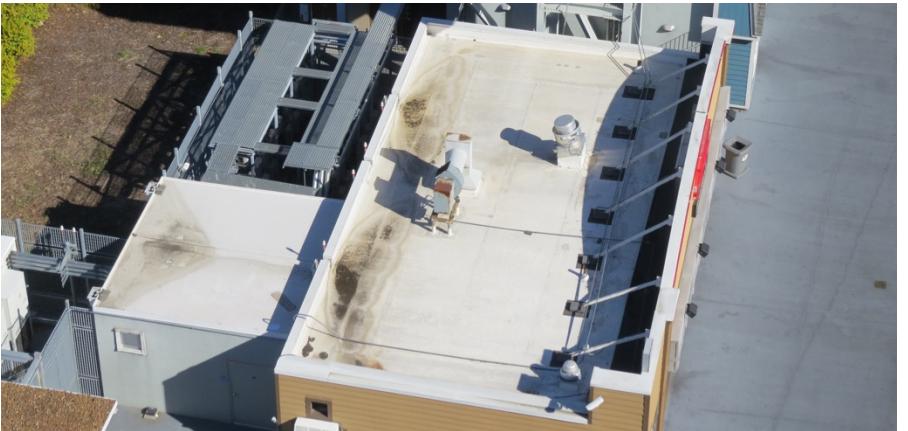
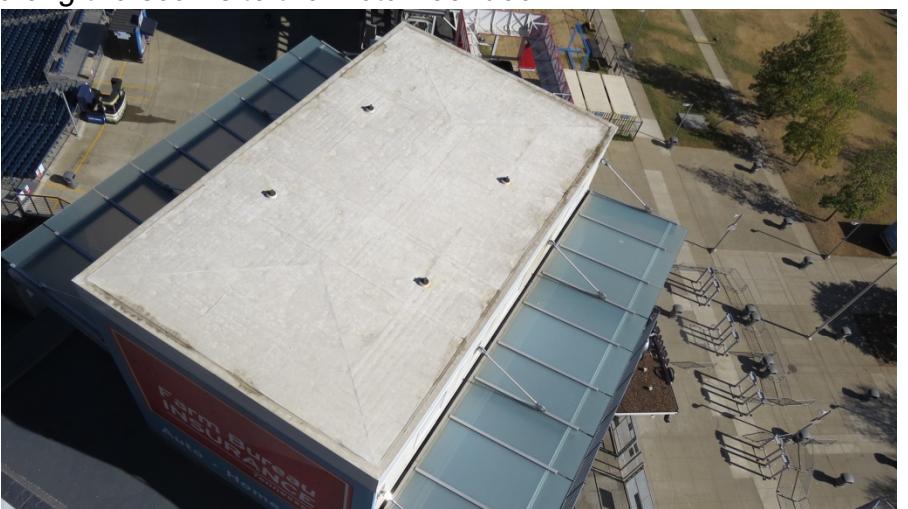
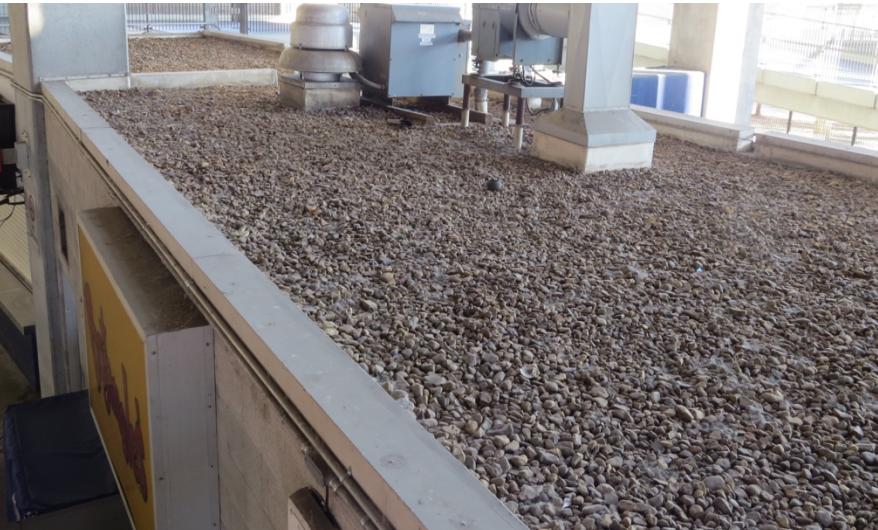
Several roof areas utilize reinforced PVC single-ply membrane roof covering systems (photos above, below, and at top of next column). A few more-recently-constructed roofs may utilize TPO membrane systems (similar to PVC). On most areas, the PVC/TPO single-ply membrane is fully-adhered to the underlying roof insulation (photos at bottom of center column, above, and immediately below), but on some other roof areas, the membrane (and insulation) are loose-laid atop the roof deck and ballasted with crushed stone (photo at bottom). Also, on a few roof areas, the roof membrane is mechanically fastened along the seams to the metal roof deck.

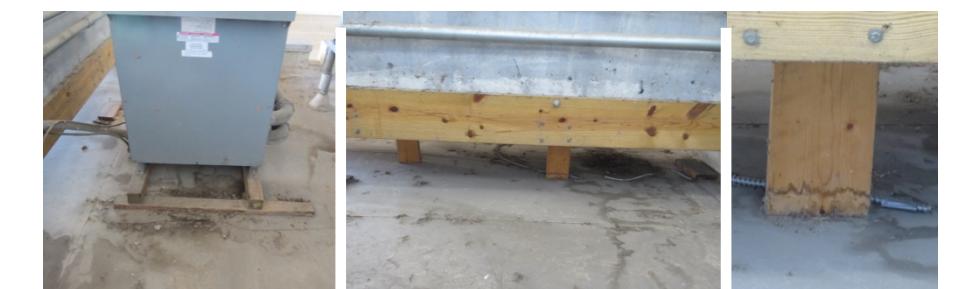
**Roof Membrane Damage:** There are several areas on the PVC/TPO-covered roofs where heavy rooftop equipment is installed atop wood sleepers that rest directly on the (unprotected) surface of the roof membrane. The weight of the heavy equipment can potentially compress the wood sleepers into the membrane and underlying insulation, causing damage to the roof membrane, and possible puncture/leakage.

Several large/heavy pieces of rooftop electrical/mechanical equipment are installed atop wood sleepers (above), and the wood sleepers (improperly) rest directly on the unprotected surface of the roof membrane. The weight of heavy equipment can potentially compress sharp edges of the wood sleepers into/through the single-ply roof membrane, causing damage/leakage. Fragments of spalled concrete have fallen from overlying seating bowl sections onto the roof membrane,

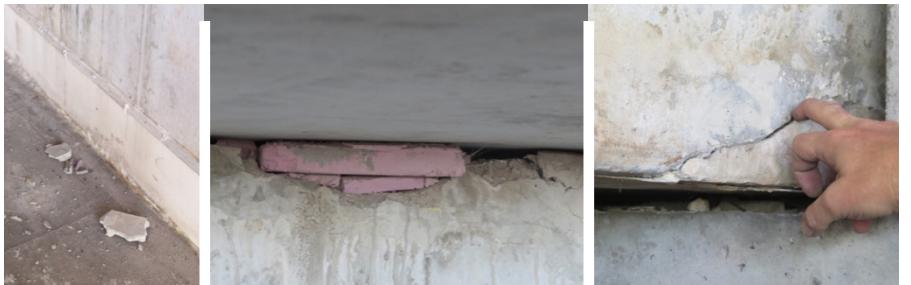
*potentially causing damage/leakage (below left). Several places were noted with spalled/cracked/missing concrete from the seating bowl structures (below center/right).*

There are several roof areas with debris, fallen fragments of concrete (spalled from the overlying precast concrete seating bowl structure), and/or deposits of grease/oil (from exhaust fans/vents from food preparation areas below) on the roof surfaces. Any of such items may potentially damage the roof membrane, and sharp-edged debris/concrete fragments may potentially cause a puncture in the roof membrane if they were to be stepped upon.

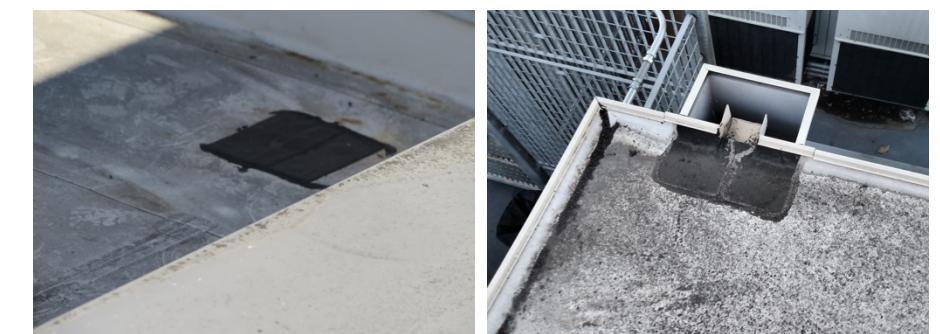
**Roofing/Flashing Membrane Repairs:** Generally, there appear to be very few areas of the PVC roofing/flashng membrane that have sustained repairs. There were, however, some roof repairs made with membrane that does not match the original PVC/TPO membrane system; several repairs are made with (what appears to be) self-adhering EPDM membrane, rather than with matching membrane that is heat-welded atop the original membrane. In our opinion, this type of repair cannot be expected to perform for the duration of the existing PVC/TPO membrane roof covering system, and may require additional repairs with time.

*Several patches/repairs to the existing PVC/TPO roof covering systems are (improperly) made utilizing black self-adhering membrane (presumably EPDM), rather than membrane that matches the existing/adjacent membrane, heat-welded to the existing roof membrane (above). A roof drain appears to have been repaired with some type of sealant (below left); however, the sealant is poorly installed and does not appear to be compatible with the roof membrane, nor does it form a reliable bond with the membrane. This repair does not appear to be watertight. A through-wall overflow scupper appears to be blocked by signage installed on the exterior wall (below right). Another through-wall scupper is damaged/non-watertight (bottom left), and may allow moisture infiltration into the masonry wall system. Metal conductor heads are utilized on some scuppers where water drains onto a lower roof area (bottom right).*

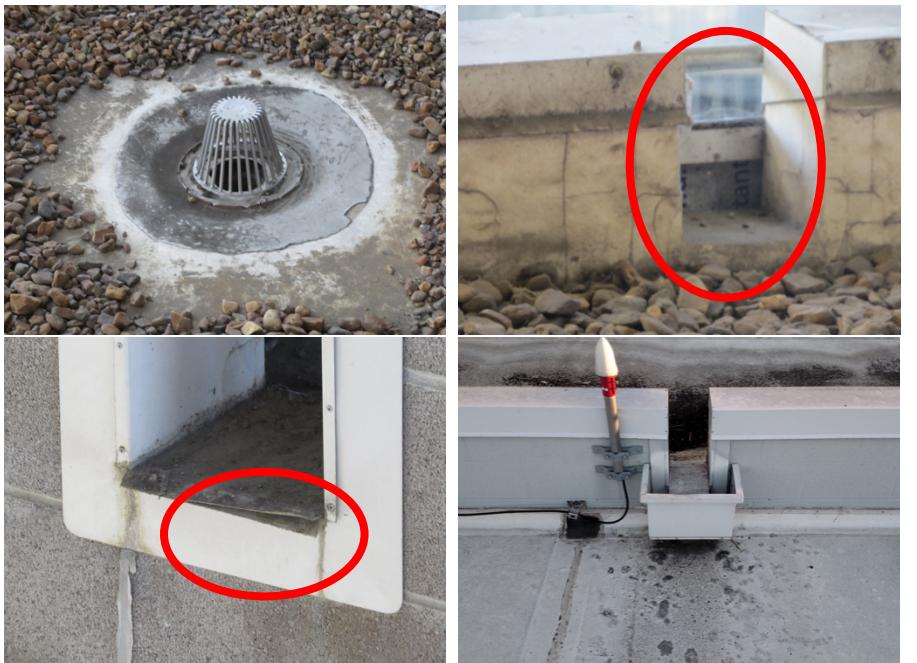
One metal through-wall scupper liner was noted as damaged/non-watertight. We also noted one interior roof drain that appears to have either been added sometime later than original construction, or was replaced; the roof drain is much smaller than those typically utilized on the project. The PVC membrane drain flashing membrane is covered-over with some type of sealant material. The sealant does not appear to have formed a reliable bond with the underlying membrane, is cracked/delaminated in areas, and does not appear to be watertight.

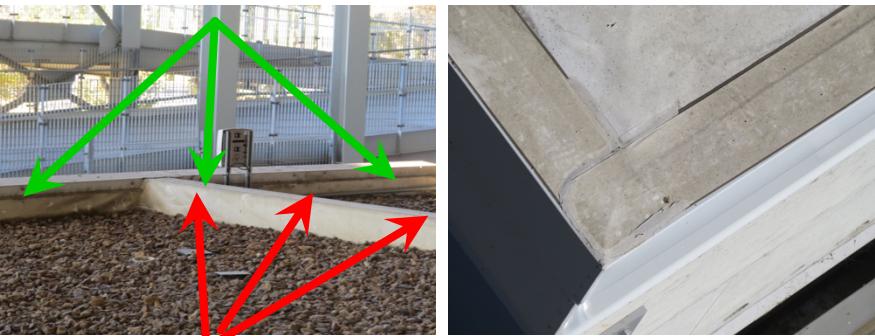
Typical parapets are flashed with membrane and capped with metal copings (green arrows, above left); however, a few areas were noted on which parapets between roof areas are flashed only with membrane, and lack metal copings (red arrows, above left). Flush edges on the elevator tower roofs are flashed with metal edge flashings that are strip-flashed with membrane (above right). The membrane strip flashings utilize self-adhering membrane, rather than heat-welded membrane. Walls and columns are flashed with membrane, and the membrane is terminated with a metal termination bar and elastomeric sealant (below left). Expansion joints that traverse roofs are flashed with pre-manufactured EPDM/metal expansion joint flashings. Depending upon the configuration, the expansion joints are flashed with either a curb-to-curb expansion joint flashing (below center), or a curb-to-wall flashing (below right).

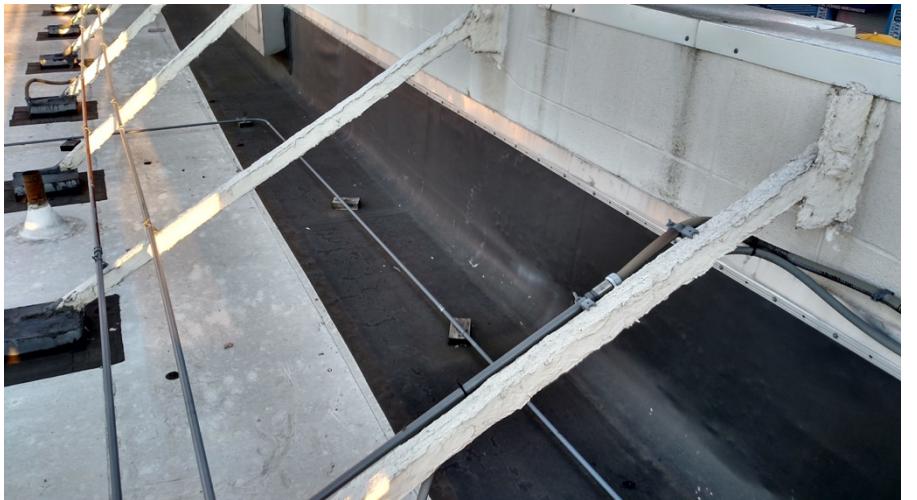
One very unusual perimeter flashing condition was noted on the two Logan's Road House concession stands in the north and south end zones. It appears that when the stands were retrofitted/converted to Logan's (in/around 2010), taller parapets were constructed along the storefronts of the stands, and at that time, the parapets were re-flashed with single-ply membrane. For some reason, sheets of black EPDM membrane were incorporated into the white (PVC or TPO) roof covering system. The purpose of this type of flashing detail is unknown. Combining different membrane materials into one roof covering system in this manner does not meet minimum industry standards; it would not comply with any roof covering system manufacturers' specifications/recommendations, nor would it be acceptable for issuance of a manufacturer's warranty for the roof covering system.

Parapets on the two end-zone Logan's Road House concession stands are (improperly) flashed utilizing black EPDM flashing membrane, rather than white membrane to match the existing roof covering system.

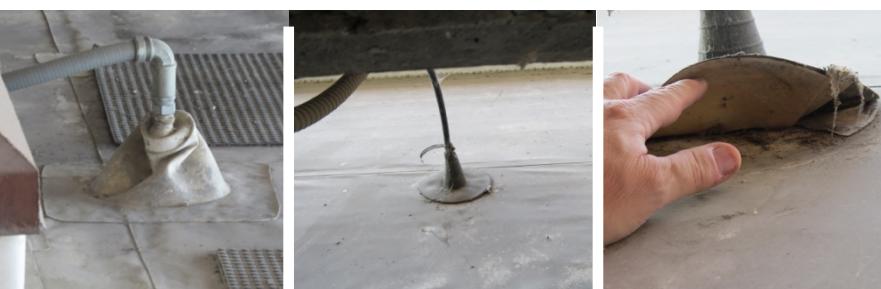
**Roof Penetrations/Flashings:** Curbs for rooftop equipment are typically flashed with PVC/TPO membrane that is heat-welded into the roof covering system. Smaller penetrations (pipes, conduits, equipment supports, etc.) are typically flashed with either a field-wrap of membrane (heat-welded to the roof membrane), or pre-manufactured roof flashing boots. During our inspection of the roofs, we noted several pre-manufactured flashing boots that are poorly installed, and at least one that is completely failing and detached from the roof membrane. Sealants on many flashing boots are poorly installed, and several do not appear to be watertight.

There are several electrical conduits that penetrate the roof and are flashed with pre-manufactured flashing boots; however, the conduits are unused, not capped, and wide open to moisture infiltration into the conduits.

Numerous small roof penetrations, particularly on the roofs atop the end-zone Logan's Road House stands and the new elevator tower roofs, are flashed with open pitch pockets. The filler material in most of the pitch pockets is badly shrunken, causing retention of water atop the pitch pockets. Several pitch pockets do not appear to be watertight. Open pitch pocket flashings typically require regular inspection/maintenance. Also, the pitch pockets on the Logan's Road House roofs (end zones) are (improperly) strip-flashed with black self-adhering EPDM membrane, rather than membrane to match the original roof covering system.

Many small roof penetrations are flashed with pre-manufactured flashing boots that are (supposedly) heat-welded/sealed to the roof membrane (above); however, some flashing boots are poorly installed (above left), and one was noted as totally failing and non-watertight (above center and right). Several unused electrical conduits penetrate the roofs that are not properly capped and allow moisture infiltration (below left). A flexible electrical conduit penetrates the roof and is simply (improperly) caulked with sealant, rather than being properly flashed (below center); this roof penetration does not appear to be watertight. The filler materials in many open pitch pockets is poorly installed and shrunken, causing water retention on top (photos below right and bottom left). A steel support frame for a rooftop mechanical unit is badly rusted (bottom right) and needs to be properly cleaned/prepared/primed/painted.

A steel rooftop mechanical unit support frame is badly rusted and needs to be properly cleaned/prepared/primed/painted.

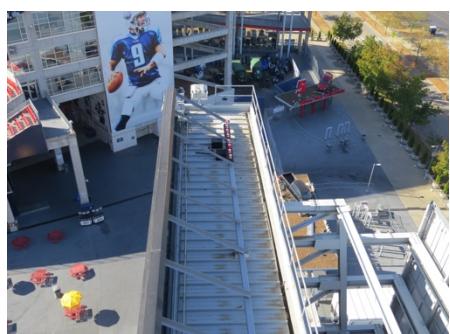
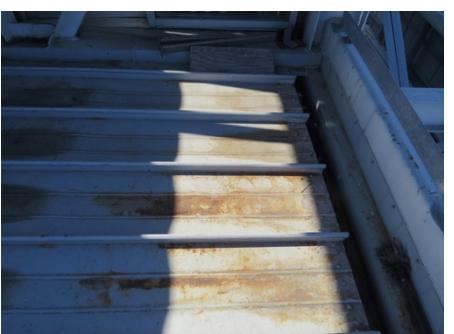
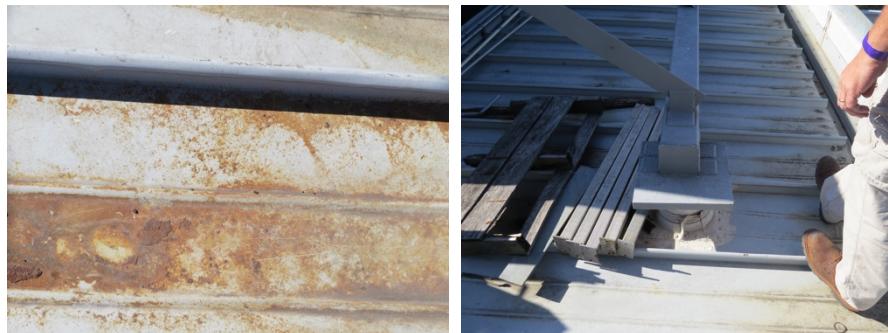
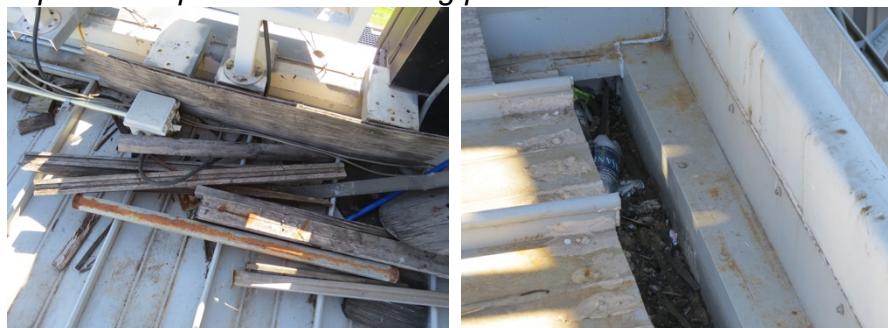
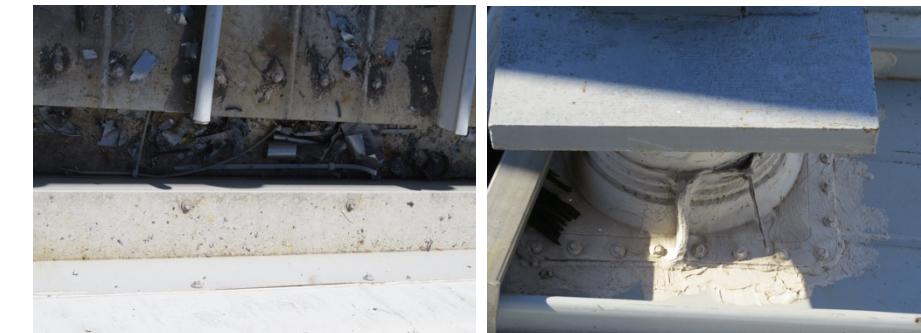
Scoreboard & Loudspeaker Enclosure Roofs: The premanufactured metal panel roof covering systems atop the scoreboards/ loudspeaker enclosures appear to have been repainted at some time since original construction; however, the paint/finish on the metal roofing is generally in poor condition, and the metal roofs are rusted in many areas. There are unused materials and debris accumulated on the roofs and gutters, potentially clogging the gutters/downspouts and/or damaging the paint/finish on the metal roof covering systems.

Many roof penetration flashings and fastener heads are covered-over with elastomeric sealant. This type of repair is temporary, at best, requiring regular maintenance/replacement.

*Roofs atop the scoreboards and loudspeaker enclosures utilize pre-manufactured pre-finished metal roofing panels that are screw-fastened to the steel roof framing. The metal roofs appear to have been repainted at some time since original construction; however, the metal panels are surface-rusted throughout, and badly rusted in some areas (photos top right and immediately above left). Abandoned/unused materials are stored on roof surfaces, and trash/debris is accumulated on the roofs in some areas (photos immediately above right and immediately below left). Gutters are also clogged with trash and debris (photos immediately below right and bottom left); clogged gutters can result in water retained on roof surfaces and potential leakage. Fastener heads and some roof flashings are coated with elastomeric sealant (photos immediately below right and at bottom). The sealant is poorly installed and cannot be expected to perform over a long period.*

- f. Repair/replace all damaged/rusted through-wall scuppers.
- g. Cleaning/Preparing/priming/painting any areas of rusted metal roofing/flashings (particularly on the scoreboard/loudspeaker enclosure roofs).

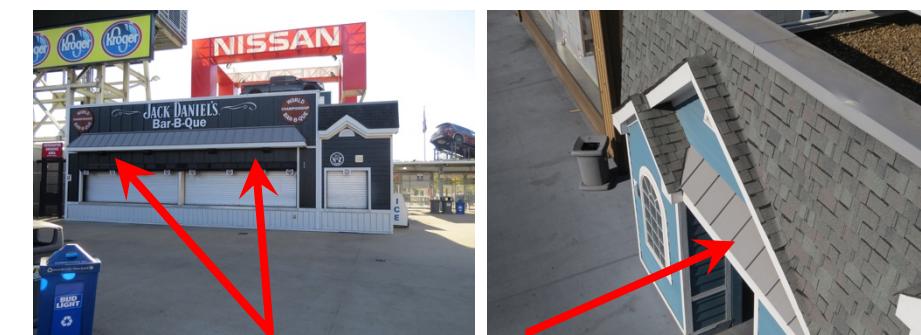
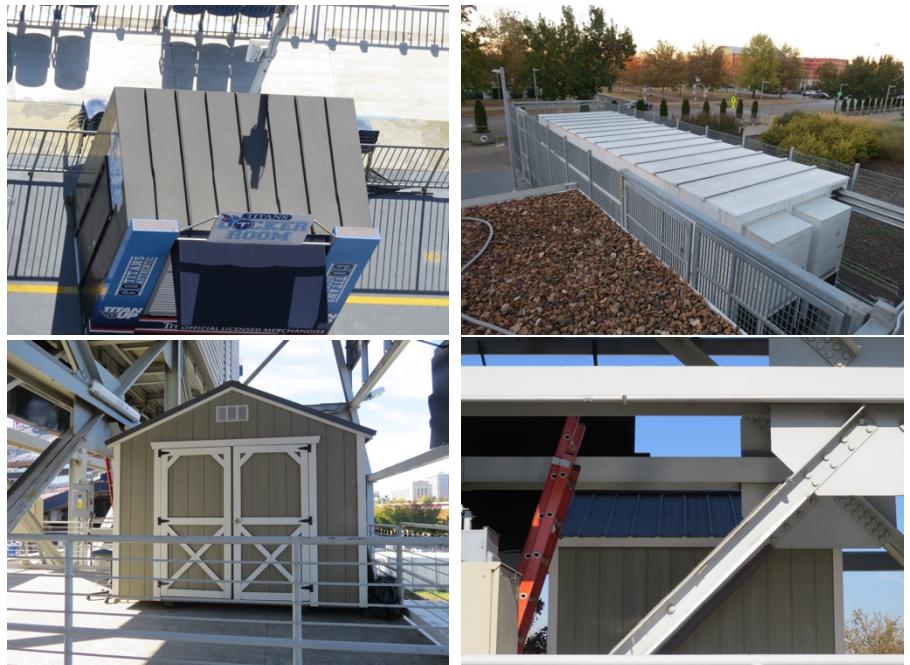
Mansard roofs on end-zone concession stand storefronts utilize pre-finished standing-seam metal panels (above); the metal roofs appear to generally be in good condition. Four pre-manufactured buildings utilize pre-finished metal roof panels (below); these roofs appear to be in good condition. A pre-manufactured storage shed, placed on overhead staging (north end zone) also utilizes a pre-manufactured/pre-finished metal roof (bottom), and the shed/roof generally appears to be in good condition.

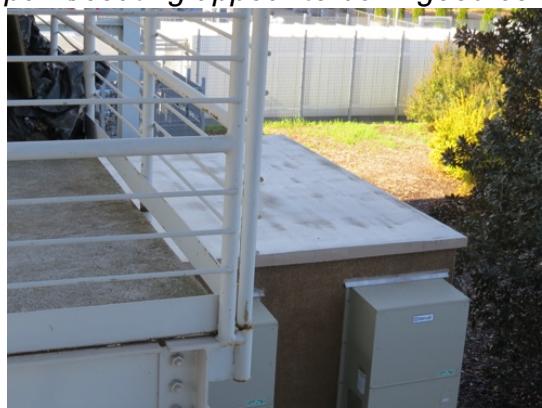
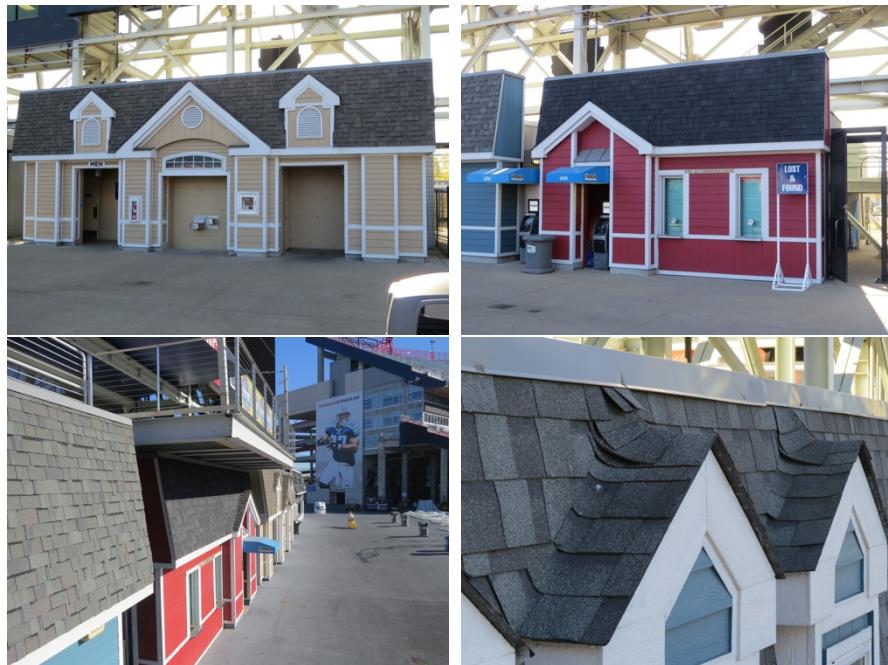
**Mansard roofs on end-zone concession stands and restroom building storefronts utilize laminated asphalt/fiberglass roofing shingles that are nailed, through a felt underlayment, to the roof deck (photos above and at top).** A small pre-manufactured storage shed, near Entrance Gate 10, also utilizes a laminated asphalt/fiberglass shingle roof covering system (below left). All of the shingle roofs generally appear to be in good condition. A small radio/telecom equipment building in the north end zone utilizes precast concrete walls and roof slab (below right). The concrete roof slab is simply painted and does not utilize any other type of roof covering system. The concrete roof slab and paint/coating appear to be in good condition.

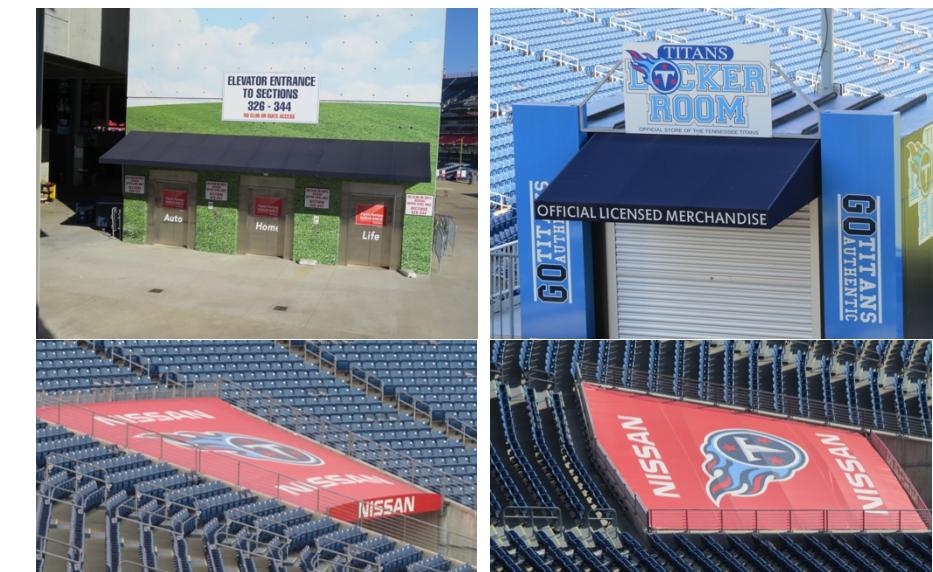
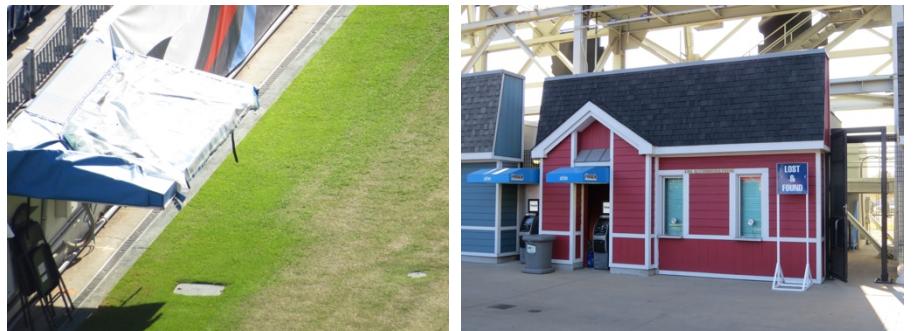
There are several small canopies above entrances, elevators, retail counters, ATM machines, etc., that utilize conventional canvas and/or plasticized canvas, which is stretched over and secured to a lightweight metal frame (photos above/below). The canvas canopies generally appear to be in fair-to-good condition.
