April 3, 2017

# Facility Condition Assessment

Nissan Stadium

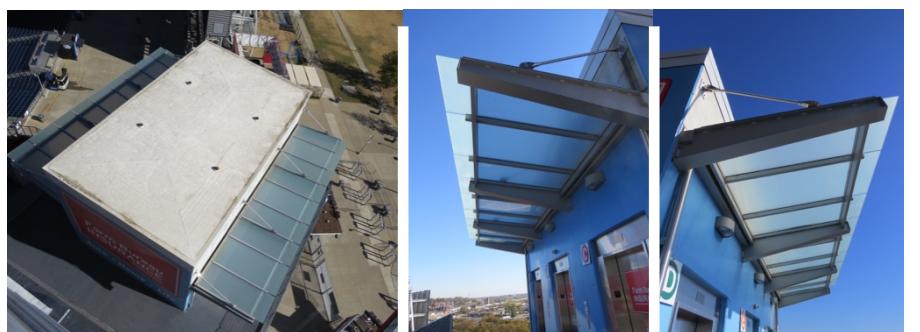
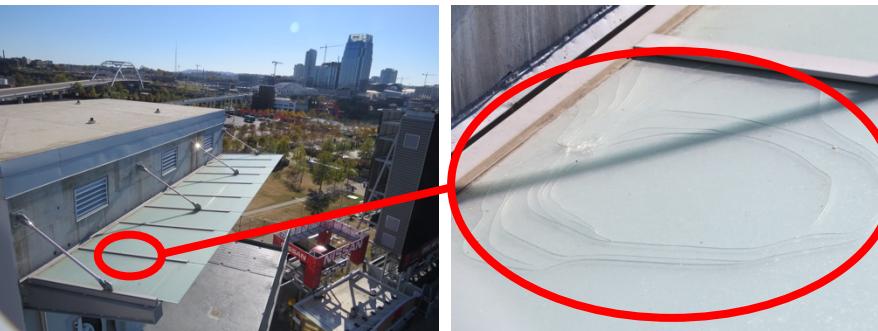
*Canopies above elevator doors, at upper concourse level (new elevator towers) utilize translucent laminated (safety) glass panels that are supported/secured by steel framing (photos above/below). One glass panel is badly cracked, and may pose a safety hazard if the panel were to collapse.*

Glass Canopies: There are 4 canopies above elevator doors at the Upper Concourse level (recently-constructed elevator towers). Each of these canopies utilizes a series of translucent, laminated glass panels that are supported/secured on steel framing. These canopies also incorporate metal built-in gutters and downspouts that discharge into the storm drainage system. These canopies appear to generally be in good condition, except that one glass panel was noted to be badly cracked; this cracked glass panel appears to pose a potential safety hazard if the panel were to collapse.

- h. Replace the cracked glass panel in the elevator tower canopy.

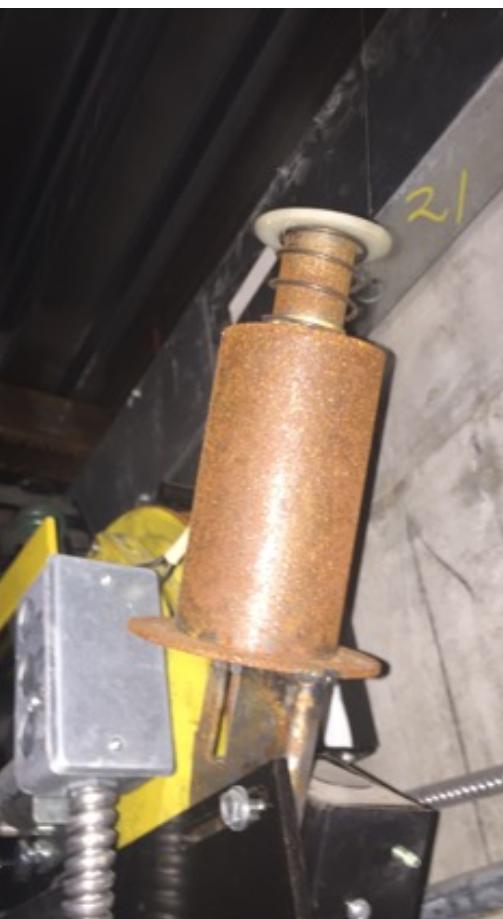
*Typical Rusted Governor Equipment Express*

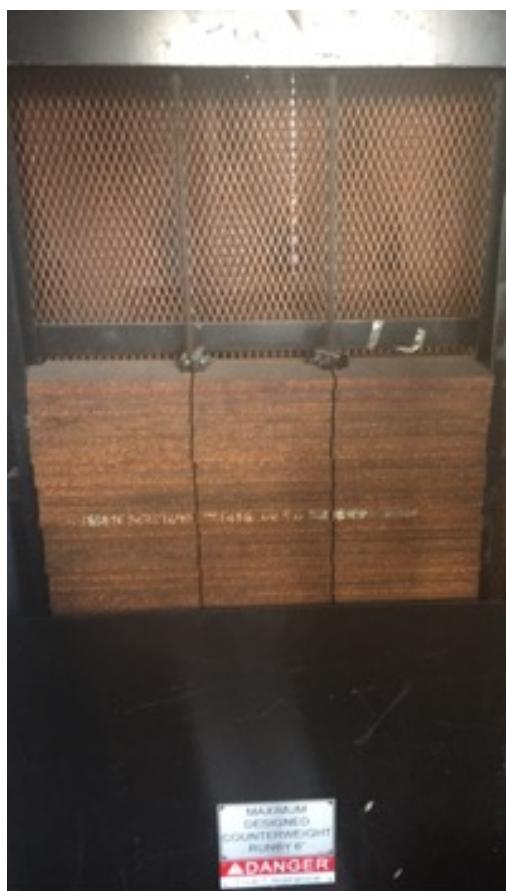
All unit car tops are clean and free of debris. It is suggested that all car top equipment be painted soon to help prevent rust and prolong equipment life. All door operator belts appeared to be in good condition and operating smoothly. ThyssenKrupp 08- LD Linear door operators are in use. All elevator equipment in the overhead needs to be painted with rust inhibiting paint.

Typical Rusted Counterweights on Express Cars

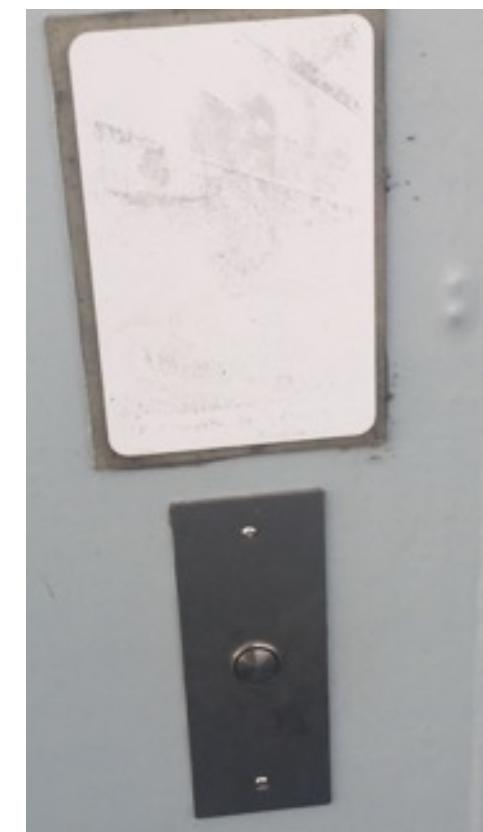
Sun Damaged Signage

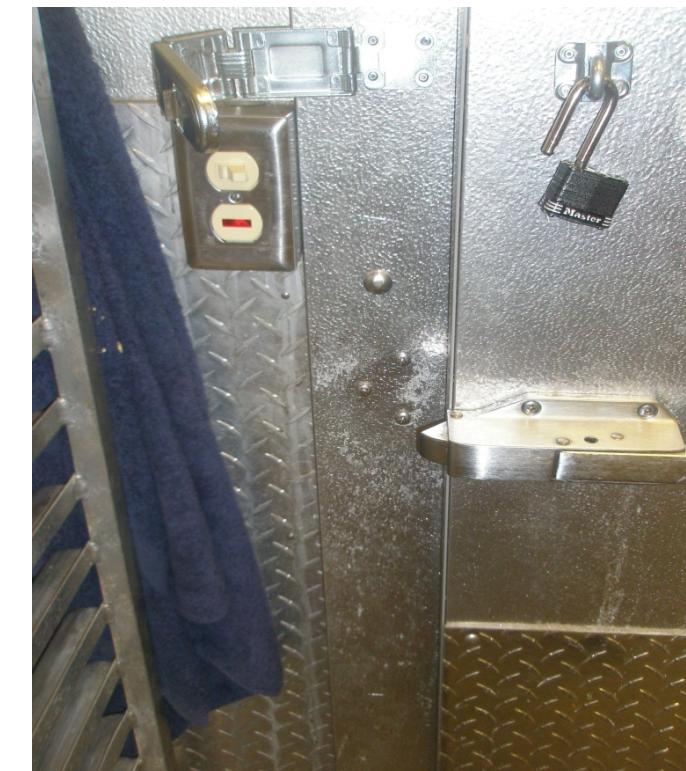
Coolers and freezers are on the topping slab and do not have interior raised insulated floors; therefore, they do not have a problem with warped flooring issues. However, several need the threshold replaced and door hardware repaired to replace missing handles and locks.

Door Handle on Walk In Cooler is Damaged

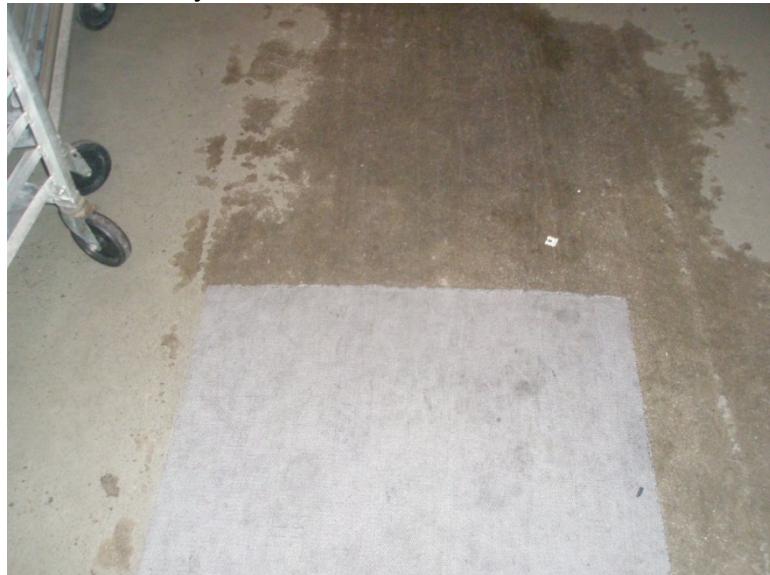
In addition, the kitchen floor covering has various patches and should be fully resurfaced.

*Damaged floor surface*

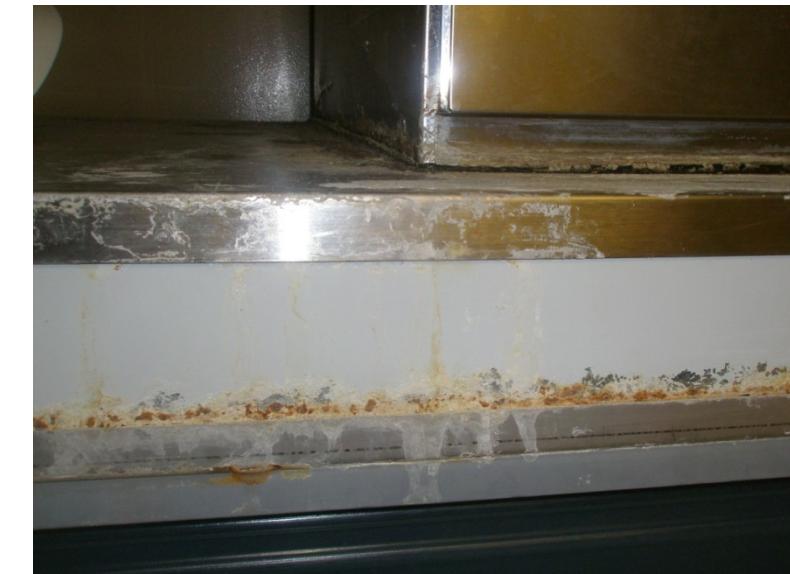
Aramark indicated that all the Manitowoc black ice makers were new in 2014; however, we observed numerous instances where along with the old machines, these new machines were already corroding from mineral build-up along the seal between the ice maker and the ice bin below.

*Mineral Build Up on Ice Machine*

All the ice makers need to be thoroughly cleaned and inspected along with the water filters to determine the cause of the corrosion.

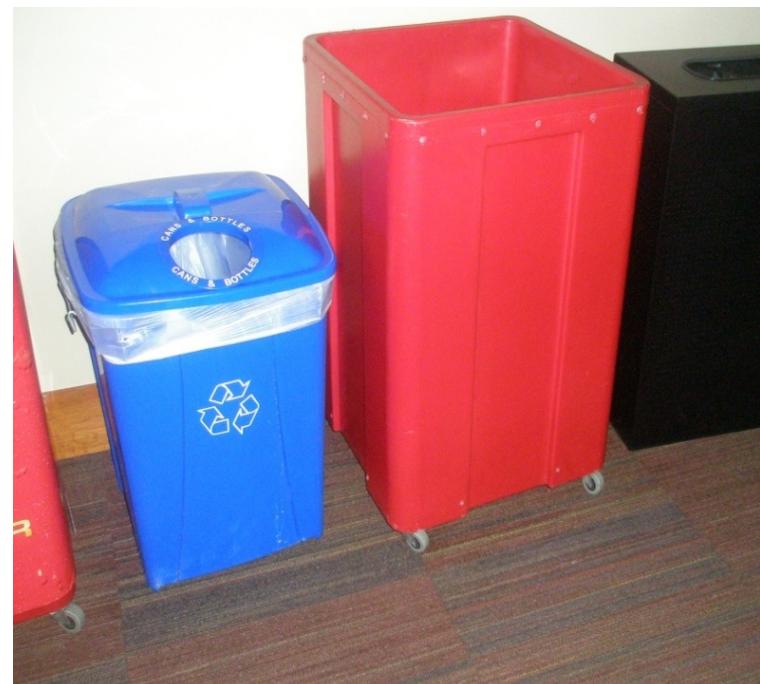
Existing original suites have 3 Sterno open flame chafing dishes and brightly colored vendor supplied plastic ice bins and recycling bins which provide a very amateurish look.

Thirty of the suites have recently been remodeled, including adding three or four induction warmers built into a credenza table in each of those suites. Some suites we saw only had three induction warmers. For future renovations, we recommend four induction warmers in all typical sized (20 seat) suites.

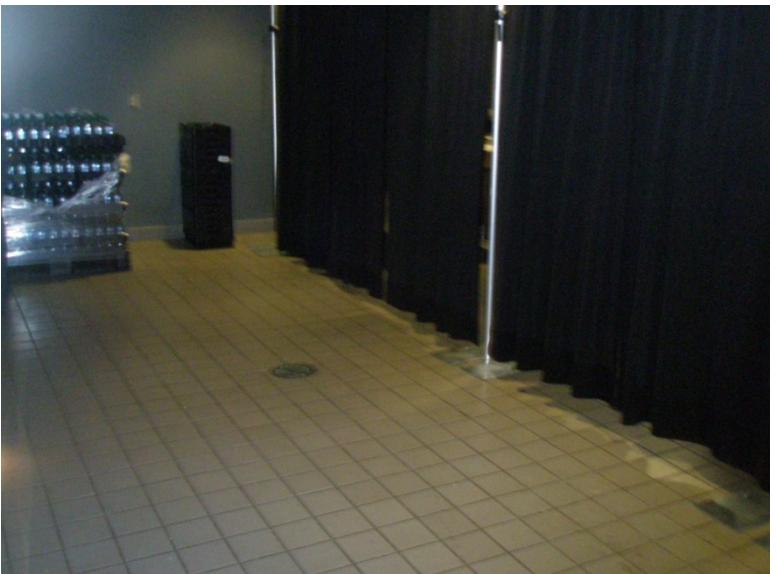
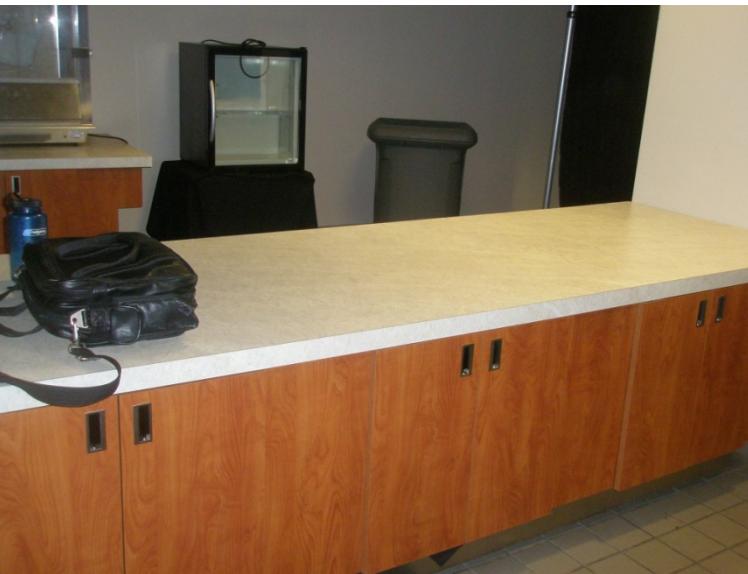
3.27.02 Press Dining; The room is a mixture of different types of portable equipment and just pipe and drape separating the front servery from the back prep station.

*Temporary food staging area*

Press dining is an expense of the team, and some teams elect to do more for the media than others. Most teams have upgraded to permanent equipment, rather than mobile cabinetry and even have a hot cooking line in the servery (exhibition cooking) serving the meals, which we would recommend.

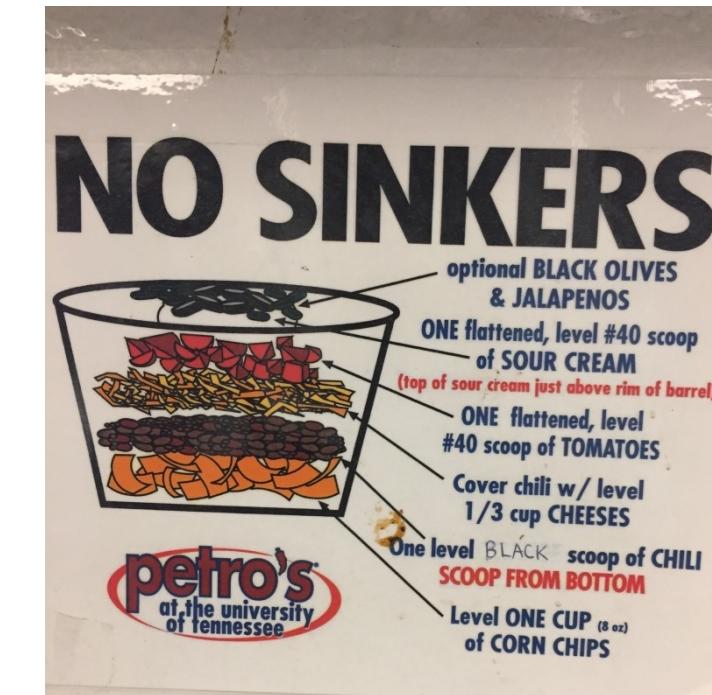
Petro's is another well-known regional brand from Knoxville that licenses their name to Aramark, who then manages the stand. Unfortunately, not all the signage is created with professional graphics. Instead, a laminated sheet was taped to the stand to explain the product. Professional graphics are needed at the Petro Stand to enhance its professional appearance.

10. Clean, repair and replace corroded ice makers and bins.
11. Replace dishwasher and tilt skillet in main kitchen.
12. Upgrade graphics in Petro's stands.

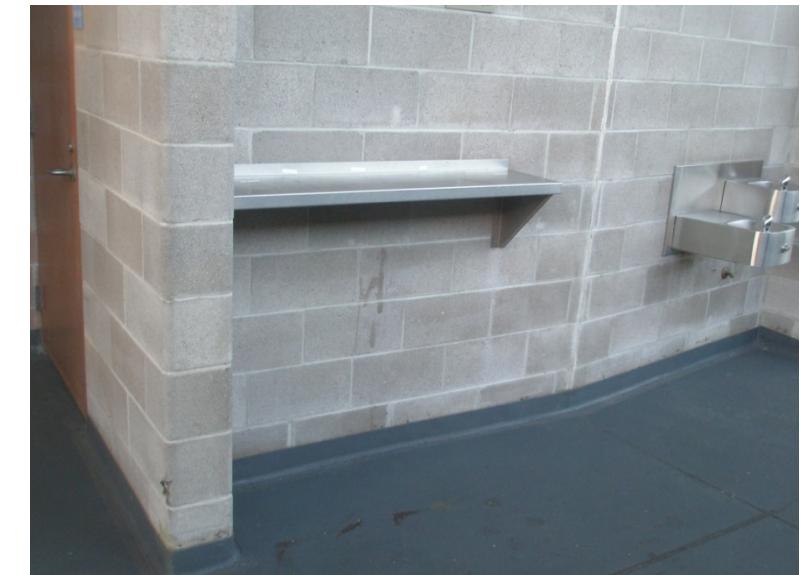
Condiments are served on a variety of stainless steel shelves mounted to the walls. While the shelves work in some locations, most the condiment shelves are mounted too high (42") to be Americans with Disability Act (ADA) compliant at 34". The shelves and walls are plain without any merchandising around them.

Shelving either needs to be relocated to meet ADA guidelines or new condiment carts for each concession stand should be purchased. We would also recommend the use of vinyl wrap on condiment carts or behind condiment shelves to provide appetizing color and allow sponsorship opportunities for the food purveyors at the stadium.

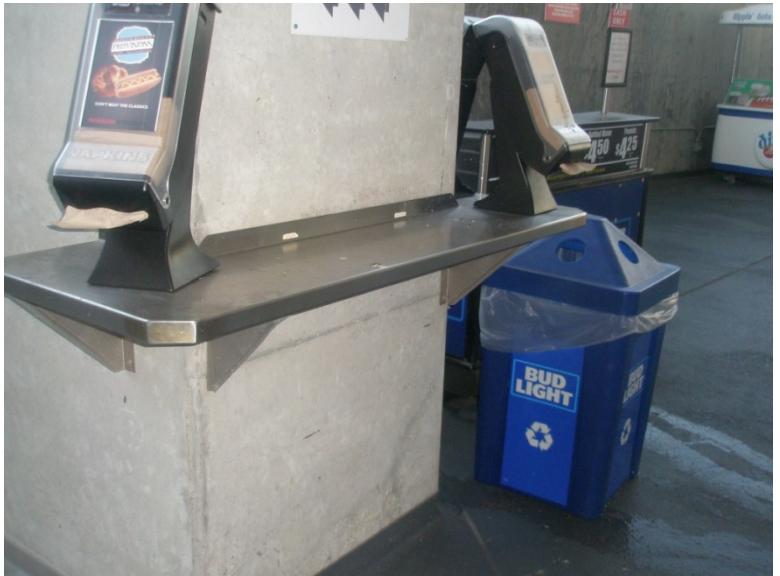
We also found concession stand (#105) counters at 36" height. Again, normal ADA height is 34", but these may have been approved at 36".

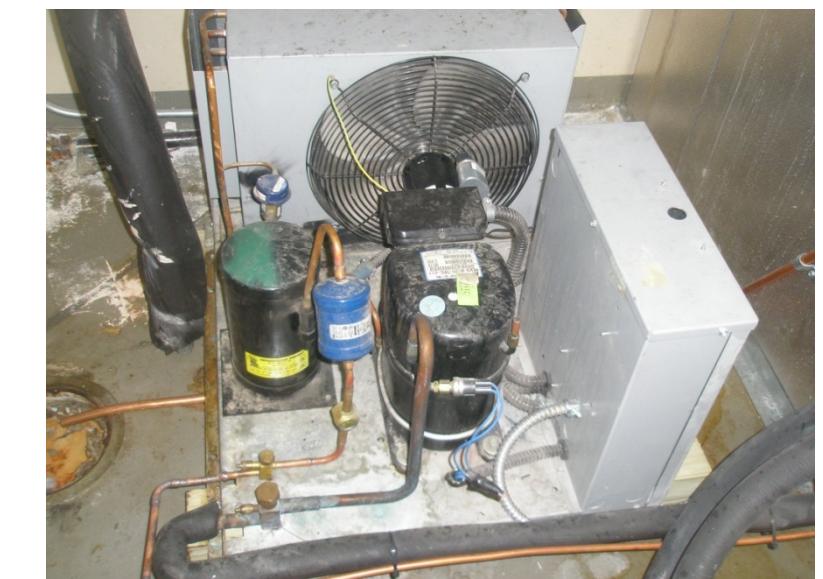
This stand gets extremely hot, so maintenance leaves the covers off compressors and roof tiles are removed to allow for more air circulation. Unfortunately, both remedies also lead to more dirt getting into the unit.

Operator needs to check on air current and add a fan and/or ventilator in the roof or louvered door as necessary.

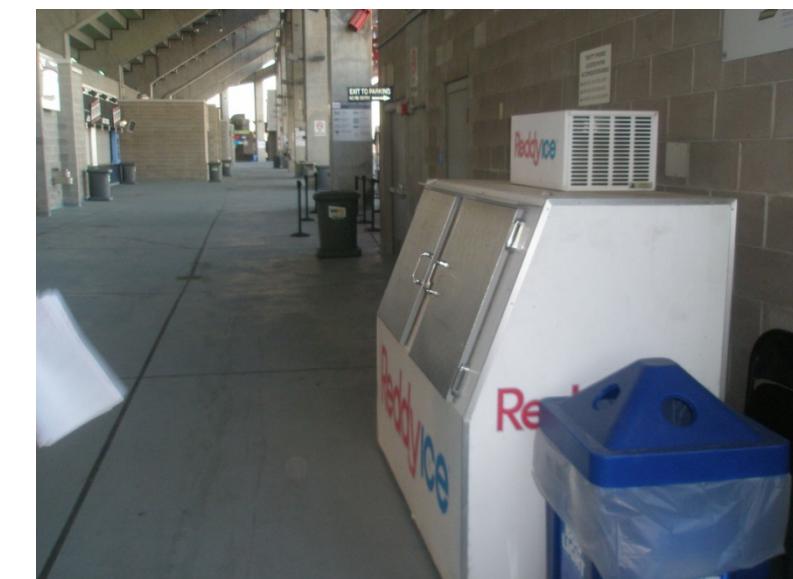
*Ice dispensers "clutter" the presentation of the concourses*

We recommend either purchasing larger ice makers to eliminate the need for merchandisers or building attractive enclosures to prevent the public from seeing these around the stadium.

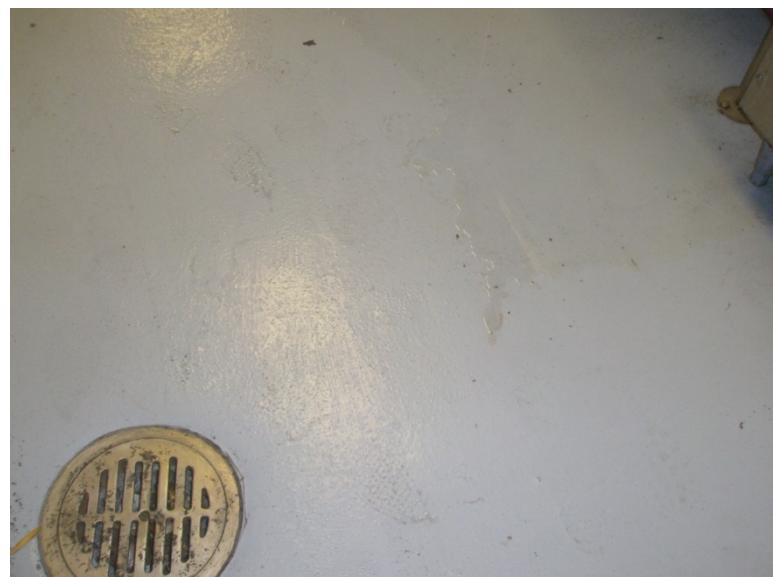
Many of the concession stands on the upper concourses are lower than the exterior concourse and had standing water on the floor. It appears that the concrete floors do not slope to the floor drains, and there are no thresholds at the doorways holding back water. Floors should be repaved to provide sloping to the floor drains.

*Floor slopes away from floor drain in concession stand*

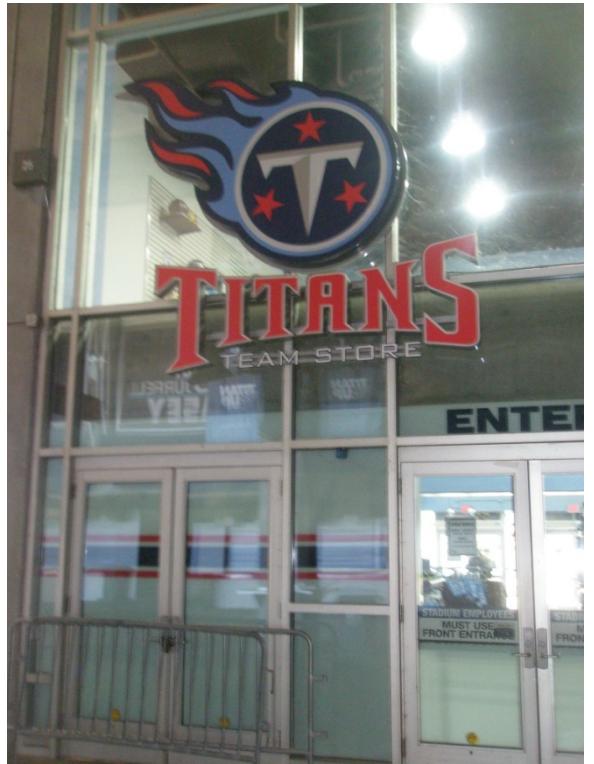
The team store is approximately 3,600 square feet, which is small in comparison with the newer NFL stadiums that can have upwards of 7,000 to 10,000 square feet. While we were told the stands and team store were updated in 2014 with new slat walls and lighting, they still appear very dated in appearance. The blue and white team colors are the only colors in the store against white slat walls and do not have a vibrant feel.

As many teams have done, we would recommend a retail consultant be hired to give all of the stands, and particularly the team store, a bolder and more vibrant look. They can use team colors but also accent them with other shades to create a more professional and inviting retail look. Also, use of interactive football related displays will enliven the team store space.

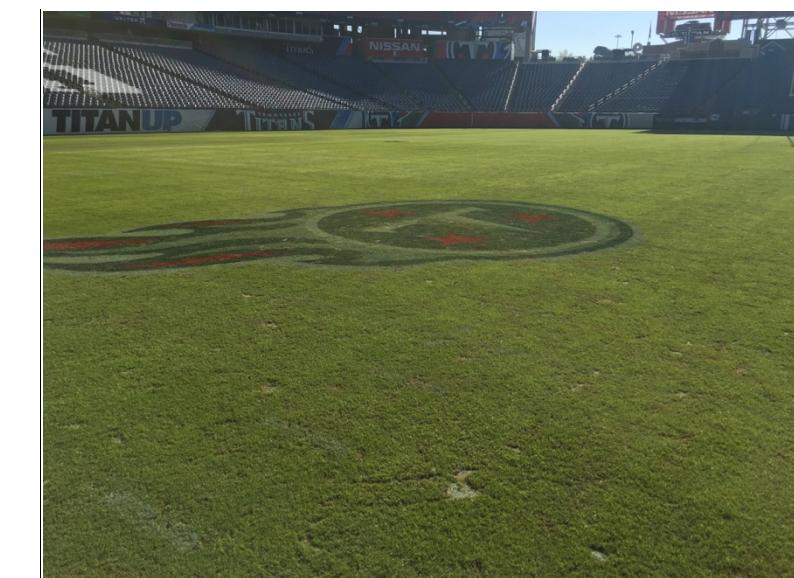
In addition, the inclusion of a perimeter warning track would greatly reduce the wear currently experienced by the sod in the areas between the sideline and the field wall. Sod health is typically compromised in these areas due to intense foot and vehicle traffic, as well as excessive shade, especially in the southern end zone late in the season.

Sod Wear/Damage at Mid-Field – Mid November

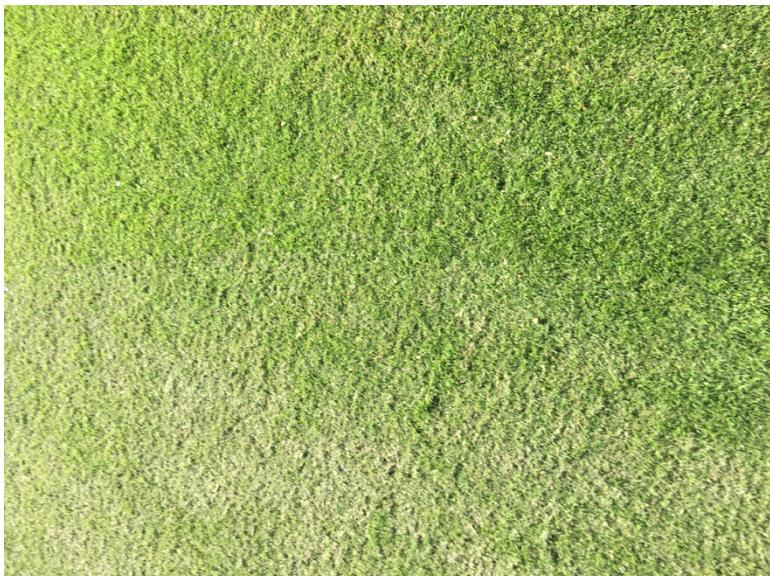
*Sod Density/Color – Typical throughout Field – Mid November*

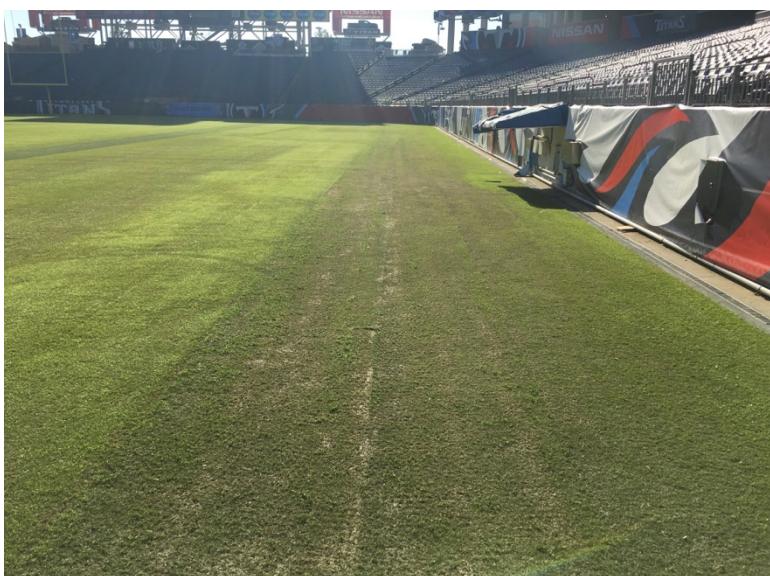
*Sod Wear/Damage at Sideline – Mid November*

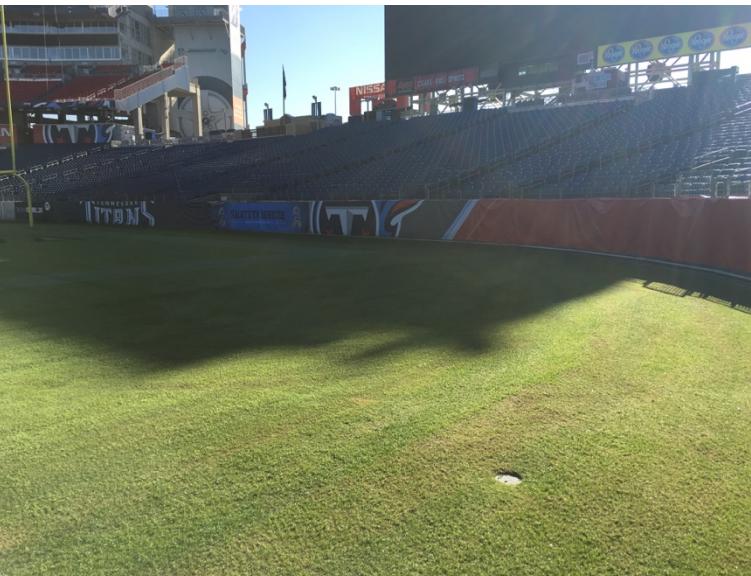
*Mid-Morning Shade Pattern – South Endzone – Mid November*

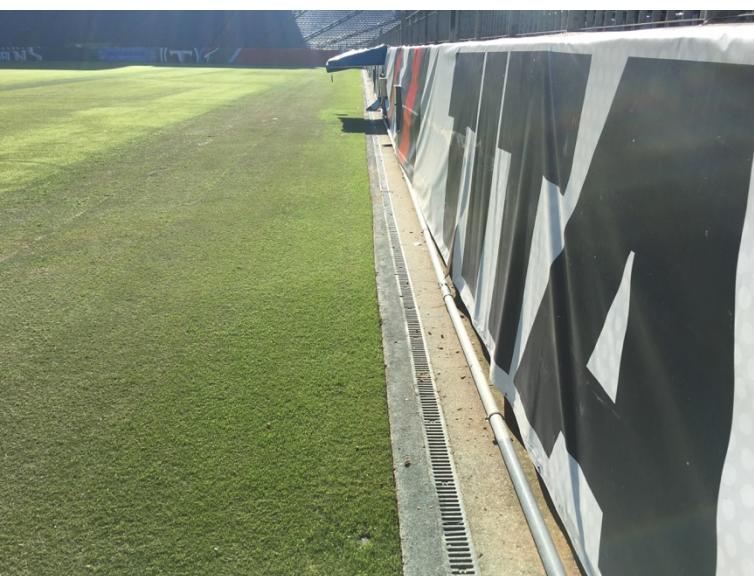
Based on conversation with Titan's staff, the drainage system seems to be performing adequately. Although, a portion of the perimeter perforated collector in the northwest corner of the field and a handful of laterals were replaced recently as it had been determined they had likely been damaged by concert trucks utilizing the adjacent field access tunnel repeatedly. The drainage system should continue to be monitored to insure no additional damage has been incurred by heavy concert trucks. Truck access to the field should be minimized when possible, and adequate field protection should always be incorporated when trucks must access the field to insure no further damage is incurred to the drainage system.

*Perimeter Trench Drain Condition*

None currently. Although drainage performance should continue to be monitored.

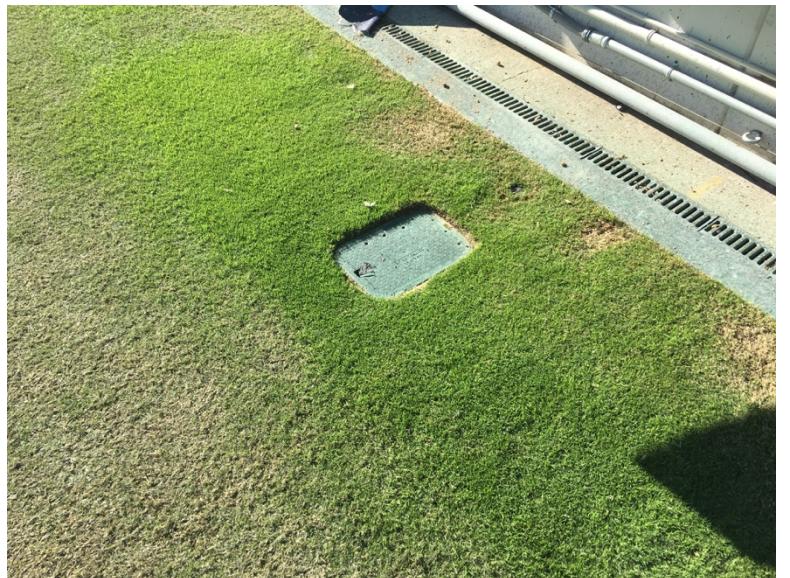
Based on conversation with Titan's staff, the irrigation system is operating in a relatively maintenance-free fashion, which is uncommon for an irrigation system of this type and age. It is typical for an automatic irrigation system of this type to experience leaks and other malfunctions after 17 years of operation to the point that total replacement is appropriate. Even with the good condition of the system, total replacement should be anticipated within the next 5-10 years.

*Perimeter Irrigation Remote Control Valve*

Water bibs should be placed at 50' on center along each field wall adjacent to the sideline would be very beneficial as it would allow game day operations staff easy access for sideline equipment requiring a domestic water supply.
