RTA 2 (O.N. 1290301)

Vessel Inspection Report

Prepared for: New Orleans RTA • New Orleans, LA

Ref: 19100-002-986-0 Rev. - December 10, 2019

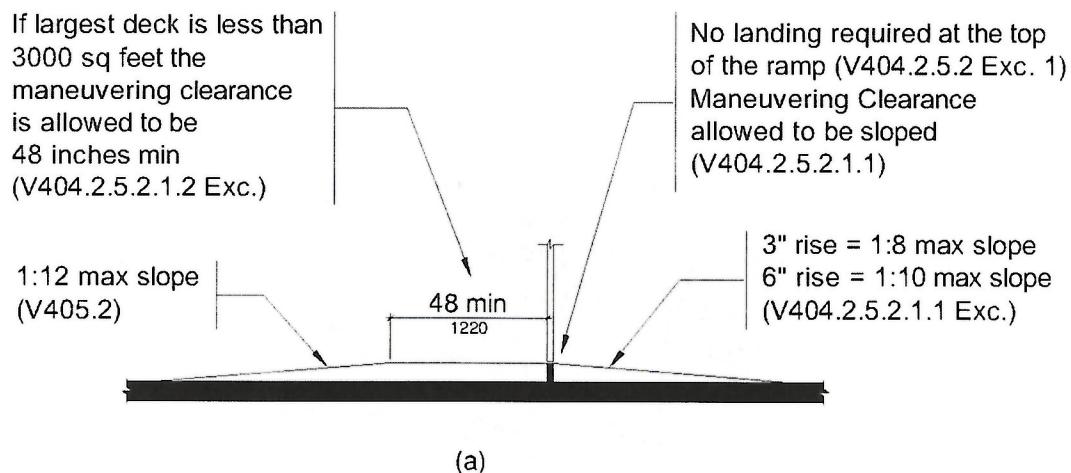
Figure 20: Wheelchair Ramp Requirements

1. Wheelchair ramp not in compliance with ADA Chapter V4, Ref. [6]. Ramp rise shown in Figure 18 and ramp run-length shown in Figure 19.

Recommended Resolution: Ramp to be redesigned to meet ADA requirements.

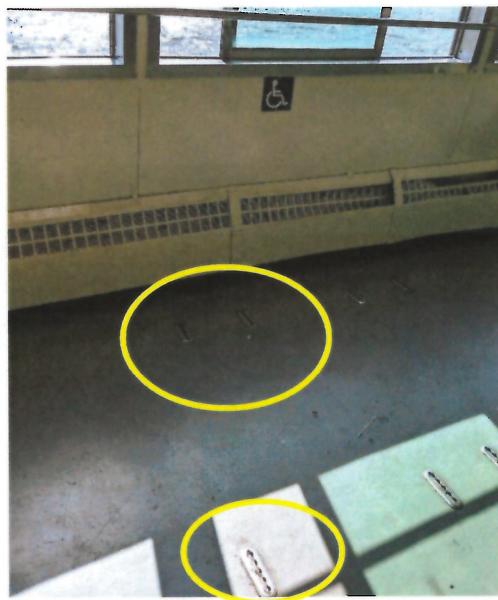
Figure 22: Example Wheelchair Hold Down Slots

2. ADA wheelchair hold down presents tripping hazard as currently installed.

Recommended Resolution: Wheelchair hold-down slots to prevent tripping hazard of unmarked wheelchair hold-downs.
