Spencer Dam Failure Investigation Report

In the early morning hours of March 14, 2019, Spencer Dam on the Niobrara River in northern Nebraska failed during a major flood and ice run on the river. An independent investigative panel was formed to examine the failure.

April 2020

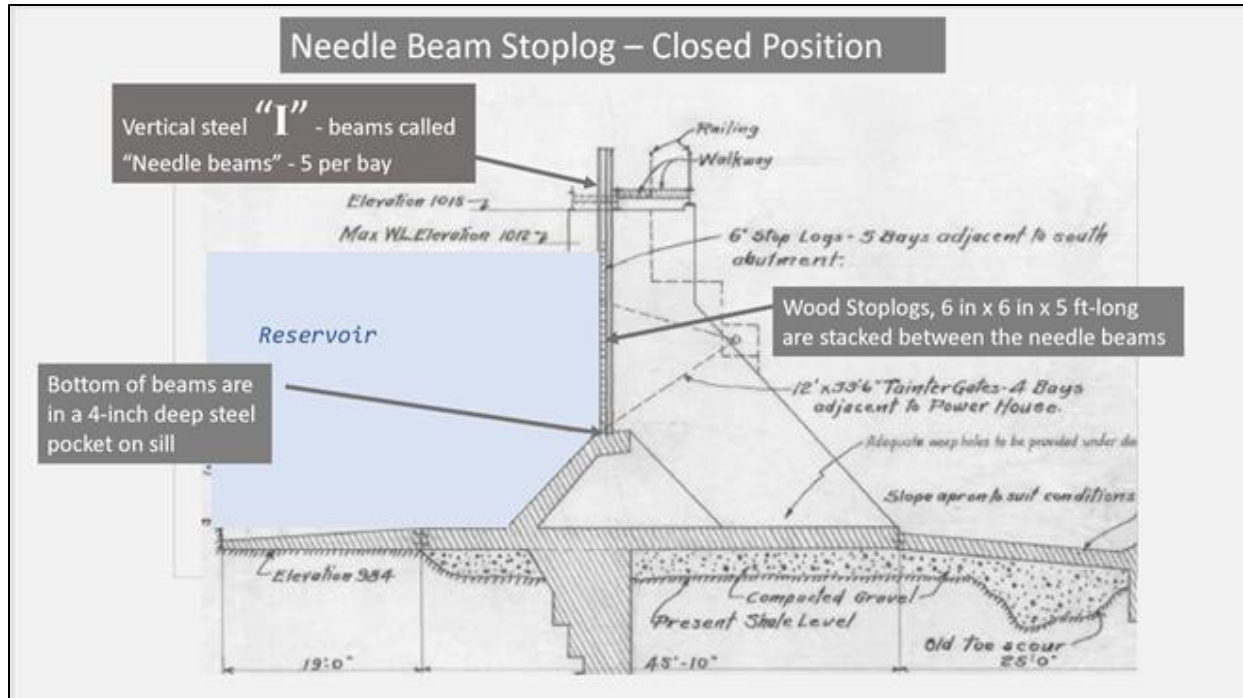
The spillway gates, hoists, and stoplog needle beams were all apparently in good operating condition before the March 2019 event. However, during the event the needle beams and stoplogs in the last two bays (Bays 8 and 9) were frozen in place by ice that had formed (See Appendix K). Also, Gate 3 shut partway through the event due to a broken lifting chain. The closure of these three bays (two stoplog bays and one Tainter (radial) gate reduced the discharge capacity of the spillway.

Figure 2.8 Needle Beam Stoplog - Closed Position - Source 1939 Spencer Spillway design drawing and Panel annotations.

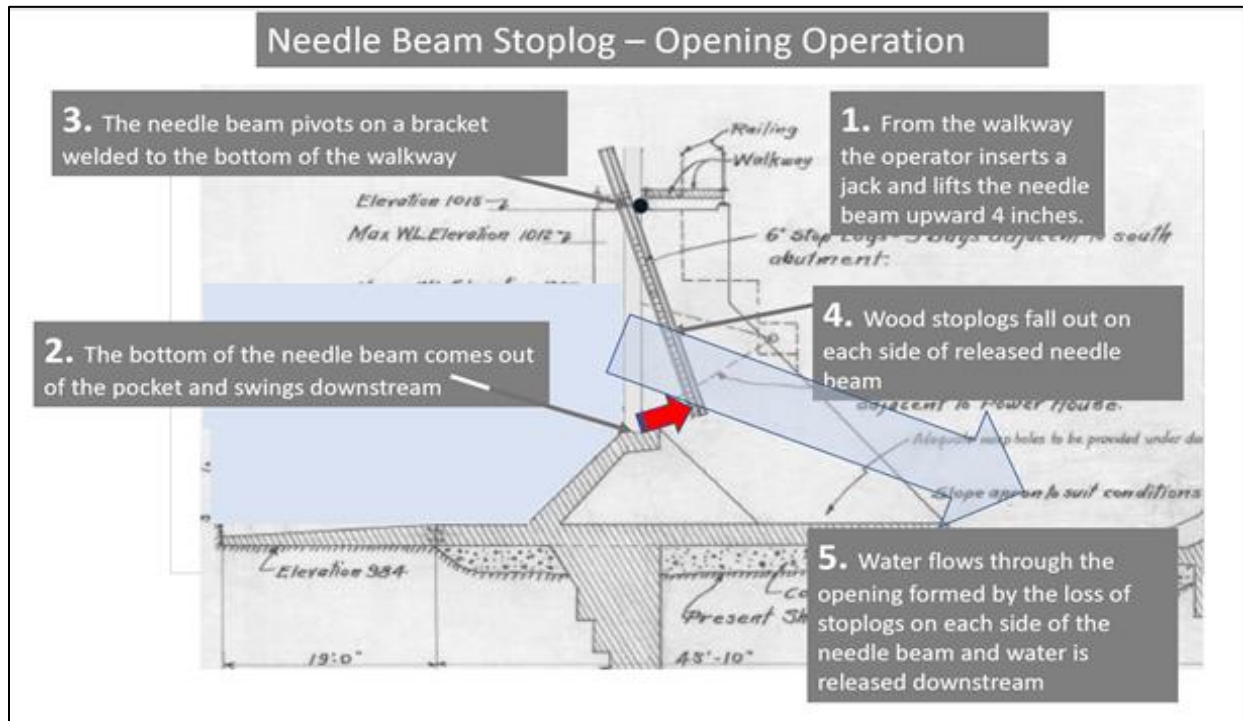
Figure 2.9 Needle Beam Stoplog - Opening Operation Sequence - Source 1939 Spencer Spillway design drawing and Panel annotations.

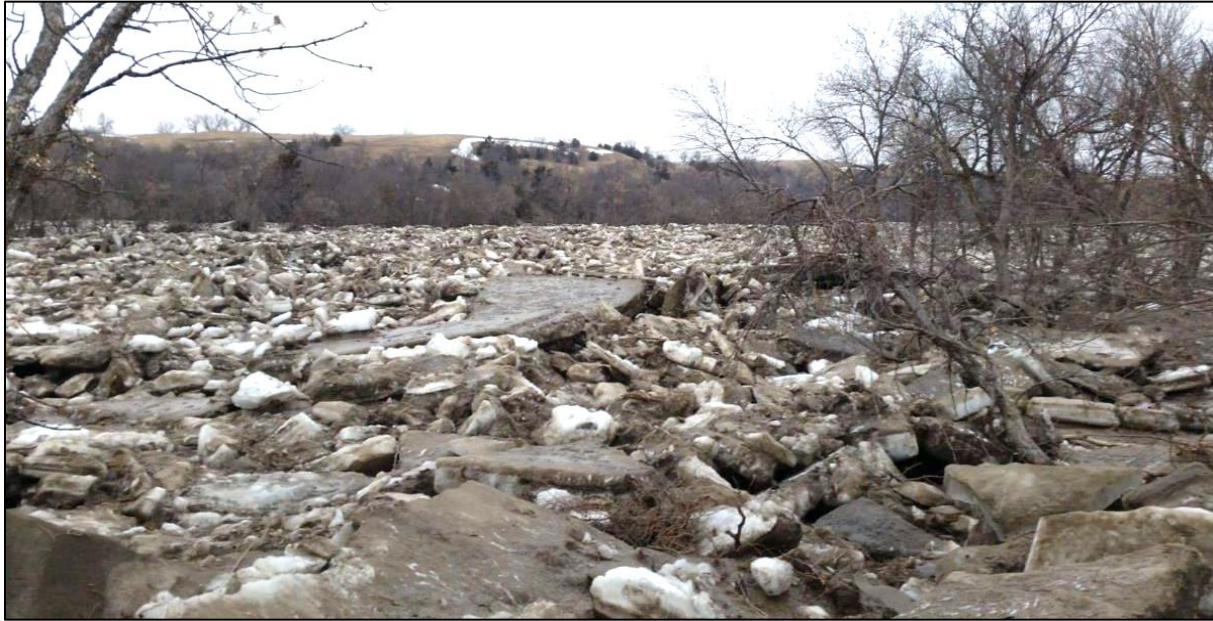
Figure 3.8 shows ice rubble jammed in a reach of the Niobrara River. Though no photographs show such jamming upstream of Spencer Dam during the event, this photograph gives an impression of jam development along the river.

Figure 3.8. Ice rubble jamming on the Niobrara River during March 2019. The jam shoves rubble into a jumbled mass and pushes rubble over the channel's banks.

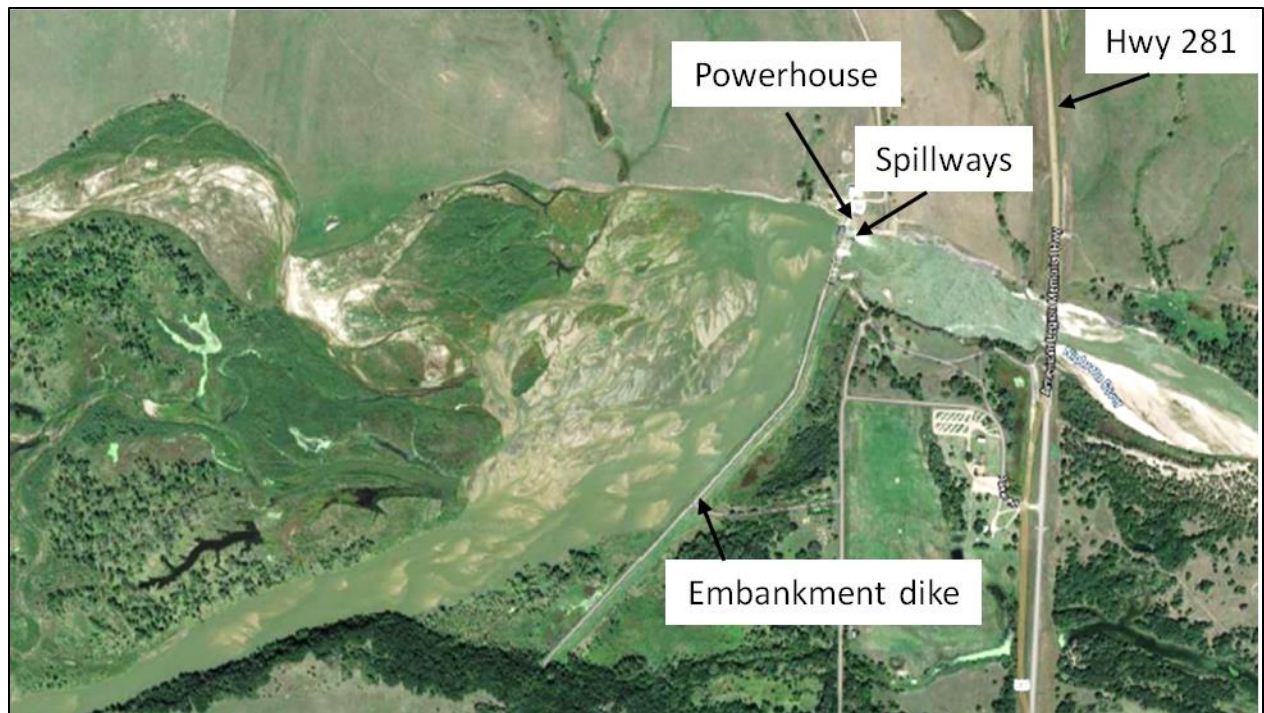
Spencer Dam extended across the full width of the Niobrara River. Figure 3.9 is an aerial view of the dam before its failure. This view depicts the river a short distance downstream of the view in Figure 3.3 and shows that water flow, sediment and ice arriving at the dam had to pass through the dam's gated spillway and two hydropower turbines.

The spillway also included a narrow trough (10 feet wide) designated as an ice chute. Such chutes are common for navigation dams on the Mississippi, Ohio and Illinois Rivers, and can be used to pass small quantities of ice (such as ice blocks cut upstream of the gates at Spencer Dam) but are considered essentially useless during major runs of ice. The layout lacked an ice bypass sluice or spillway.

Figure 3.9. The layout of Spencer Dam on the Niobrara River. North is up. The west end of this view is about 0.5 mile downstream of the east end of the view shown in Figure 3.3 (Google Earth Image).

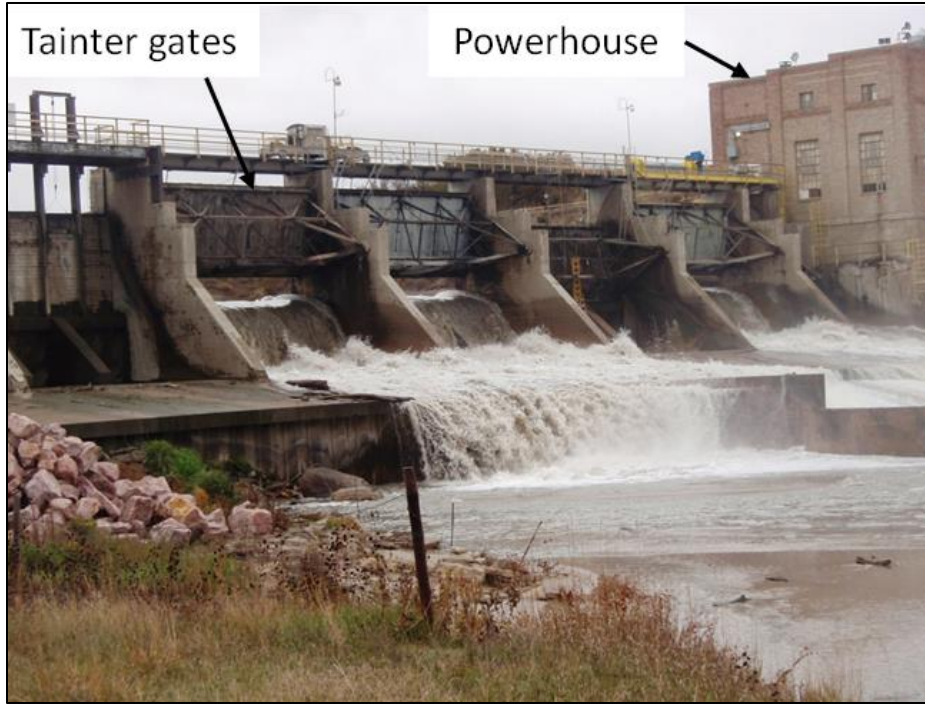
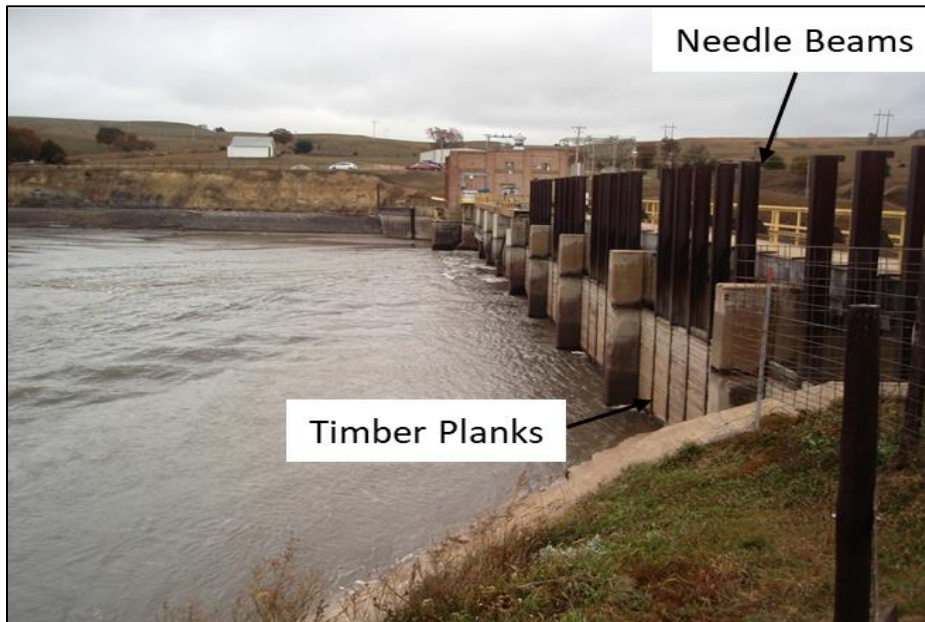
The dam's layout posed problems for the movement of ice rubble conveyed to the dam from the reach upstream of the dam. When the rubble was weak and comprised smaller pieces, typically after a thermal break-up of the cover (or during freeze-up), the rubble would disintegrate when impacting the dam and its spillway. Evidently, such ice rubble was not particularly problematic (according to the dam's operators). However, when the rubble was relatively hard and large in piece size (as would result from the dynamic break-up of the upstream ice cover), the spillway experienced major difficulties passing the ice. For gate-opening widths of 33.5 feet and taking ice congestion to become problematic when the maximum length of an ice piece was about $33.5 \text{ feet}/8^2$, suggests that congestion and blockage could occur at gates when they attempted to pass ice pieces larger than about 4.2 feet in plan length. This estimate is made worse for large pieces of ice rubble obliquely approaching a gate opening; the opening's capacity to pass ice decreases as the angle increases relative to a line perpendicular to the opening.

Figure 3.10. Two views of the spillway of Spencer Dam during sediment flushing: (a) the four Tainter (radial) gates; and, (b) the five stoplog bays with five needle beams and stacks of timber planks.

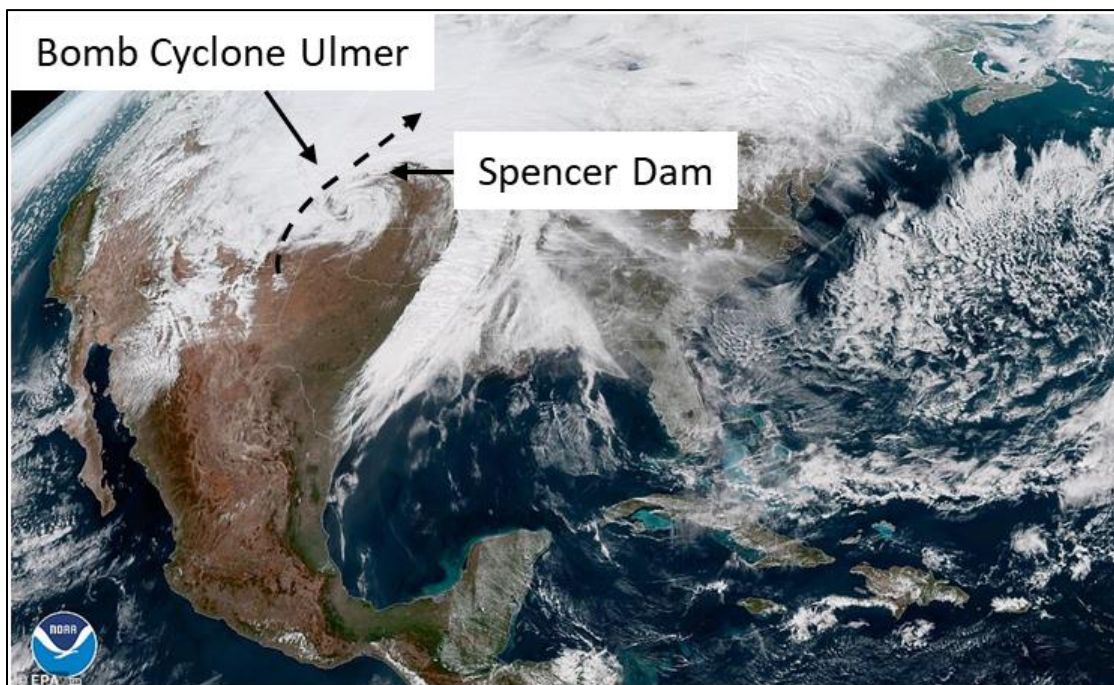
A fast-moving large storm called Winter Storm Ulmer (named on 11 March) tracked northeastward during March 12-14. The storm underwent bombogenesis and became a bomb cyclone early on March 13 (See Chapter 4 and Appendix H). The bomb cyclone (Figure 3.11), pushed mild air and moisture northward, hastening snowmelt and adding about two inches of rainfall on the melting snow upstream of Spencer Dam. As evening developed on March 13, the rain became freezing rain, wind speeds became in excess of 60 mph and blizzard-like conditions prevailed as the bomb cyclone passed over the watershed of the Niobrara River.

Figure 3.11. Winter Storm Ulmer becoming a bomb cyclone on Wednesday, March 13 (Source NOAA).

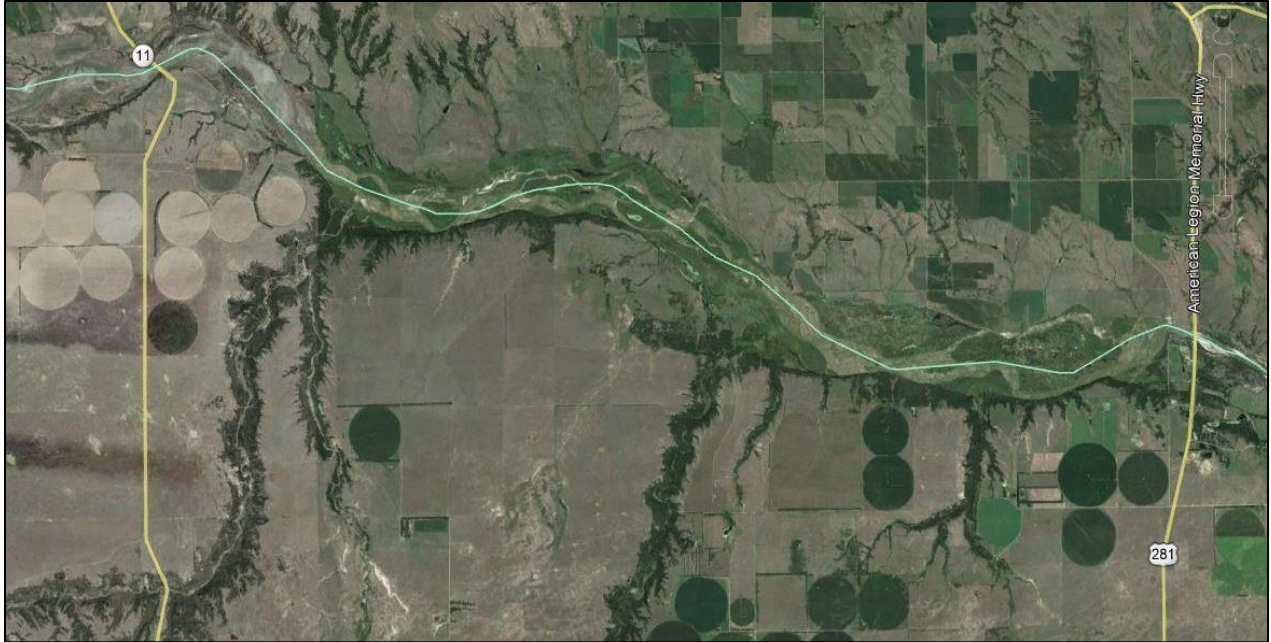
showed pieces of ice that appear to be even thicker. Figure 4.1 shows how the channel would have looked before the March 2019 flood. The channel averaged about 1,000 feet wide. The after-flood image, Figure 4.2, indicates the flood flow averaged about 3,000 feet wide.

Figure 4.1 – Niobrara River between the Highway 11 Bridge (upstream) and the Highway 281 Bridge (downstream from the dam) before failure. From Google Earth (6/2018).

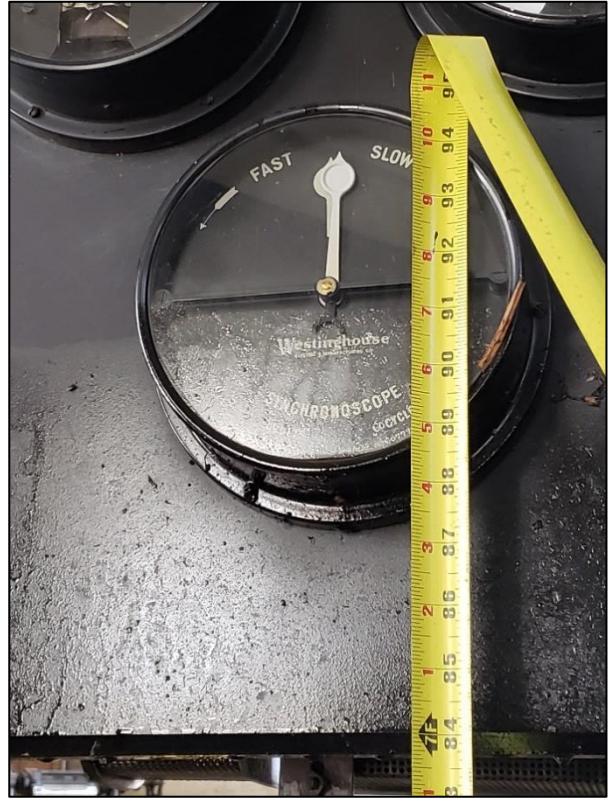
Figure 4.6 - Stopped clock in the powerhouse office (NPPD photo).

Based on the time stamp on photo files (e.g., Figure 4.6) the operators did not initially leave the powerhouse until at least 4:38 AM. According to the stopped clock on the wall of the office, it is believed the plant was flooded at 5:15 AM (Figure 4.6). The Panel does not know how long the dam overtopped before the clock stopped, or for how long after the clock stopped. The operators said they saw (by vehicle headlights) the hole in the powerhouse at about 5:30 AM. This observation apparently was after the dam had breached, but they could not see a breach due to darkness, and the reservoir had already dropped below the powerhouse wall.

If the surge pushed the ice to a level higher than the reservoir water surface, and the level of water in the powerhouse matched the reservoir water surface, the office clock may have stopped before the dam failed. The clock is believed to have been mounted on the wall about a foot or more below the high-water mark. The initial surge to the top of dike could have taken longer than the 15 minutes if it caused the clock to stop. Assuming the first surge took the full 37 minutes, the time between the last photo in the powerhouse (Figure 4.4) and the clock stopping (Figure 4.6), the estimate of 7,000 AF of inflow in 37 minutes would result in an average inflow of about 137,000 cfs (without considering any outflow). While this lower inflow seems more believable than 274,000 cfs, it would also result in less time for the reservoir water surface to rise two feet above the dike. Assuming two feet of water above the dam is the high-water mark just before the dike failed, even at the lower rate of inflow, the dam probably would have failed too fast to match the operators' account of the timeline.

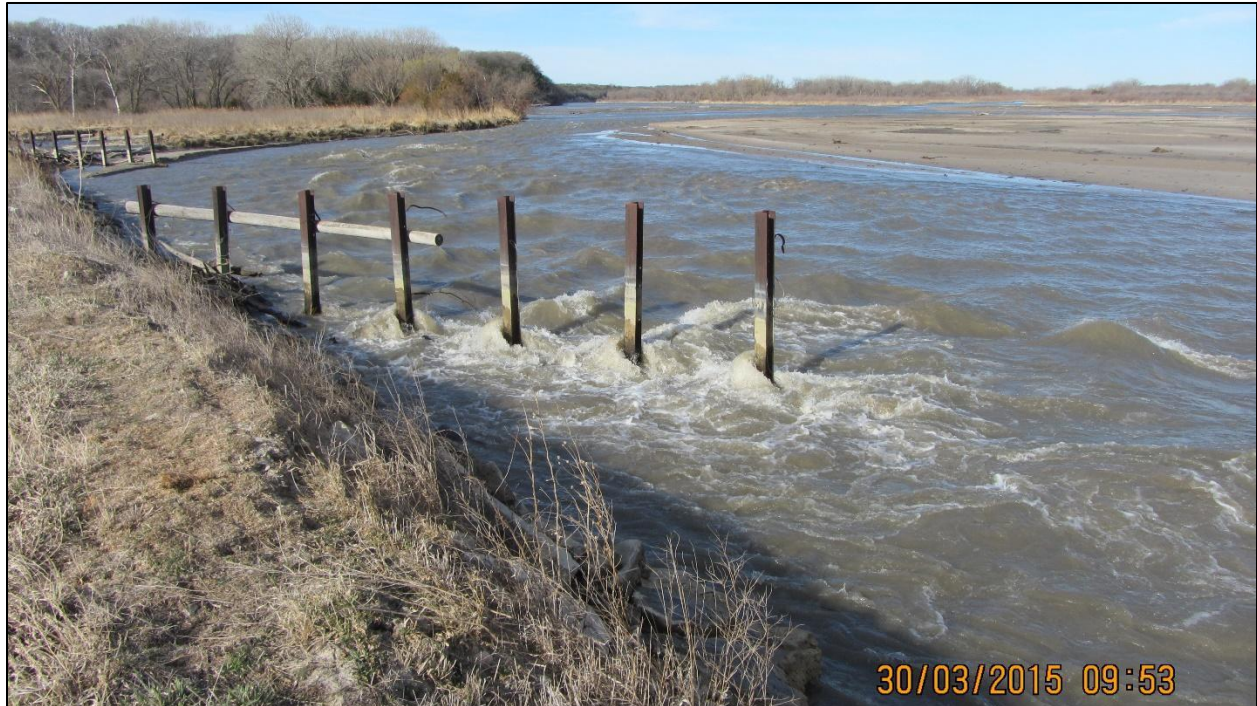
The embankment breached in two locations that the Panel has identified as the north (adjacent to the spillway) and south (near the access ramp) breaches. In past flooding, the dike failed or suffered erosion damage near the location of the 2019 south breach. It is believed that flow from the south channel, that is directed towards the dike, caused erosion of the dike in this location (Figure 4.10). The momentum of the ice-laden flow in 2019, which was much higher than the flow in the figure, likely caused run-up of ice and water onto the embankment, making this location the most likely spot for erosion damage and overtopping.

Figure 4.10 – Flow from south channel changing direction at the dike. (Corps of Engineers photo, 2015).

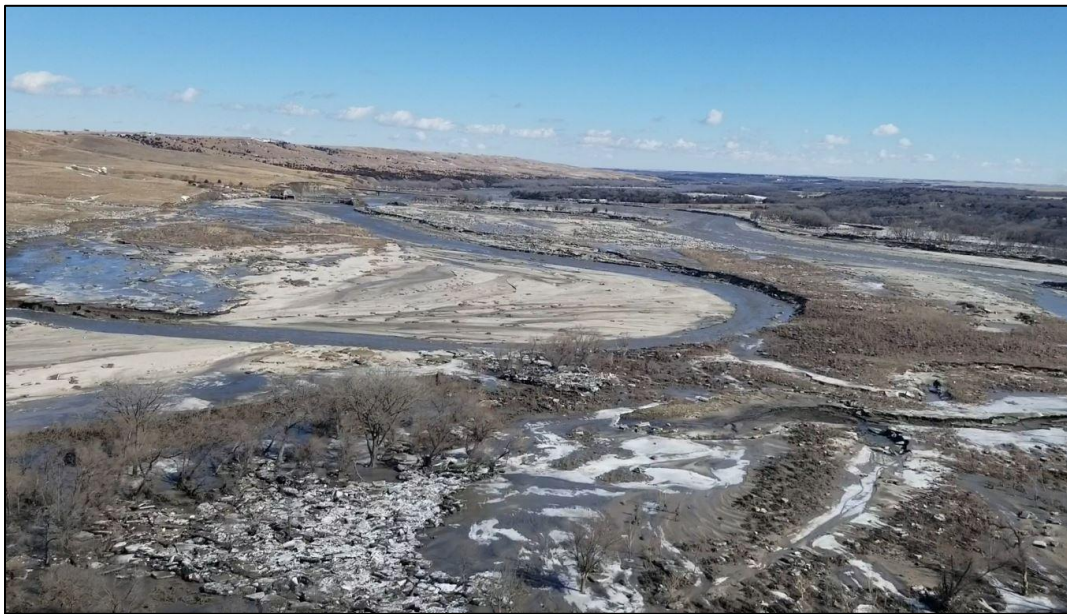
An image from an aerial reconnaissance after the dam failed (Figure 4.16) shows how the upstream island is prominent in the reservoir area, with just two main channels, the north (on the left side), and the south channels. It is believed the reservoir was not large enough to contain the 2019 flood. Though the spillway was estimated to have enough capacity to pass a 500-year flood (See Appendix E), it would have needed a much larger spillway, without gates, to pass the amount of ice and flow that entered the reservoir on March 14, 2019.

Figure 4.16 – View from above the upstream island looking downstream (east) towards the dam (NPPD photo). The run-of-river reservoir was small in comparison to the flooded river.

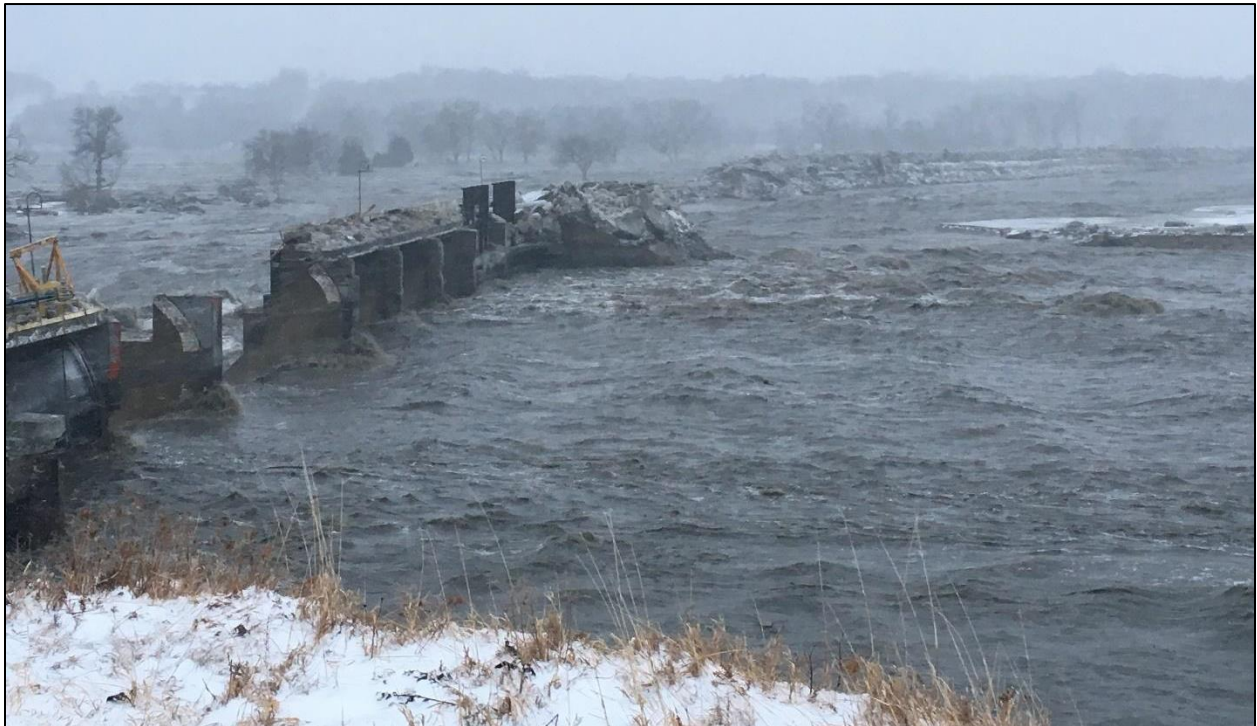
A photograph taken nearly three hours after the dam failed (Figure 4.17) shows a significant amount of flow passing over the spillway and through the north breach. At the same time, high flow was also passing through the wider south breach. Each breach was considerably wider than the spillway and the bottom of the channels formed by the breaches were lower than the spillway crest elevation. From this photo it seems clear that

the flood, even hours after the dam failed, likely exceeded the spillway capacity. The downstream flow was so deep that only trees and no ground can be seen in the downstream area that is now an island surrounded by the north and south channels (submerged trees on the upper left of the figure). Hours after the dam failed, the flooding downstream was the result of the river flow and not the breach outflow that occurred nearly three hours earlier. The photograph confirms that, even without the dam, the structures immediately downstream would not have been safe during this flood.

Figure 4.17 – Photo of Spencer Dam taken at 8:04 AM on March 14, 2019 (NPPD photo).

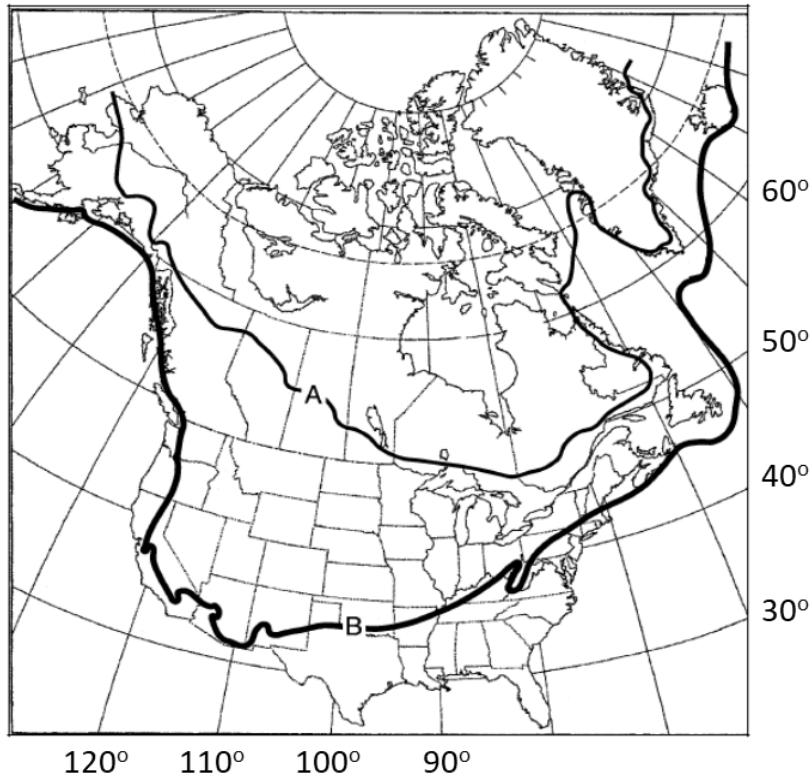
Findings: There are thousands of dams in cold weather regions in 31 states of the U.S. (see Figure 7.1). Run-of-river dams or dams forming small reservoirs in cold weather regions can be vulnerable to large ice run events. Until the Spencer Dam failure, the dam safety industry did not consider that ice runs could fail dams. Ice runs are not included in Reclamation/USACE risk best practice methodology or in other well-used guidelines. Decades can pass between major ice runs, requiring research into river history to understand the true risk. There are so little available data at this point in time that it would be difficult to tie these events to realistic recurrence periods, but they are most certainly more likely on rivers like the Niobrara than other loadings such as the extreme floods that the dam safety industry designs for and routinely checks.

Figure 7.1. Cold regions of North America (latitude and longitude indicated). The A-line is the southernmost boundary of the area where the average air temperature of the coldest winter month is -18°C (0°F) or less and ice forms covers over navigable rivers for at least 180 days of the year. The B-line is the southernmost border of the area where the average air temperature of the coldest month is between -18°C (0°F) and 0°C (32°F) and ice covers navigable waters for 100-180 days. (Source: adapted from USACE 2002).

Recommendation 1A: The dam safety industry should develop a screening-level tool for dam owners and regulators in cold weather regions to determine which dams could be vulnerable to ice runs. Dam engineers need to screen dams with small reservoirs in cold weather regions for ice run potential. When the potential exists, engineers need to account for ice runs when evaluating the dam's performance. This would include evaluating the potential for waterways to plug with ice, and the ability to safely pass large surges that can potentially have peak inflows greater than peak rainstorm inflows.
