UNITED STATES AIR FORCE
AIRCRAFT ACCIDENT INVESTIGATION
BOARD REPORT

RC-135V, T/N 64-14848

OFFUTT AIR FORCE BASE, NEBRASKA

DATE OF ACCIDENT: 30 APRIL 2015

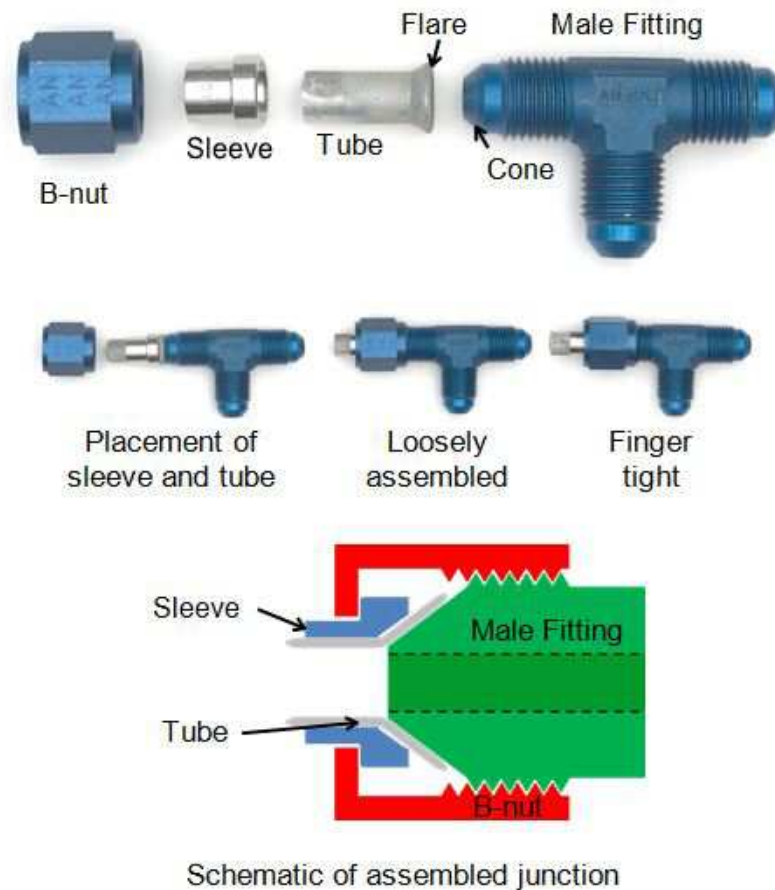
Figure 5. Oxygen System Fittings (Tab J-28).

Fittings used in the oxygen system are shown in Figure 5. The T-shaped fittings may be replaced by elbow-shaped fittings as needed (Tab J-29). These fittings are commonly referred to as “AN” fittings because each fitting has a specification that begins with “AN” (Tabs J-8, J-28). These fittings consist of four components; a male threaded end, a female nut (referred to as a B-nut), a sleeve, and a flared tube. A schematic of the system shown in Figure 5 indicates that contact between the inside of the flared tube and the male fitting cone constitutes the sealing surface of the fitting (Tab J-28). The B-nut itself does not provide sealing force to the fitting (Tab J-28). When properly tightened, the B-nut and sleeve provide clamping force to the sealing surface between the flared tube and the male fitting cone (Tab J-28).

Tightening (or torquing) “AN” fittings to the proper specification requires initial torquing, leak checking and final torquing (Tab U-2.15). Initial torquing is a two-step process which involves hand tightening the B-nut (in accordance with the schematic in Figure 5) to ensure proper alignment and a firm seal between the male cone fitting and the flared tube, and then torquing the B-nut using a torque wrench to an initial minimum torque value (Tabs U-2.15, V-11.1). The initial minimum torque value for 5/16 inch aluminum tubing used in the MA is 100 inch-pounds (in-lbs) (Tabs U-2.16, J-9, J-30). Leak checking involves pressurizing the oxygen system to operational specifications while examining all fittings and connections using a leak test compound (Tab U-2.17). Final torquing is required if any leaks occur and involves increasing the torque value as necessary to stop the leak, up to a maximum specified torque value (Tab U-2.15). The maximum torque value for 5/16 inch aluminum tubing used in the MA is 125 in-lbs (Tabs U-2.16, J-9, J-30). Replacement or repair is necessary if leakage cannot be stopped at the maximum torque value (Tab U-2.15).
