SUBJECT: Site Inspections at Samsung Mangilao Solar Project Site, July 23 and 18, 2021

ADDENDUM (July 28, 2021)

Site Inspection at Samsung Mangilao Solar Project Site, July 23 & 28, 2021
Page 5 of 24

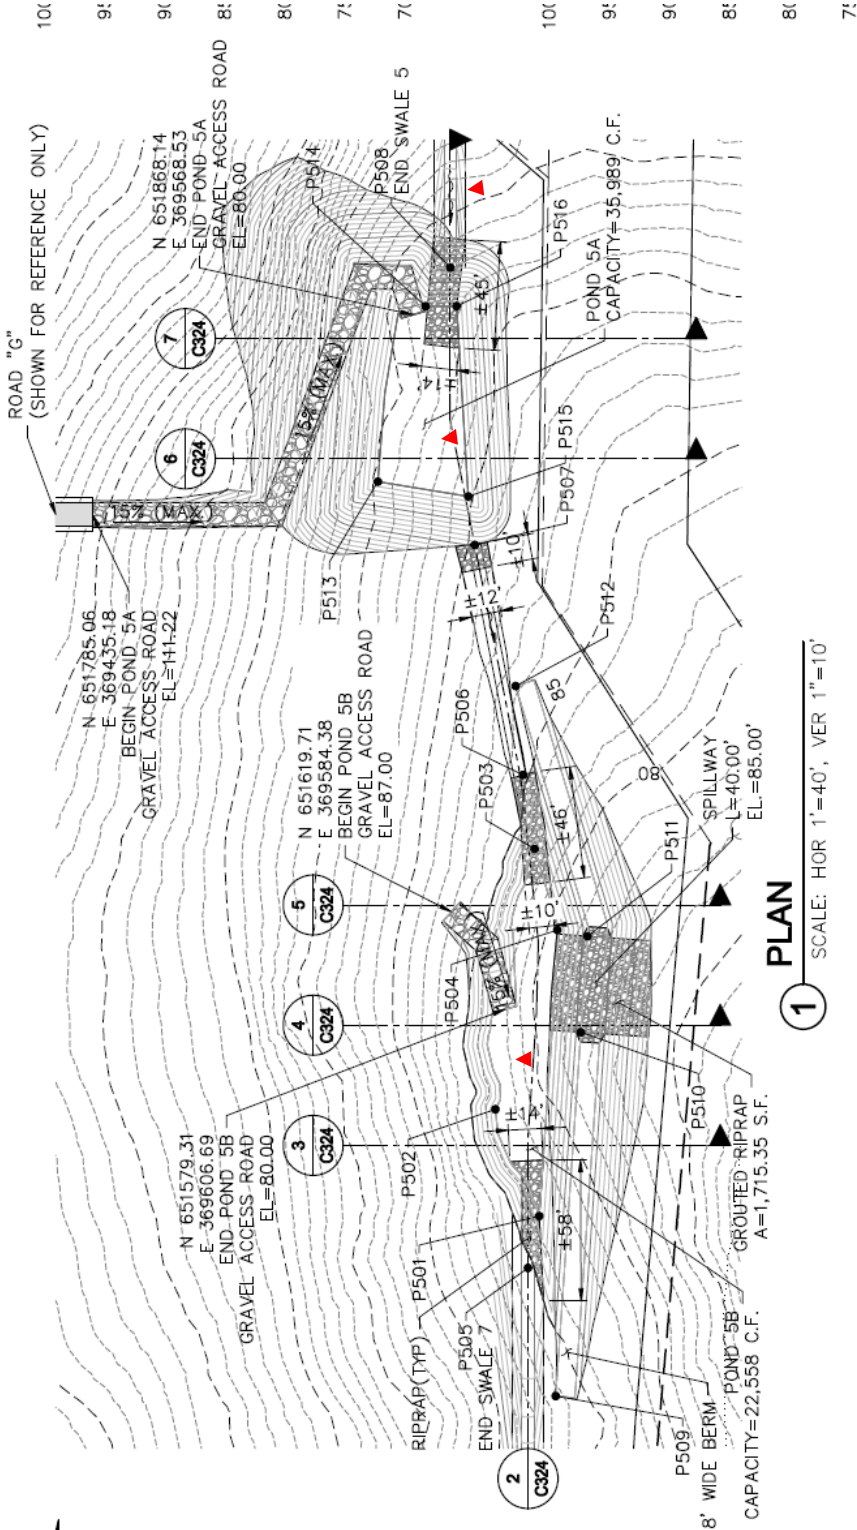
ADDENDUM: Inspection of Pond 5, July 28, 2021. Excerpt from revised E&SC plans approved by GEPA January 4, 2021, adding Pond 5 to the area which would discharge toward Marbo Cave:

We observed that the perimeter swale had discharged to the open ground near the fence, and along with the surface runoff from the surround project area, had left a very large alluvial/delta formation of sediments, up to and including rocks around 1 to 2 feet in diameter. The deposited sediments could be seen extending into the forest far past the site boundaries, toward the Marbo Cave area.

Perimeter swale shown in photos

Pond 5A
