# School Consolidation Study

PREPARED FOR:  
WEST RIVER EDUCATION DISTRICT

STEVENS & ASSOCIATES, P.C.  
SMART DESIGN FOR LIVABLE COMMUNITIES

## FACILITY CONDITION ASSESSMENT

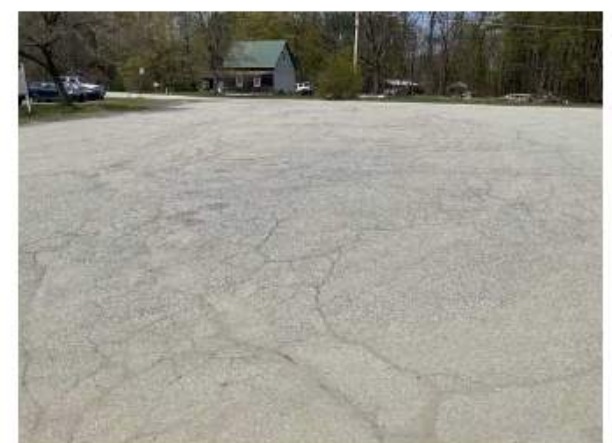
54 - PARKING LOT ASPHALT, MILL & OVERLAY

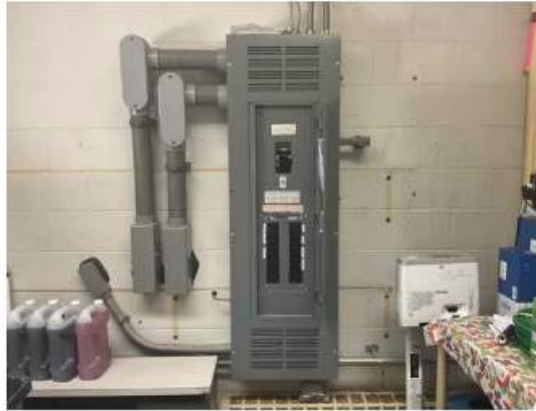
46 - DISTRIBUTION PANEL, 120/208 V, 400 AMP,

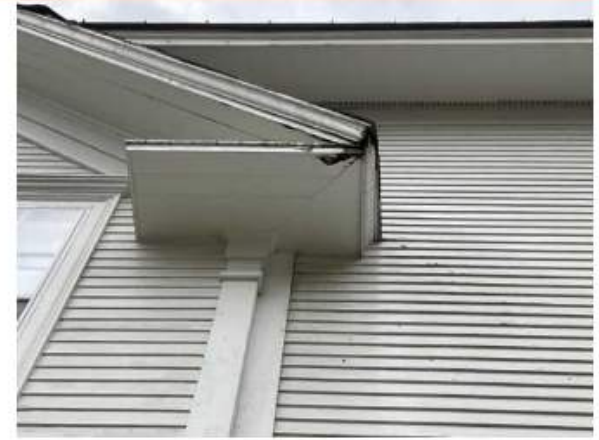
8 - ROOF EDGE CONDITIONS DETAIL

Roof is original to the 1850 building and is repaired on an as needed basis. -

Uniformat Code: B3010  
Recommendation: **Replace in 2023**  
Priority Score: **89.9**  
Plan Type: Performance/Integrity  
Cost Estimate: \$213,000  
\$\$\$\$

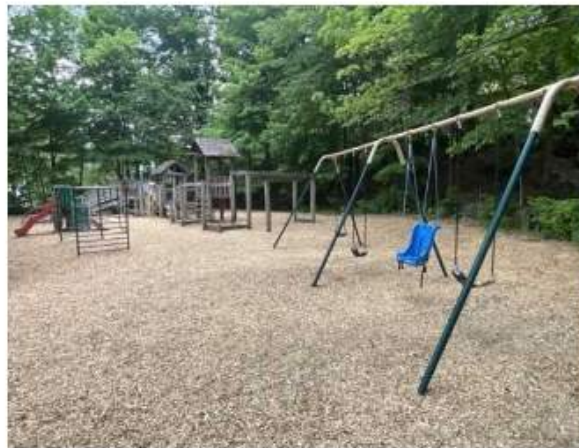
28 - PLAY STRUCTURES IN REAR

### Play Structure in Poor condition.

Uniformat Code: G2050  
Recommendation: **Replace in 2023**  
Priority Score: **91.9**  
Plan Type: Safety  
Cost Estimate: \$20,000

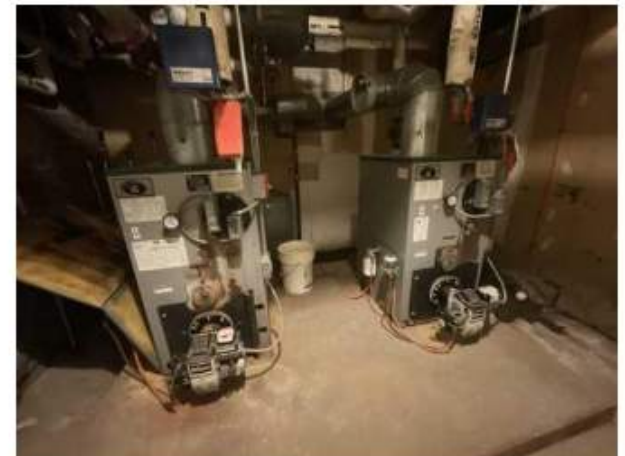
18 - MAIN BOILER HEATING COMPONENT

### Boiler in Poor condition.

Uniformat Code: D3020  
Recommendation: **Replace in 2023**  
Priority Score: **86.9**  
Plan Type: Performance/Integrity  
Cost Estimate: \$46,800  
\$\$\$

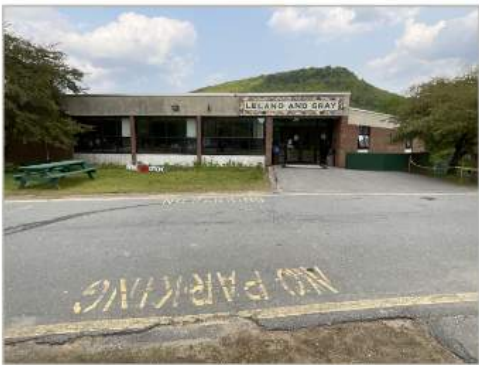
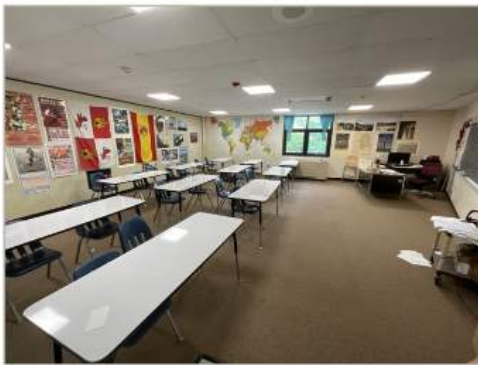
2. Main Building and Site Information

| Key Issues and Findings | Weather-beaten siding around woodshop, inadequate ventilation, antiquated HVAC components and infrastructure, building lacks fire suppression, aged electrical infrastructure, heavy asphalt wear, severe alligator cracking and potholes, significant sidewalk trip hazards, inadequate site lighting. | |
