| <b>Report Title:</b> | Safe Drinking Water Act Compliance Inspection Report | | |
| <b>Inspection Date(s):</b> | Tuesday, July 26, 2022 – Thursday, July 28, 2022 | | |
| <b>System Name:</b> | City of Richmond | | |

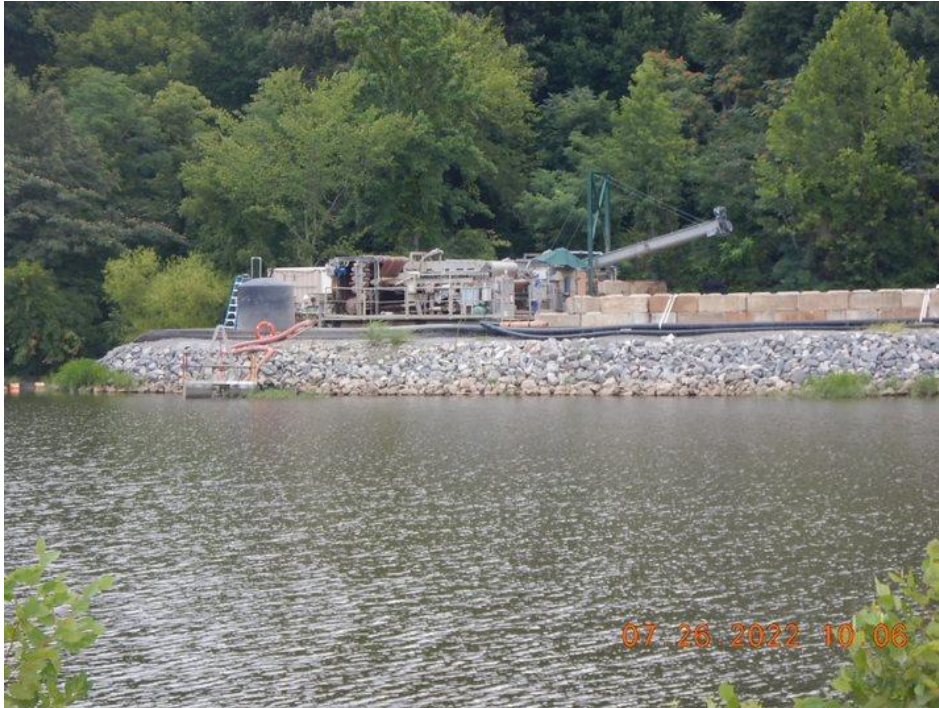
- The Superintendent explained that the trigger for lagoon dredging is a visual inspection and when it appears to be full.
  - Lagoon waste is dredged and pumped through above-ground pipes across the lagoon and pre-sedimentation basin to a dewatering operation at the southeast corner of the pre-sedimentation basin. The dredged material is pressed and used in land application offsite (*Photo 3*).

**Photograph 3.** Lagoon waste processing and dewatering operation.

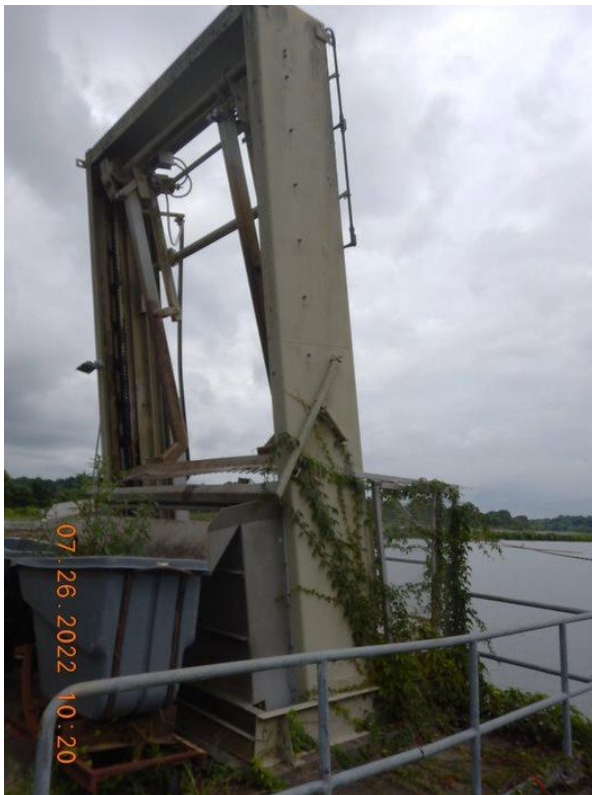
**Photograph 4.** Bar screens and vegetation growing alongside the structure.

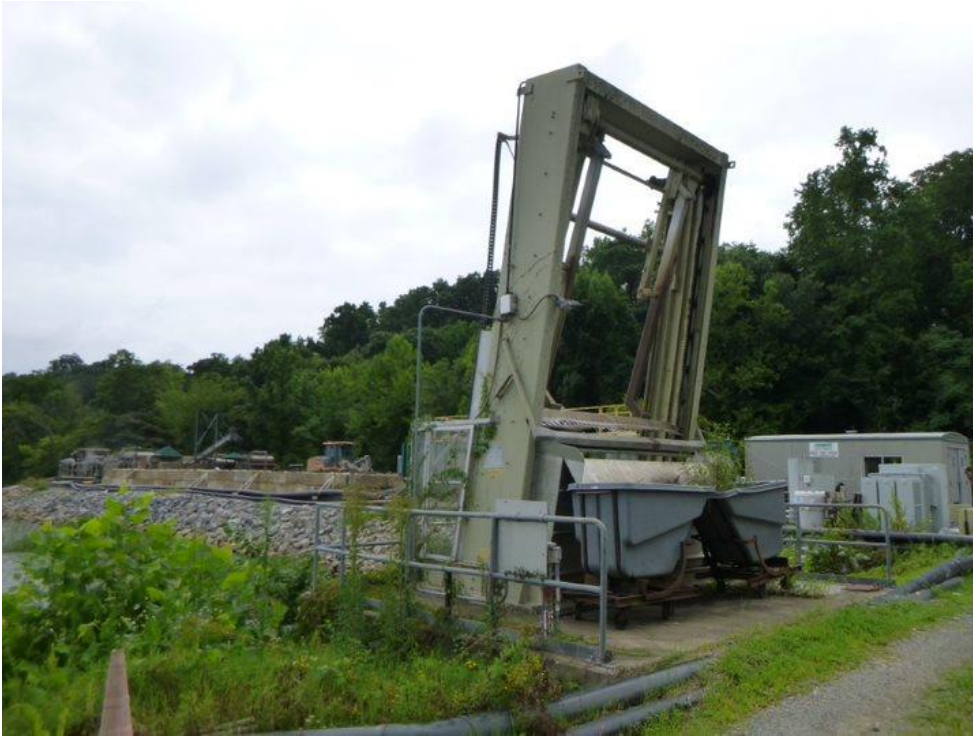
**Photograph 5.** Bar screen and waste containers with vegetation and other debris.

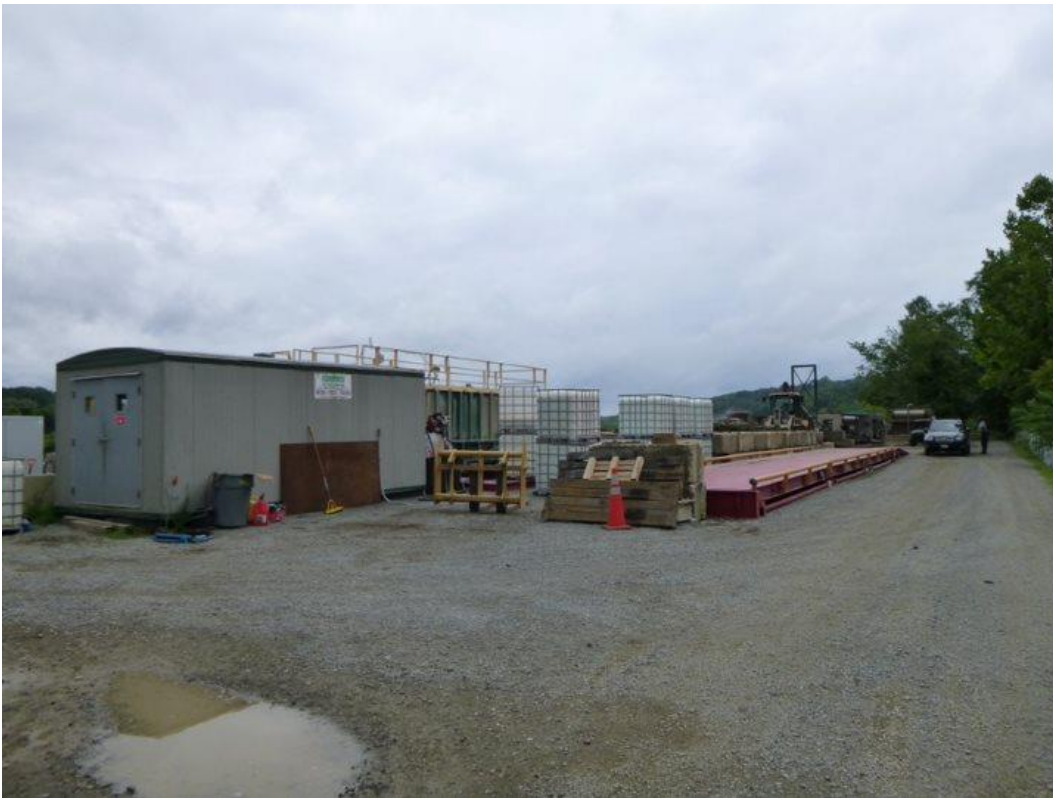
- EPA observed at least ten approximately 300-gallon containers of polymer without secondary containment near the dewatering operation to the northeast of the pre-sedimentation basin (*Photo 6*). The Superintendent explained the polymer is used in the dewatering process for the lagoon dredge material.

**Photograph 6.** Polymer containers without secondary containment in the dewatering area.

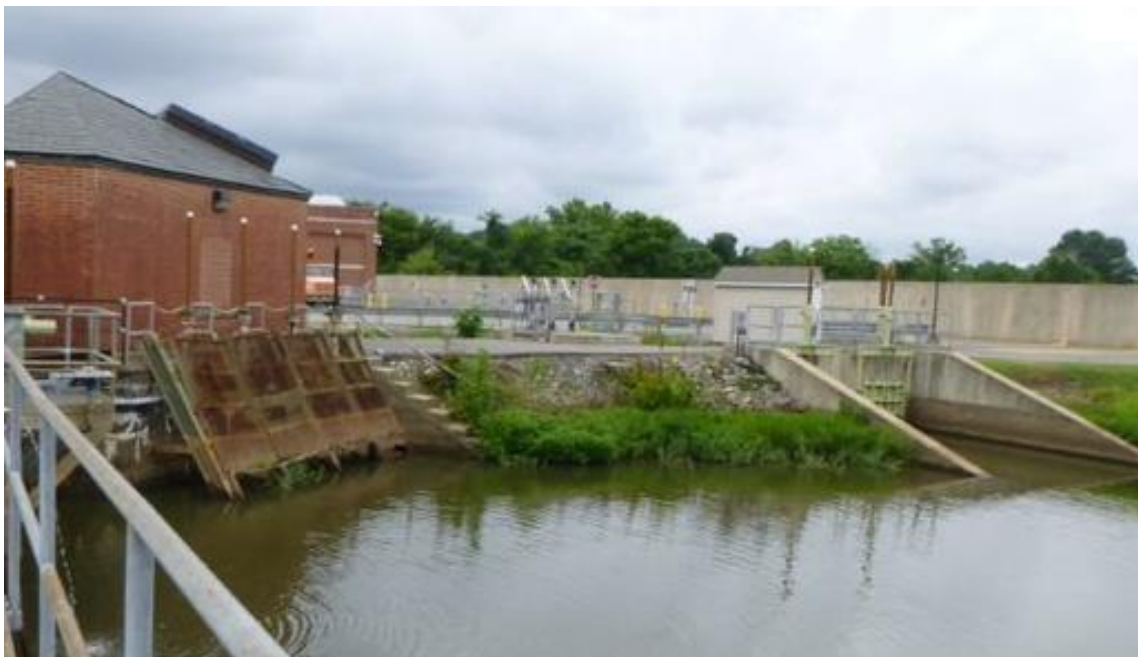
**Photograph 10.** Raw water intake and out of service screens.

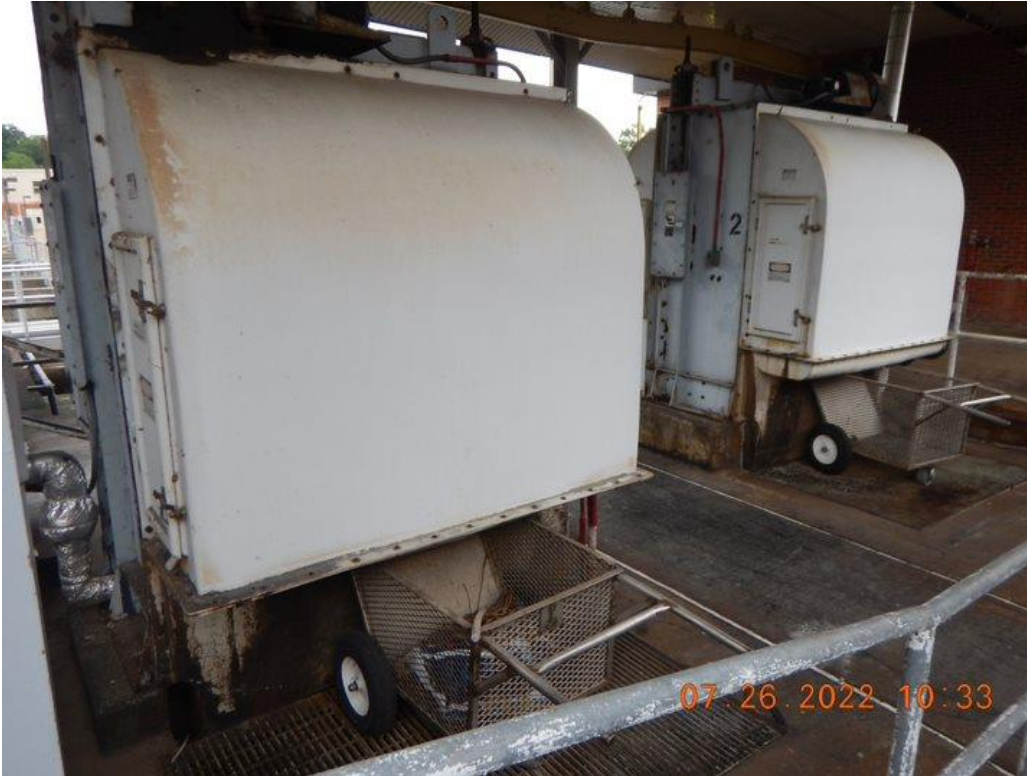
- The Superintendent stated that traveling screens and rakes were not operational, however the Program & Operations Supervisor explained that they can be used if needed. The screens did not appear to be exercised or used as part of an operational protocol. System Representatives explained that the screens were to be replaced and the bid package was in preparation for award (*Photo 12*).

**Photograph 12.** Traveling screens at raw water intake.

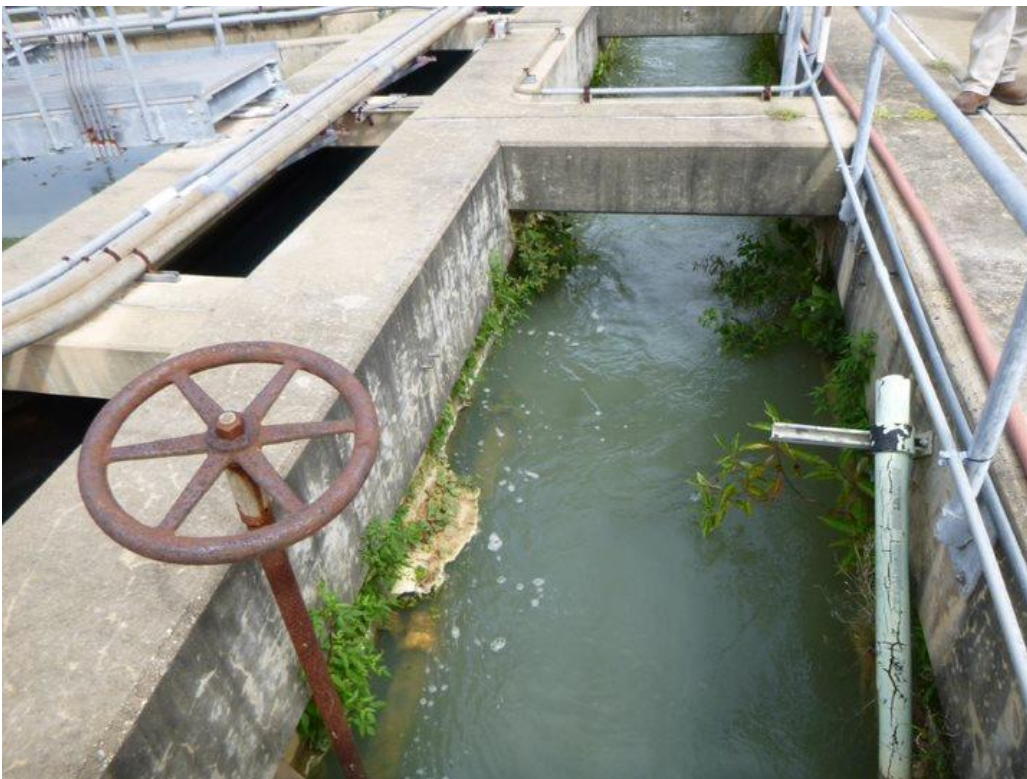
- EPA observed vegetation growth near the entry of the concrete raw water coagulation channel at the water line (*Photo 13*).
  - EPA observed that the potassium permanganate chemical application was not in operation at the time of the inspection, as the water discharging from the chemical pipe was clear rather than purple. The Superintendent acknowledged that the chemical application would be purple if the chemical application was dosing properly. The Superintendent confirmed that the chemical system was in operation, but that the chemical feed had failed (*Photo 14*). The Superintendent said that he notified operators to address the issue.

**Photograph 13.** Vegetation growing in concrete raw water channel at water line.

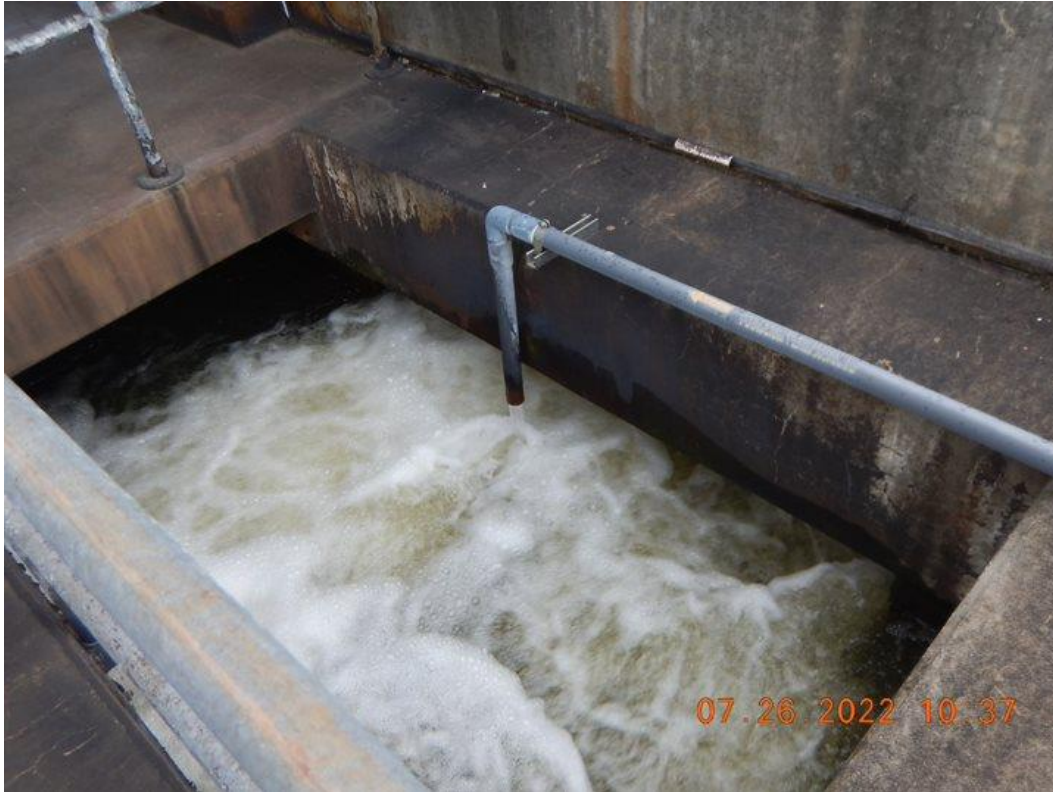
**Photograph 14.** Potassium permanganate chemical application area, not operating properly since water is clear instead of purple.

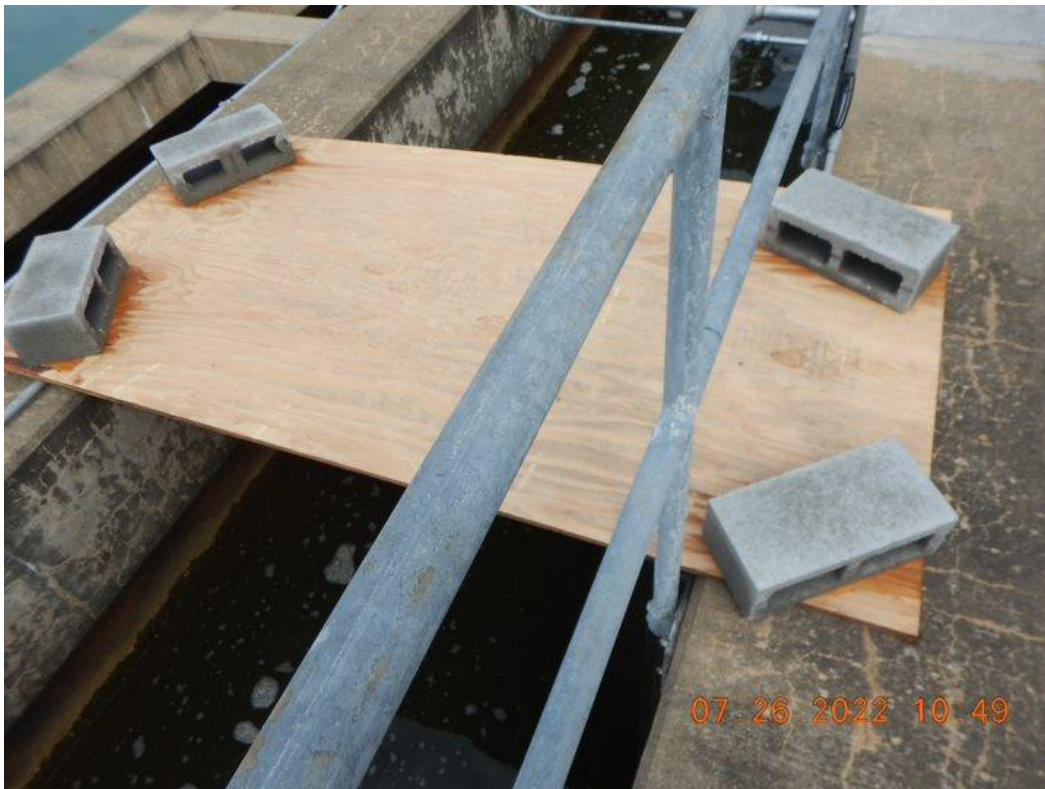
**Photograph 15.** Plant 2 flow meter above raw water coagulation channel, wood to block potential sun interference.

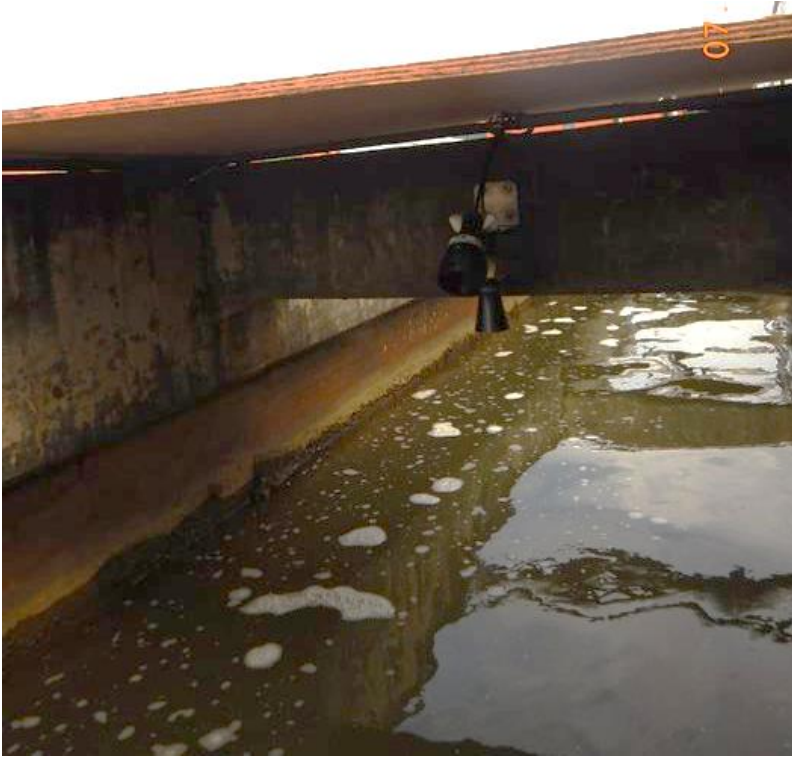
**Photograph 16.** Plant 2 flow meter above raw water coagulation channel, below piece of wood.

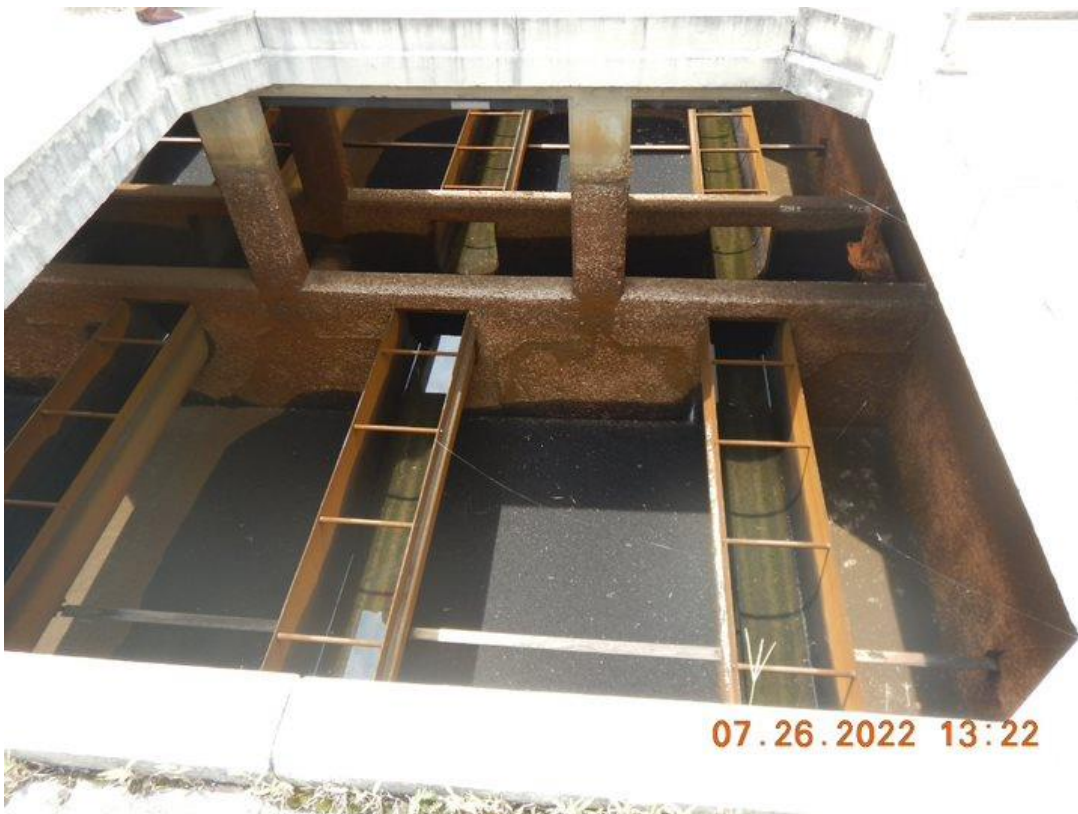
- Filters 14, 15 and 19 of Plant 2, as well as Filter 2 of Plant 1 were out of service at the time of inspection due to issues with rate of flow effluent valve actuators (*Photo 25*). No date was provided for their return to service.

**Photograph 25.** Filter 19, not in service.

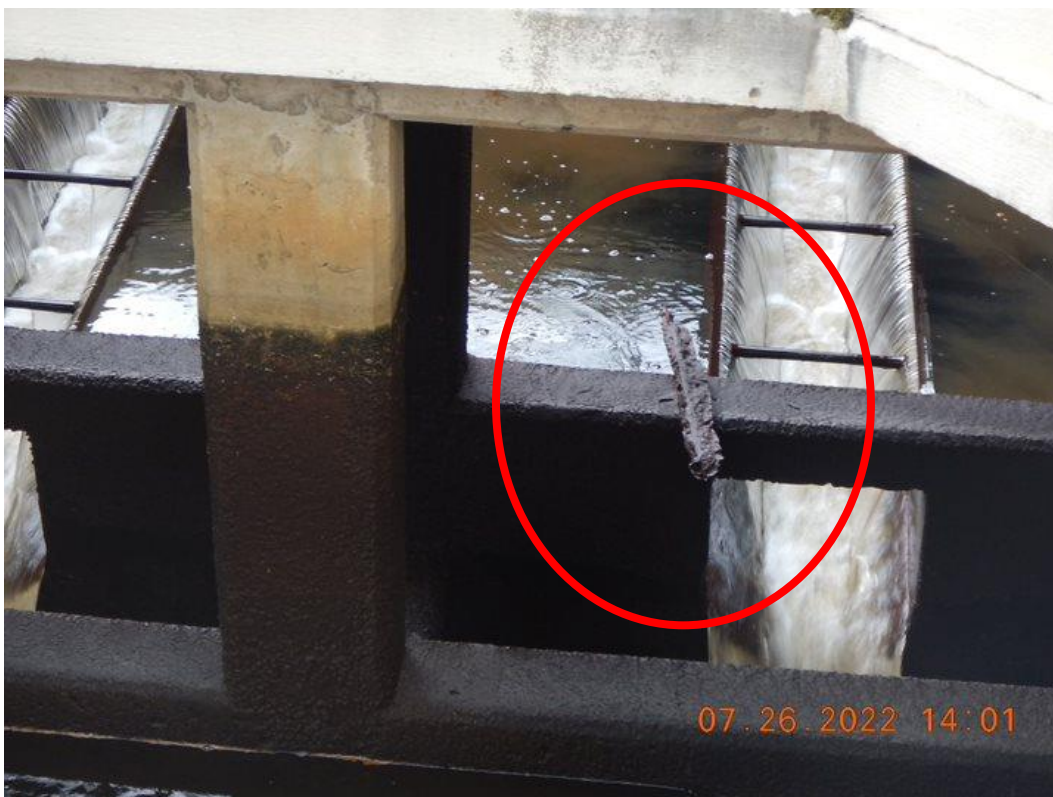
**Photograph 31.** Debris near influent/effluent channel of Filter 16.

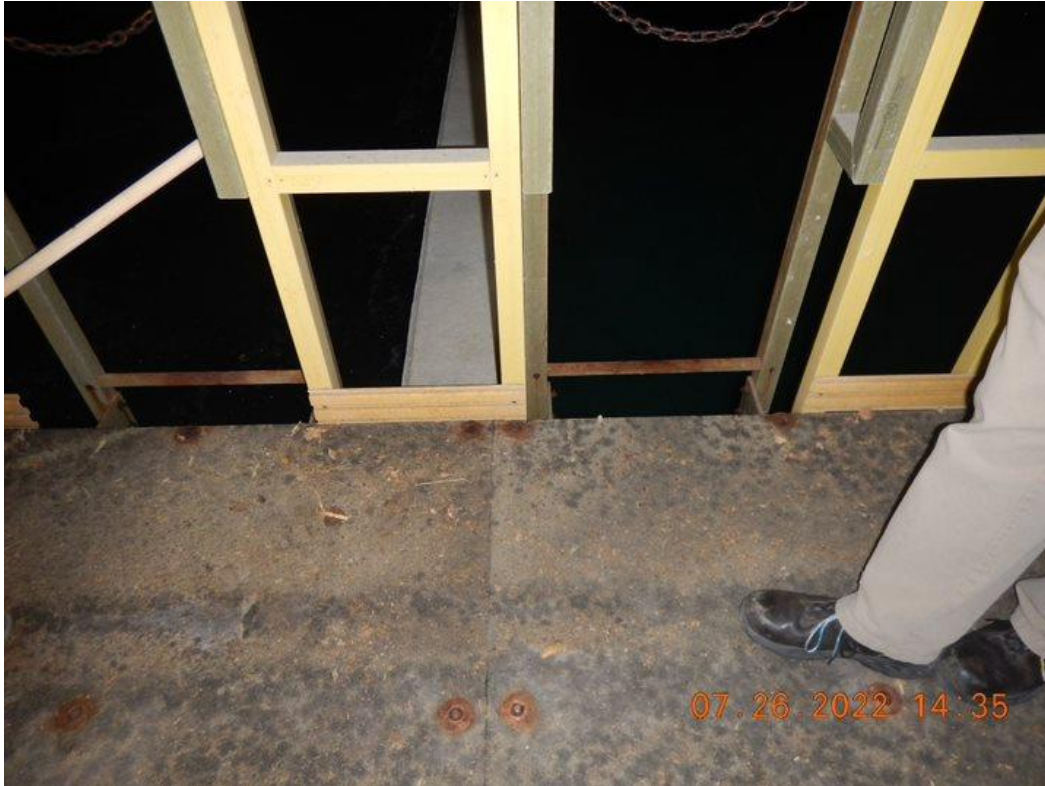
**Photograph 32.** Landing area at entry of Plant 2 finished water basin; no baseboards to prevent debris from falling into water.

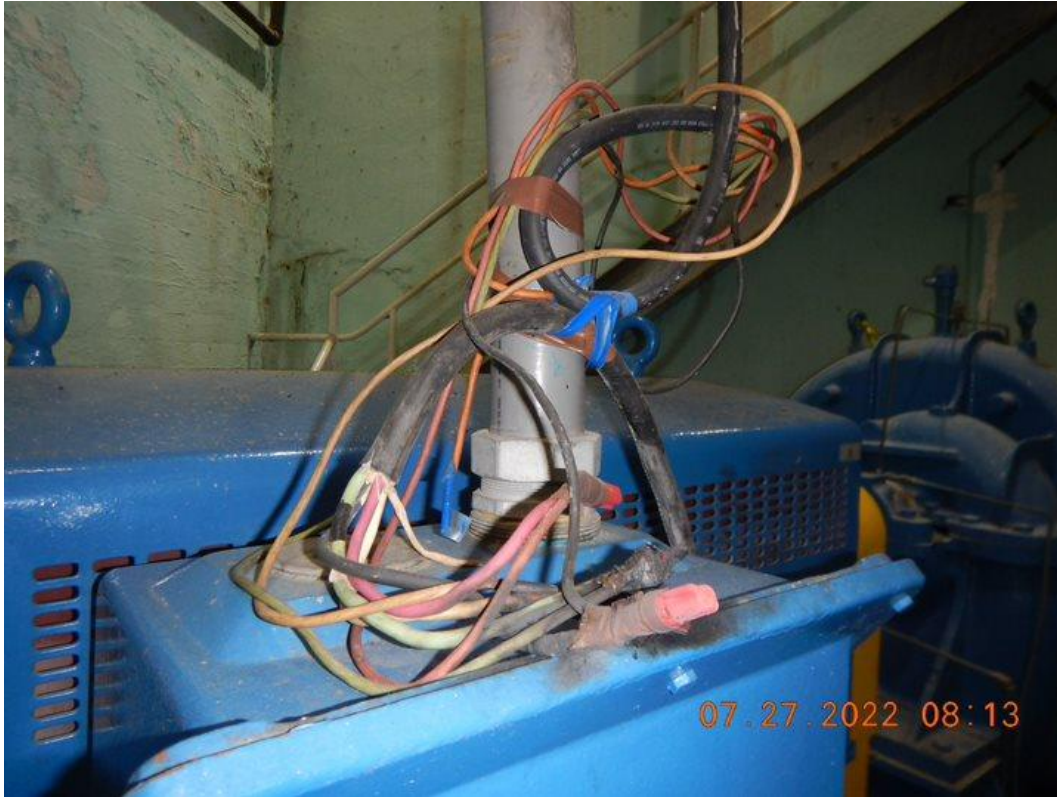
- System Representatives explained that Korah 1 pumps to the Byrd Park Reservoir.
- EPA observed a caustic soda line with chemical on the exterior of the pipe. There was caution tape around the pipe and the immediate area (*Photos 34-35*).
- EPA observed pH meters reading 8.16 and 7.62; System Representatives explained they are used to control caustic soda dosing (*Photo 36*). EPA observed dust and dirt built up on the analyzers and the screen.
- The caustic soda is stored in a separate area adjacent to the pump station in two tanks, one is 9,000 gallons and the other is 8,000 gallons (*Photo 37*). There are four pumps, two were in operation at the time of the inspection (pumps 2 & 3). There was secondary containment at each of the pumps. The caustic soda is injected at the end of the finished water basin.
- EPA observed exposed wiring at the K1-2 pump (*Photo 38*).

**Photograph 38.** Exposed wiring on K1-2 pump at Korah 1 Pump Station.

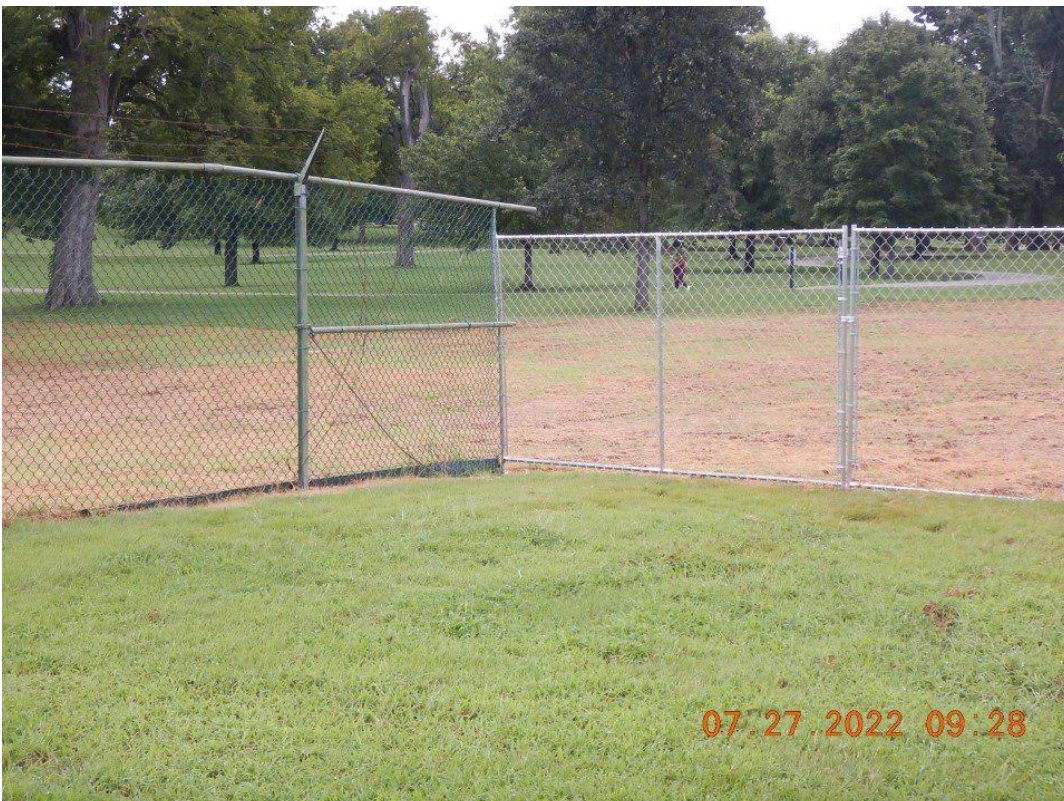
- EPA observed security fencing around the pumphouse with barbed wire on one side. System Representatives explained that new transmission mains were recently installed, and more permanent fencing is to be installed eventually (Photo 50). The new transmission mains will increase redundancy and reliability of power.

**Photograph 50.** Fencing at the Trafford Pump Station.

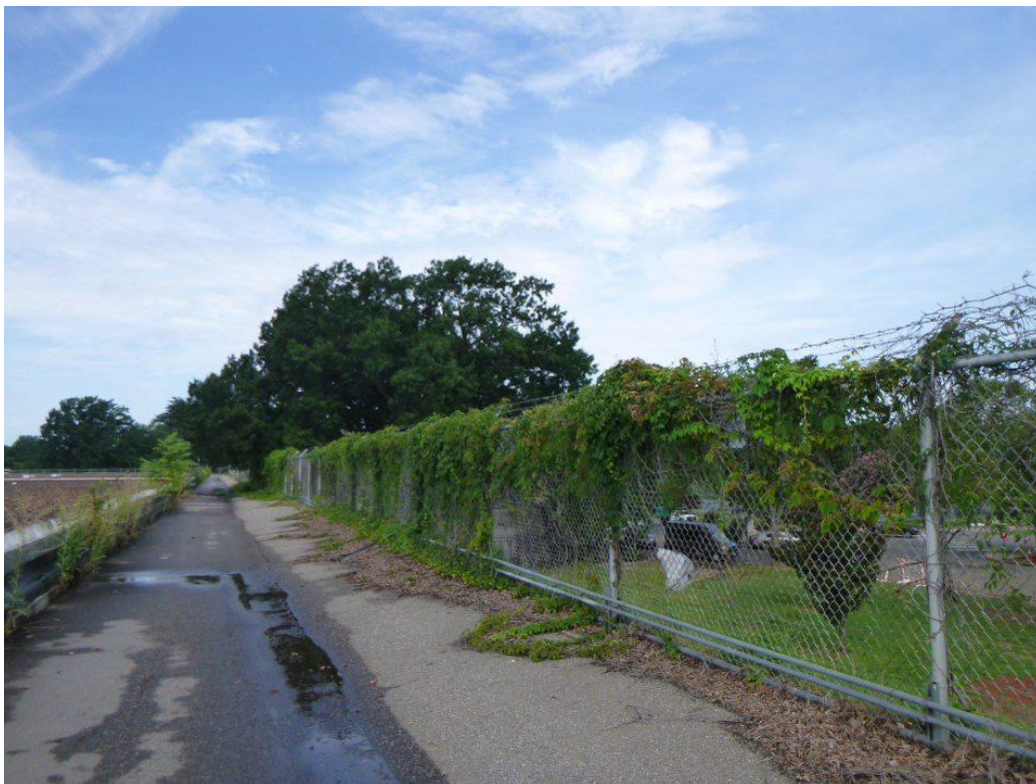
**Photograph 52.** Fencing and vegetation growth at the Byrd Park Reservoir.

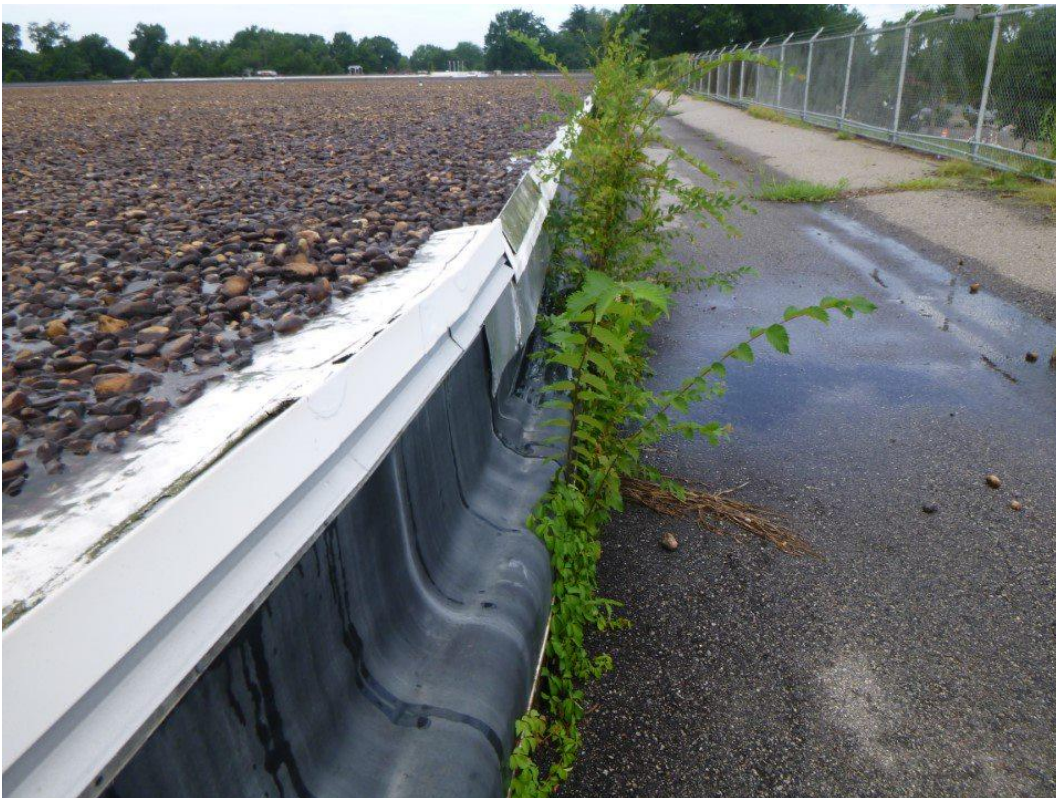
**Photograph 62.** Plant growth at base of Byrd Park Reservoir.

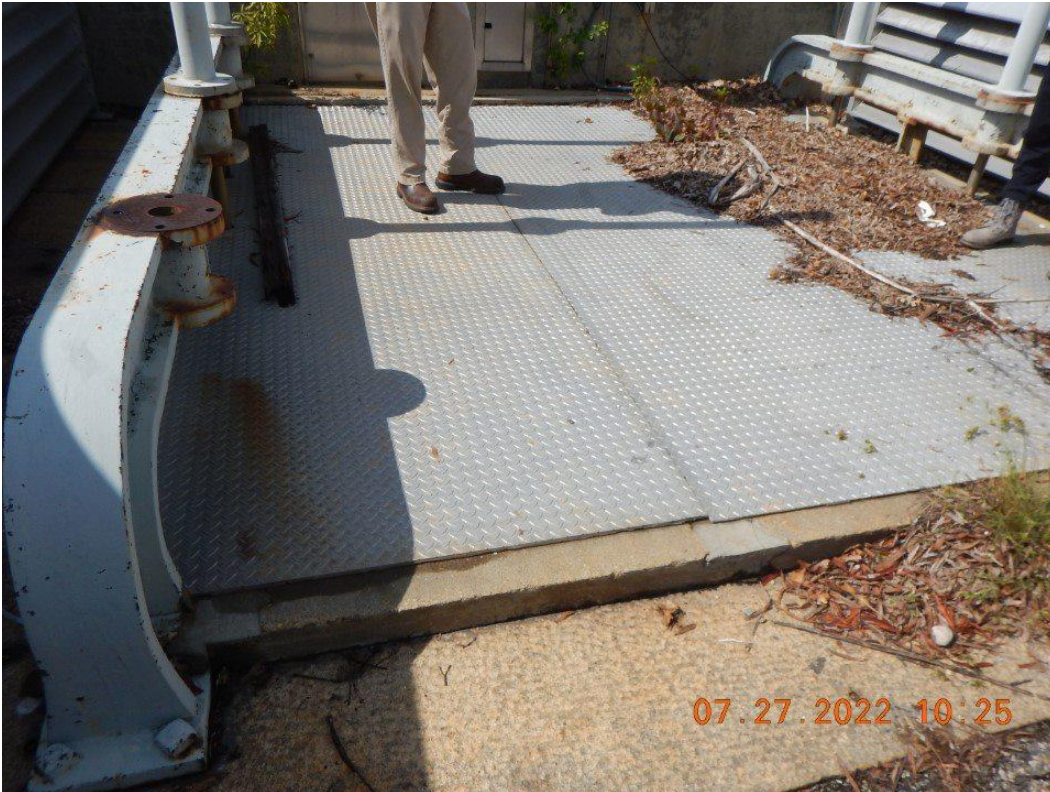
**Photograph 67.** Access vault filled with water in northern walkway of Byrd Park Reservoir.

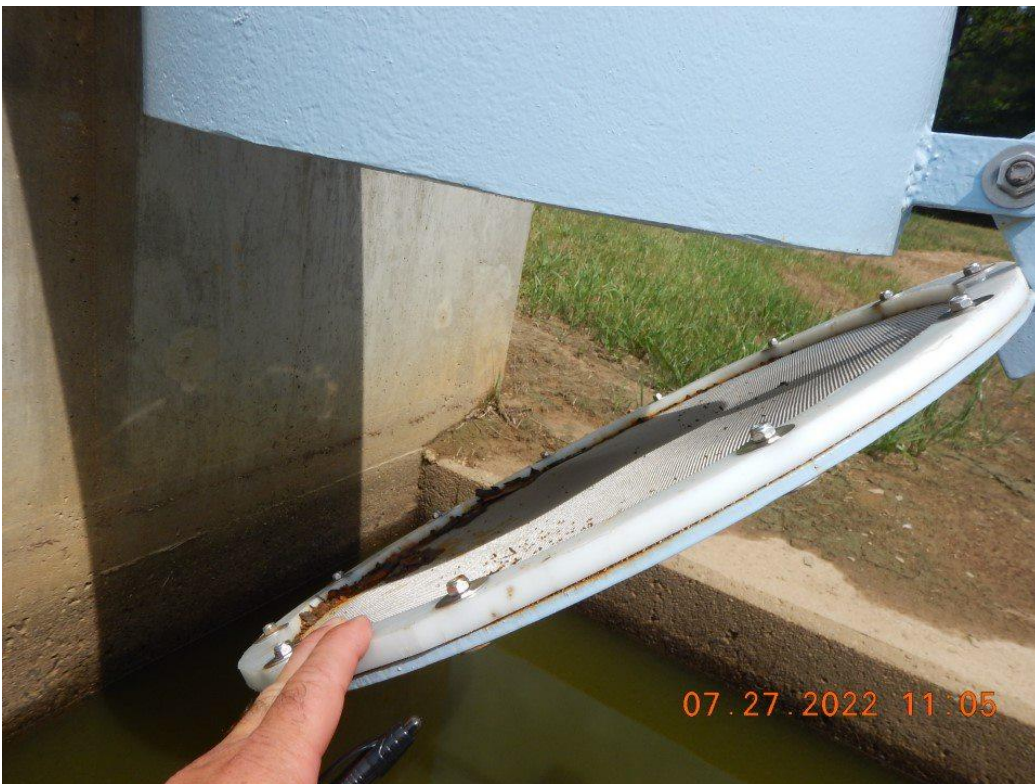
**Photograph 71.** MACPU unit, not in service at Cofer Road Tank A.

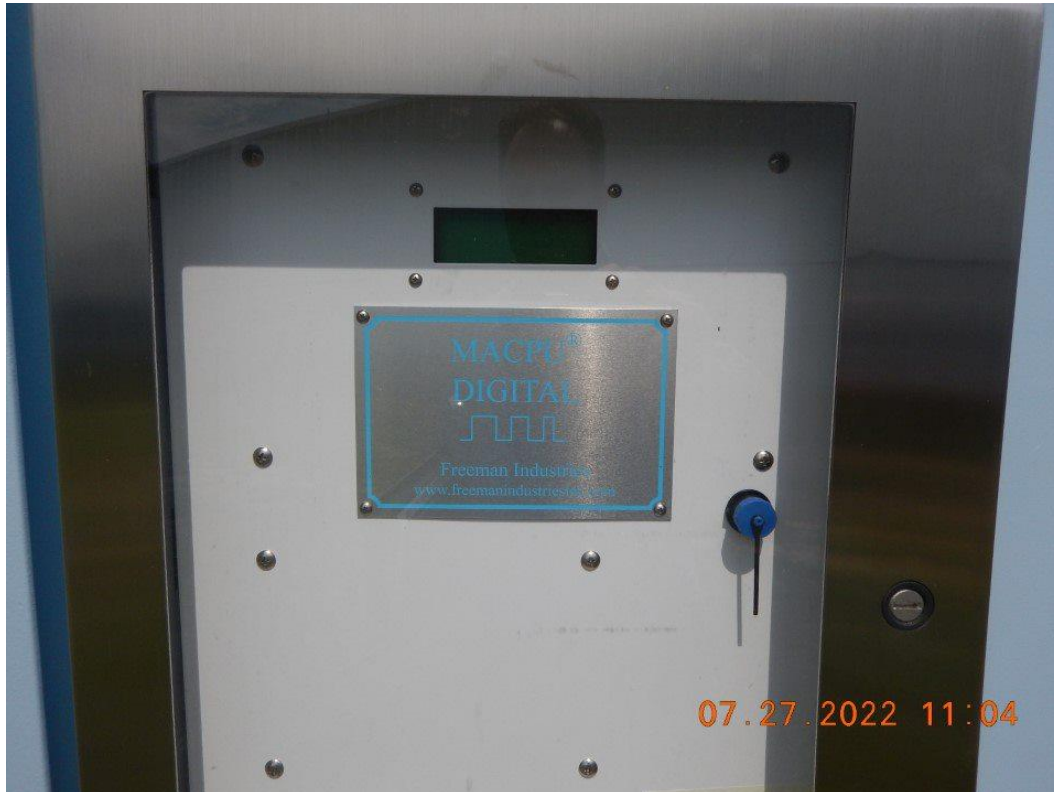
**Photograph 72.** Flow meter at Cofer Road Pump Station, reading 9065.0 gallons/minute.

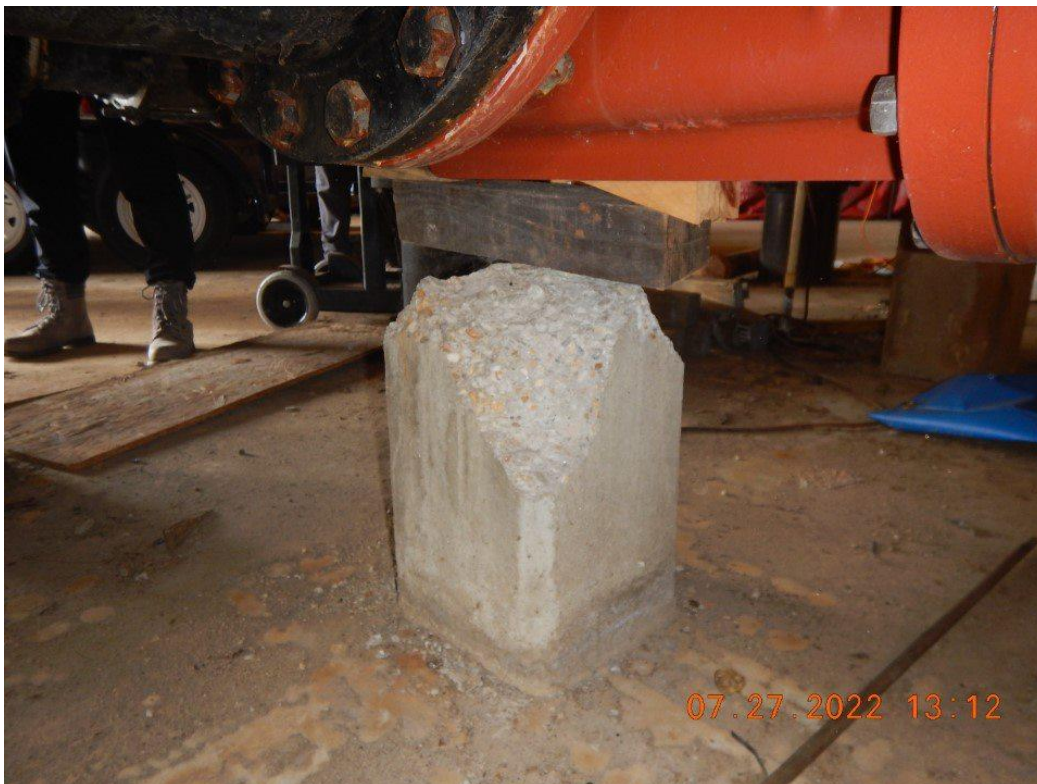
**Photograph 83.** Pieces of wood stacked to attempt to provide support to the transmission pipe at Warwick Road Tank.

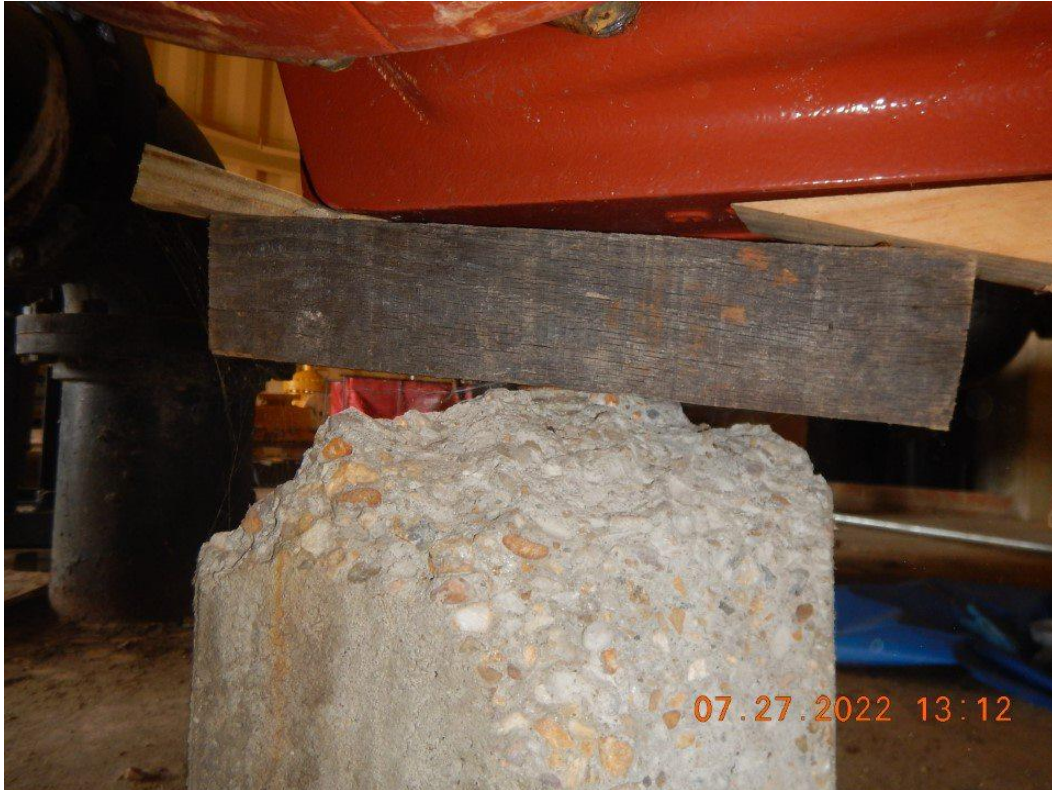
**Photograph 84.** Corrosion on the control valve on the transmission pipe of the Warwick Road Tank.

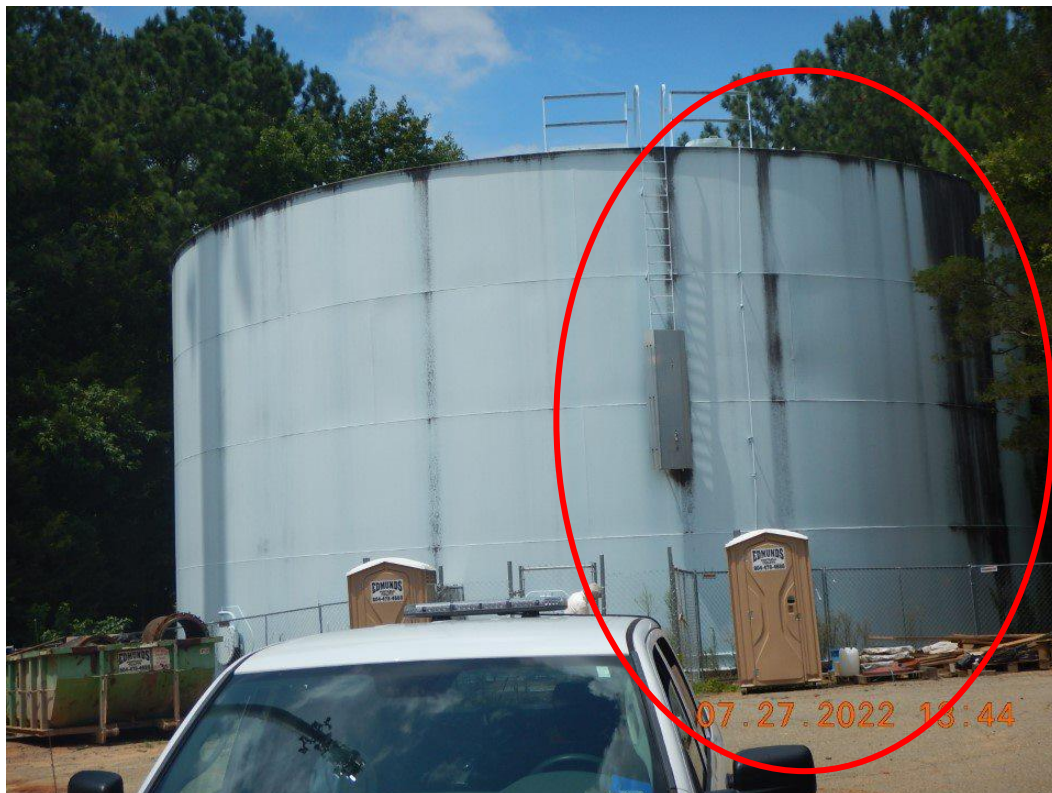
**Photograph 86.** Huguenot Road Tank with temporary fencing and staining.

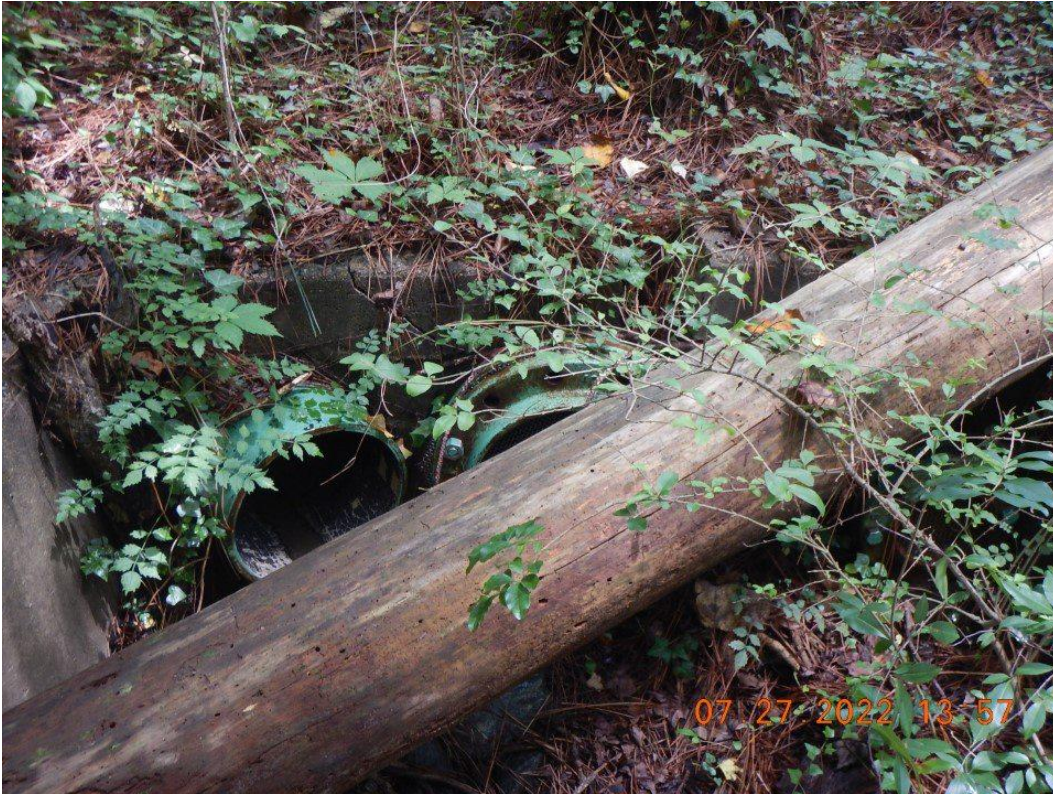
- EPA observed temporary fencing around the front of the tank and permanent security fencing without barbed wire at the rear of the tank. System Representatives explained there is ongoing construction in the area and the temporary fencing will be replaced. EPA also observed staining on portions of the tank (*Photo 86*).
- EPA observed tree branches rubbing against the side of the tank. EPA observed extensive vining vegetation at the rear of the tank. EPA observed some staining and/or algae growth on the exterior coating of the tank (*Photos 87-88*).
- EPA observed three overflow/discharge pipes at the rear of the tank, below grade and within a concrete wall: one 10” pipe that did not have any screening, one 10” pipe that had fine screening but was blocked with debris, and one 6” pipe that had ¼” rough screening (*Photos 89-90*).

**Photograph 89.** Overflow and/or discharge pipes from the Huguenot Road Tank.

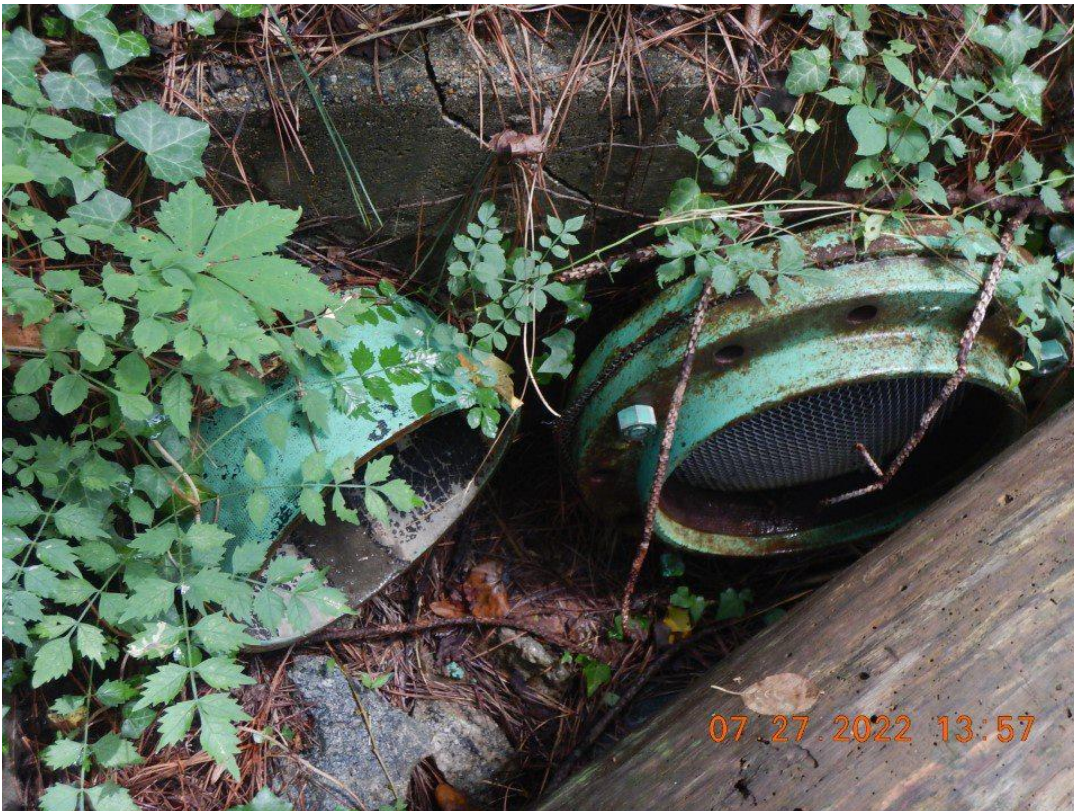
**Photograph 90.** Overflow and/or discharge pipes from the Huguenot Road Tank.

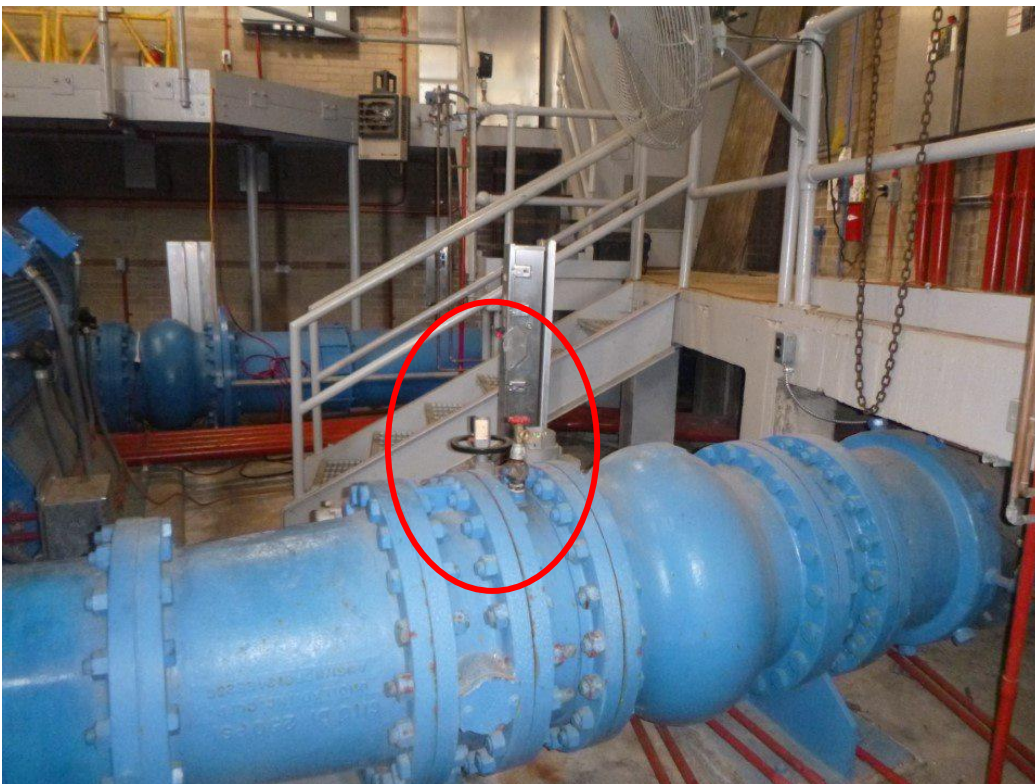
- EPA observed that the programmable logic controller (PLC) display screen in the main pump station building was not operational (*Photo 91*).
- EPA observed a threaded tap on a finished water line (*Photos 92-93*).

**Photograph 92.** Threaded tap on finished water line without backflow prevention at the Columbus Pump Station.
