| <b>Report Title:</b> | Safe Drinking Water Act Compliance Inspection Report | | |
| <b>Inspection Date(s):</b> | Tuesday, July 26, 2022 – Thursday, July 28, 2022 | | |
| <b>System Name:</b> | City of Richmond | | |

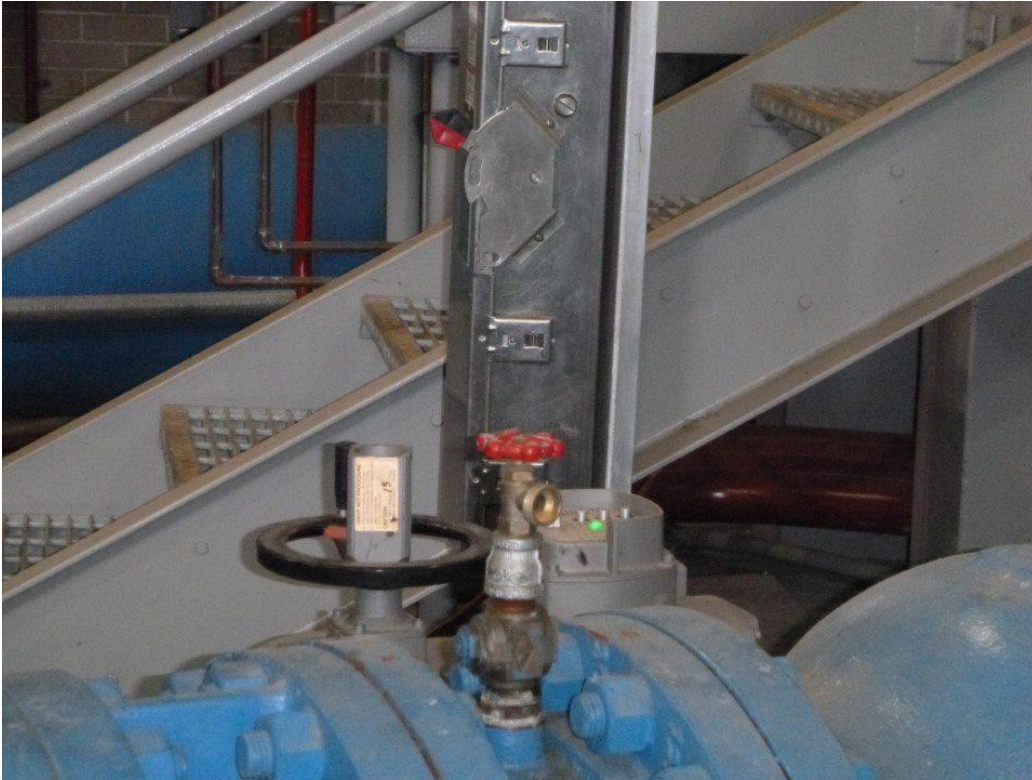
- EPA observed that the programmable logic controller (PLC) display screen in the main pump station building was not operational (*Photo 91*).
- EPA observed a threaded tap on a finished water line (*Photos 92-93*).

**Photograph 93.** Threaded tap on finished water line without backflow prevention at the Columbus Pump Station.

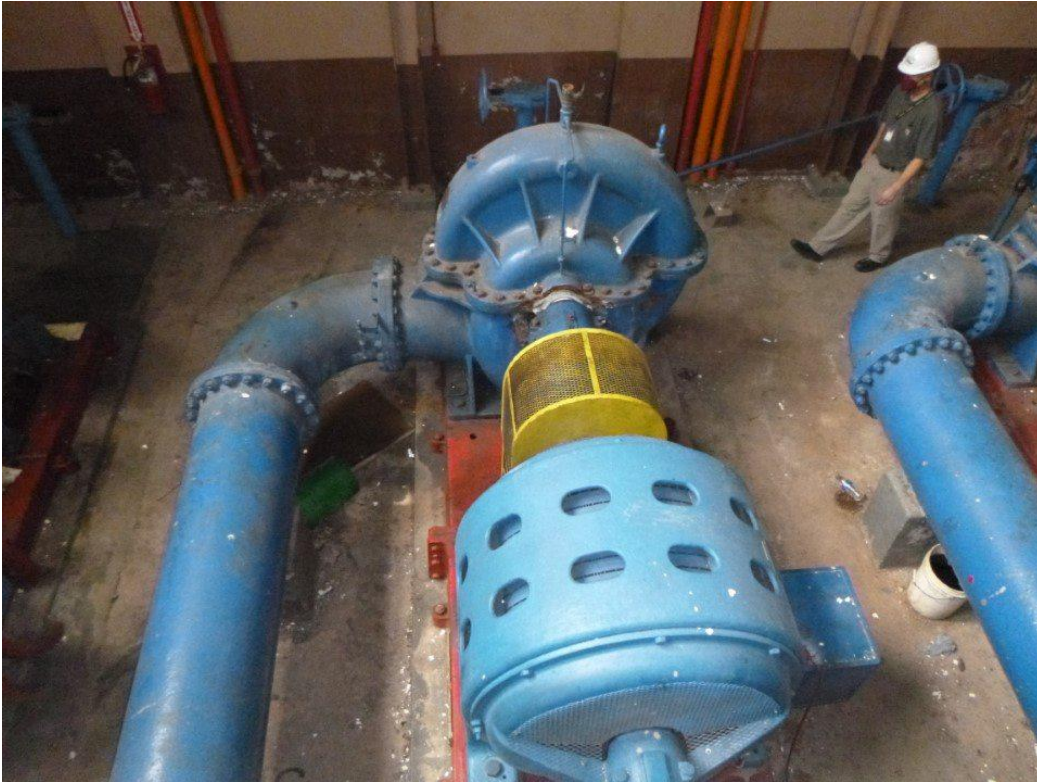
**Photograph 97.** Byrd Park Main Pump Station floor with debris.

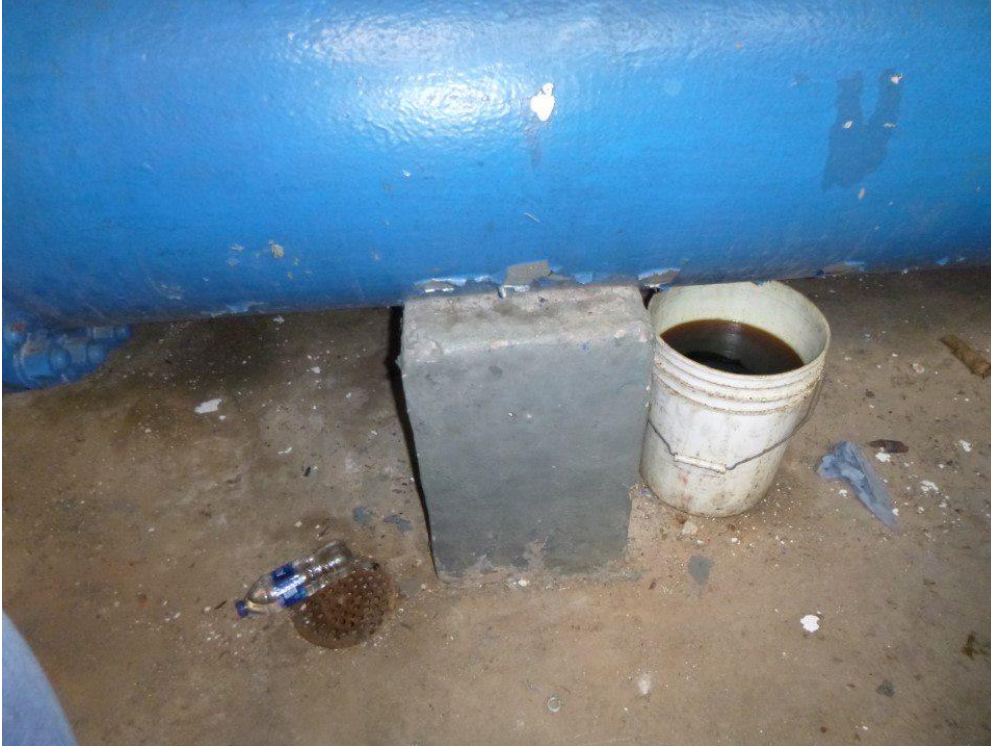
- EPA observed seals leaking on two gate valves and observed corrosion on the bolts of the gate valves (*Photos 99-100*).
- EPA observed poor housekeeping conditions throughout the pump station, including debris, standing water on the ground, and lubrication leaking from the pumps (*Photos 101-102*). EPA also observed a nearly full and uncovered five-gallon bucket of oil/water mix (*Photo 103*).

**Photograph 103.** Five-gallon bucket of oil/water mixture at Byrd Park Main Pump Station.

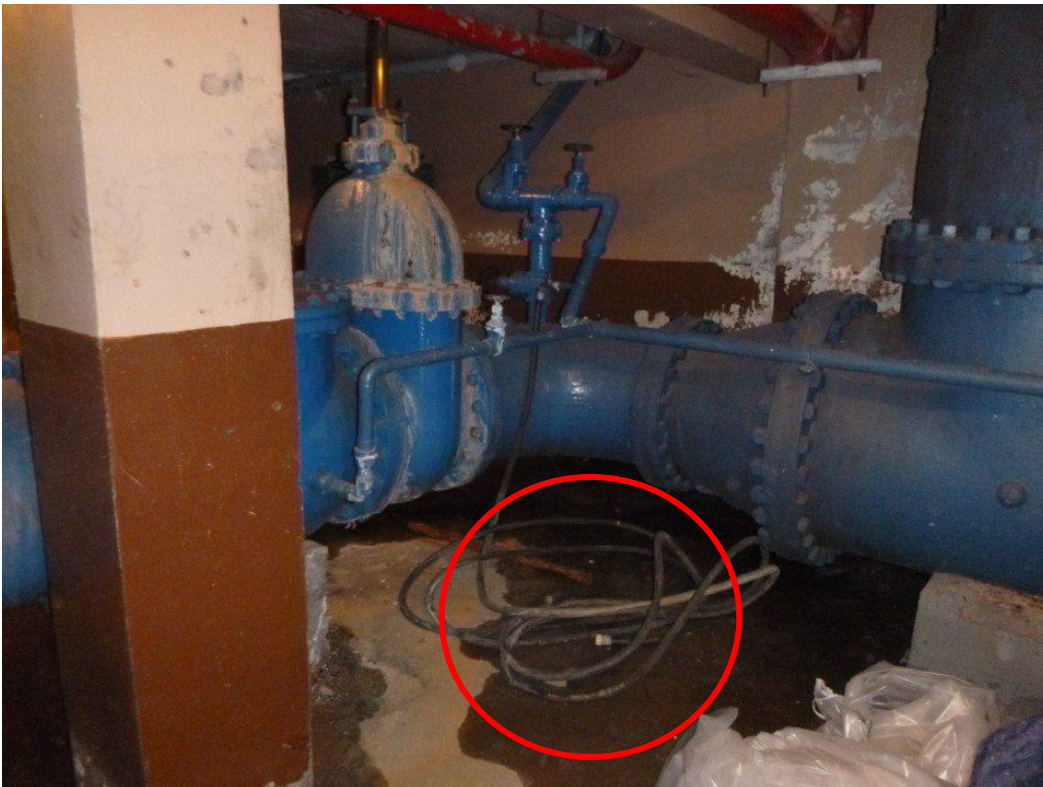
**Photograph 104.** Hose on ground in standing water attached to finished water line without vacuum breaker at Byrd Park Main Pump Station.

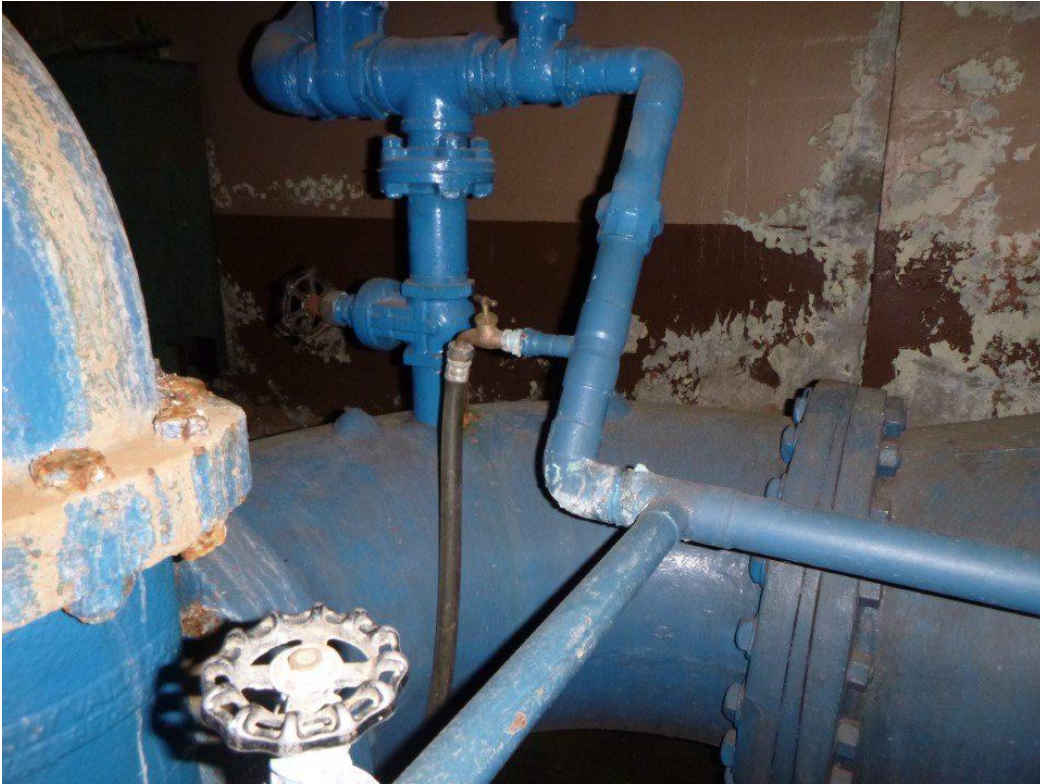
**Photograph 105.** Hose on ground attached to finished water line without vacuum breaker.

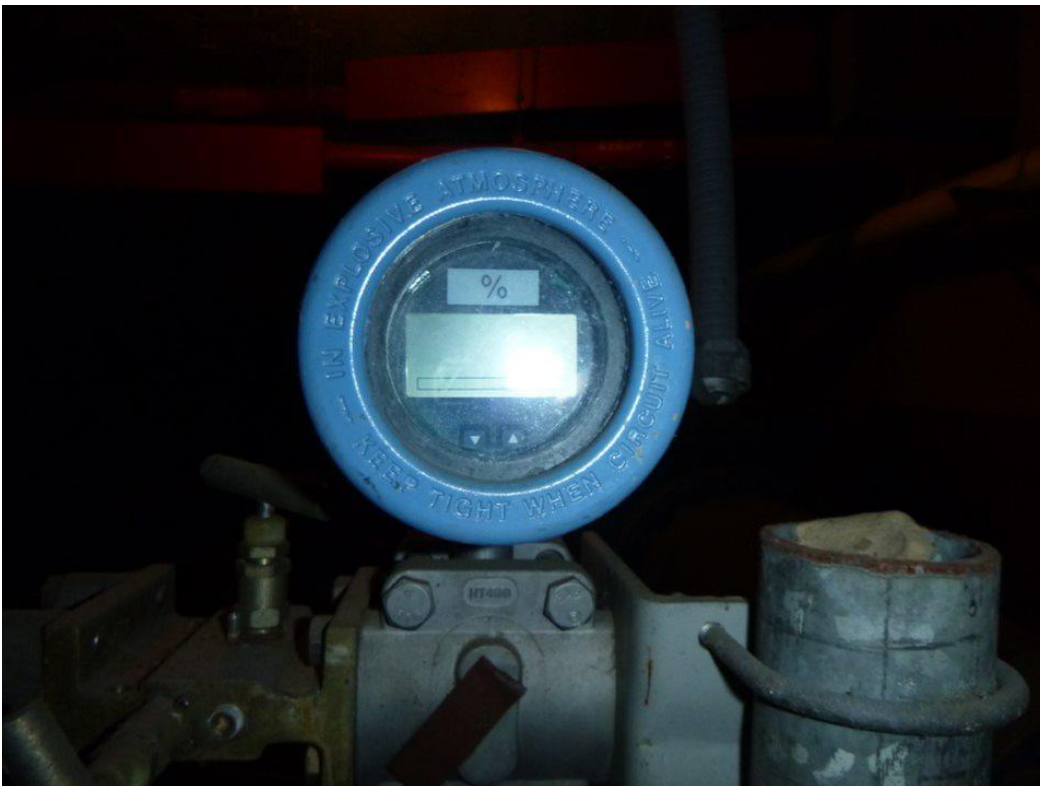
**Photograph 106.** Non-operational meter at Byrd Park Main Pump Station.

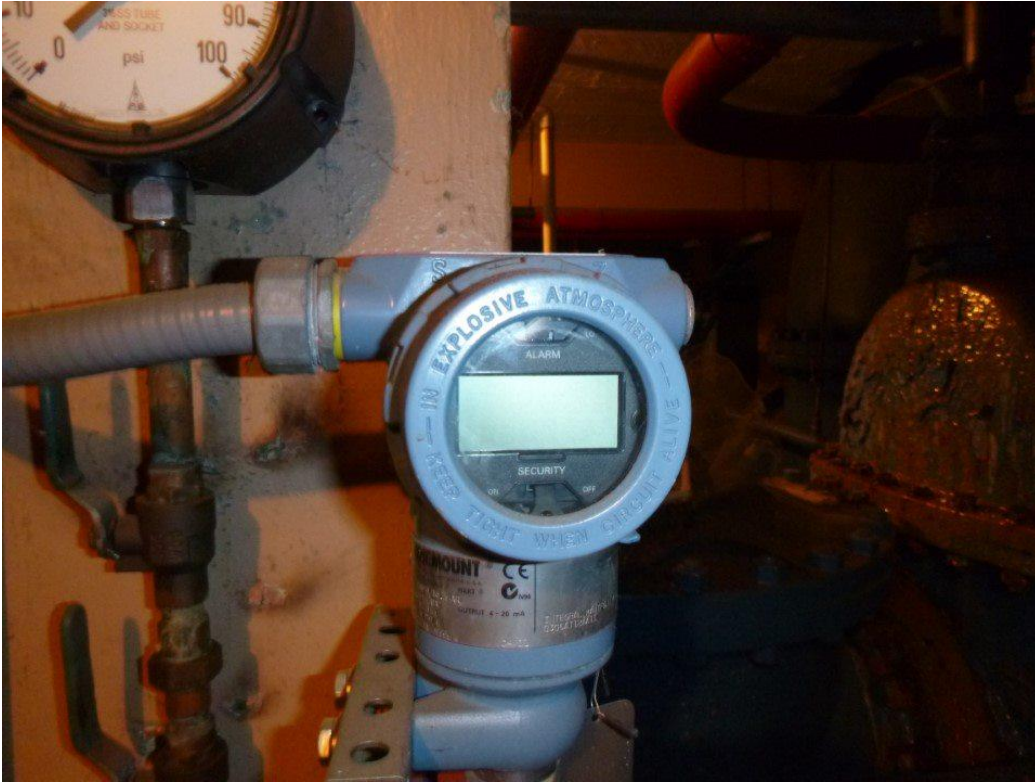
**Photograph 107.** Non-operational meter at Byrd Park Main Pump Station.

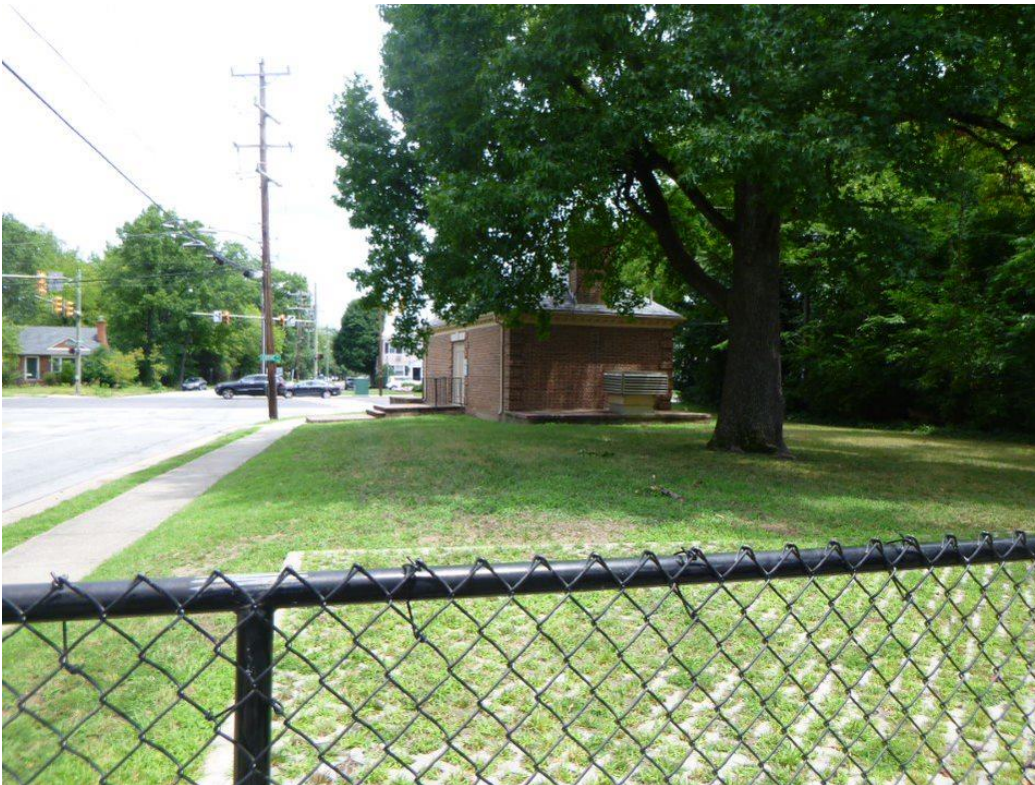
- EPA observed the pump station is located at intersection of two busy residential streets, without a security fence in place (*Photo 108*).
- EPA observed four pumps at the pump station, Pump 4 was operational and on.
- EPA observed a threaded tap and a connected hose on finished water line without a vacuum breaker (*Photo 109*).
- According to System Representatives, the pump station did not have a dedicated sampling location.
- The System Representatives explained that backup power for the pump station consisted of a quick connection for a portable generator.

**Photograph 108.** Four-foot fencing at Westhampton Pump Station in highly trafficked residential area.

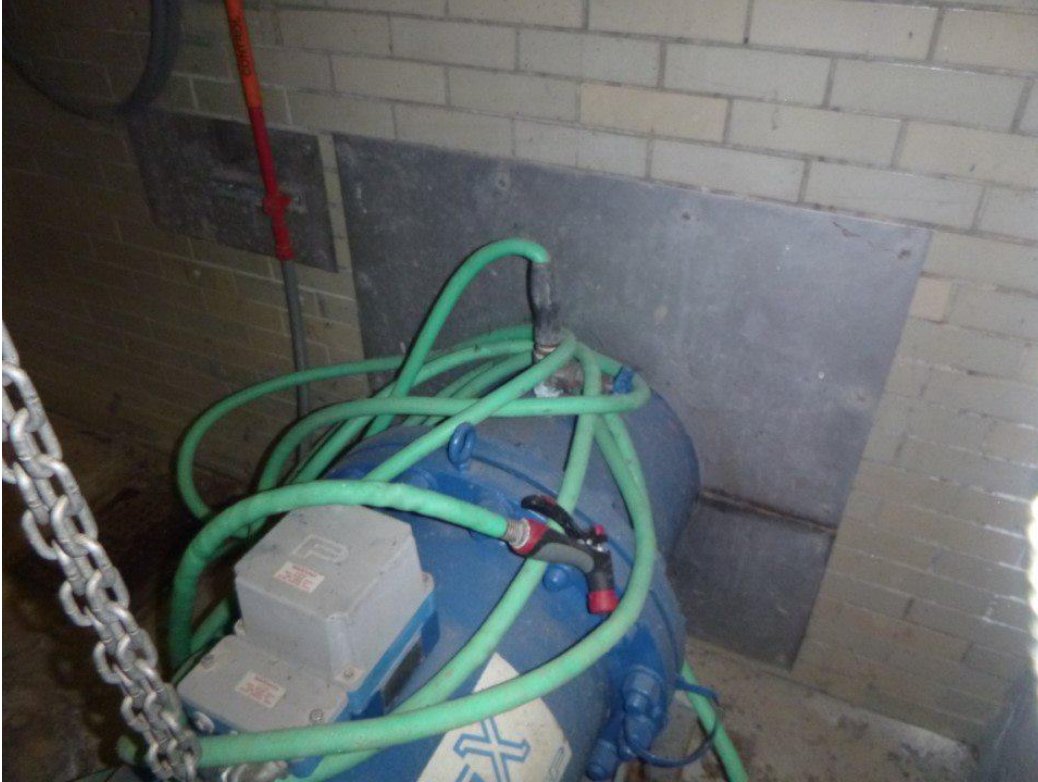
**Photograph 109.** Hose connected to threaded tap without vacuum breaker at Westhampton Pump Station.

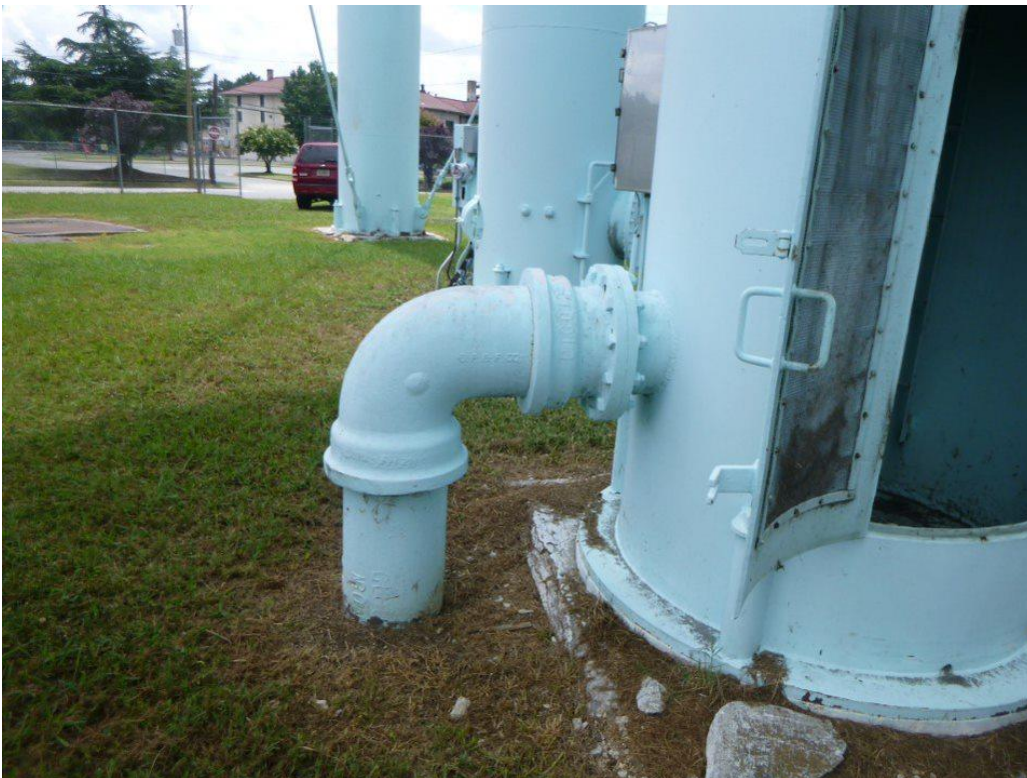
- The System Representatives stated the tank has 1 MG capacity. The tank feeds pressure zone 2N of the System.
- The System Representatives experienced difficulty locating the tank's overflow pipe. The Program & Operations Supervisor identified the overflow pipe at the access hatch, which was piped directly underground. The Program & Operations Supervisor was unsure where the pipe led to and if there was a method in place to prevent cross connections or backflow (*Photo 110*).

**Photograph 110.** Potential overflow pipe for Ginter Park Tank.

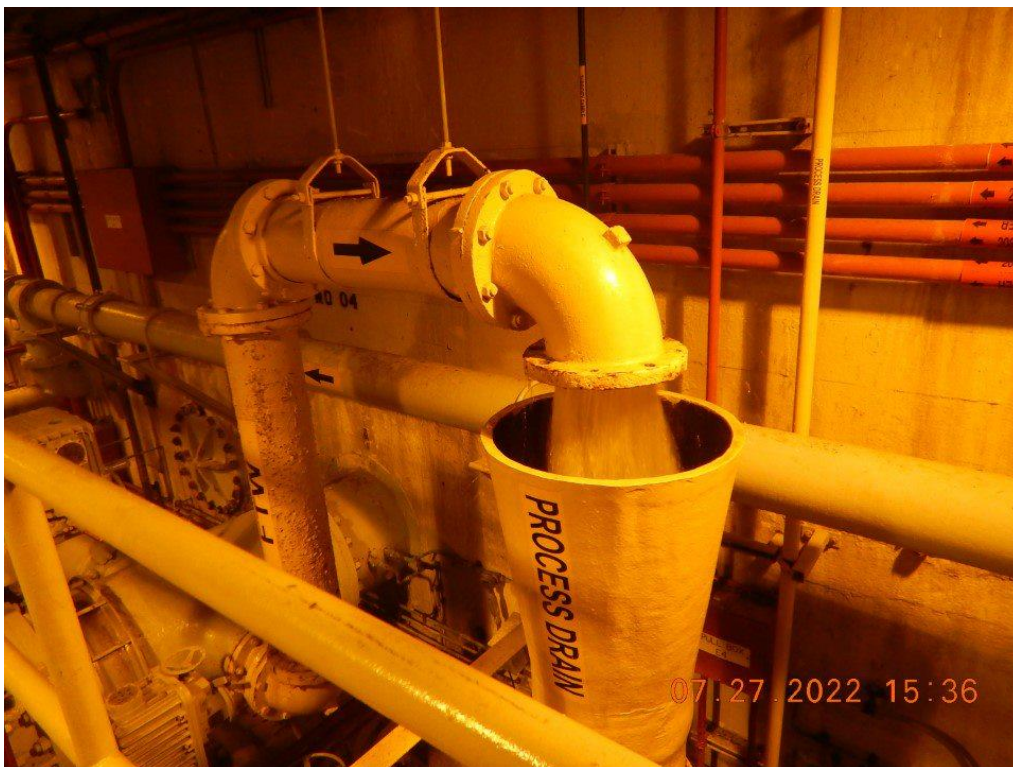
- Filter 2 was out of service at the time of inspection.
- Filter 4 was being backwashed at the time of the inspection; EPA observed the filter-to-waste water being sent to the process drain in the pipe gallery of Plant 1 (*Photo 111*).
- EPA observed significant corrosion on the air scour pipes above the filters at Plant 1. The room with the filters was fully enclosed (*Photos 112-113*).

**Photograph 111.** Plant 1 pipe gallery and Filter 4 filter-to-waste drain in process.

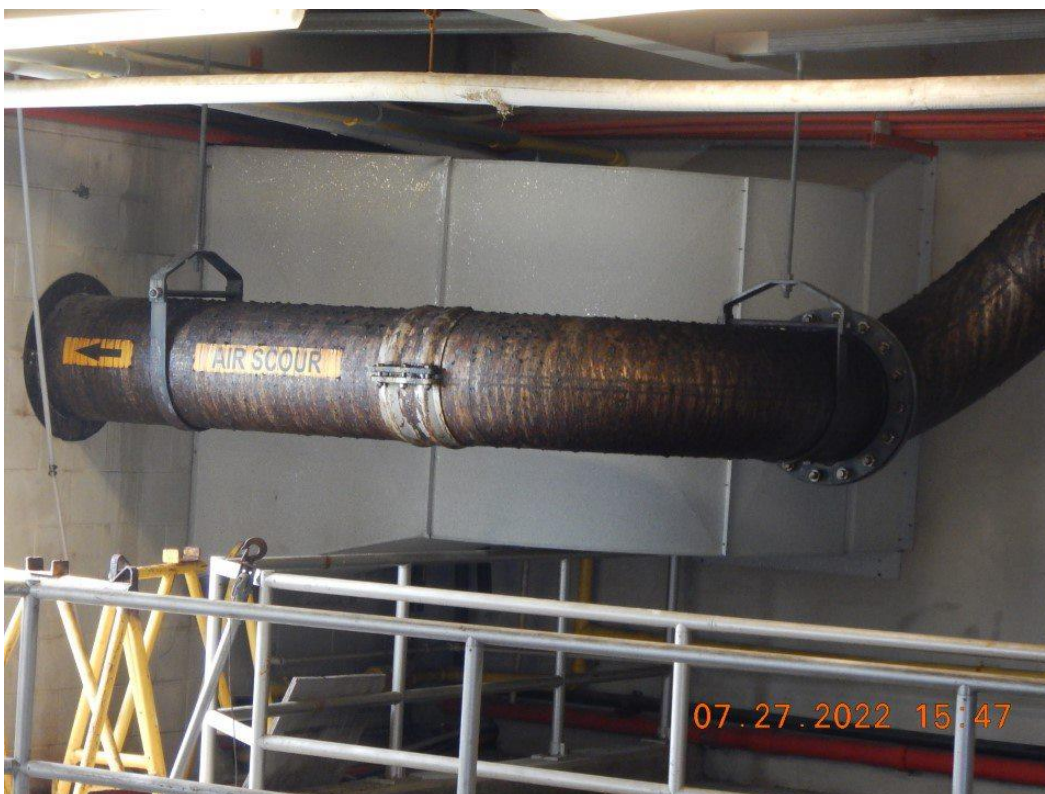
**Photograph 112.** Corrosion on air scour pipes located inside the enclosed Plant 1 filter room.

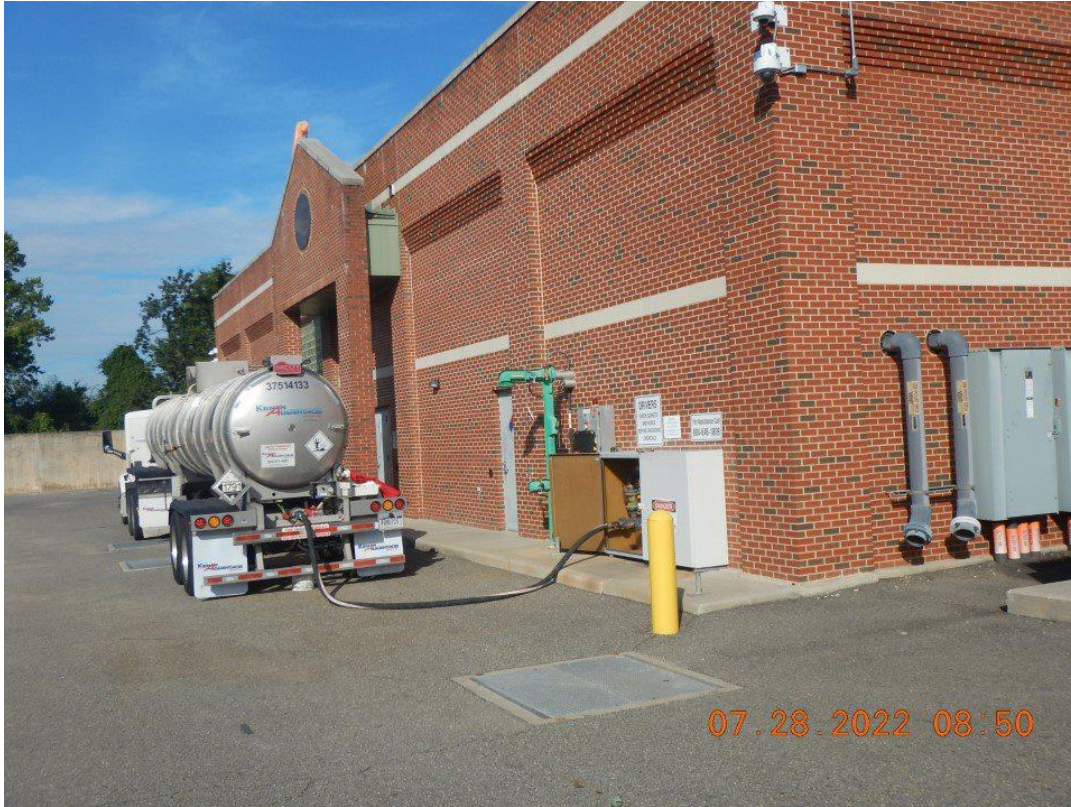
**Photograph 121.** Sodium hypochlorite offloading in process at West Chemical Building.

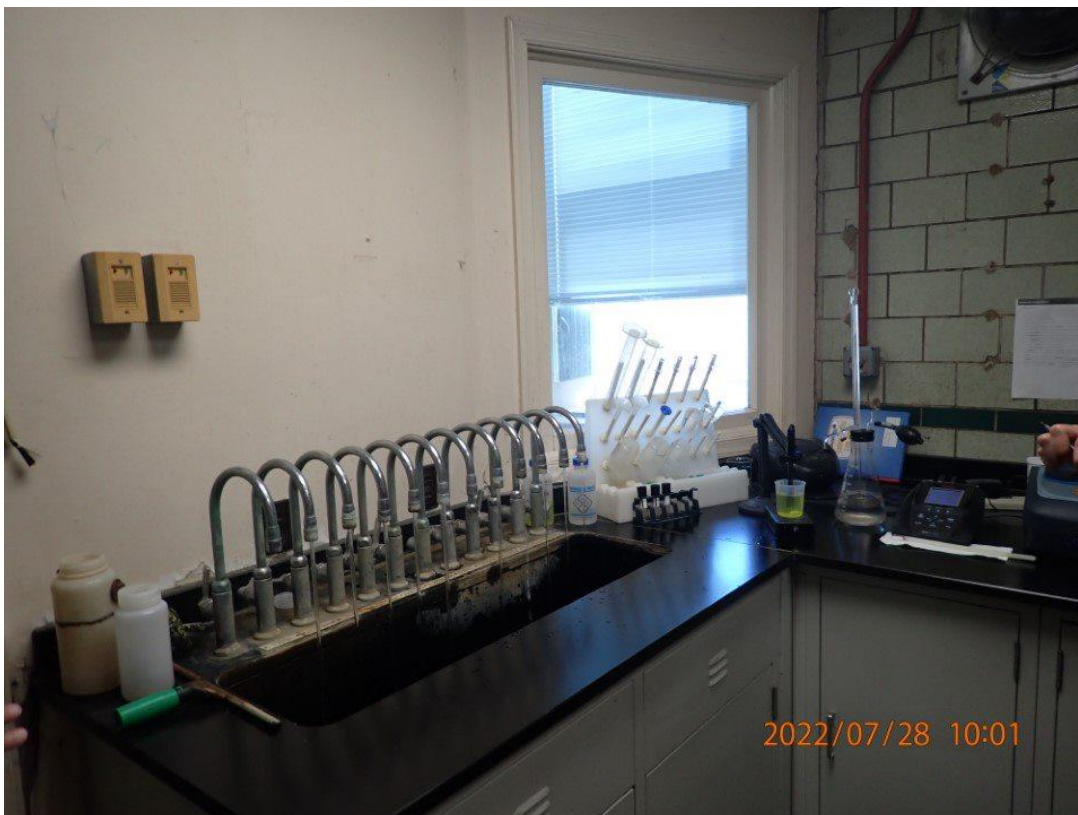
- The Sr. Plant Operations Supervisor explained that operators collect grab samples at the following frequencies (*Photo 126*):

**Photograph 126.** Grab sample location for operators in the Plant 2 process laboratory.

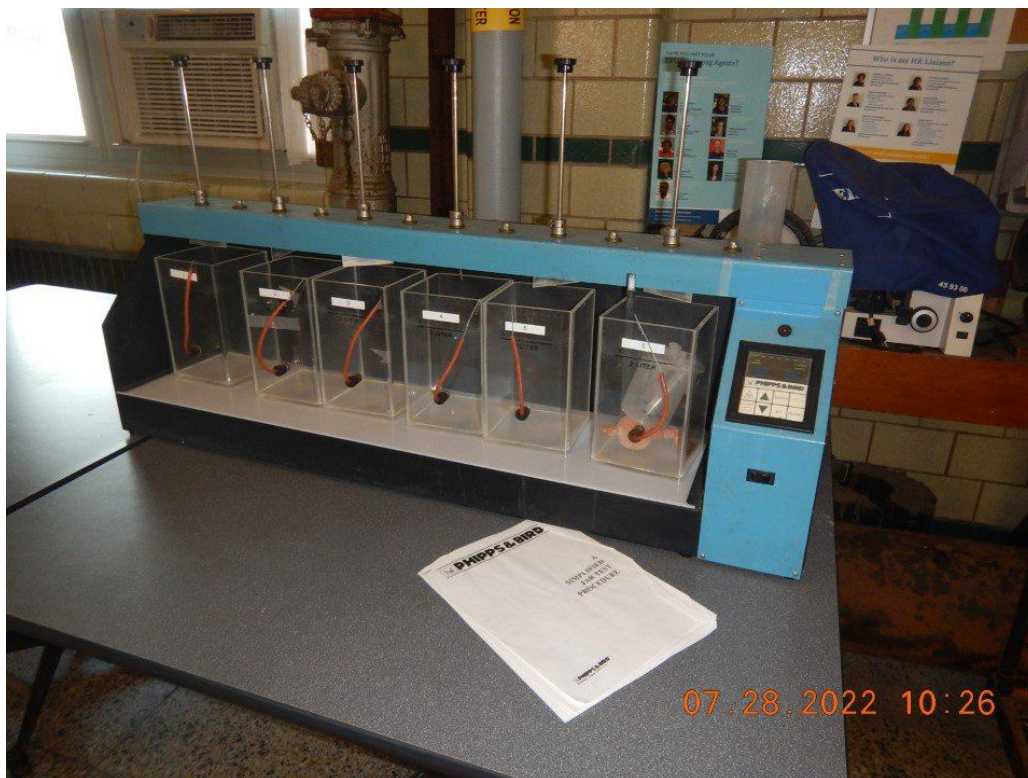
- EPA observed the jar test apparatus outside of the operator control room in Plant 2 (*Photo 128*).
  - EPA observed several data sheets that are completed by the operators to record water quality at different points throughout the treatment process. The ‘Monochloramine and Free Ammonia’ data sheet reflects several instances where free ammonia levels exceed 0.1 mg/L, primarily in Plant 2 with some instances in Plant 1 (*Photo 129*).

**Photograph 128.** Jar test apparatus outside of SCADA control room and process laboratory of Plant 2.
