Field Investigation of Sinkhole Occurrences at the West Fork Tailings Dam, Impoundment ID No. 23-00409-04 Doe Run Company, West Fork Unit-Fletcher Mine, Mine I.D. No. 23-00409, Reynolds County, Missouri

REPORT NO. MW14-095

INVESTIGATION OF SINKHOLE OCCURRENCES  
DOE RUN COMPANY  
WEST FORK TAILINGS DAM  
IMPOUNDMENT I.D. NO. 23-00409-04  
FLETCHER MINE  
MINE I.D. NO. 23-00409  
REYNOLDS COUNTY, MISSOURI

SEPTEMBER 29, 2014

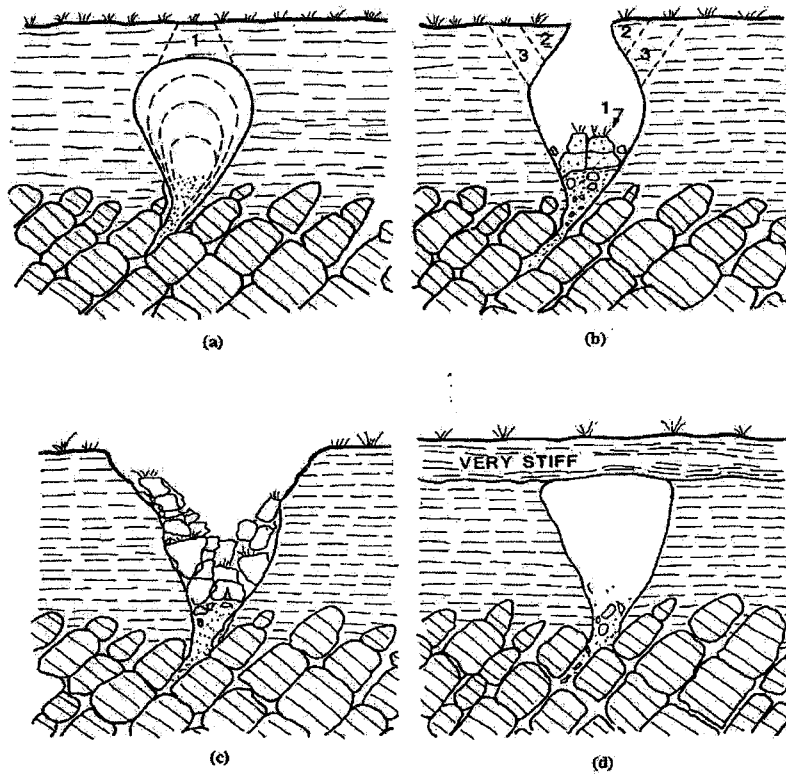
Sinkholes are a common hazard in karst areas, particularly, if disturbances to groundwater levels and flows occur. In areas of hard limestone or dolomite bedrock, sinkhole formation is only rarely a result of the collapse of cavities in the bedrock. Instead, most sinkhole occurrences are a result of conditions at the soil/weathered bedrock interface. Limestone and dolomite weathers primarily by dissolution to produce a volume of residual soil much smaller than the original rock volume. A consequence of this is that zones of very loose or soft soil are often present at the soil-rock interface. Another characteristic of solution weathering is an irregular, pinnacled rock surface with cavities in the rock extending to considerable depth. The cavities typically develop along existing vertical joints and are filled with soft or loose soils, but may connect to open conduits for groundwater flow at the depth. Groundwater flows or gradual raveling of soil into cavities can create a void in the soil above the cavity, which propagates to the surface to form a sudden surface collapse. This is illustrated in Figure 2. The development of sinkholes is normally a gradual process and the development of sudden collapses is infrequent. However, the process can be greatly accelerated by abrupt changes in groundwater levels and flow gradients. There are a large number of documented cases of rapid development of sinkholes due to well pumping or mining activity disrupting groundwater conditions.

FIG. 3.9. Ravelling Erosion Dome Progression and Roof Collapse in a Cohesive Soil: a. Usual Inverted Tear-drop Shape with Potential Initial Dropout, 1; b. Initial Roof Dropout; Overhanging Rim and Successive Additional Dropouts, 2 and 3; c. Final Rim Collapse with Debris in Dome; d. Flat Dome Roof Beneath a Very Stiff Pedologic Horizon

**Figure 2 - Sinkhole collapse mechanisms (excerpted from Sowers, G. (1996) *Building on Sinkholes: Design and Construction of Foundations in Karst Terrain*, ASCE Publication.**
