# Inspection Report

## General/Annual Inspection Inspection Result

| Address | Suite | City | State | Zip |
|---|---|---|---|---|
| 3111 S 31ST ST | Temple Mall<br>Master | TEMPLE | TX | 76502 |
| 3111 S 31ST ST TEMPLE MALL<br>MASTER, TEMPLE, TX, 76502 | | Temple Mall | This inspection report is provided to help clean-up previous inspection reports without losing historical data. Violations are listed in order of acuity - Low, Moderate, High. | |

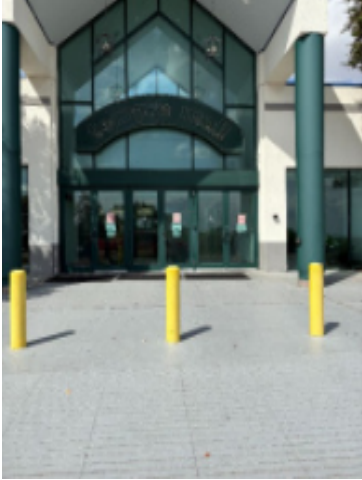
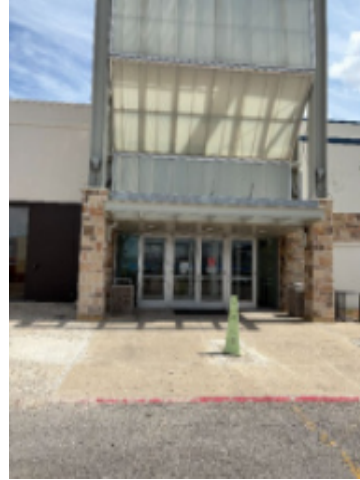
**ITEM: Address identification****REMARK:****505.1 Address identification.**

New and existing buildings shall be provided with approved address identification. The address identification shall be legible and placed in a position that is visible from the street or road fronting the property. Address identification characters shall contrast with their background. Address numbers shall be Arabic numbers or alphabetical letters. Numbers shall not be spelled out. [Each character shall be not less than 6 inches \(102 mm\) high with a minimum stroke width of 1/2 inch \(12.7 mm\). Where required by the fire code official, address identification shall be provided in additional approved locations to facilitate emergency response. Where access is by means of a private road and the building cannot be viewed from the public way, a monument, pole or other sign or means shall be used to identify the structure. Address identification shall be maintained.](#)

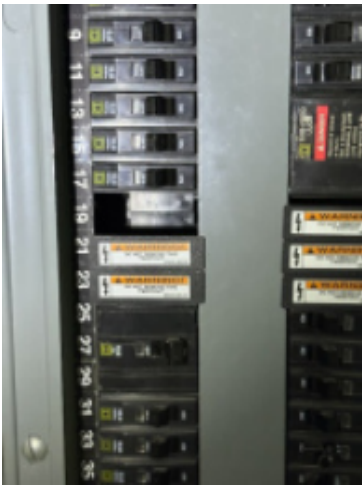
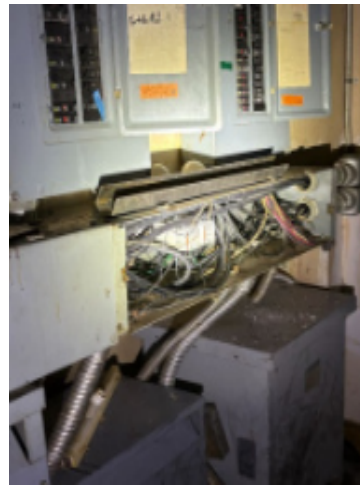
### ITEM: Abatement of electrical hazards

#### 605.1 Abatement of electrical hazards.

Identified electrical hazards shall be abated. Identified hazardous electrical conditions in permanent wiring shall be brought to the attention of the responsible code official. Electrical wiring, devices, appliances and other equipment that is modified or damaged and constitutes an electrical shock or fire hazard shall not be used.

#### 605.6 Unapproved conditions.

Open junction boxes and open-wiring splices shall be prohibited. Approved covers shall be provided for all switch and electrical outlet boxes.

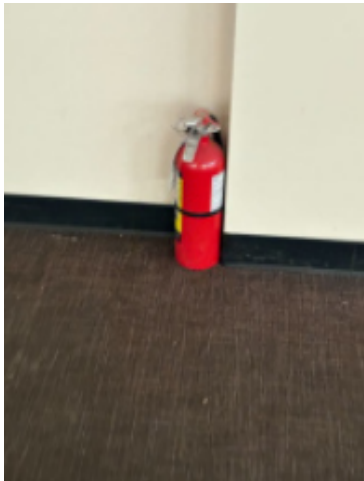
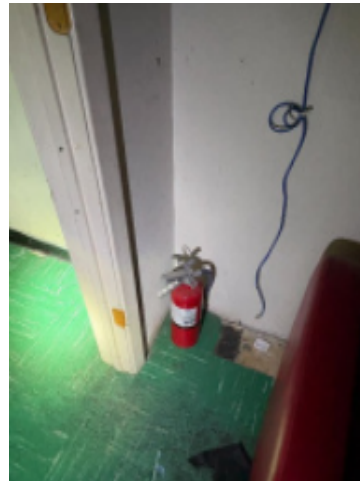
**ITEM: Mounting height for portable extinguishers (top of extinguisher not more than 5' above floor)**

CODE: IFC - 906.9.1 - Extinguishers weighing 40 pounds or less. - Portable fire extinguishers having a gross weight not exceeding 40 pounds (18 kg) shall be installed so that their tops are not more than 5 feet (1524 mm) above the floor.

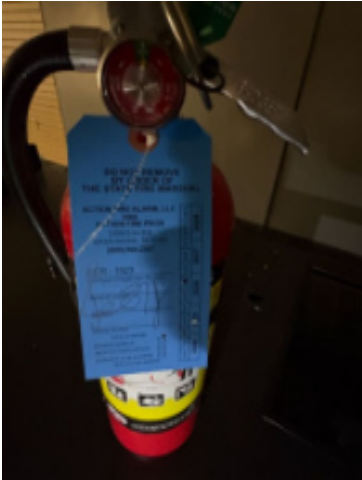
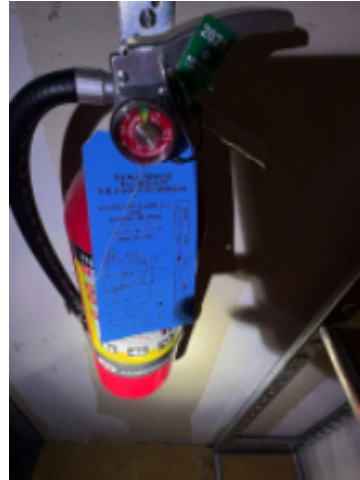
**ITEM: Fire Extinguishers are charged with current inspection tag and no violation (red) tag. Must inspected every 12 months.**
