# Seismic Risk Assessment, Conceptual Seismic Retrofit, Budgetary Structural Construction Estimate and Additional Liquefaction Analysis Report

**CONNEL F. SMITH BUILDING/IL-7-4**  
1101 Ohio St.  
Cairo, Illinois

OCTOBER 19, 2022

# Seismic Risk Assessment and Conceptual Retrofit Report

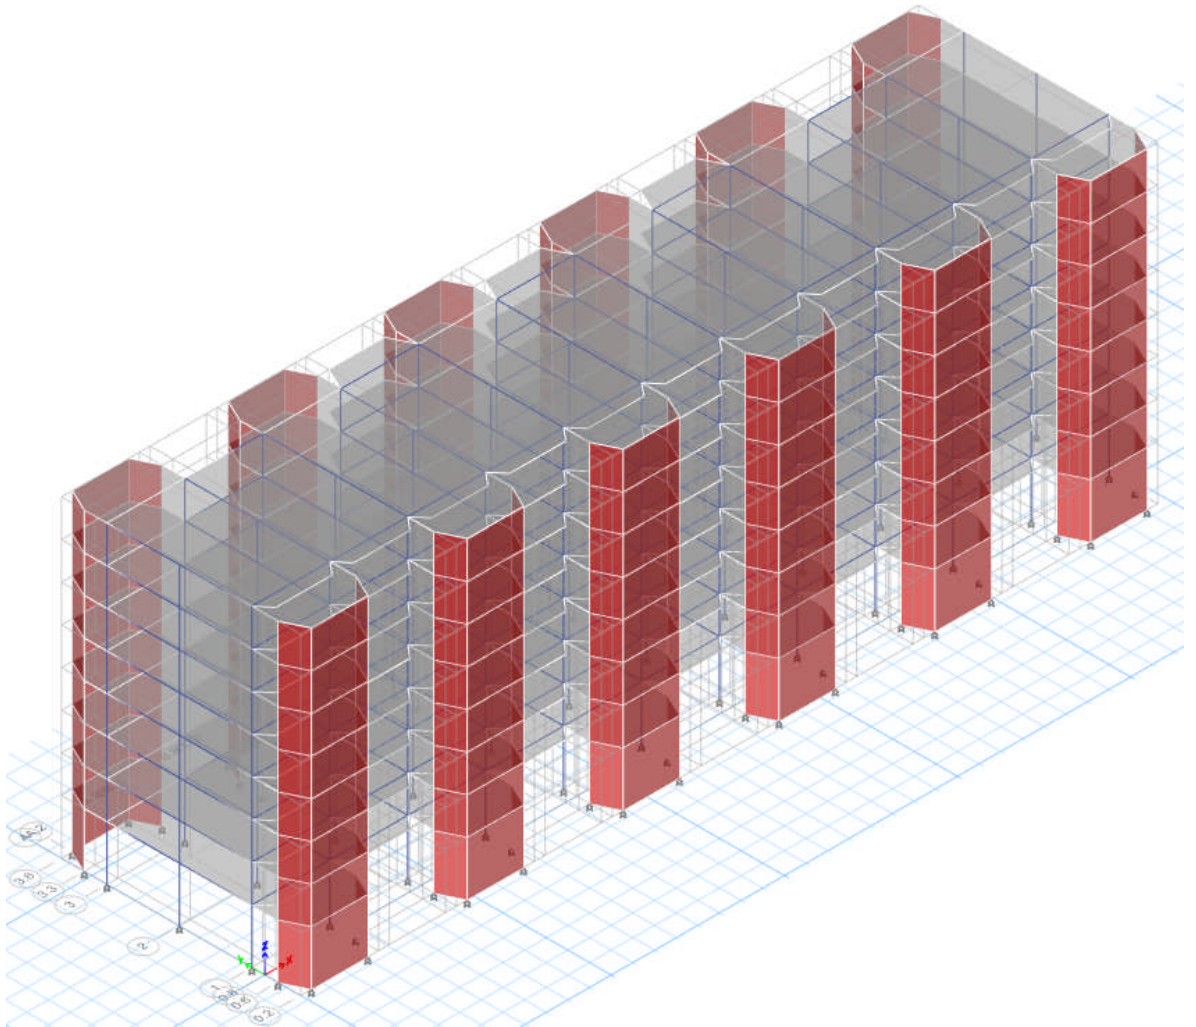
Figure 4 – 3: Conceptual Retrofit Structural Analysis Model

A conceptual retrofit with concrete shear wall buttresses, concrete grade beam supports, and deep foundations has been developed. The design intent of the concrete shear wall buttresses is to provide a new lateral system for the existing building. The design intent of the grade beams is to provide adequate support for the existing pile caps. Both the concrete shear wall buttresses and grade beams would be supported by deep foundations and pile caps. Additional fiber reinforced polymer (FRP) column strengthening, FRP collector trusses, and demolition of the existing unreinforced hollow block masonry and unreinforced brick masonry walls are also included in this conceptual retrofit. The scope of this conceptual retrofit is to mitigate all the seismic deficiencies previously noted for the existing building, including the mitigation of liquefaction and lateral spreading risk. The scope of this conceptual retrofit is shown in Appendix A. The three-dimensional structural analysis model is shown below in Figure 4 – 3.

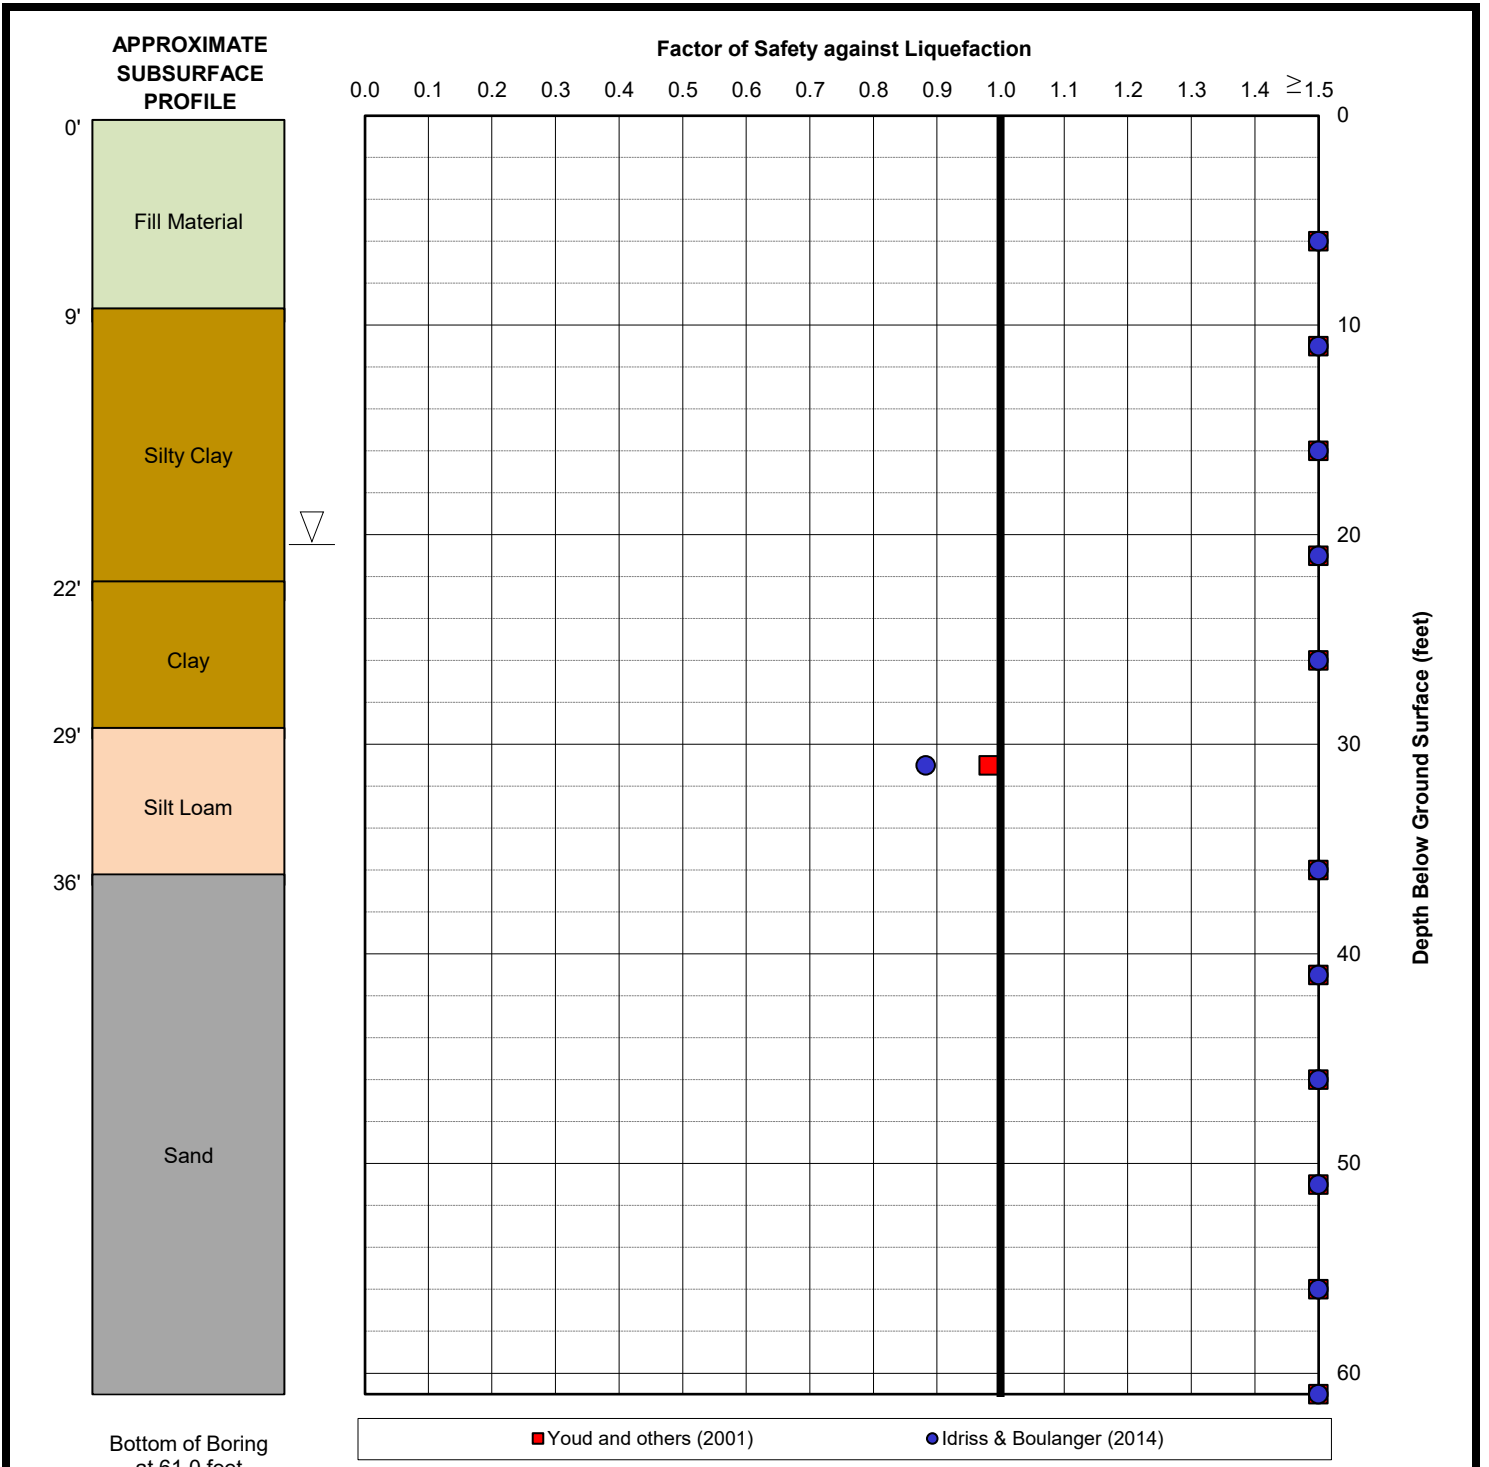
Liquefaction Analysis Alexander County Housing Authority Building Cairo, Illinois	
<b>RESULTS OF LIQUEFACTION ANALYSES</b> <b>BORING B-1 (1965)</b> <b>M = 7.5, PGA = 0.18g</b>	
September 2022	110072-001
<b>SHANNON &amp; WILSON, INC.</b> Geotechnical and Environmental Consultants	<b>FIG. 1</b>

Our analyses indicates that an acceleration of 0.18g and 0.31g for the soil profiles in Borings B-1 and B-4, respectively, has the possibility of inducing liquefaction. The results of our liquefaction analyses are presented in Figures 1 and 2. We have also calculated the return period and probability of exceedance for the accelerations that will trigger liquefaction. For Boring B-1, the acceleration of 0.18g has a return period of 127 years and a probability of exceedance of 34% in 50 years. For Boring B-4, the acceleration of 0.31g has a return period of 234 years and a probability of exceedance of 19% in 50 years.
