## Aviation Investigation Preliminary Report

| <b>Location:</b> | Canton, MS | <b>Accident Number:</b> | CEN25MA115 |
| <b>Date &amp; Time:</b> | March 10, 2025, 12:37 Local | <b>Registration:</b> | N835CS |
| <b>Aircraft:</b> | EUROCOPTER DEUTSCHLAND<br>GMBH EC 135 P2+ | <b>Injuries:</b> | 3 Fatal |

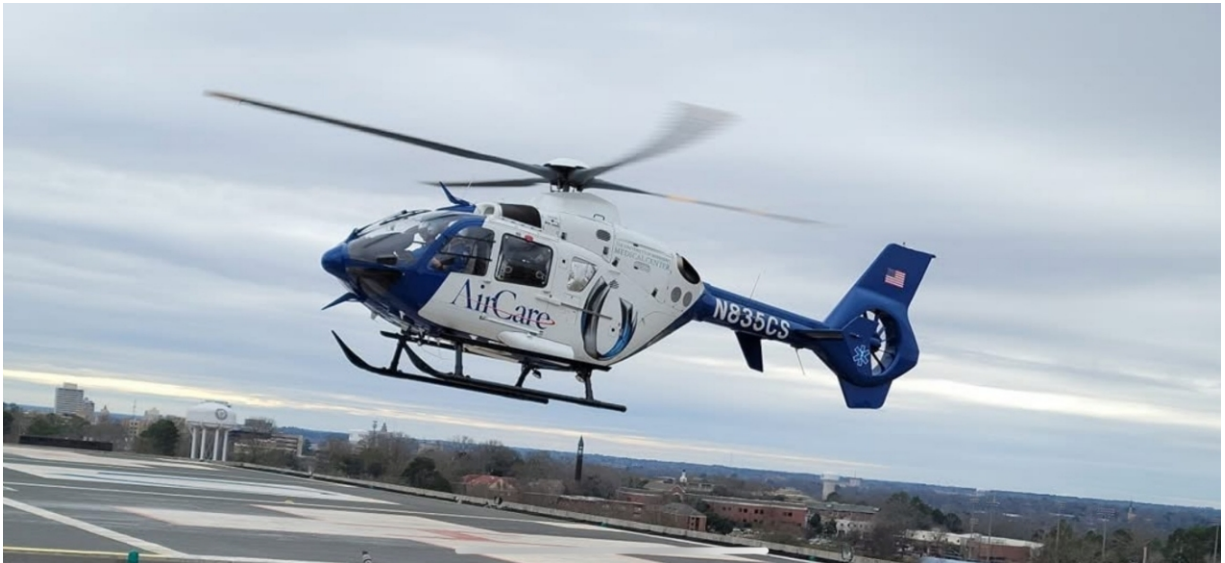
The helicopter was manufactured in 2012 (figure 4 is a pre-accident photograph of the helicopter). It was equipped with two Pratt & Whitney Canada PW206B2 turboshaft engines, an autopilot system, and a crash-resistant fuel system. The helicopter was transferred to the Med-Trans operating certificate in 2020. The helicopter underwent its most recent inspection during an approved aircraft inspection program, which was about 2.7 hours before the accident.

**Figure 4.** The helicopter before the day of the accident (Source: Med-Trans Corporation).
