MEMORANDUM

**RE:** Investigation of June 13, 2018 Incident at Rock Island Dam, Gate No. 17

EXECUTIVE SUMMARY

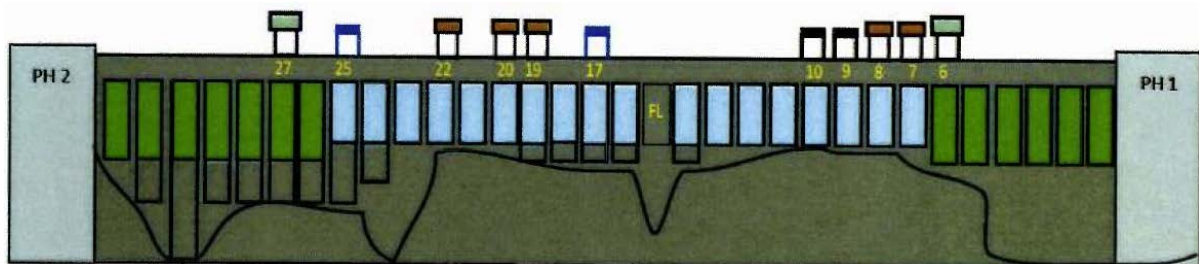
Diagram No. 1 - Rock Island Dam has two powerhouses (PH1 and PH2) and 31 spillway bays -- 13 (green) are deep bays, and 18 (blue) are shallow bays. The numbered gates, as discussed *infra*, are fixed-hoist bays.

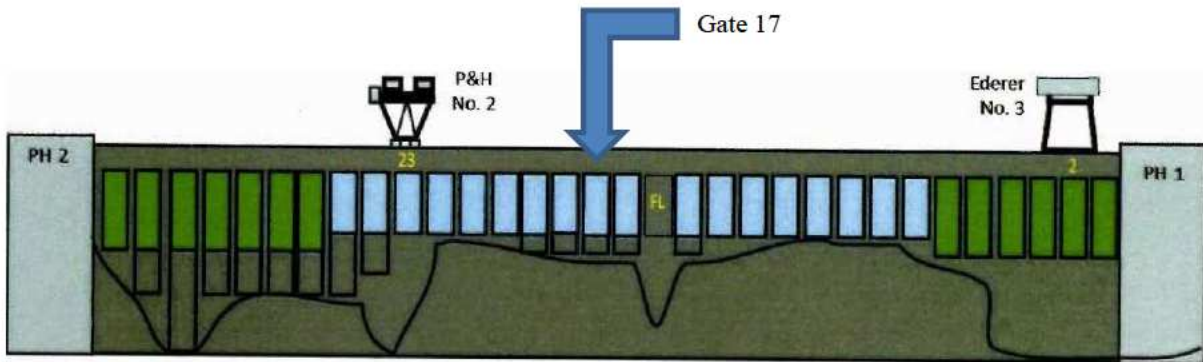
Diagram No. 2 - Rock Island Dam's two gantry cranes used in gate lifting operations are typically situated over Gate 23 and Gate 2. Gantry Crane 3 was used to lift Gate 17 on June 13, 2018.

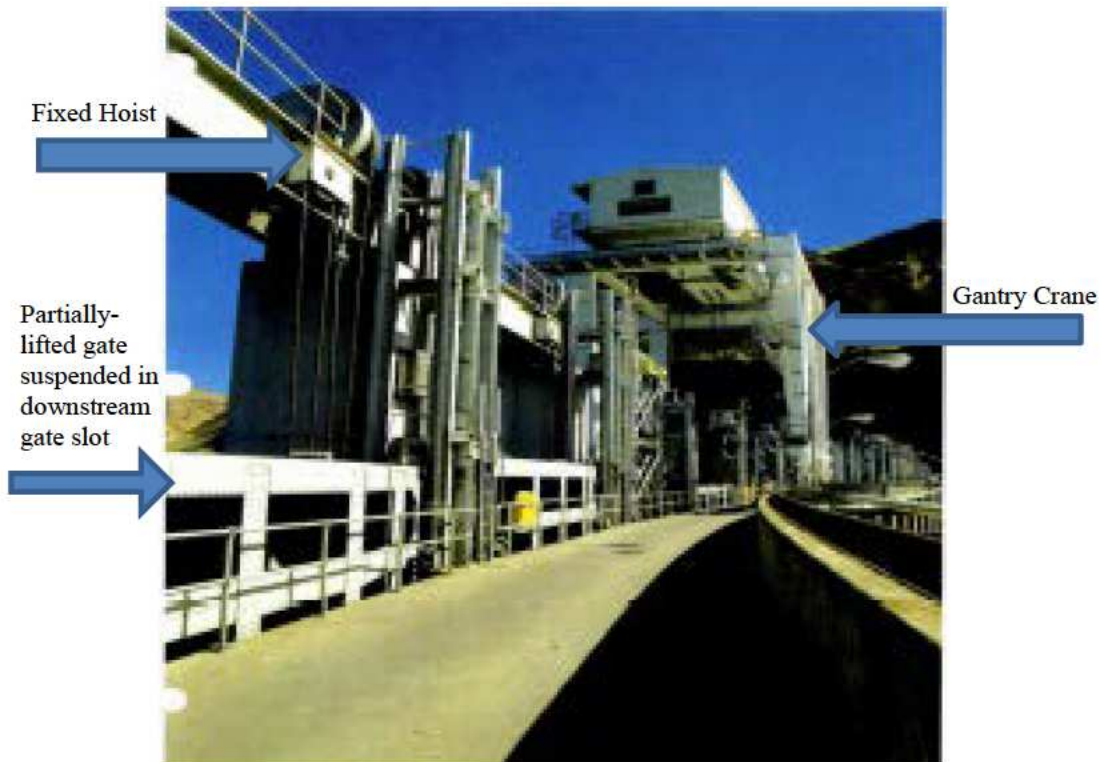
Photo No. 1 - View of spillway bays along spillway deck. The spillway bay in foreground is outfitted with a fixed hoist while a gantry crane is positioned over bay/gate in background.

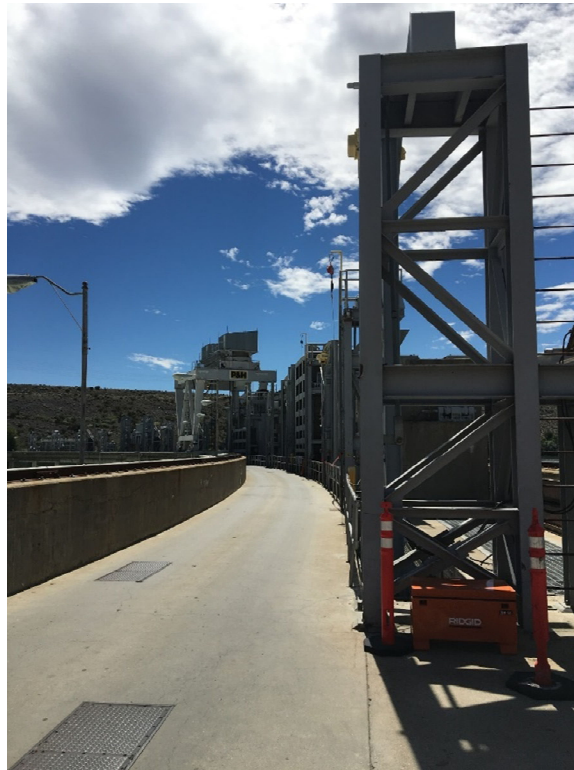
Photo 1: Rock Island Dam Deck Supports Multiple Stanchions for Removal and Storage of Segmented Lift Gates
