# Request for Proposals for the Rehabilitation, Reuse and Maintenance of:

The former Beartown Superintendent's House is in Beartown State Forest in the southern Berkshire town of Monterey. Beartown welcomes over 100,000 visitors annually for activities such as hiking (including the Appalachian Trail), camping, fishing and cross-country skiing. The house is located at the park's southern entrance, adjacent to park headquarters. The house is minutes from multiple state parks, ski areas, Great Barrington, Stockbridge and other vibrant and creative towns and villages as well as world class attractions such as Jacob's Pillow Dance Center, Tanglewood Center for the Performing Arts, and Naumkeag Estate.

## B. Description

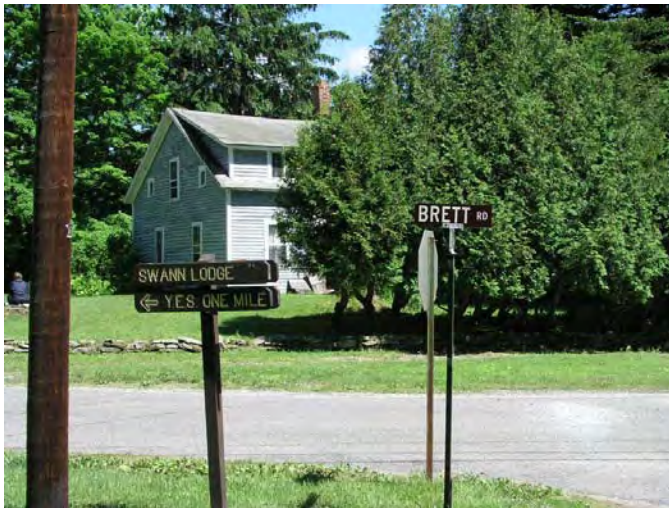
Fig. 1.2. View of property from across intersection. Parking areas are best located to the left, away from the intersection and the stone retaining wall.

Accessible parking serving the Headquarters House could be accommodated adjacent to the building. Regrading and the construction of one or more wheelchair ramps would be required to provide access to the interior of the house.

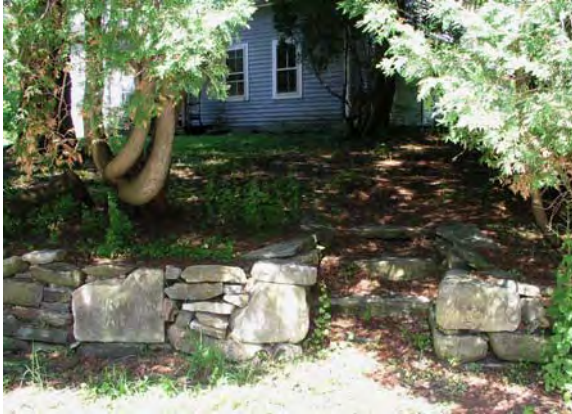
Fig. 1.3. View from Blue Hill Road; note stone steps and retaining wall.

The property contains extant plant materials and structural landscape features (e.g., stone walls and steps) significant to the evolution of the agricultural and forest landscape surrounding the Headquarters. As such, these features should be preserved and maintained to the maximum extent possible.

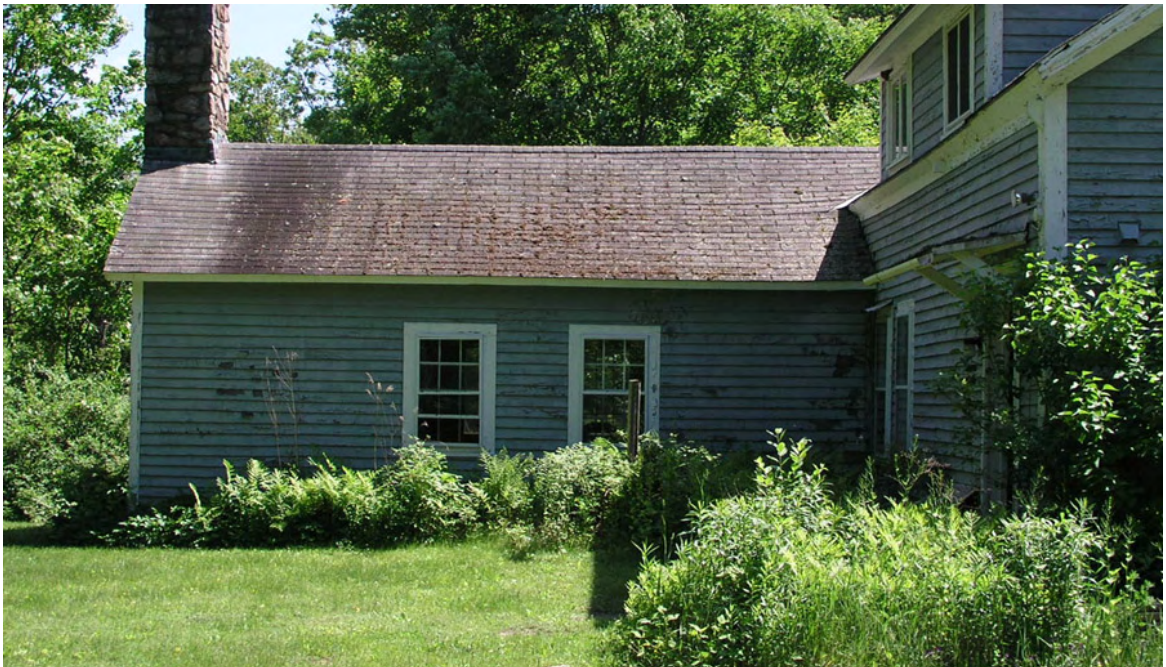
Fig. 1.5. Landscaping and “mulched-up” grade adjacent to house. As part of a coordinated effort to re-route roof drainage, the grounds should be regraded to pitch away from the building.

Site drainage must be reconfigured in the immediate area around the house, in order to protect the framing and wood cladding from further damage (Fig. 1.5).

The Headquarters House does not appear to be connected to any storm drainage system(s). The House is not fitted with any gutters or downspouts. Roof runoff sheet flows off the roof areas and appears to discharge directly onto the surrounding ground or into window-well areas. Reportedly, a substantial quantity of this runoff flows through foundation openings into the basement of the House.

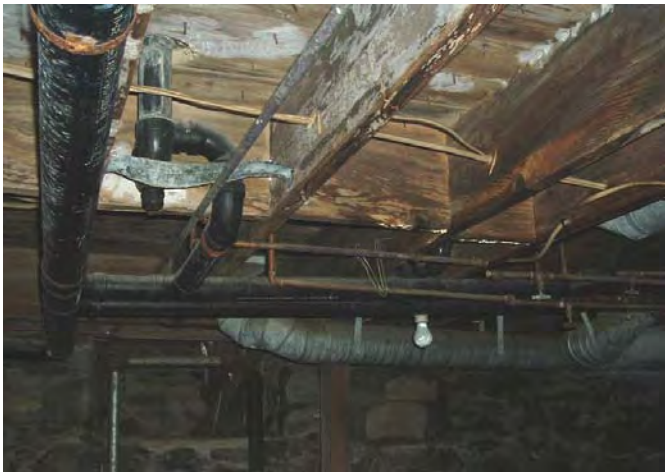
Fig. 4.1. Typical condition, basement ceiling (first-floor framing).

The first floor framing, visible in the basement, has been modified many times throughout the house's history. Similar to the second floor framing, two heavy timbers (6x8 and 8x8) span the width of the house on either side of the chimney mass. Intermediate framing ranges from apparently original half-log purlins to modern 2x10 joists. A variety of wood and steel posts are arranged throughout the basement. The framing has been modified to accommodate in an expedient manner whatever first floor improvements were made or to reinforce decayed elements.

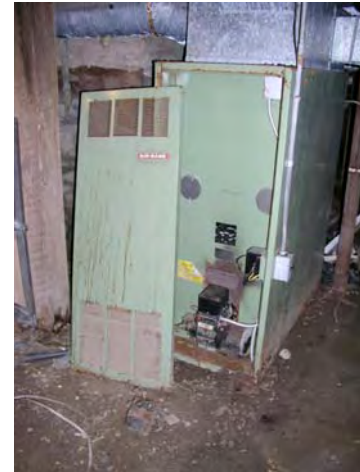
Fig. 4.2. Furnace.

The mechanical systems are generally old, have apparently been unused for nearly ten years and remain in poor- to failed condition. An oil-fired Air Ease hot-air furnace (Fig. 4.2) with associated 275-gallon oil storage tank (Fig. 4.5) and trim is situated in the basement; the equipment would require complete review by a certified technician to make it operable again. The associated supply and return ductwork is in poor condition due to basement atmosphere (damp, mold, dust and insulation; see Fig. 4.1). The associated flue to the existing chimney does not appear to be code-compliant; chimney lining, sleeve penetration and flue replacement would be required in order to bring the existing system into compliance.

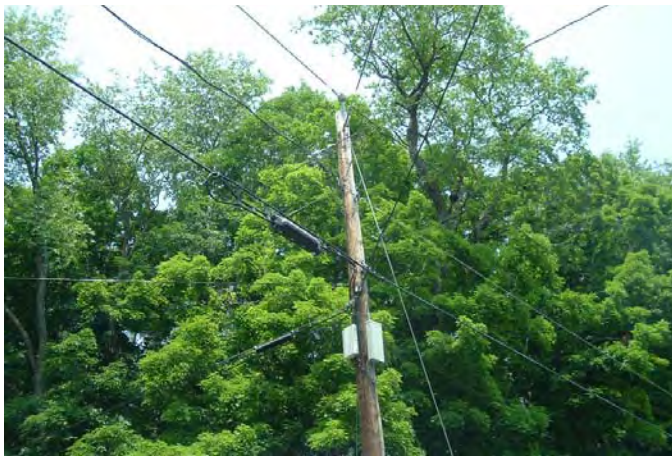
Fig. 4.3. Existing utility pole.

The electrical overhead service is derived from a utility pole on Blue Hill Road (Fig. 4.3). A service meter is located on the exterior of the building. The main service disconnect, sized at 100 amps, is located within a panelboard at the basement level (Fig. 4.4.). There is a 30-amp disconnect adjacent to the panelboard that serves the electric water heater. Branch circuit wiring consisted of non-metallic sheathed cable and BX armored cable. Minimal light fixtures are powered at this time.

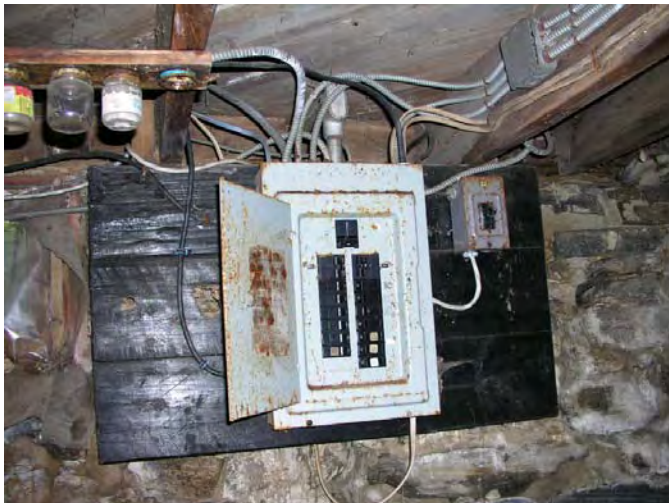
Fig. 4.4. Main distribution panel.

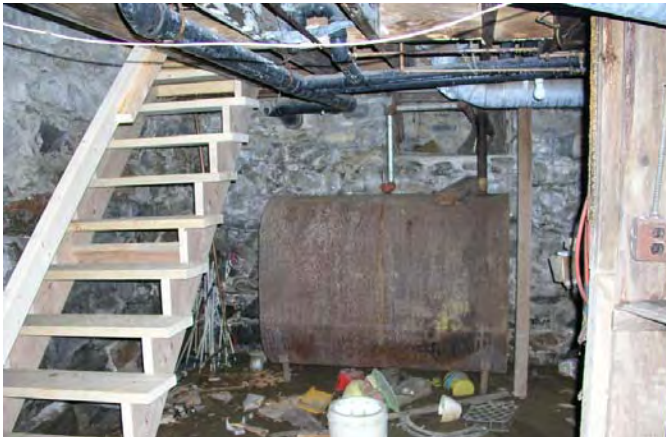
Fig. 4.5. Existing 275-gallon oil tank.

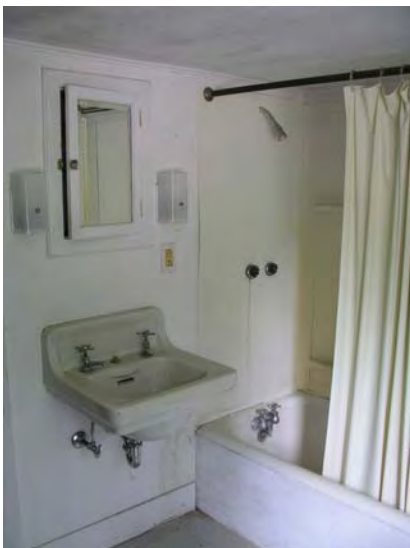
Fig. 4.6. Second-floor bathroom fixtures.

At this time, the entire plumbing system is inoperable. The overall condition of the piping, connections and fixtures remains poor, if not failed, due to age and lack of use.

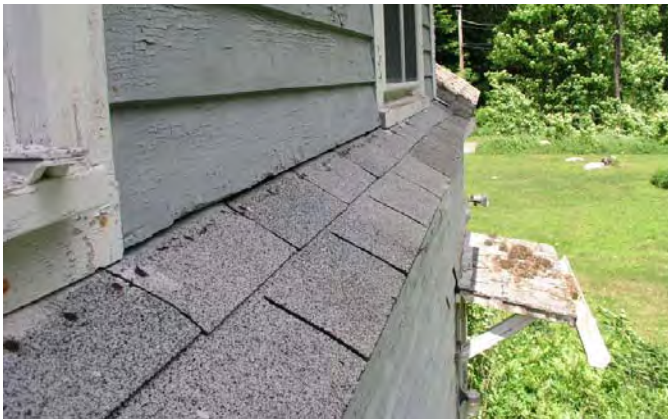
Fig. 5.1. Roof adjacent to east dormer.

The asphalt shingles are in fair condition, with several areas evidencing biological growth. A number of areas of shingling are worn or broken. As the 1994 report noted, the raking cornices (i.e., gable ends) are poorly detailed, such that the dimensional wood sheathing is exposed at its vulnerable end-grain (Fig. 5.3). Replacement of the roof system is recommended; preparation of the roof “substrate” should include installation of ice-and-water barrier at the ridges, valleys and perimeter (i.e., at eave and raking cornices).

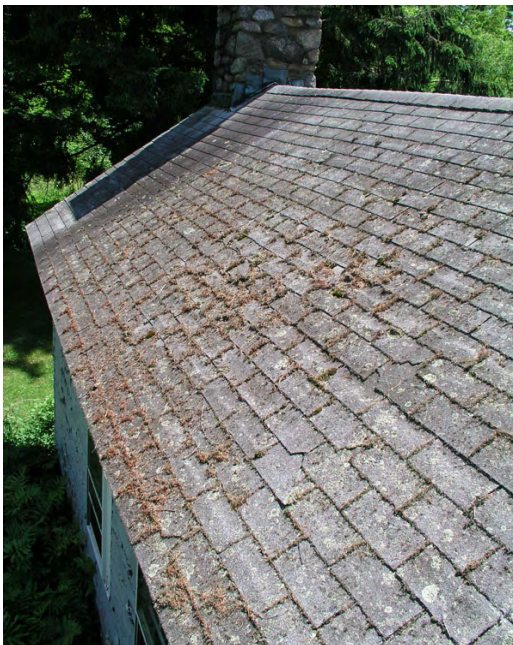
Fig. 5.2. Condition of shingles at ell.

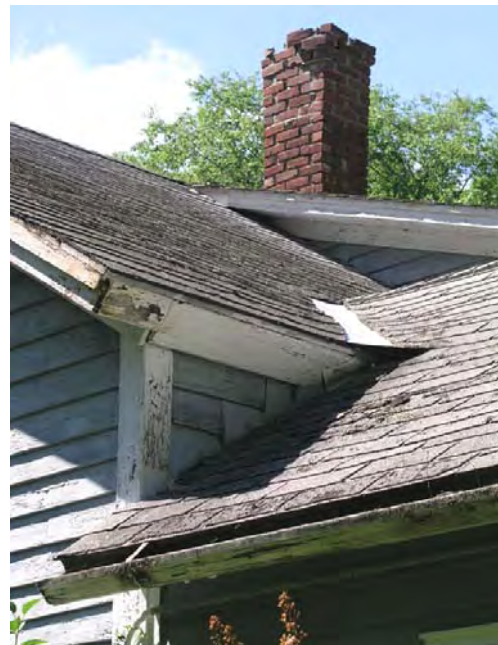
Fig. 5.3. Existing valleys and stepped flashing.

In conjunction with the re-roofing effort, the stepped flashing identified in the prior report (Fig. 5.3) should be improved or replaced so that it properly sheds water away from the dormer assemblies. Similarly, the existing open valleys should be replaced with new valleys; new metal work should be separated from the ice-and-water barrier to allow thermal expansion to occur without self-destruction of the assembly.

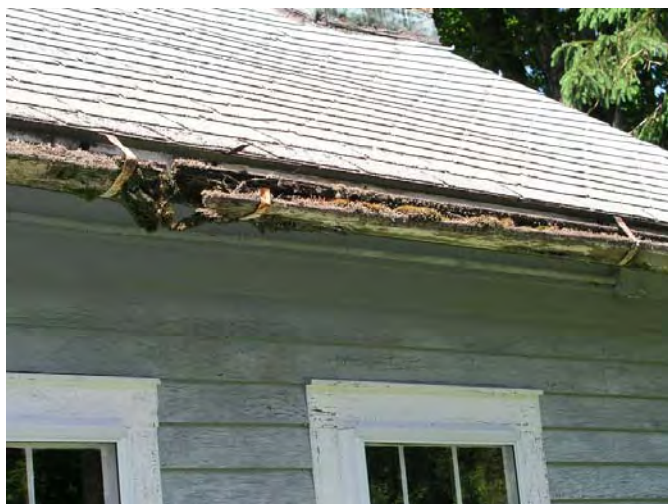
Fig. 5.4 Rotted gutter section.

Where they exist at all, existing gutters are in poor condition (Fig. 5.4). Uncontrolled roof drainage has become a major problem, as much of the roof drainage water channeled via the valleys east of the house has been funneled directly into the basement, via the unprotected areaways. This condition has further deteriorated the basement floor and created a high-humidity environment promoting rot, mold-growth and pest-infestation (Fig. 5.5). Consequently, a high-priority should be placed on reconstruction of the roof drainage system, together with restoration of the areaways and basement windows and regrading of the immediate area to direct runoff away from the house.

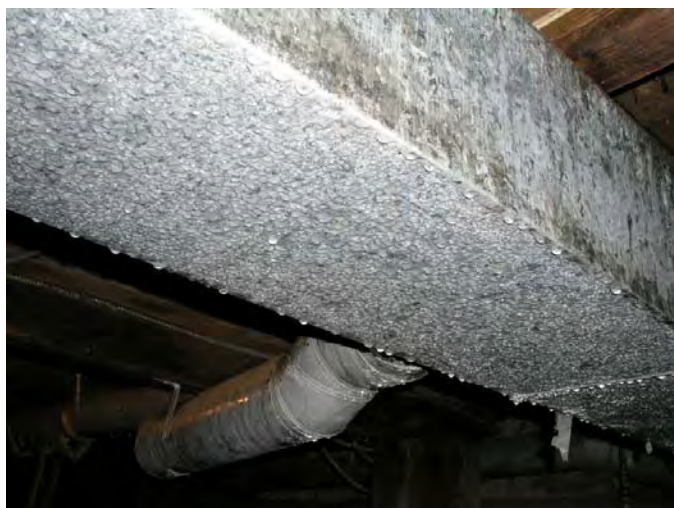
Fig. 5.5. Extreme humidity in basement aggravated by uncontrolled roof runoff is deteriorating structural framing and HVAC equipment.

Due to the volume of roof drainage and runoff water that has been allowed to run directly into the basement, moisture conditions were extreme during the time of the site visit, with condensed water dripping from metal and wood surfaces alike. The conditions have resulted in punky wood at some beams and joists, with the potential for compression and eventual failure.

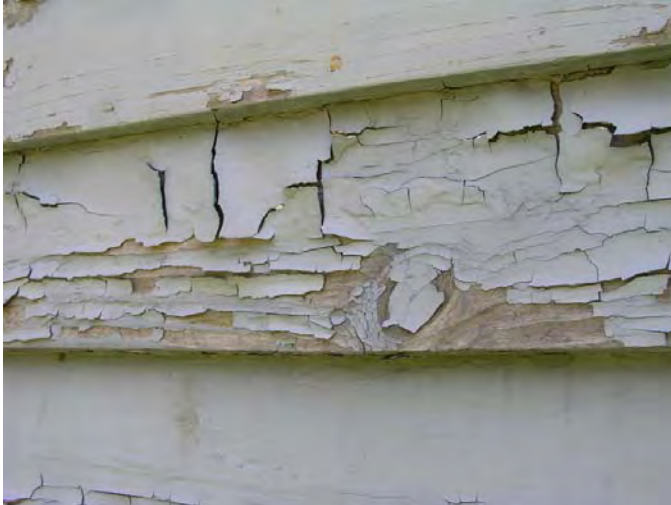
Fig. 5.6. Typical condition at clapboard siding, 2007.

Various finish-carpentry repairs are needed throughout the exterior of the house, including replacement of deteriorated siding and trim. The siding and trim does not appear to have been painted since just before the 1994 report was written, and the paint finishes are in poor condition. Where the paint film has peeled off completely, leaving bare wood exposed to UV degradation, the wood grain should be consolidated by light sanding and application of spar varnish, prior to priming and painting.

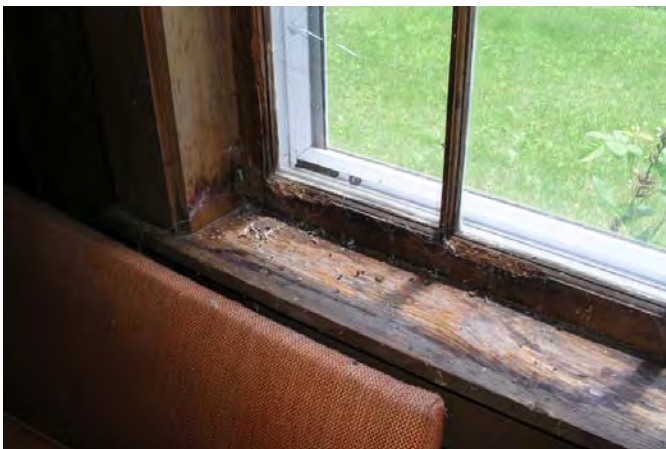
Fig. 5.7. Ell window; note damage to stool and sash.

Although all windows were reportedly restored and painted by the time of the 1994 report, they have suffered typical weathering and moisture-related deterioration. In addition, windows in the ell have pest-related damage (i.e., rodents trying to escape, Fig. 5.7).

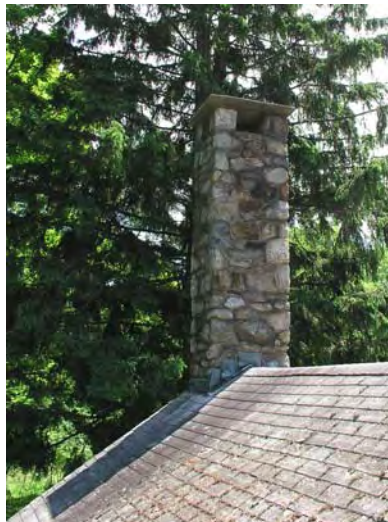
Fig. 5.8. Ell chimney.

The rustic stone chimney located at the east end of the ell requires spot-repointing in several areas. In addition, the gaps between the chimney and the adjacent wood-framed walls must be filled with insulation, backer and sealant, where possible.

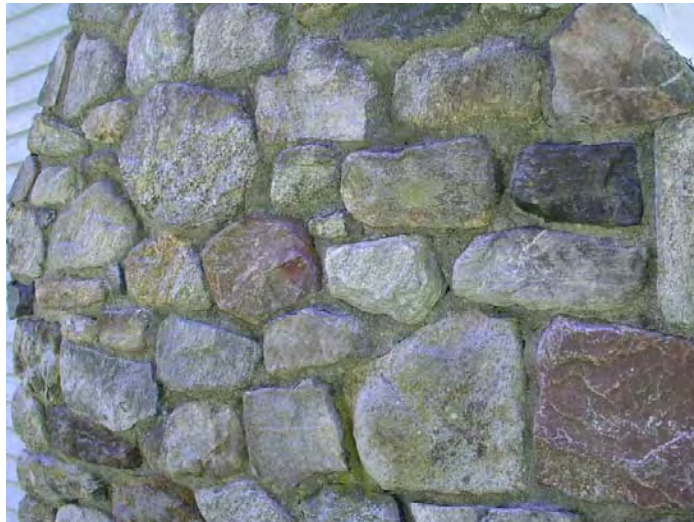
Fig. 5.9. Stone masonry needs spot-repointing.

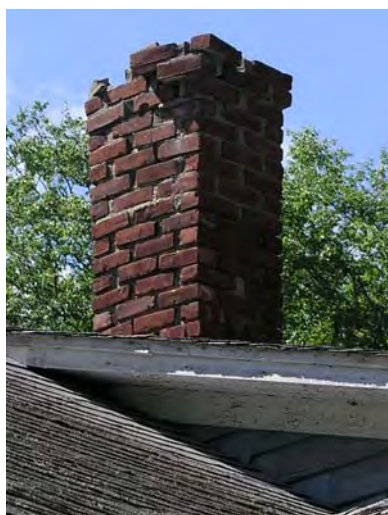
Fig. 5.10. Brick (flue) chimney.

The brick chimney (reconstructed as a heating system-flue at some point) is in extremely poor condition above the roof and needs to be rebuilt (Fig. 5.10). As part of this process, the clay-tile flue liner should be inspected and repaired. From the attic (Fig. 5.11), the masonry appears to be in fair to good condition, but should be inspected in more detail, nonetheless, to check for leaks.

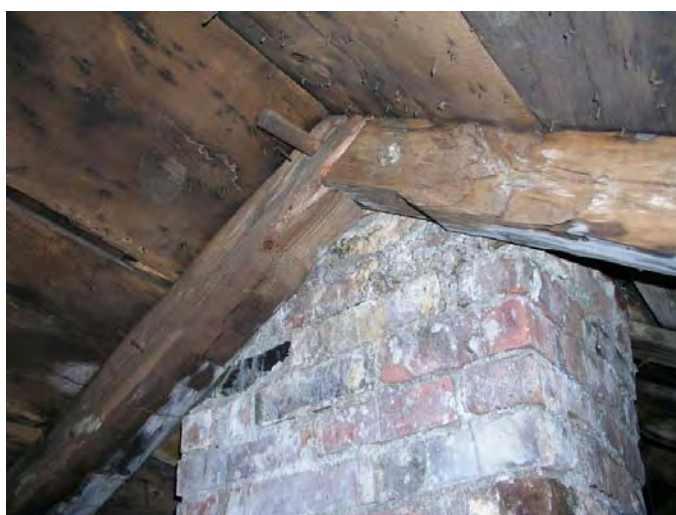
Fig. 5.11. Chimney at attic.

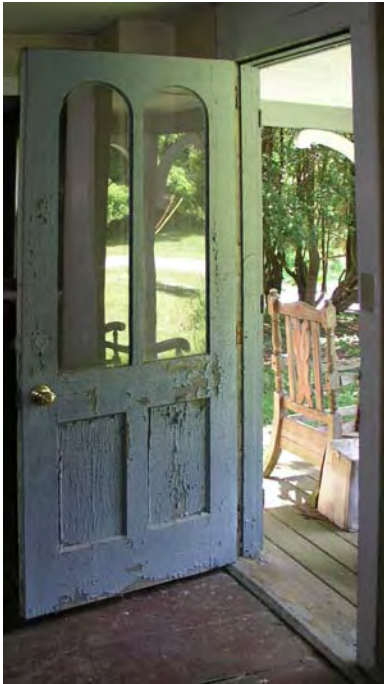
Fig. 5.12. Italianate-style front door.

Historic doors should be preserved and maintained. In particular, the Italianate-style front door, with its double-arched glass lights (Fig. 5.12), and the Colonial-Revival door at the ell (Fig. 5.13) should be restored.

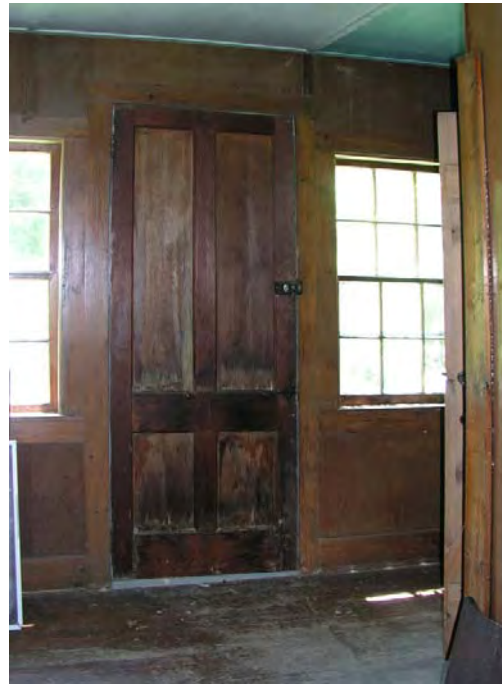
Fig. 5.13. Interior face of recessed-panel door at ell.

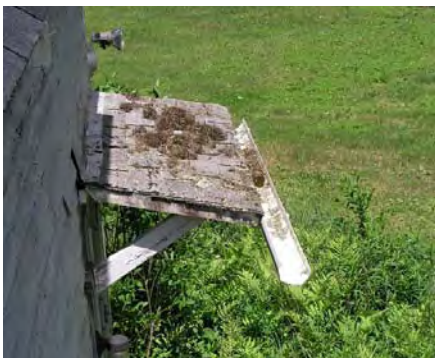
Fig. 5.14. Rear portico.

The portico over the rear door (Fig. 5.14) is in poor condition and could either be rebuilt and re-roofed, or removed, as part of a larger renovation project.

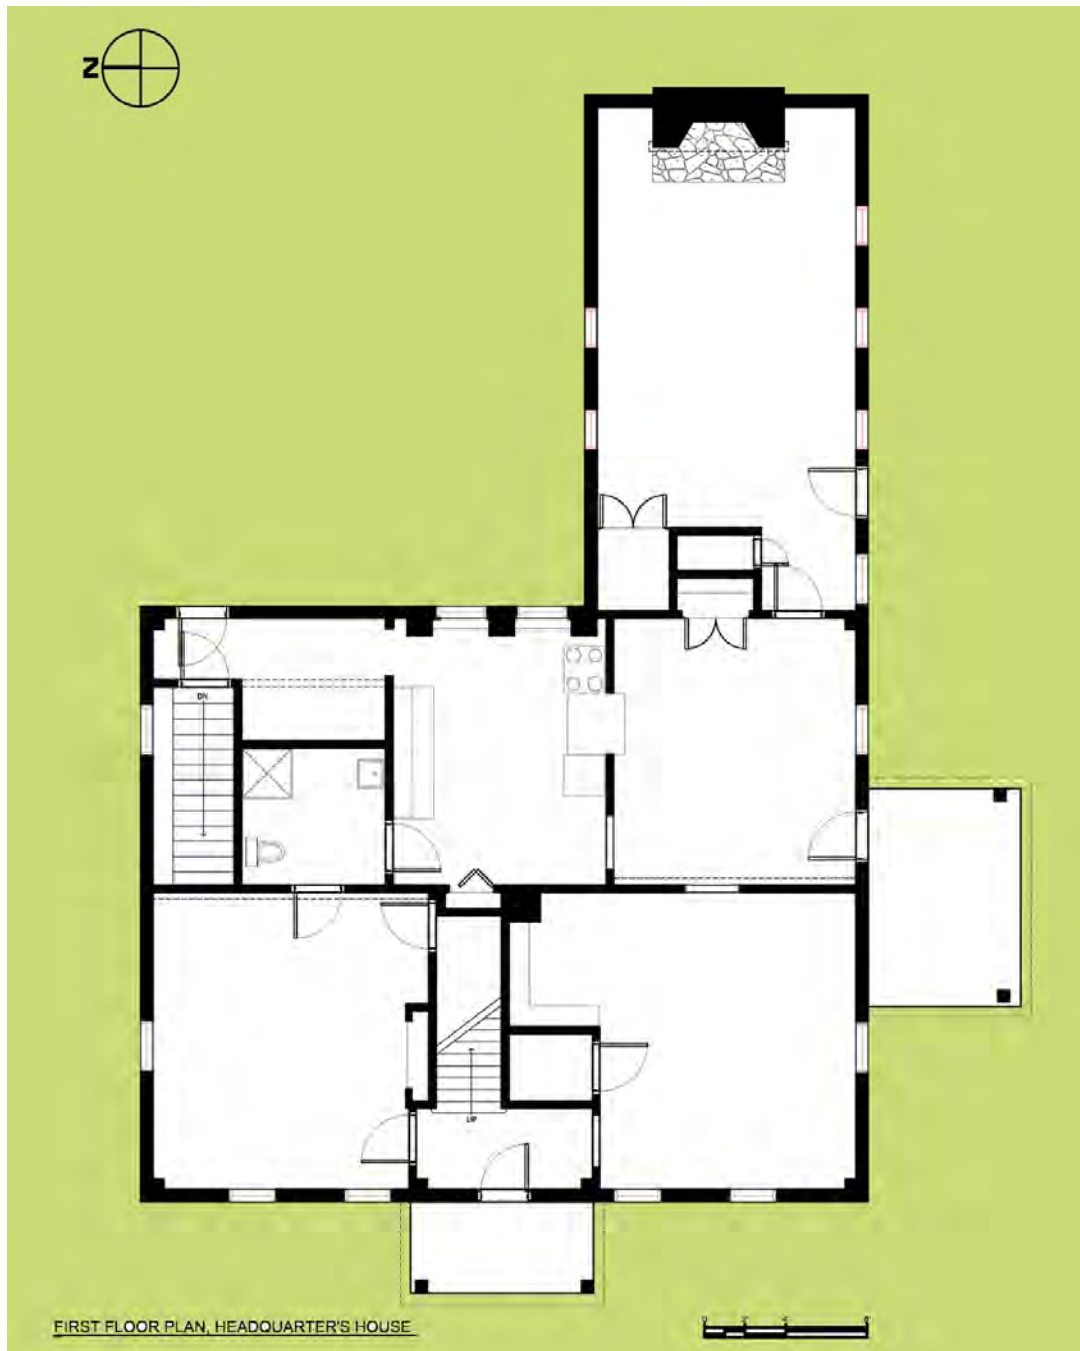
Fig. 6.1. Existing first-floor plan of Headquarters House

The L-shaped floor plan incorporates the original post-and-beam house, as modified and expanded over the years, including a one-story rear ell added by the CCC during the 1930's. The ell is a large "living-room" featuring a large stone fireplace at the far end and built-in cupboards and map file drawers adjacent to the French-door entrance.

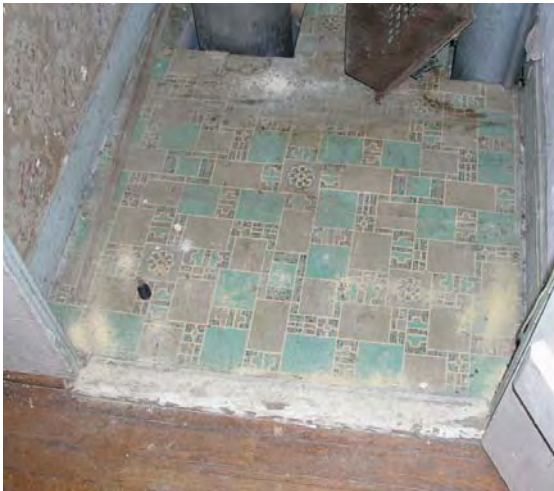
Fig. 6.3. Linoleum flooring in closet: original location – or moved?

Fragments of early- to mid-century linoleum and wallpaper exist in closets. If these must be removed, they should first be documented photographically, and representative samples should be submitted to DCR for archival purposes. More-recent flooring surfaces and wallpapers (e.g., the kitchen) appear to be non-contributing and can be removed.

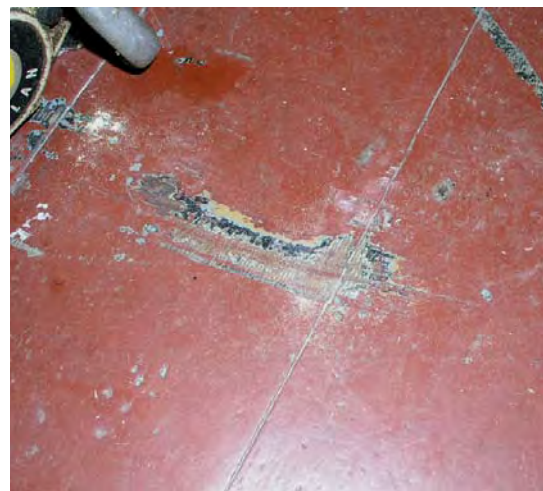
Fig. 6.4. Scratches on painted pine wood floor at NW parlor reveal an interesting "paint history."

Original flooring at the first and second floor levels survives in good condition, despite the fact that the floors pitch at an angle or sag in a number of areas, due to structural alterations made during modern times (refer to structural assessment). Extant joints and patches in the floor provide an interesting record of changes over time (Fig. 6.4), and should be documented and analyzed. The wide-board flooring must be preserved in place, and any changes or floor coverings should avoid damage to the surfaces and be easily reversible. Similarly, the hardwood flooring at the Dining Room and ell should be preserved and maintained.

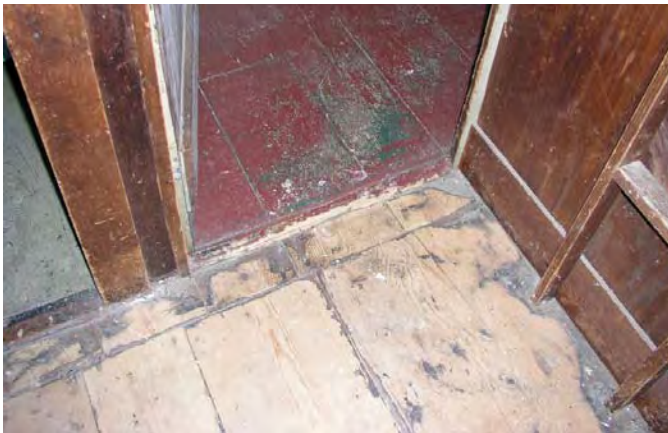
Fig. 6.4. Joints in wide-board pine flooring at second floor seems to indicate prior changes to the floor plan.

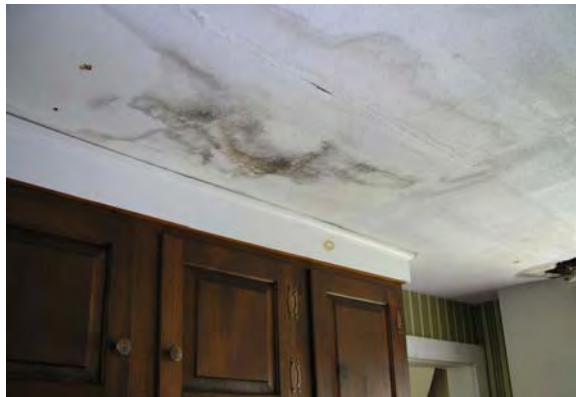
Fig. 6.5. Water damage and mold at kitchen ceiling.

Refer to the structural assessment and recommendations, regarding the kitchen ceiling, which concur with the 1994 Report.

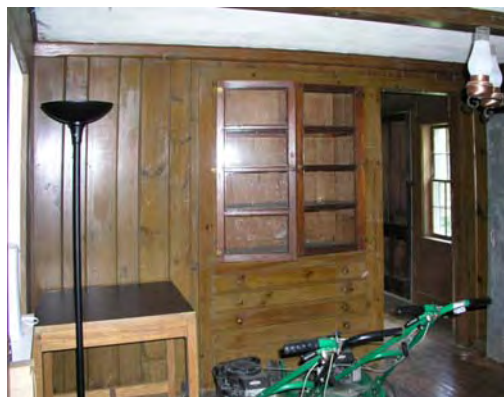
Fig. 6.6. Paneling and beams at Dining Room.  
Note apparent difference in wood species between paneling and glass-fronted cupboard.

The Dining Room ceiling is faced with timber “beams” that are apparently decorative in nature (Fig. 6.6). Together with the V-groove pine wall paneling and built-in cabinets, the room retains its historic character and is worthy of preservation, even if required structural changes and other improvements are made to the adjacent kitchen and the wall dividing the two rooms. The cabinet along the east wall of the dining room appears to have been modified, in that the glass doors and china cabinet are of different wood species from that of the built-in plan files below them/

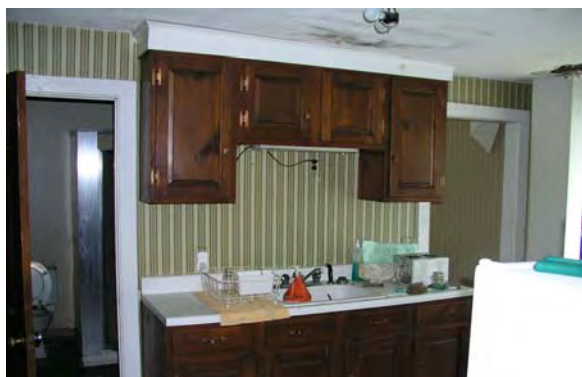
Fig. 6.7. The existing kitchen cabinets and wallpaper.

Modern wallpaper and other finishes in the kitchen (Fig. 6.7) can be removed and discarded, as part of an overall kitchen renovation.

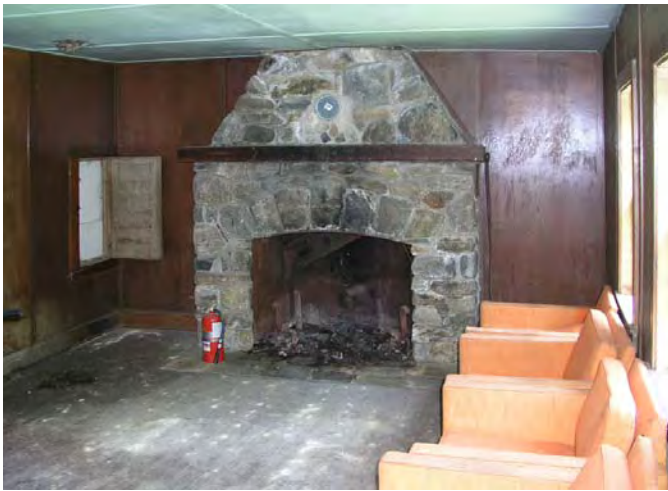
Fig. 6.8. Stone fireplace in ell. Note also the wood paneling, which is in need of renewal.

The newest area is a one-story wing, forming the el, that was built during the 1930's depression at the direction of the first park superintendent. Also built as a post-and-beam structure, it is over an inaccessible crawl space and consists of one room with a large rustic, stone fireplace at its east wall.

The large fieldstones that comprise the fireplace demonstrate the stonemason's art and introduce a rustic quality to the house, recalling the "Great Camps" of the Adirondacks. The fireplace and its prominent chimney may represent the influence of the National Park Service in sponsoring what has been called the "Golden Age of Rustic Design" of parks and recreation structures. The fireplace appears to be in reasonably good condition, but the damper needs renewal in order to return to functionality, the stonework needs repointing, and the gap between the chimney and the east wall must be properly filled and sealed. As an important and "anchor" feature of the building and the site, the fireplace must be preserved.

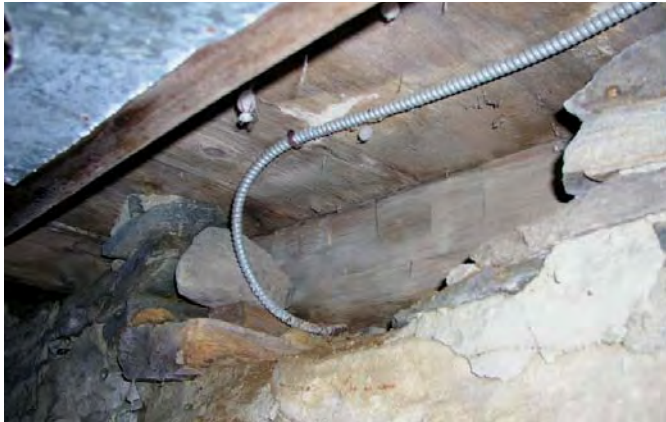
Fig. 6.9. The sill of the house is exposed to the basement interior in only a couple of spots; therefore an accurate determination of its condition is difficult without more extensive testing and/or removal of exterior cladding.

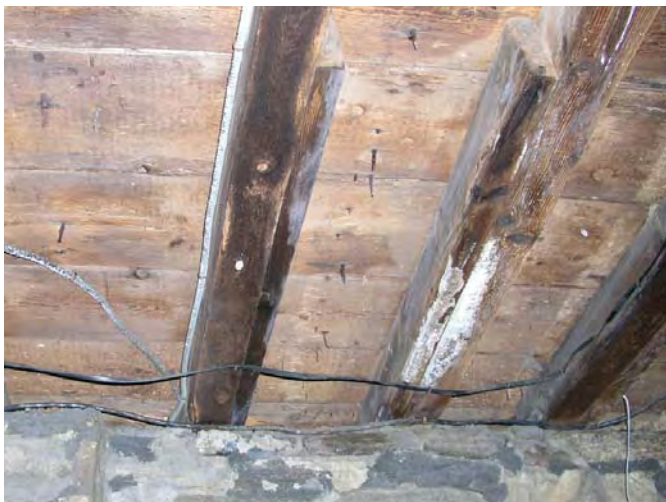
Fig. 6.10. First floor framing evidencing mold growth.

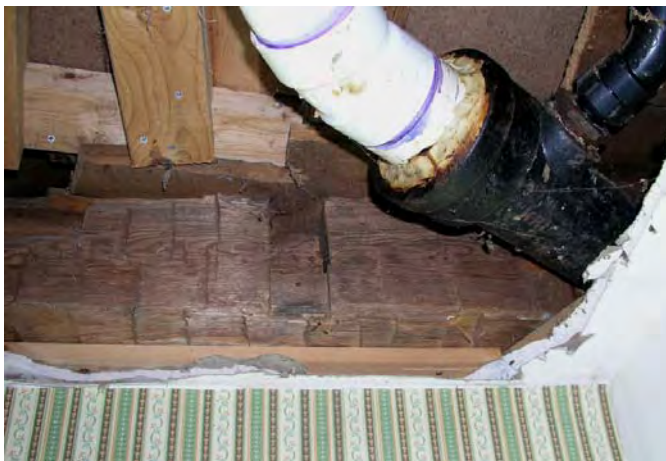
Fig. 6.11. Hand-hewn beam and modern additions.

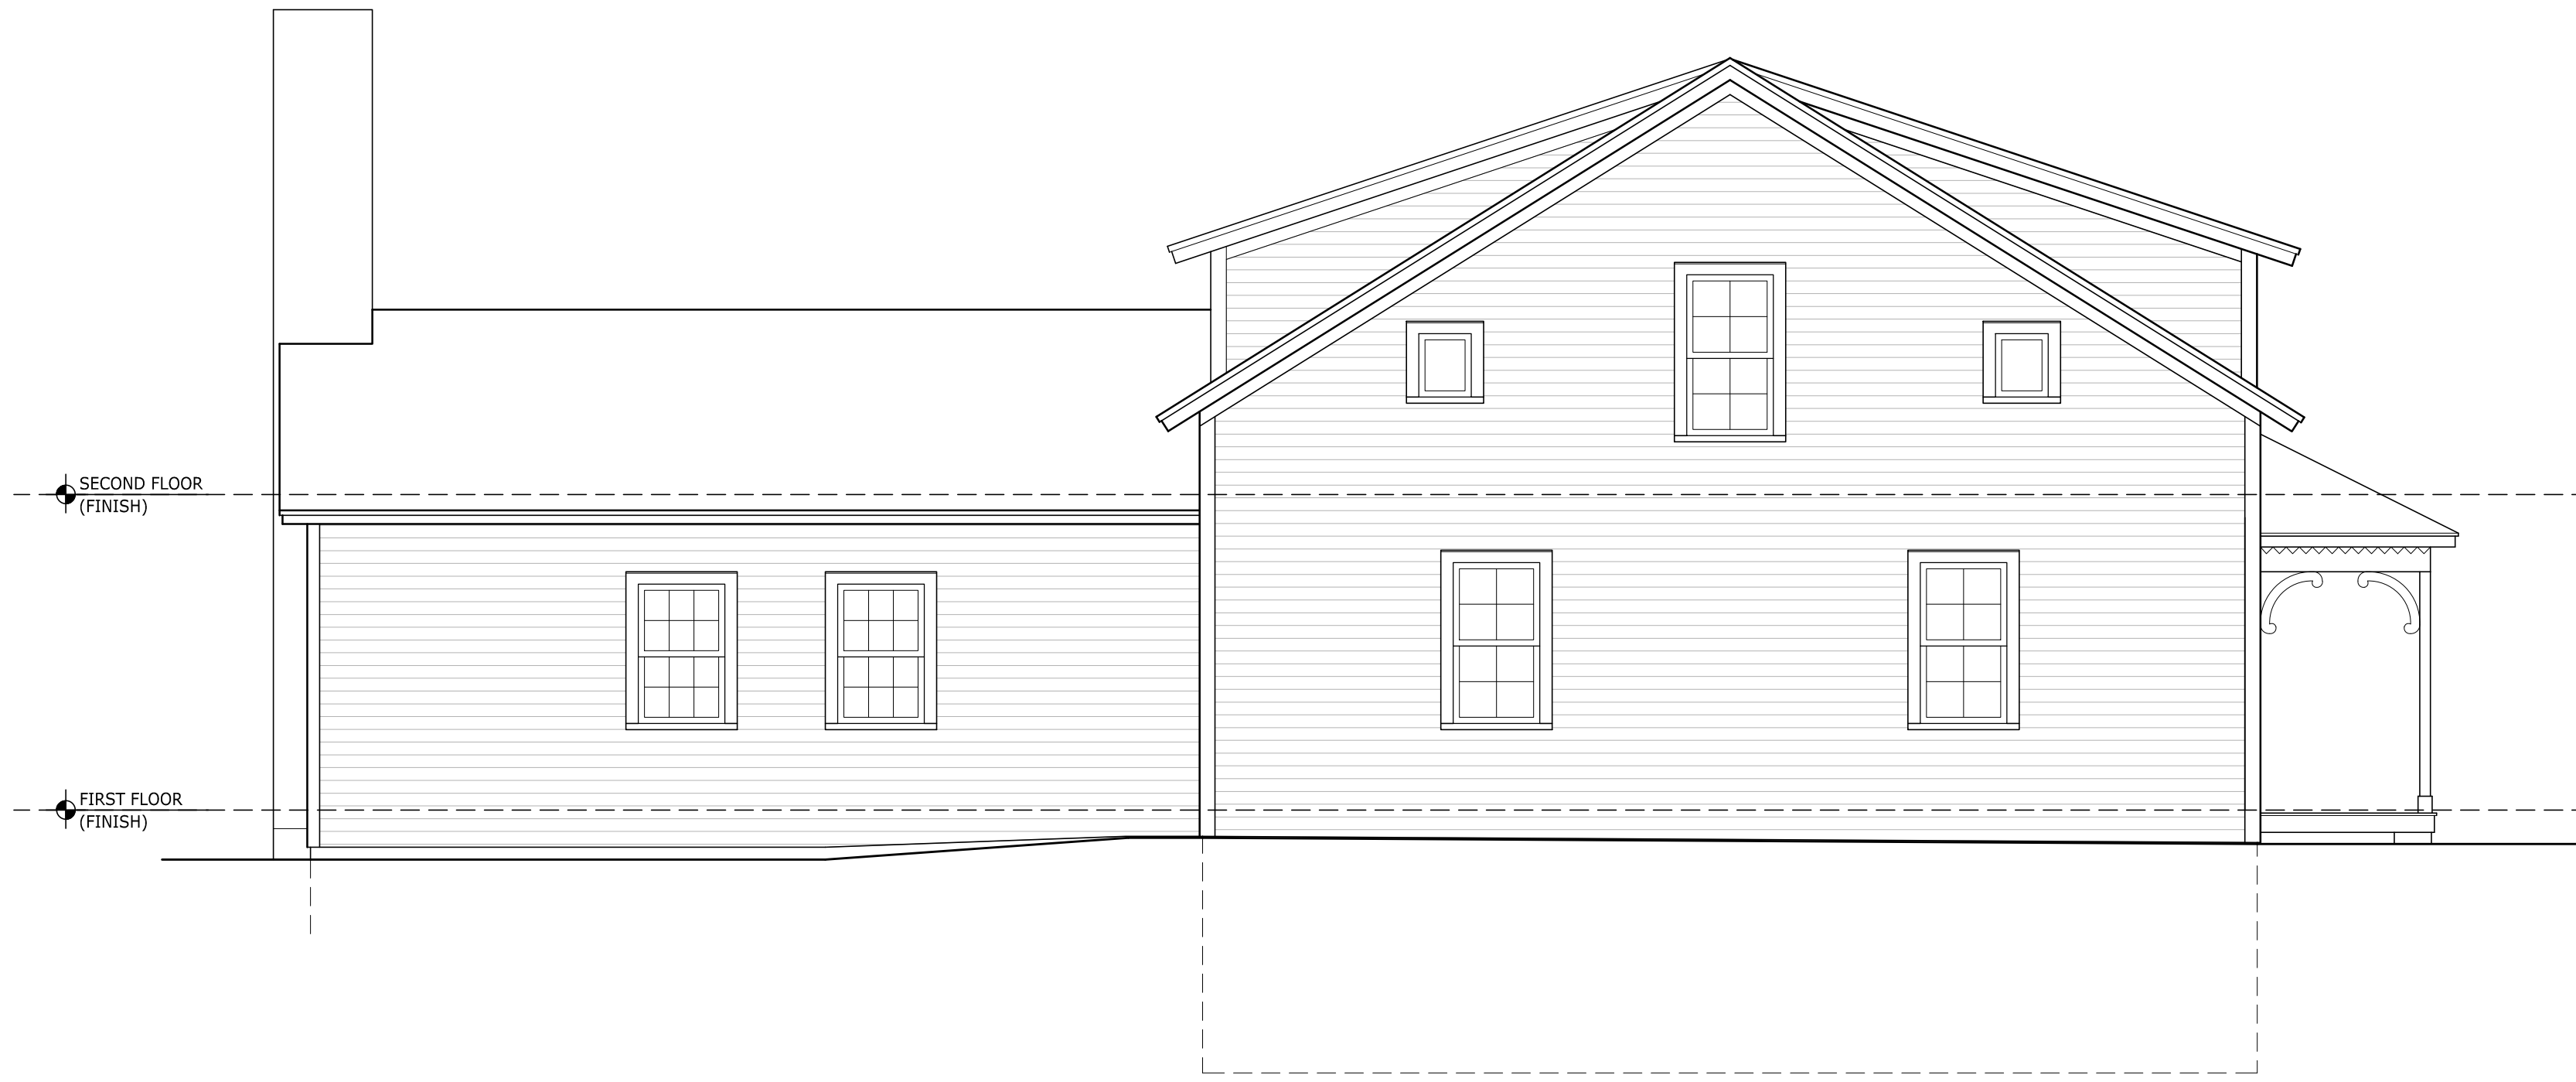
1 EXISTING NORTH ELEVATION  
1/4" = 1'-0"

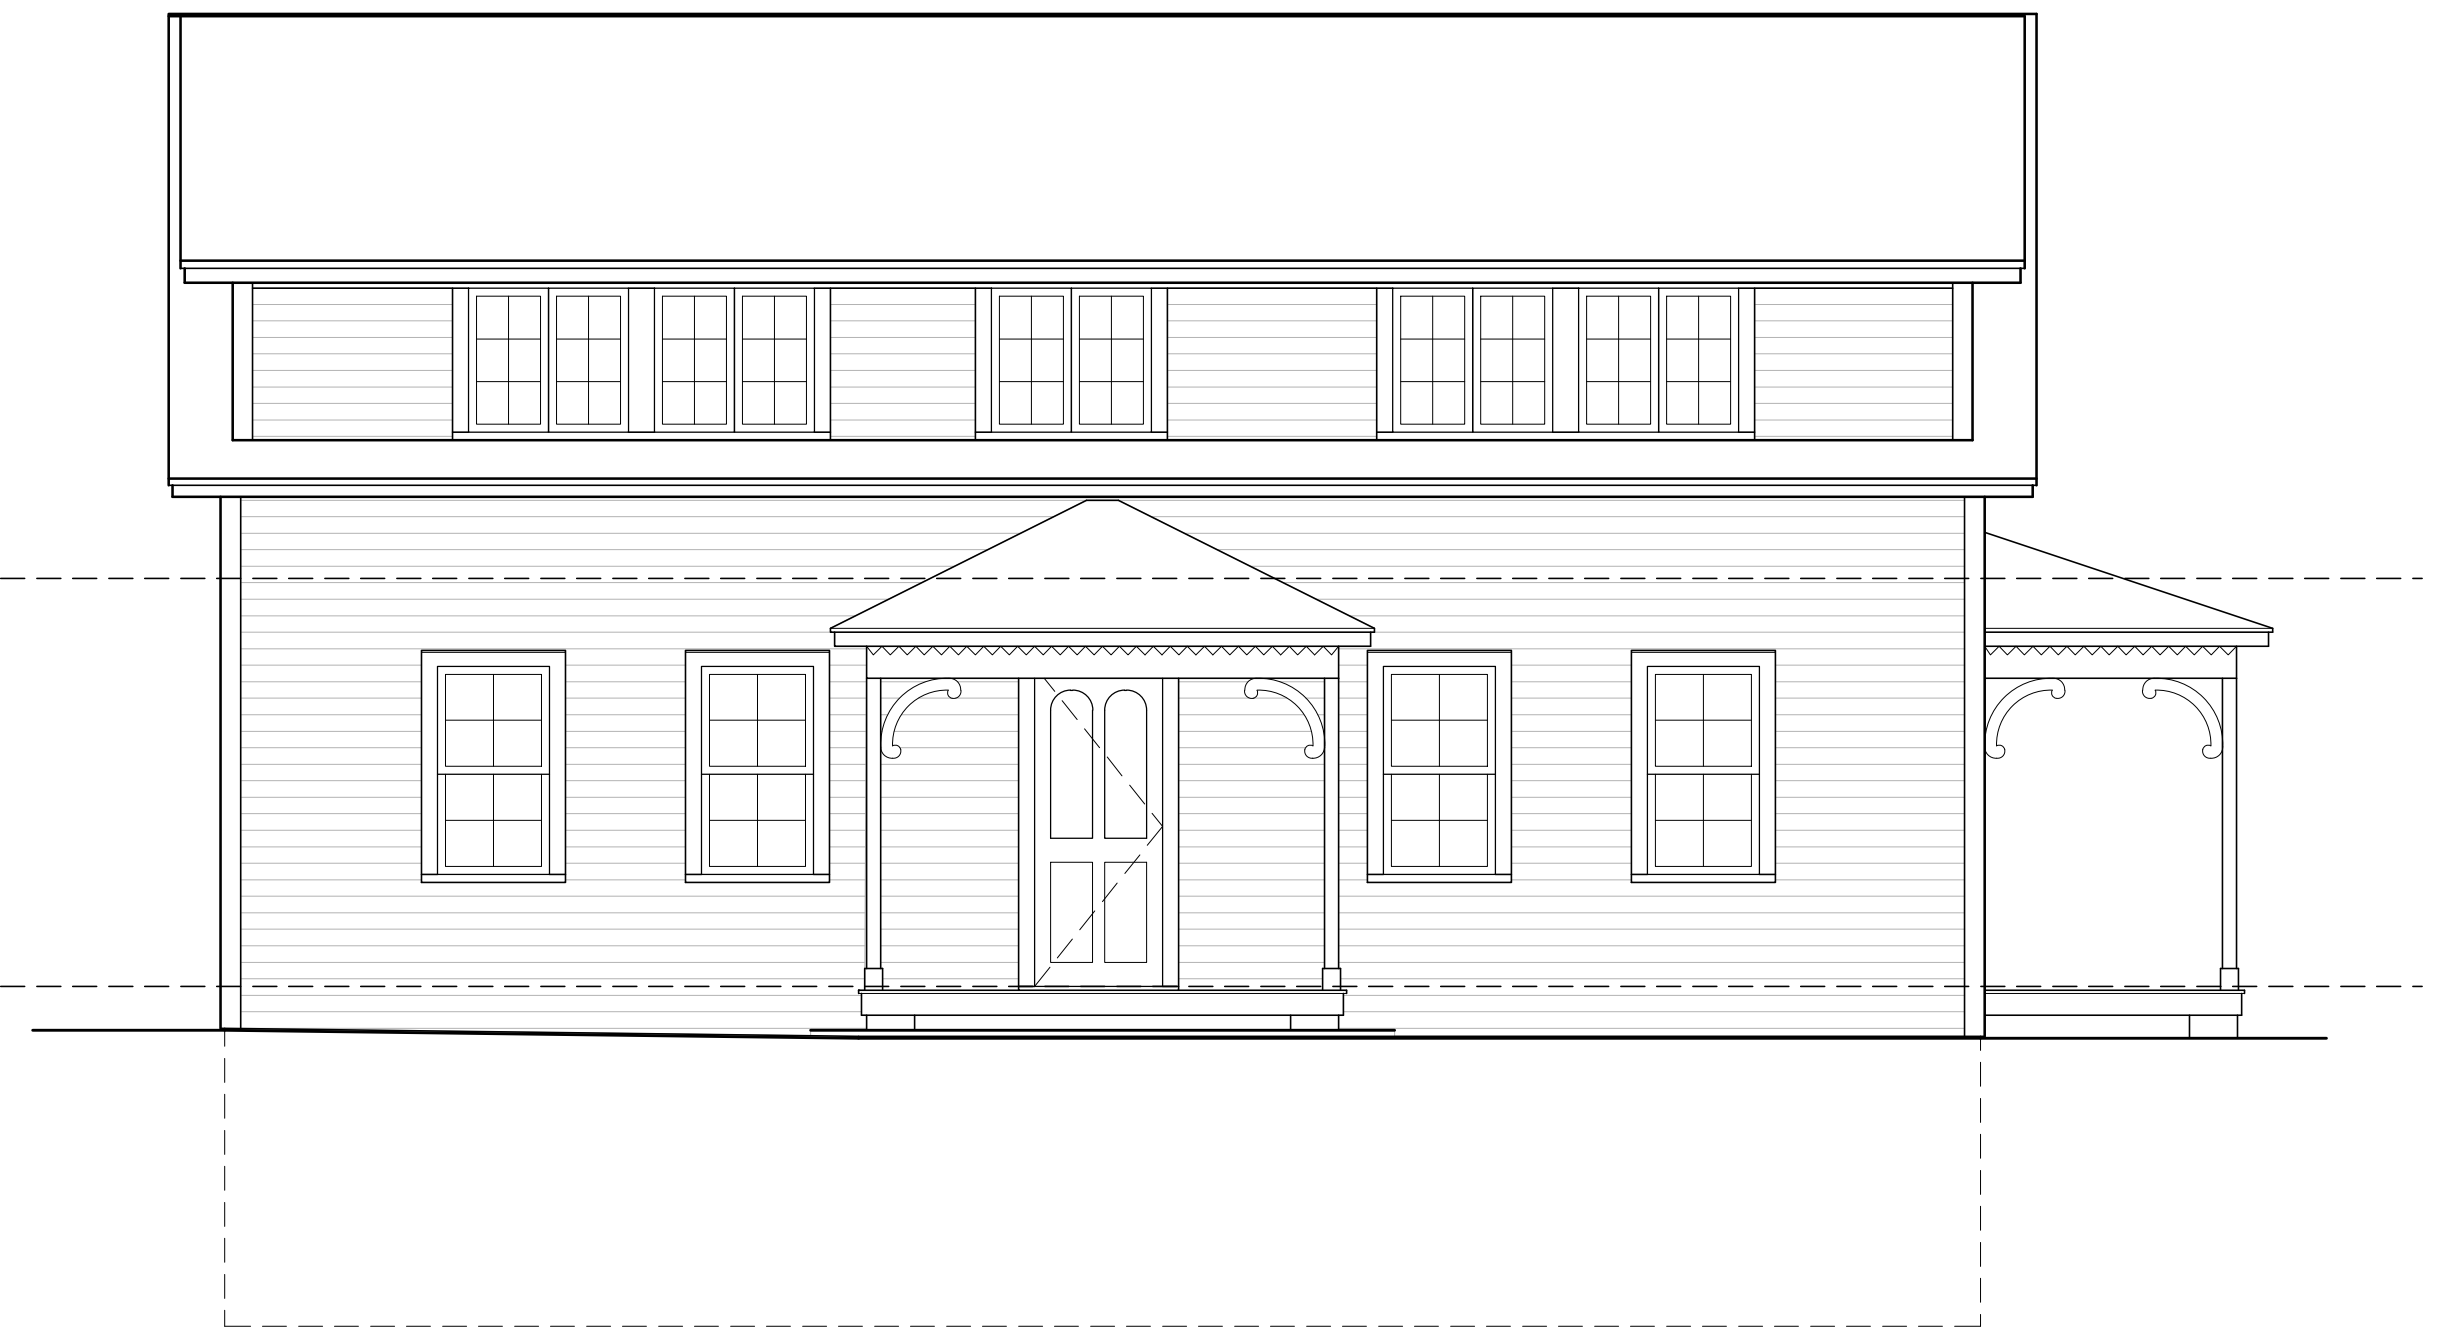
2 EXISTING WEST ELEVATION  
1/4" = 1'-0"
