# Request for Proposals for the Rehabilitation, Reuse and Maintenance of:

The former Beartown Superintendent's House is in Beartown State Forest in the southern Berkshire town of Monterey. Beartown welcomes over 100,000 visitors annually for activities such as hiking (including the Appalachian Trail), camping, fishing and cross-country skiing. The house is located at the park's southern entrance, adjacent to park headquarters. The house is minutes from multiple state parks, ski areas, Great Barrington, Stockbridge and other vibrant and creative towns and villages as well as world class attractions such as Jacob's Pillow Dance Center, Tanglewood Center for the Performing Arts, and Naumkeag Estate.

## B. Description

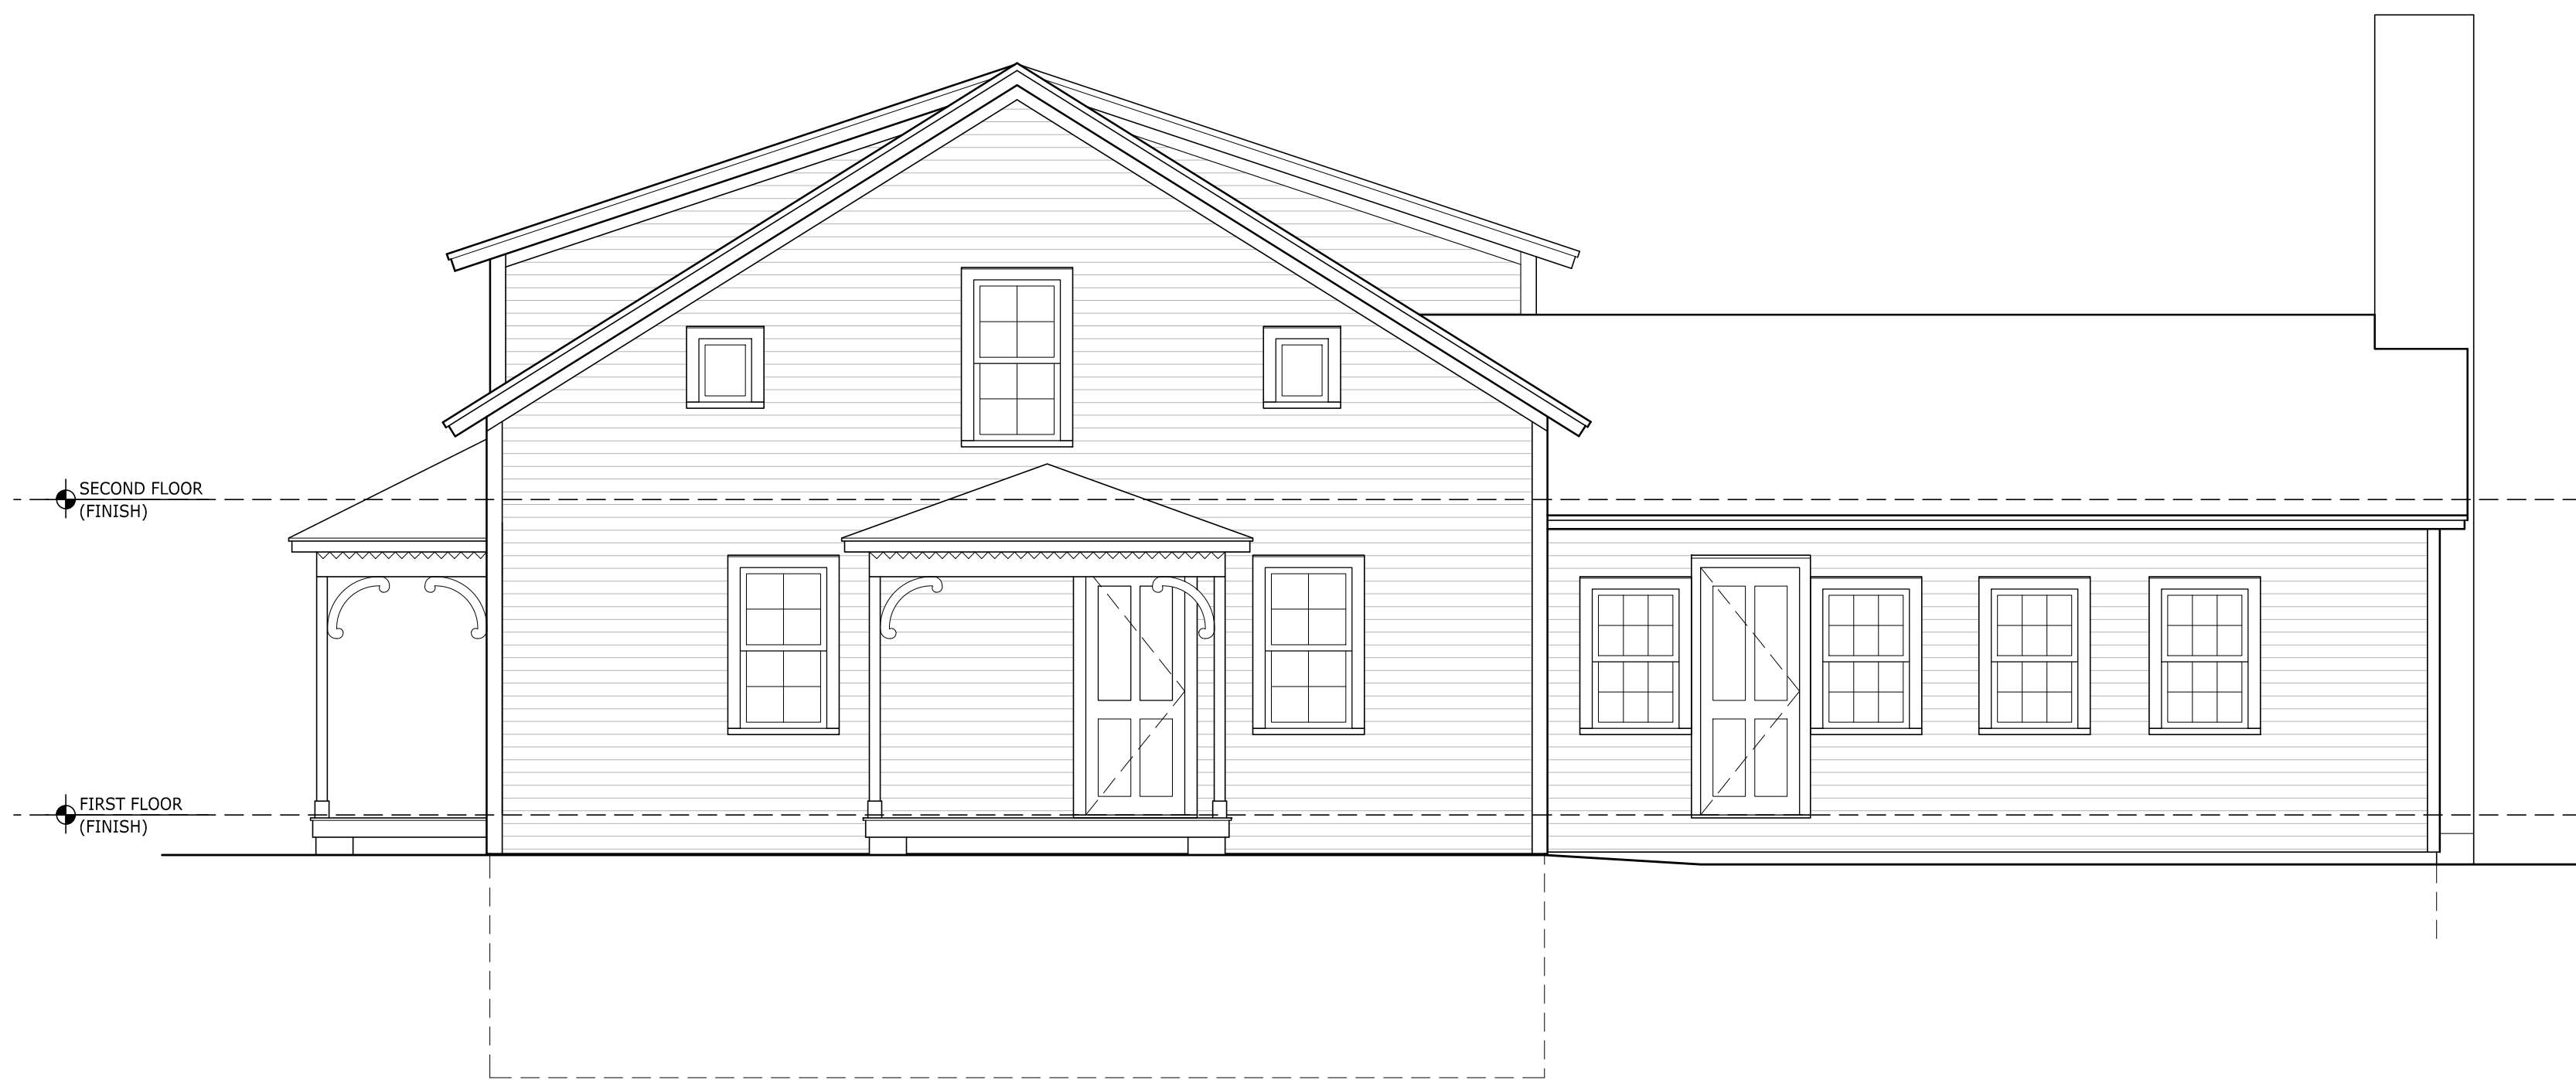
3 EXISTING SOUTH ELEVATION  
1/4" = 1'-0"
