# **EMERGENCY ACTION PLAN**

## **Rising Pond Dam**

**Updated November 2022 (Rev. 4)**

**GREAT BARRINGTON, MASSACHUSETTS**  
**NID # MA 00250**

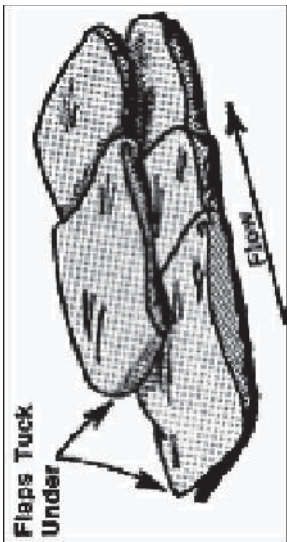
| HEIGHT OF BERM | BAGS/100FEET |
| 1 FOOT | 800 |

Sand bag berms are one of the most common methods for temporarily increasing freeboard to reduce overtopping of a dam during a flood event. Figure D-5 provides information on proper methods for constructing sandbag berms. Sandbag berm construction can be highly effective but requires appropriate material and is labor intensive. The maximum effective height should be limited to approximately three feet. (Source: Flood Fighting: How To Use Sandbags, US Army Corps of Engineers) It is expected that the Town of Great Barrington will either stockpile sandbags at a Town facility or make arrangements with a local supplier to obtain sandbags in the event of an overtopping emergency. Sand to fill the sand bags will be obtained from a local sand and gravel pit.

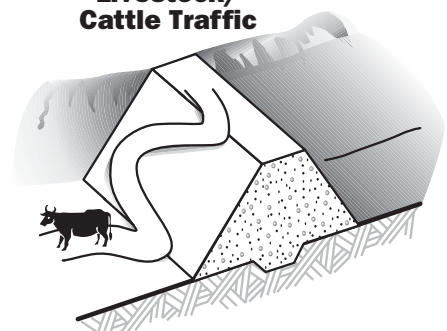
**Figure 5.2i**

**Livestock/  
Cattle Traffic**
