Technical Memorandum

Reference: 516025.105
Date: April 29, 2019
To: Kenny Croyle, Central Valley Regional Water Quality Control Board
From: Mike Foget, PE, SHN
Subject: **Mule Creek State Prison–CCTV Weekly Status Report (Week #3)**

This technical memorandum summarizes major findings for the closed-circuit television (CCTV) inspection of the storm drain and sanitary sewer system at Mule Creek State Prison (MCSP). The inspections summarized in this memorandum were completed from April 1, 2019, to April 5, 2019, by Nor Cal Pipeline Services.

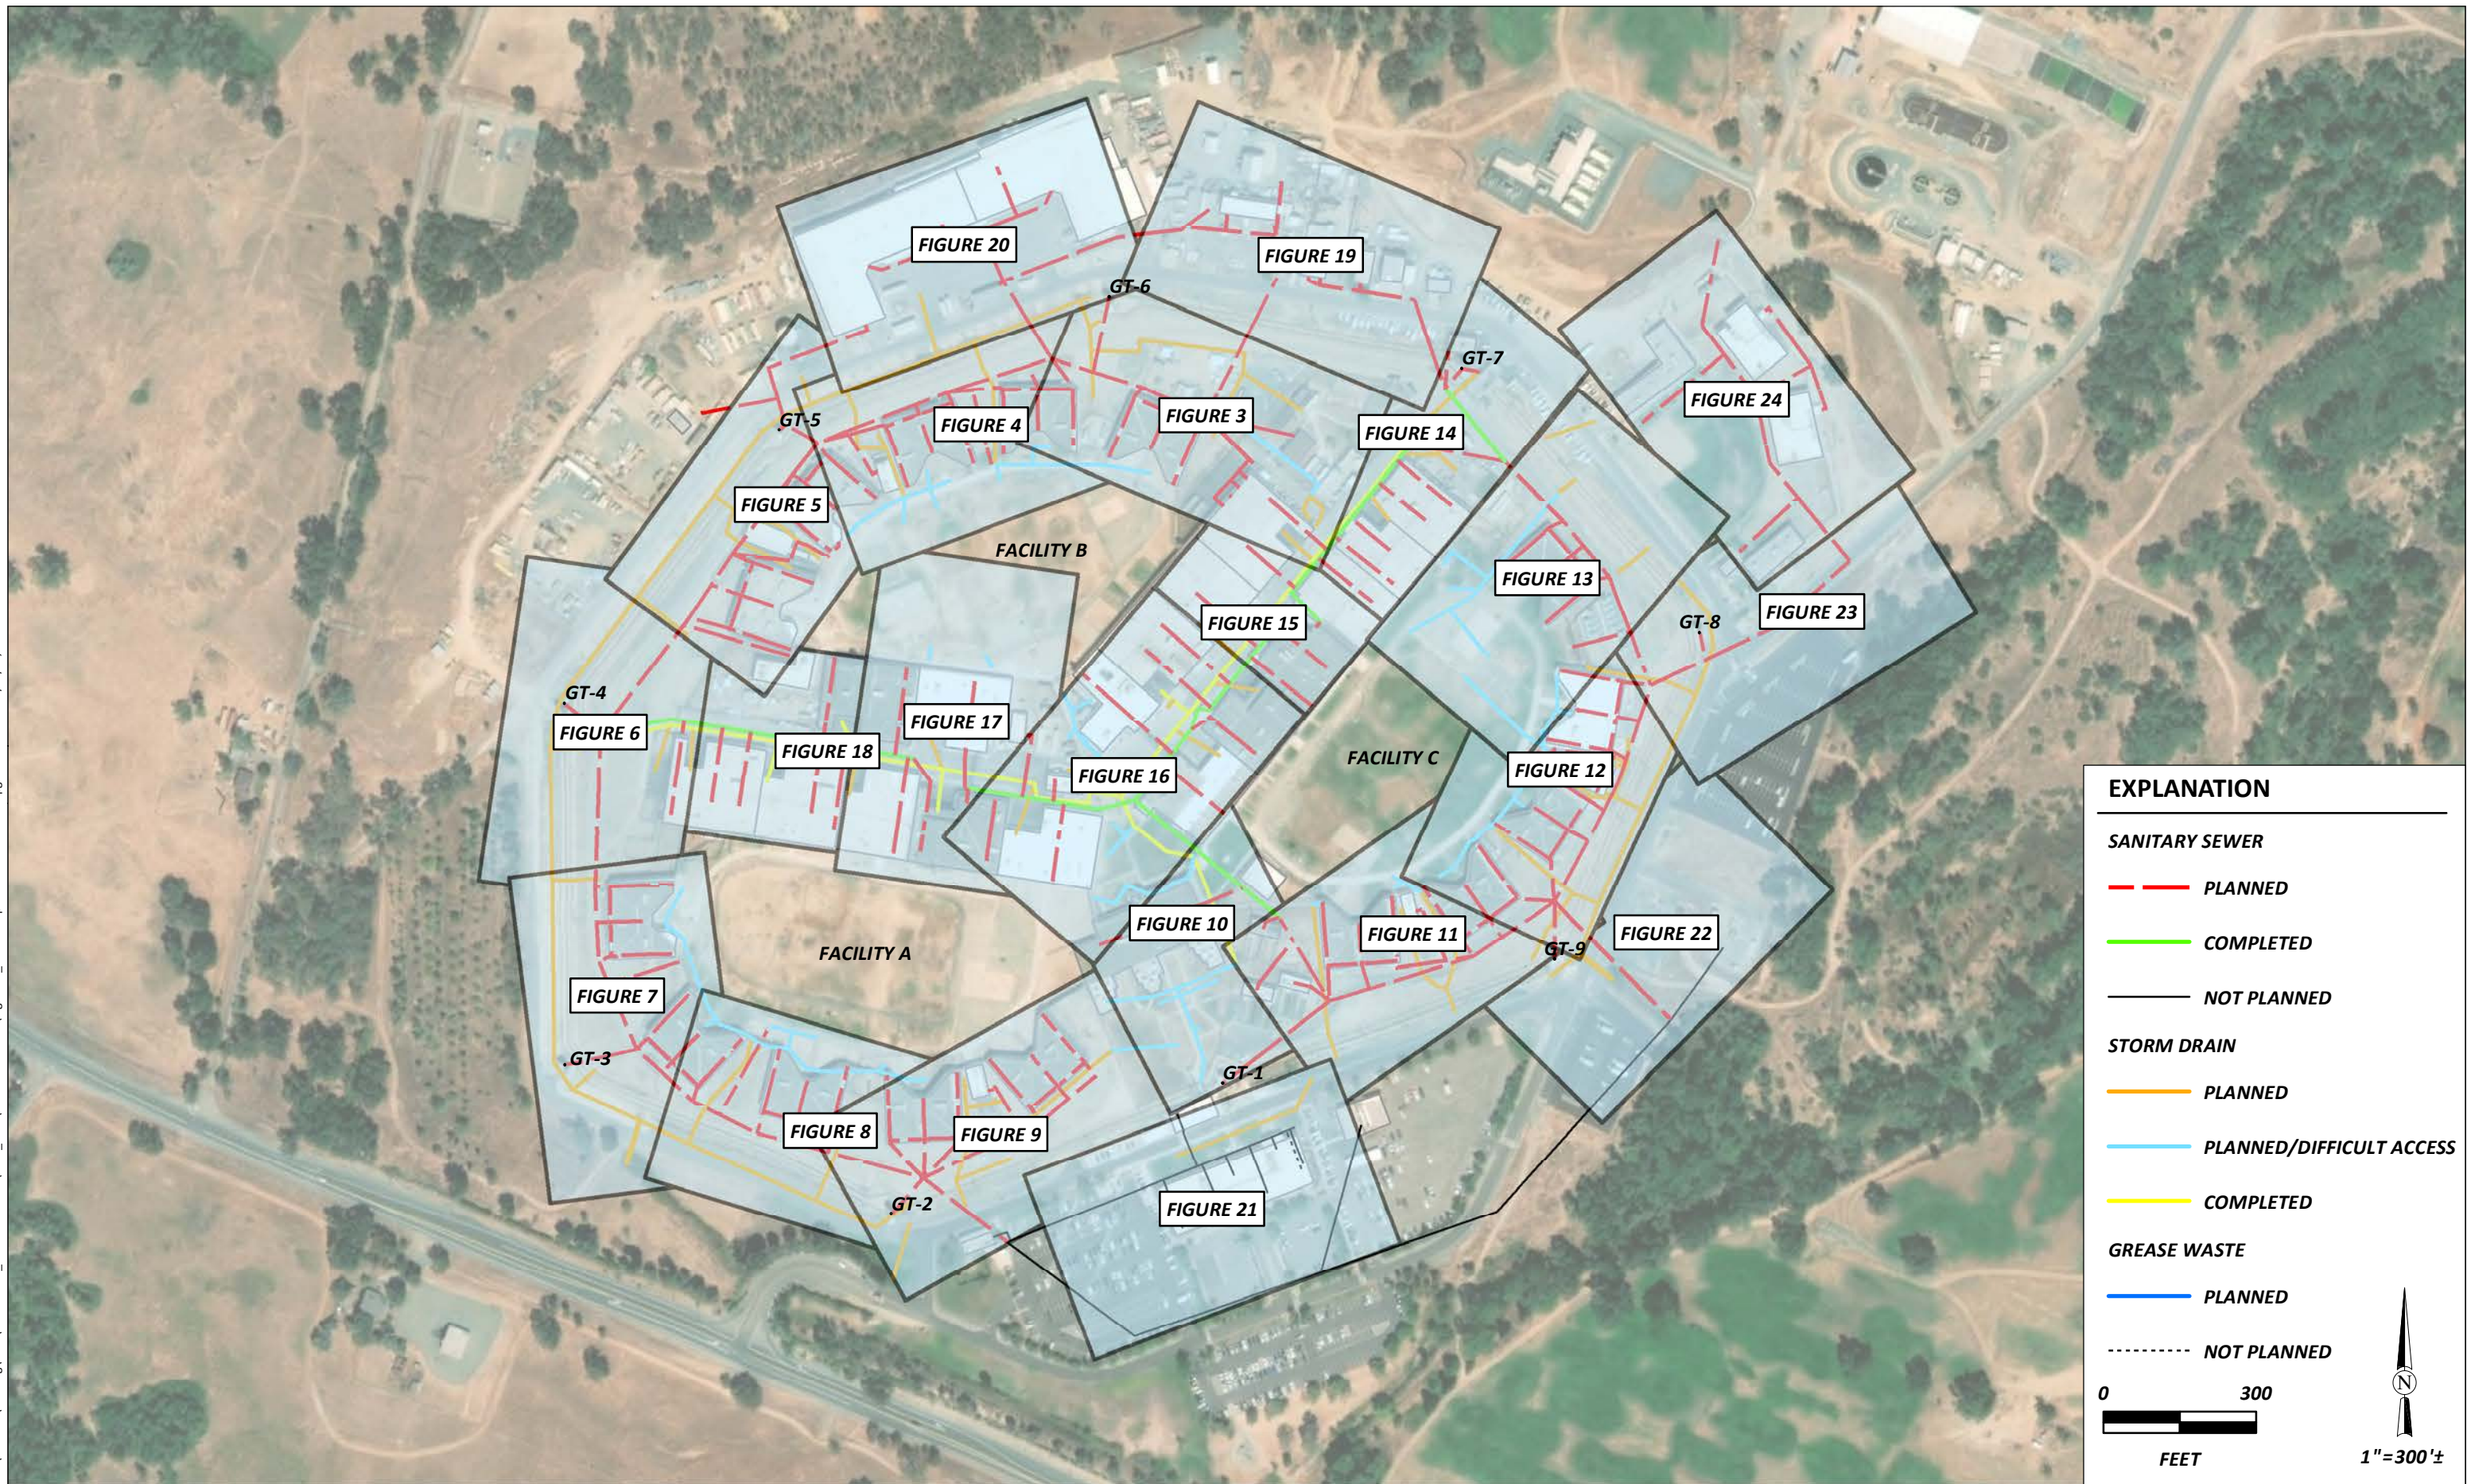
Figure 2

**NOTE: PRELIMINARY LINEWORK SHOWN.
MAPPING IS NOT FINAL AND WILL BE UPDATED AS
CONNECTIVITY AND STRUCTURES ARE VERIFIED.**

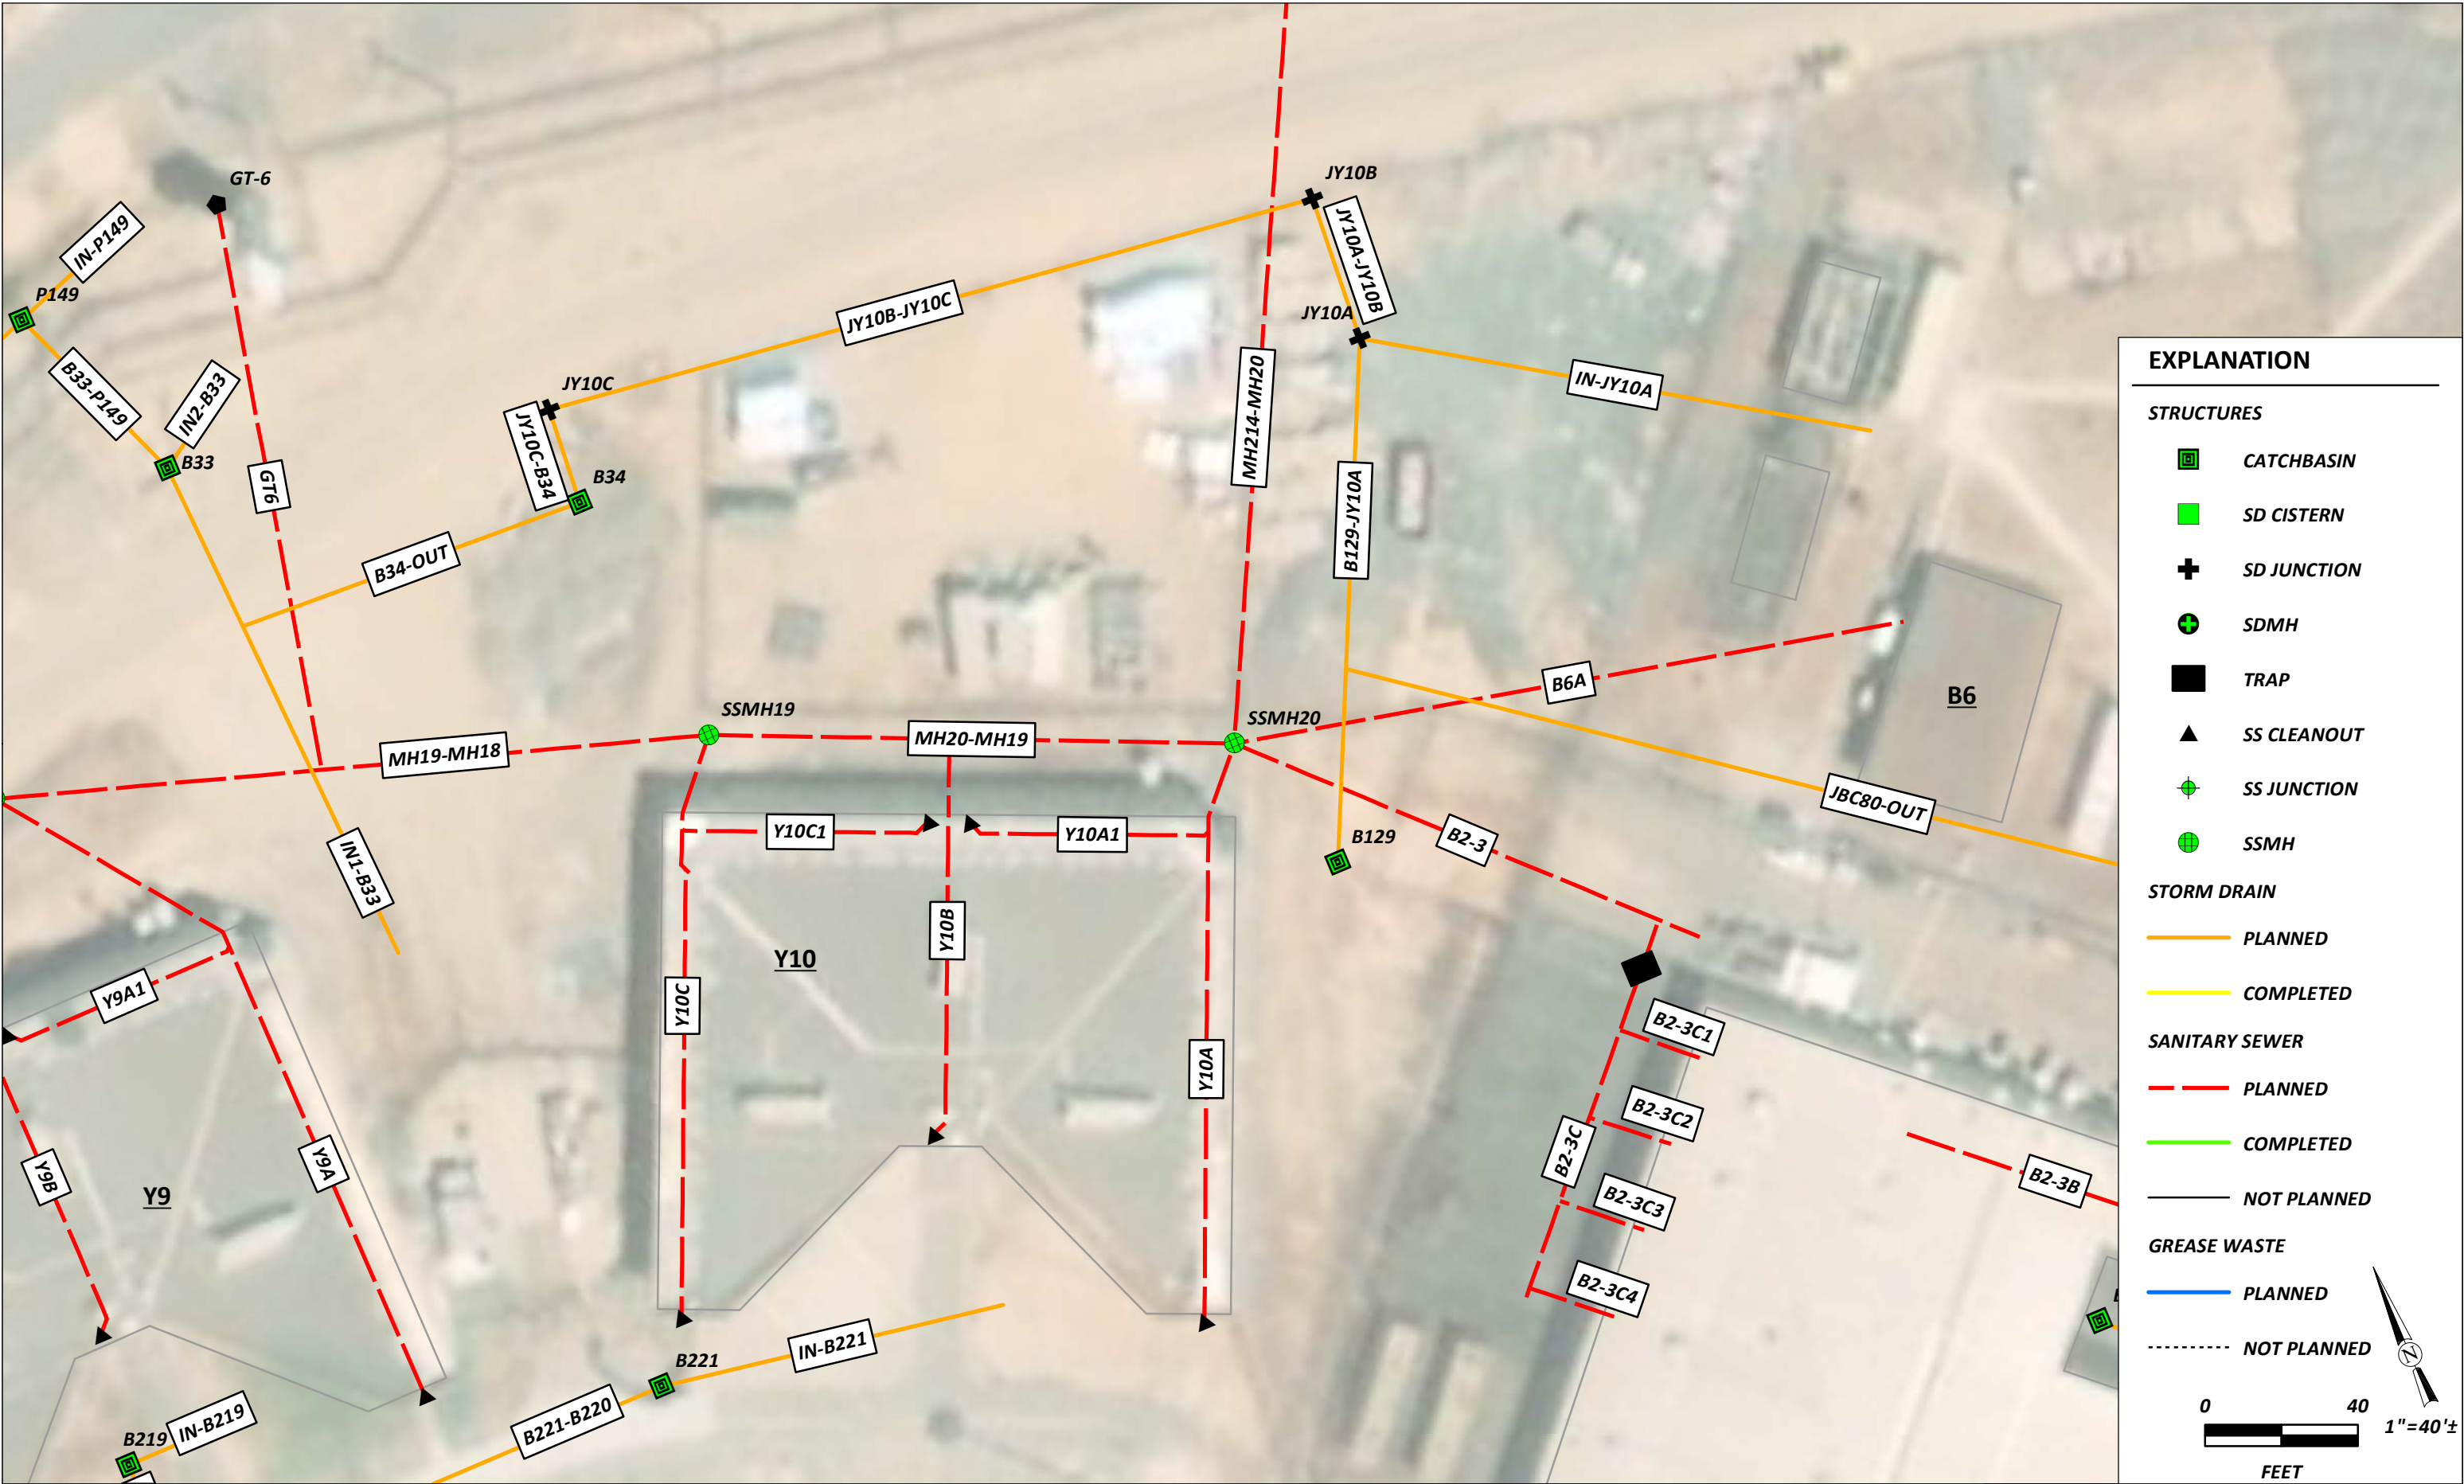
Figure 3

**NOTE: PRELIMINARY LINEWORK SHOWN.
MAPPING IS NOT FINAL AND WILL BE UPDATED AS
CONNECTIVITY AND STRUCTURES ARE VERIFIED.**

Segment ¹	Figure ²	Segment Type	Finding	Distance from Start of Inspection ³	Comment
Y10C1-SSMH19	3	Lateral	Intruding Sealing Ring	93.5 ft ⁴	Gasket visible at building Y10 connection. Seal appears intact.
Y10A1-SSMH20	3	Lateral	Intruding Sealing Ring	92 ft	Gasket visible at building Y10 connection. Seal appears intact.
SSMH20-SSMH19	3	Main	Intruding Sealing Ring	65 ft	Rubber couplings visible in main at lateral connection for building Y10. Seal appears intact.
			Joint Offset	135 ft	Joint slightly offset at coupler 2 feet upstream of MH19. Seal likely intact.

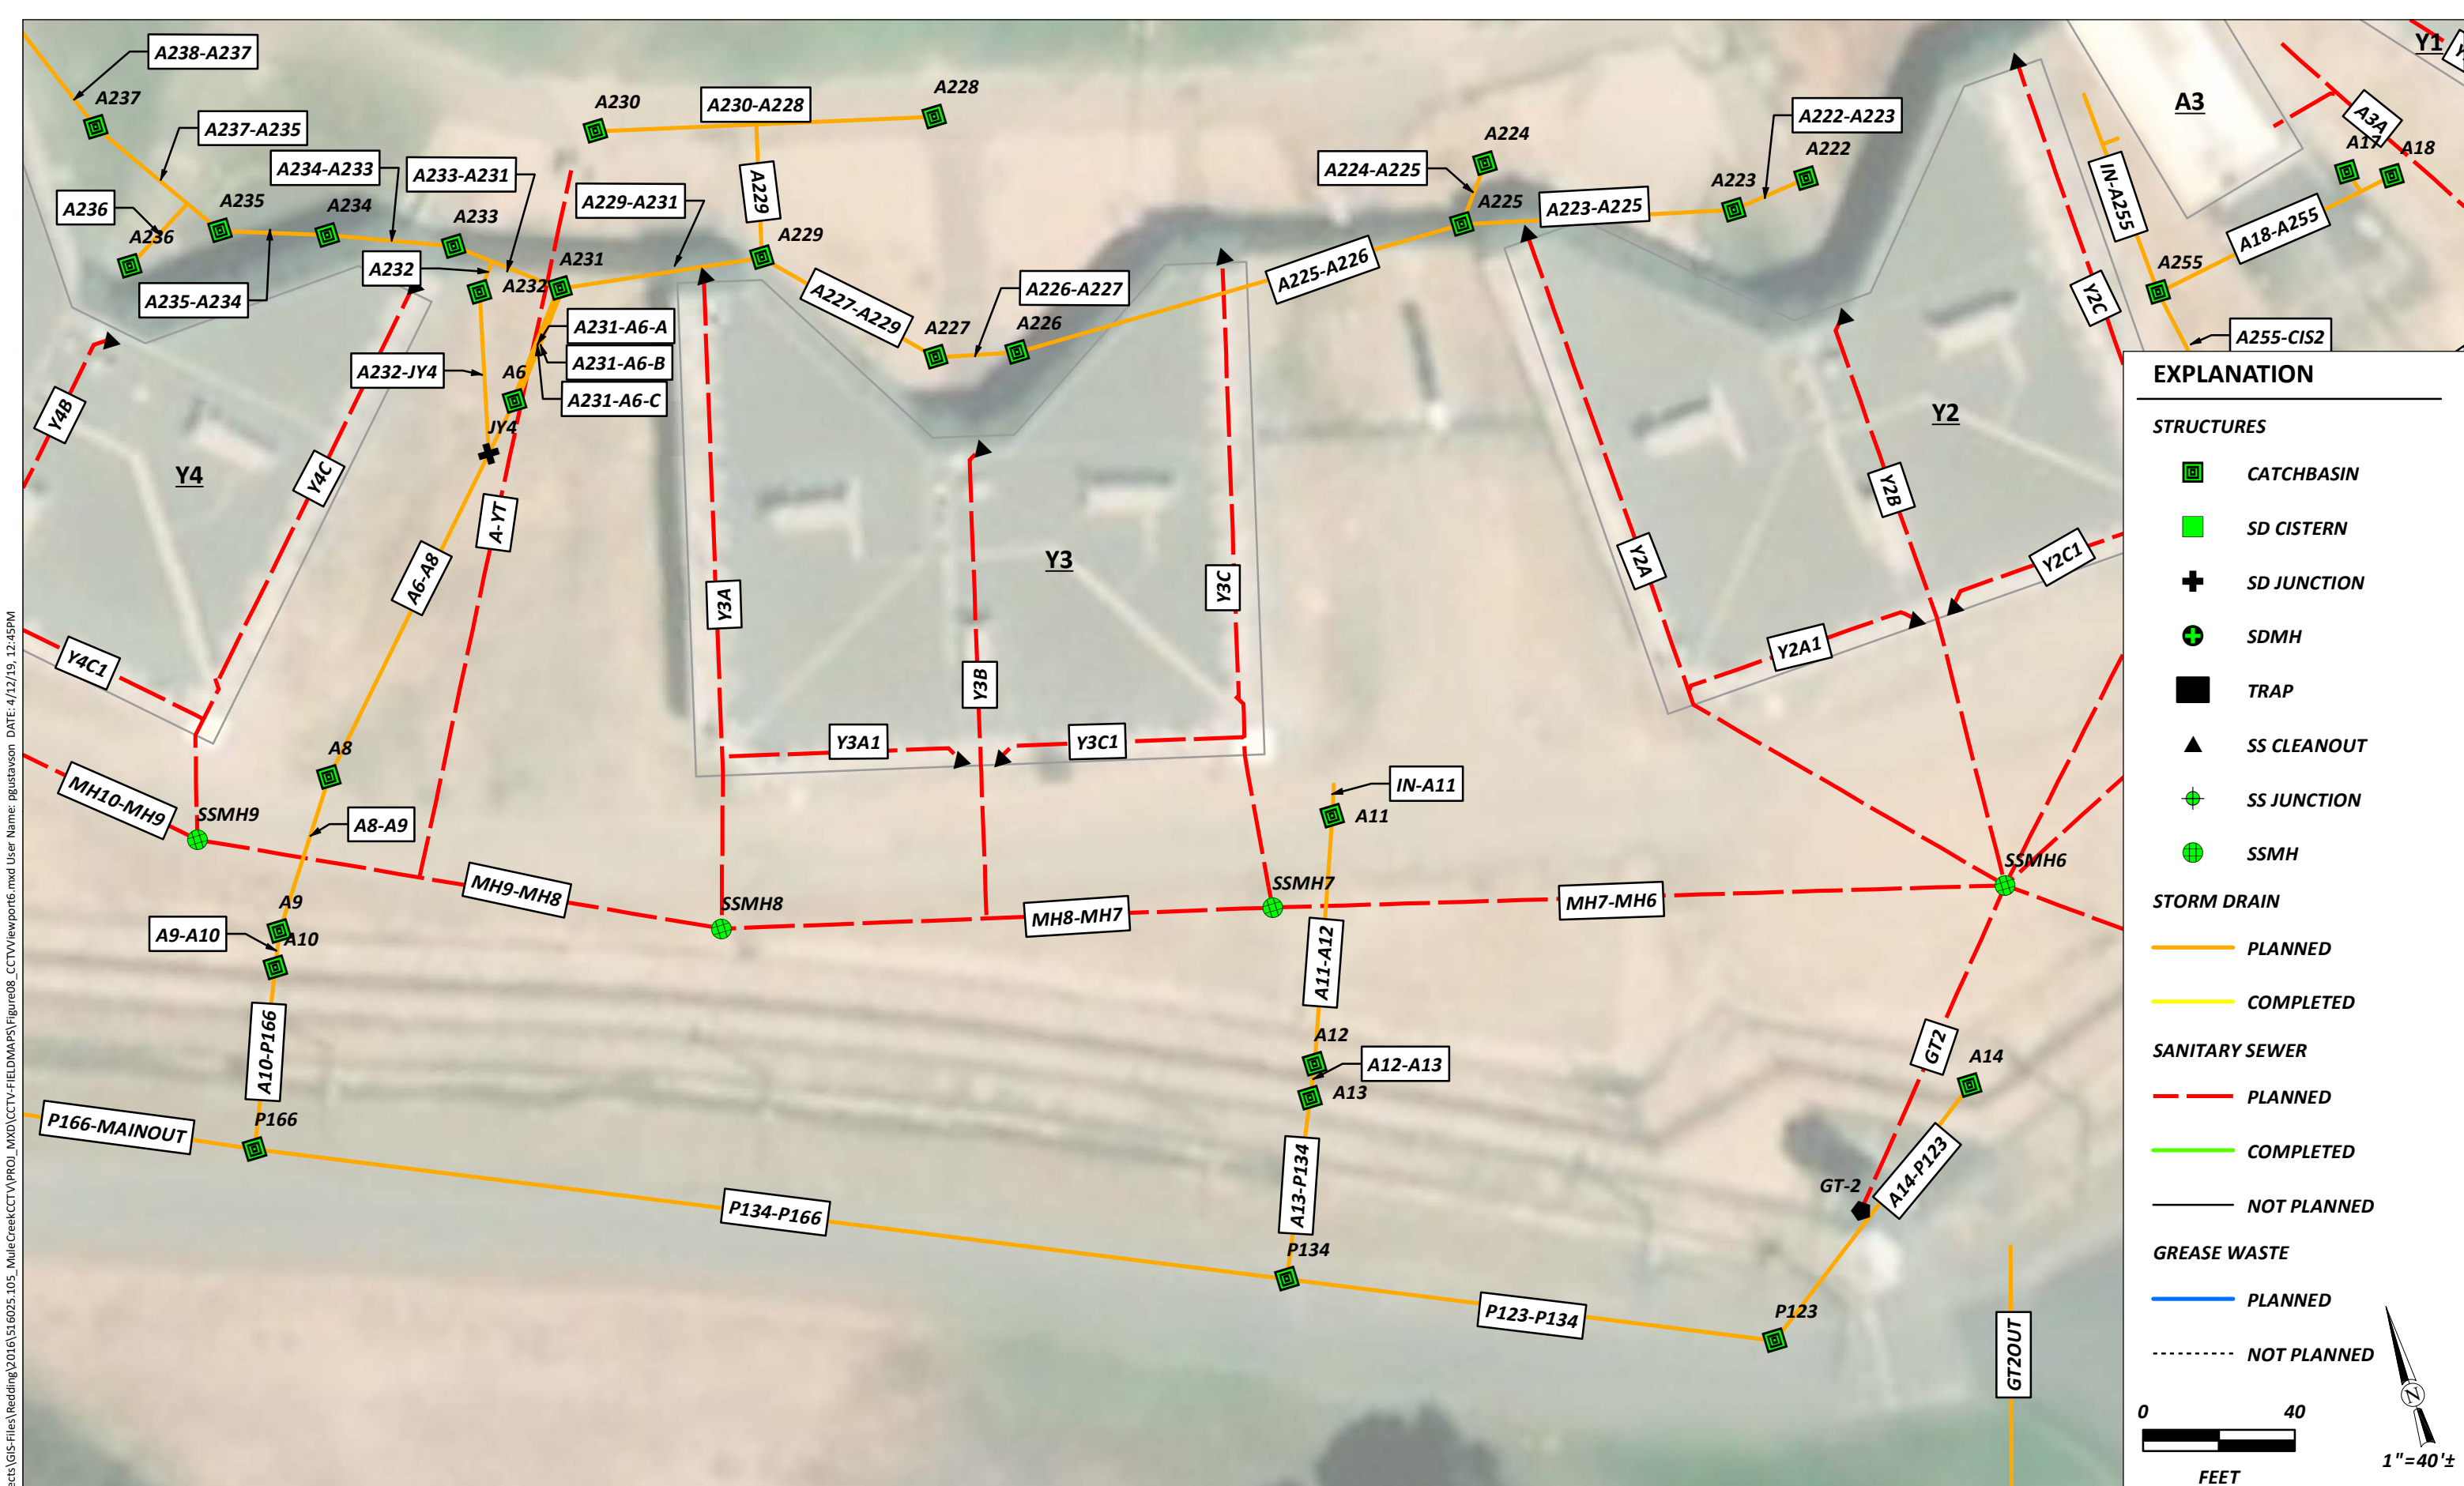
Figure 8

**NOTE: PRELIMINARY LINEWORK SHOWN.
MAPPING IS NOT FINAL AND WILL BE UPDATED AS
CONNECTIVITY AND STRUCTURES ARE VERIFIED.**

Figure 1 provides an overview of the work completed this week. Attachment 1 includes Figures 7 and 8, which have been updated from the preliminary mapping set that was submitted with the Week 1 CCTV Status Report. These figures are updated to reflect additional pipes that were encountered during the inspections; however, they are still considered preliminary and may be further updated as needed.
