TO THE ALTERNATIVES PUBLIC MEETING FOR THE BLACKBURN POINT BRIDGE REPLACEMENT STUDY

## BLACKBURN POINT BRIDGE REPLACEMENT STUDY

PROJECT NUMBER: SR 2515

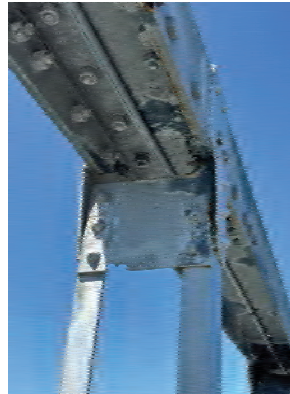
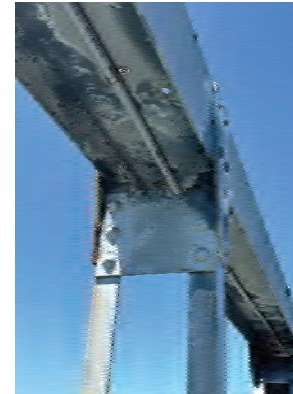
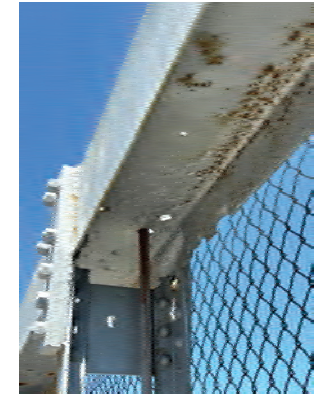
Photographs representative of existing conditions of the swing bridge's main upper truss members

- Steel truss corrosion
- Piling deterioration
- Fender system deterioration & impact damage

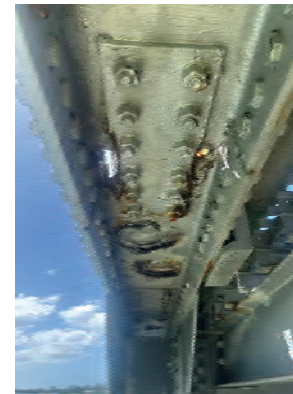
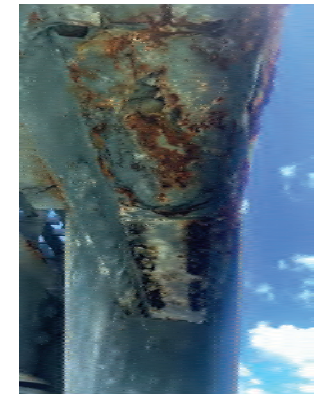
Photographs representative of existing conditions of the swing bridge's main lower truss members

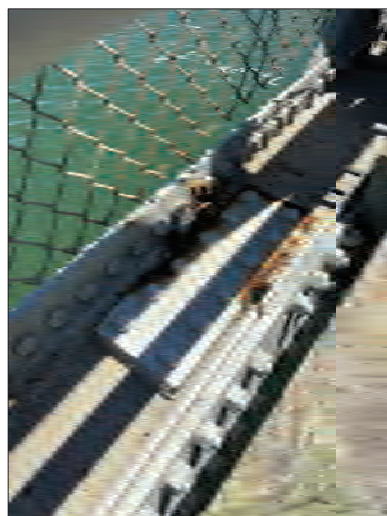
Prior truss repairs exhibiting corrosive section loss

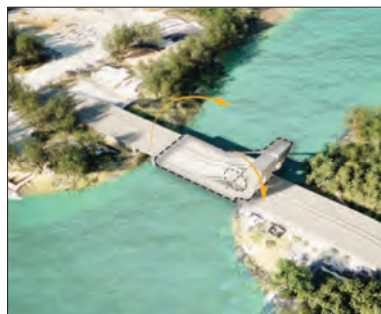
Span Motion Diagram

- **Rotates about a horizontal axis and translates at the same time**
  - Smallest movable span length
- **Rolling Lift Type with Overhead Counterweight**
  - Maximum clearance above the water
  - Resiliency:
    - Most durable with operating machinery located above the splash zone
    - Machinery is easily accessible without going below deck
- **Counterweight and machinery located on the east abutment**
  - Minimizes impacts to Blackburn Park
  - Requires rest pier in the waterway
- **Can be constructed to the north then slid to the existing alignment after existing bridge is removed – this avoids a temporary bridge**

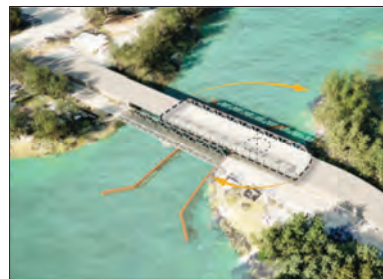
Span Motion Diagram

### Swing Bridge with Pivot Located East of the Channel

- **Bob-tailed configuration (long span over channel, shorter back span) reduces movable span length**
- **East pivot minimizes impacts to Blackburn Pt. Park**
- **East pivot results in swing span over land**
  - Pushes control house back from channel restricting bridge operator's view off the channel
- **Resiliency:**
  - Pivot machinery is below deck level
    - Close to splash zone – exposed to salt air
    - Difficult to access for maintenance
- **Requires large fender system to protect swing span from vessel impact when open**
- **Construction challenges:**
  - Requires a temporary bridge to construct on the existing alignment
