# **Climbing Accident Report**

North Early Winters Spire Early Winters Couloir, AI 2-3, M4+ May 10, 2025

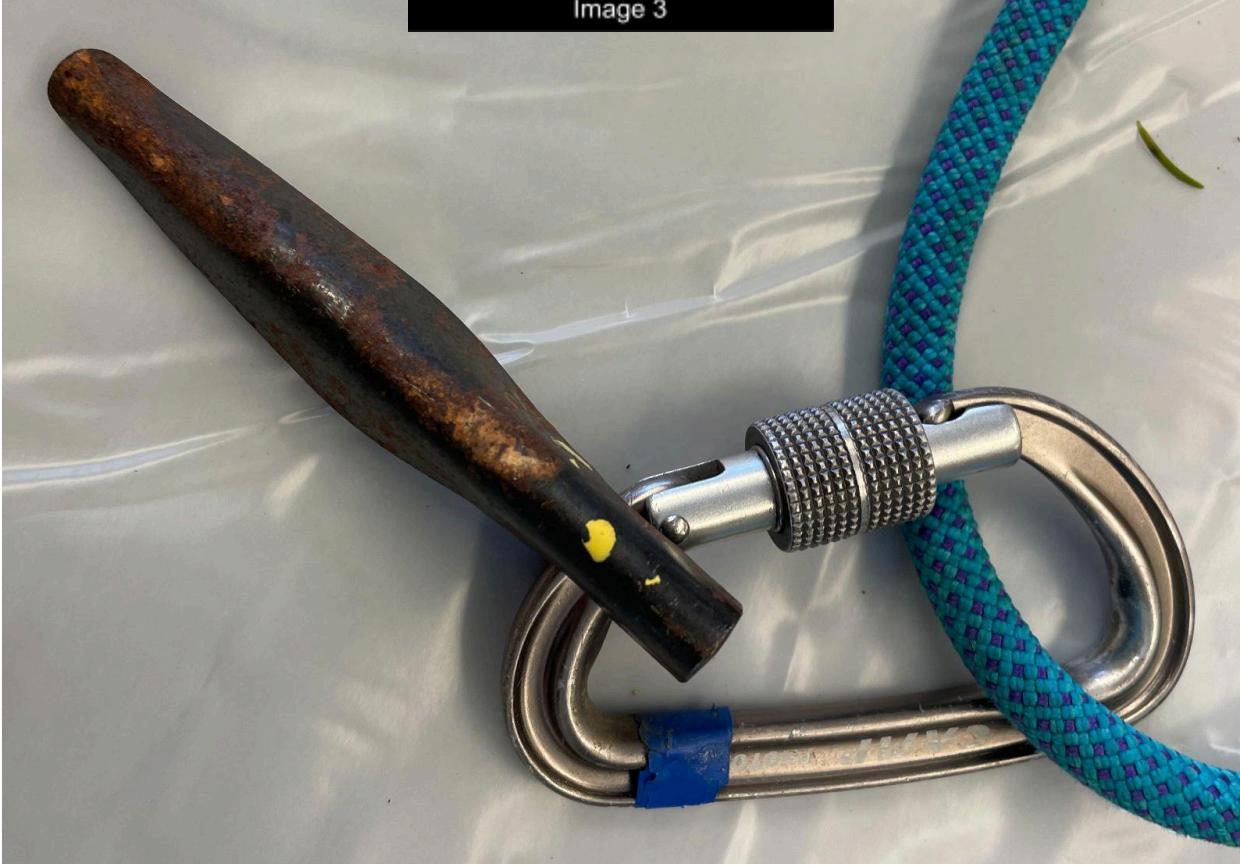
5-10-25 Climbing Accident Report Image 3

On May 11th, first responders identified a single angle piton which was clipped to the team's rappel ropes with a locking carabiner. Consistent with the surviving climbers description of the 4th rappel anchor as a single point piton anchor, no other anchor point pieces were found attached to the rope. The piton left in place by a previous party showed moderate amounts of rust, but did not break. The age of the piton is unknown, but appears to be more recent than the 1978 first ascent of EWC.
