Full NFIRS v1.0

Incident Type: 111-Building fire

Primary Narrative: Chico Fire units, with assistance from Cal Fire Butte Unit, responded to a confirmed commercial structure fire at Pleasant Valley High School (PVHS), Arts Building (D). Fire units had responded to a structure fire at the same location earlier the same day (CFD Incident #250005003).

Preliminary Fire Investigation Report Narrative

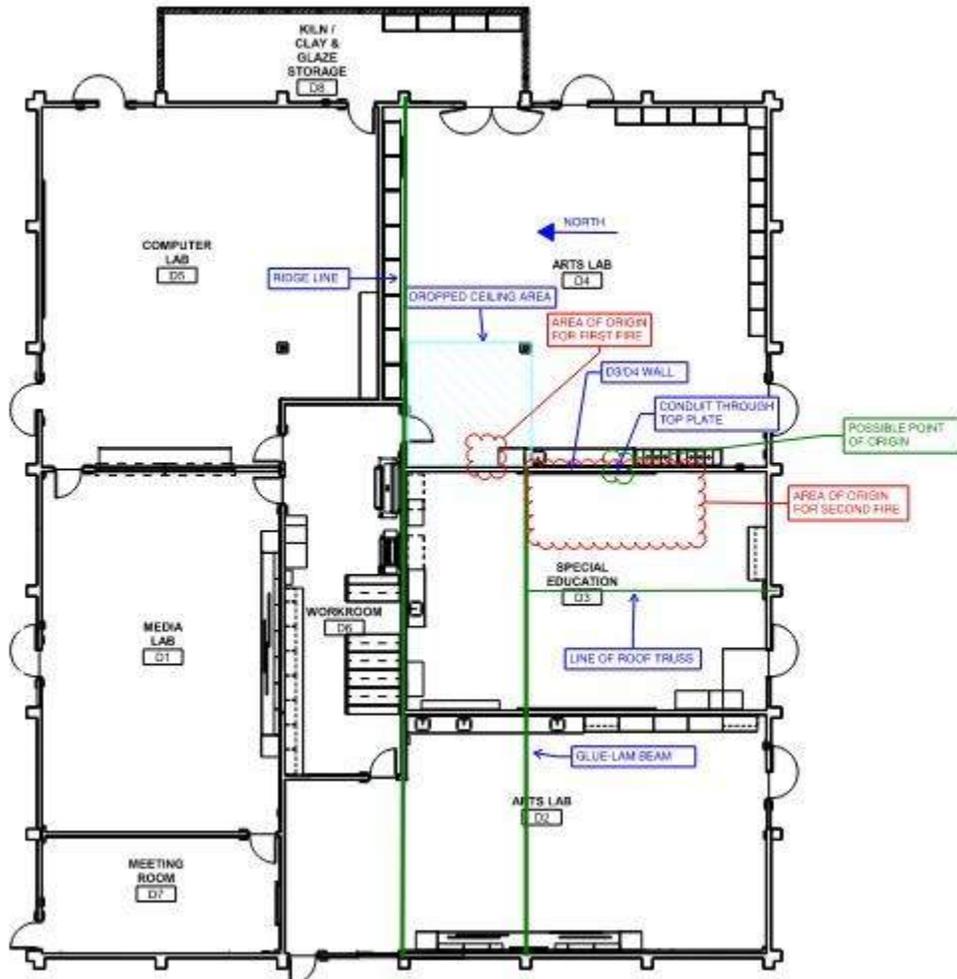
FIGURE 2 - BUILDING PLAN

Based on witness information, fire effects, and fire dynamics, the area of origin was west of the D3/D4 wall and south of the glue-lam roof beam (see Figure 2). Based on the fire effects, the possible point of origin was in the stud bay on the D3/D4 wall, directly above the top plate where the conduit penetrates it (see Figures 2 & 3).

The attic space was divided into two areas by a glue-lam beam at the roof level, which extended from the east to the west side of the building. Below this beam was a framed-in wall, which divided the attic space north and south of this beam into two separate compartments. There was at least one door on this wall, and based on fire effects observed, this door was closed at the time of the second fire.

Based on the fire damage, it appears that the fire developed in the area of origin and moved north up the roof slope to the ridgeline. Once the fire reached the ridge line, the openings in the west and east side dormers supplied increased ventilation to the fire. The fire rapidly spread across the ridgeline and down the north and south slopes.
