COMMONWEALTH'S SUPPLEMENT TO ITS RESPONSE TO DEFENDANT'S MOTION FOR NEW TRIAL: EXPERT REPORT

EXPERT REPORT AND OPINION:

CASE BACKGROUND

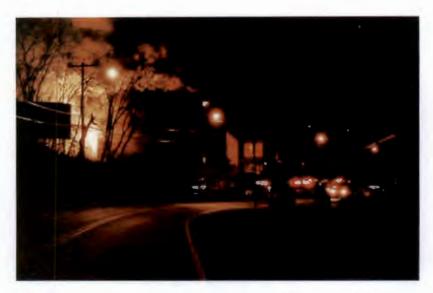
Earliest image captured by Steve Gramaldi while he was driving north on State Road. Fire can be seen on the rear porches and second floor center window.

All interviews are consistent with the fire being on the rear porches and not inside any of the apartments. Fire fighters reported seeing fire on the rear porches. The Gramaldi photos, although capture images only from the south end looking towards the north, show fire initially burning on the rear porches with the progression both upwards and downwards.

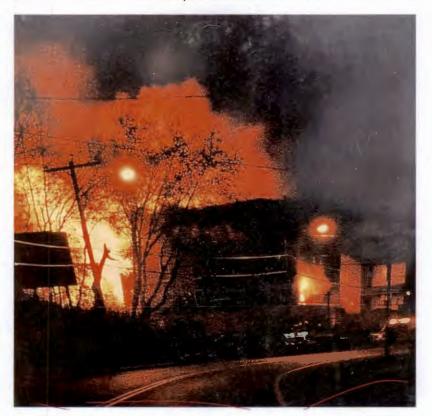
Fire on rear porches. Fire showing 2nd floor front center window.

Trial exhibit 1 shows heavy fire at the rear porches along with a glow in the second-floor center front stairwell window. The overall design of the rear porches was not uniform. The second-floor porch at ground level was concealed from the outdoors with full walls from the floor to the ceiling. There was a full dividing wall separating the south and north sides of the second-floor porch. The 3rd and 4th floor were open sided halfway up from the floor to the ceiling. Also, the fuel load packages on each floor were different. The third floor had a mattress and cloths lines with hanging clothing. The fourth floor had boxes with household goods. The first floor south had various household goods being stored.

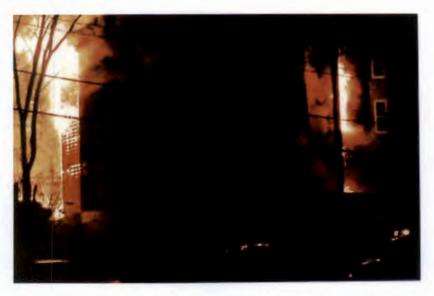
Trial Exhibit #3 shows greater fire

Fire spread from 3rd to 4th floor. Fire spread out to third floor front.

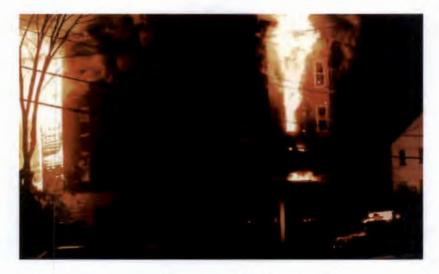
Counter and concurrent flame spread on rear porches

Concurrent flame spread and drop-down fire onto front store roof

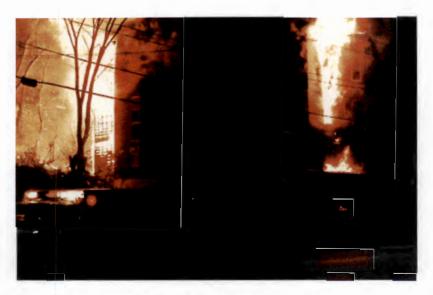
Continued progression both front a rear of structure

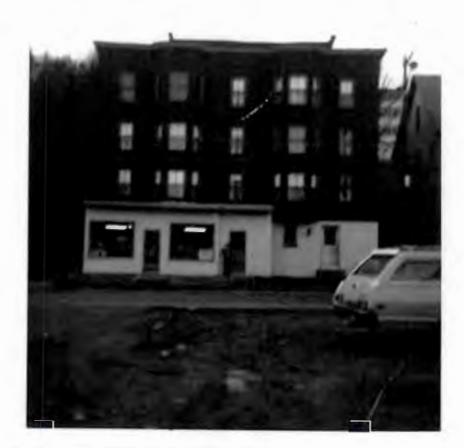
Pre-fire image of "A" side, front of building

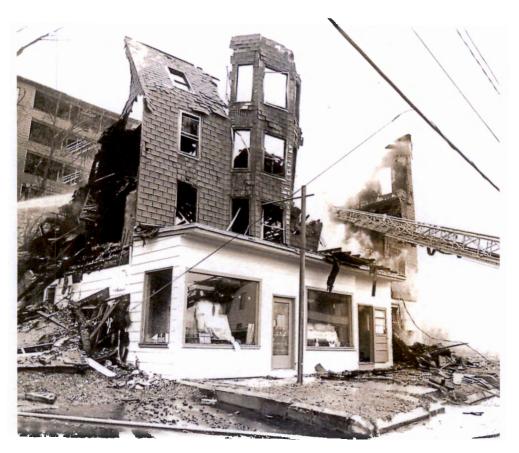
Post fire image of "A"," D" corner
