DRAFT Analysis of Brownfields Cleanup Alternatives (ABCA)
Former Curtis Paper Mill
115 Howland Avenue
Adams, Massachusetts

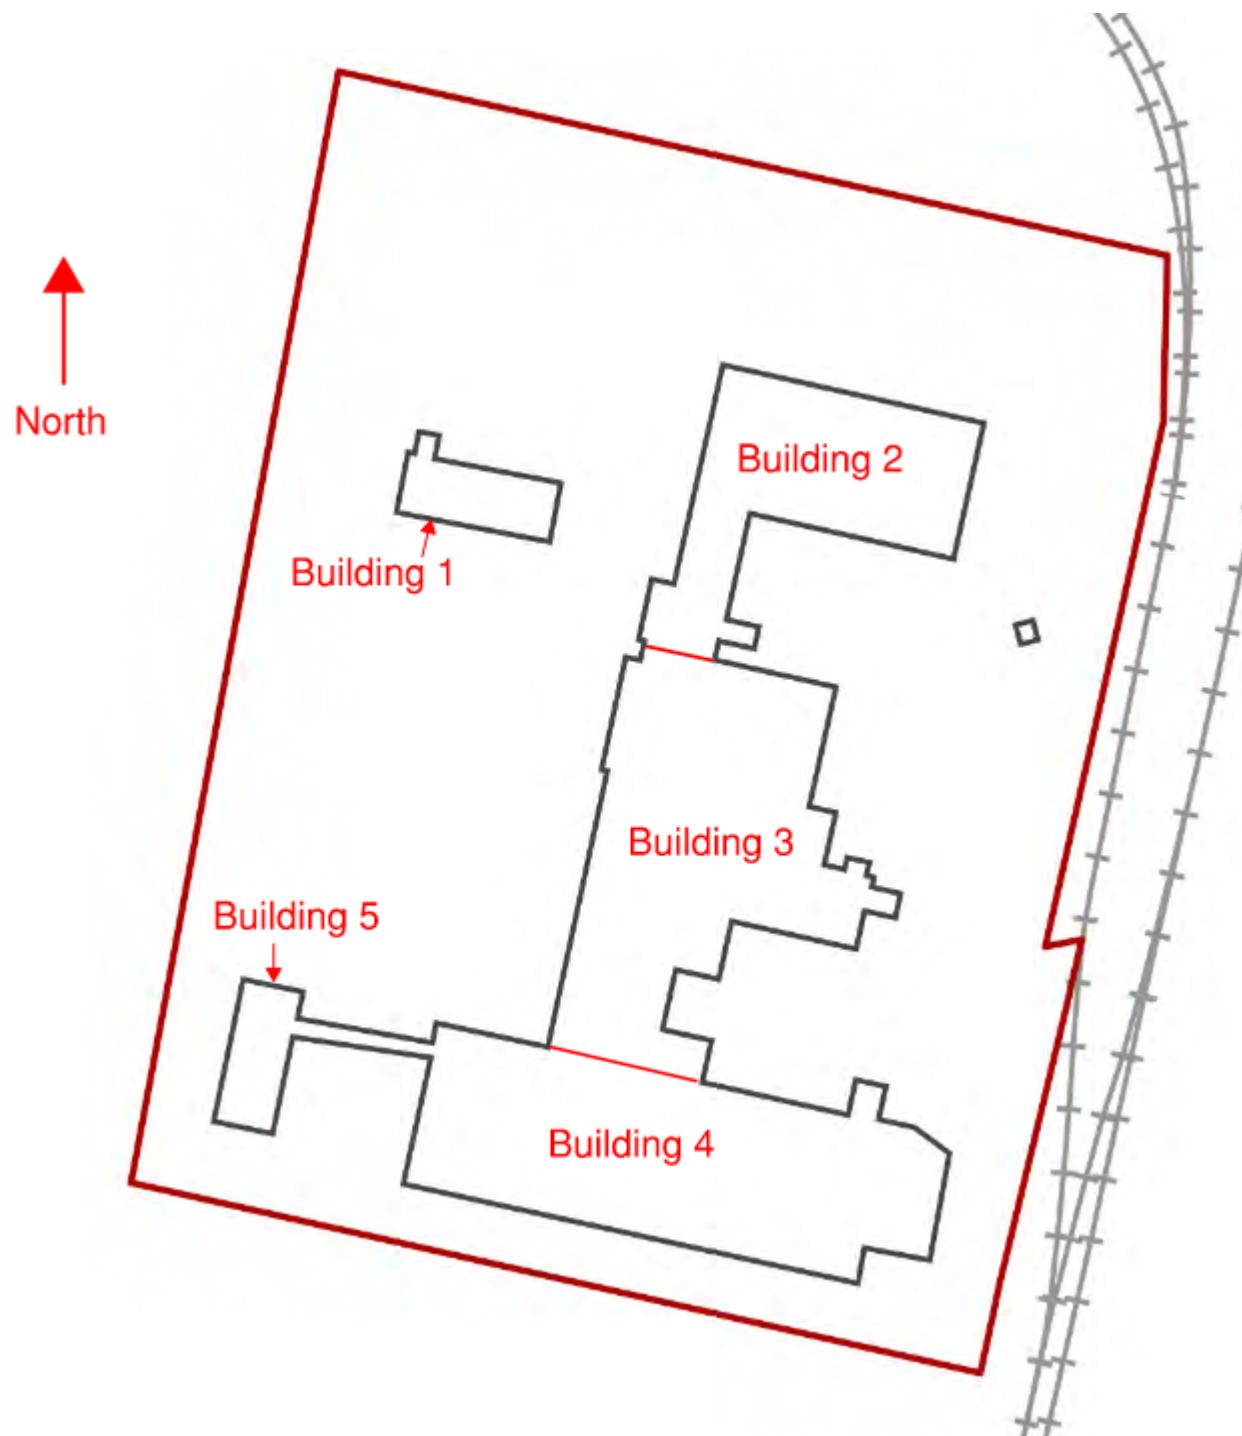
APPENDIX A: Map of Buildings

A figure identifying the building numbers is attached.

The structural inspection identified building conditions that ranged from fair to significantly damaged throughout the mill complex and roof conditions in Buildings 1, 2, 3 and 4 ranged from poor condition to total collapse. The structural inspection concluded that all the buildings have been exposed to water and moisture causing various levels of damage to the structural members. It is Weston & Sampson's professional opinion that Building 1 and the south portion of Building 4 are economically viable to repair, while Buildings 2, 3, and the north portion of Building 4 are not and Building 5 may be able to be repaired.
