National Transportation Safety Board Aviation Accident Preliminary Report

Location:	Floral City, FL	Accident Number:	ERA20LA330
Date & Time:	September 23, 2020, 07:50 Local	Registration:	N6106Z
Aircraft:	Piper PA25	Injuries:	1 Fatal
Flight Conducted Under:	Part 137: Agricultural

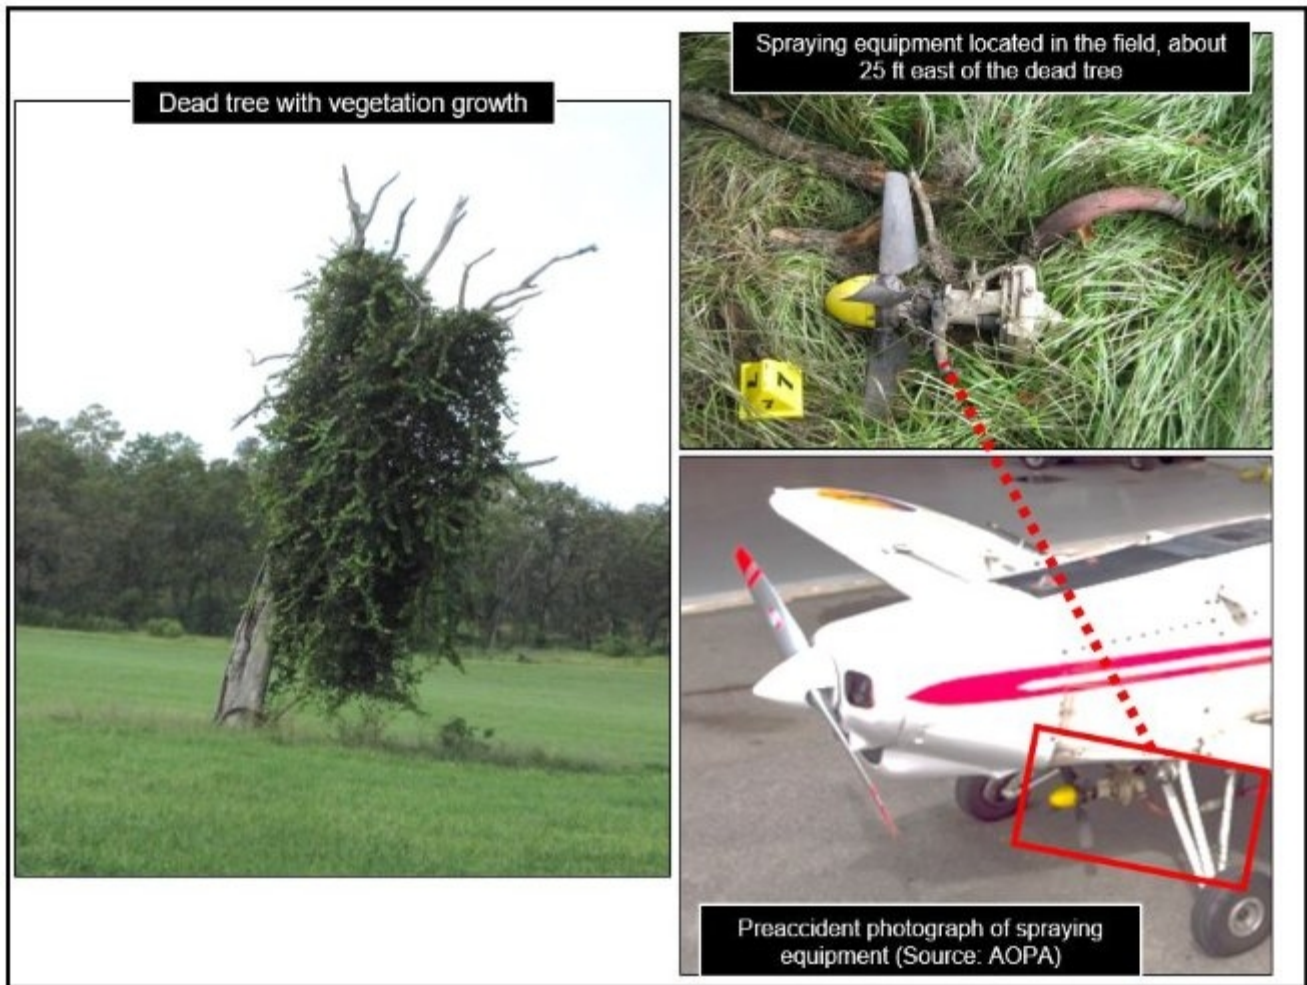
Figure 1 provides a view of the dead tree and the spraying equipment that was found about 25 ft east of the tree. An additional photo in the figure shows where the agriculture equipment was likely mounted on the accident airplane (*Source of photograph, Aircraft Owners and Pilots Association (AOPA)*).

Figure 1: View of the dead tree in the field being sprayed, with accompanied photographs of the agriculture spraying equipment located in the field.

According to an FAA inspector who traveled to the accident site, the main wreckage was located inverted in a row of trees that lined the field the airplane was seeding. A postcrash fire consumed a majority of the fuselage; however, all primary flight controls were present with the main wreckage. He further reported that within the field that was being sprayed, about 350 ft directly west of the main wreckage, a large dead tree with vegetation growth contained broken branches and components of the agricultural spraying equipment near its base.

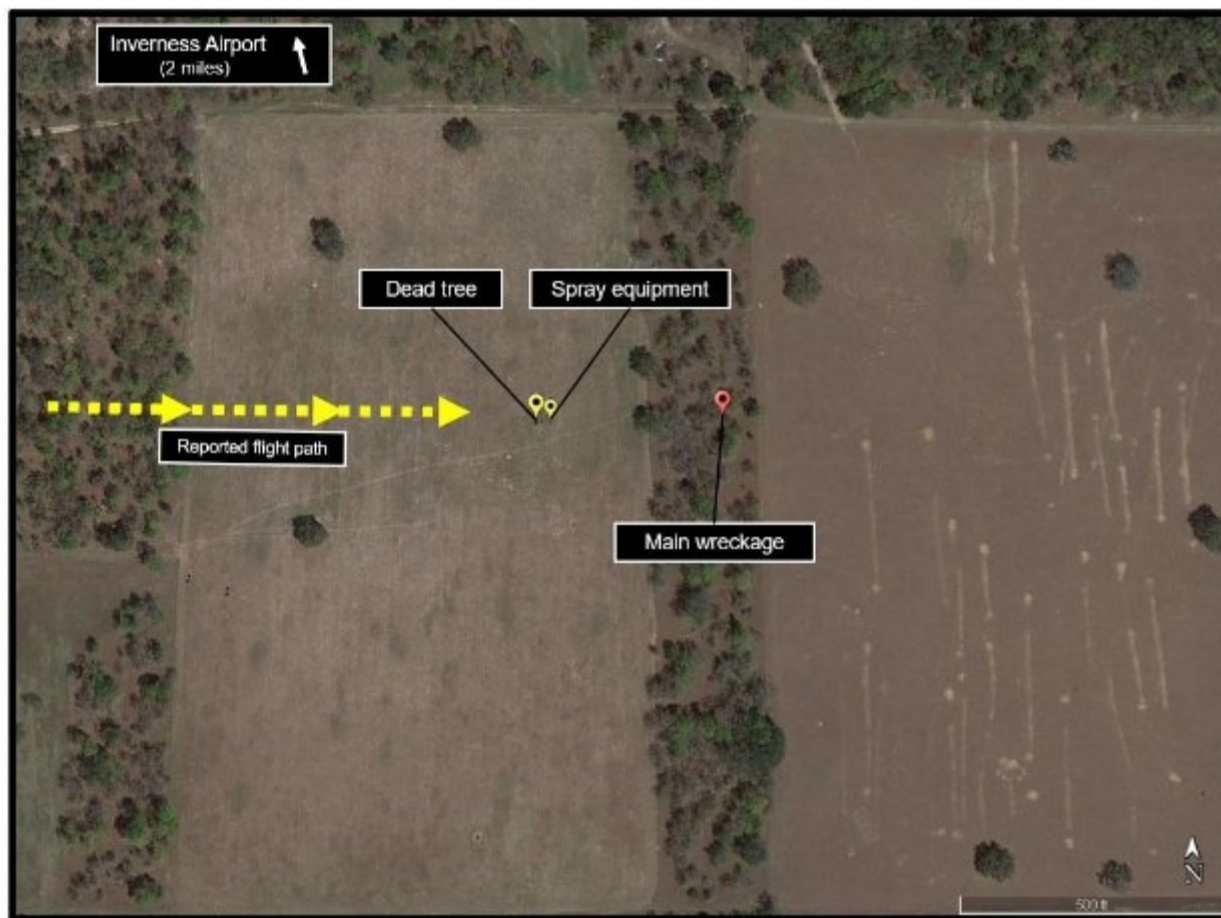
Figure 2 provides an overview of the field being sprayed, the accident site area, and the reported flight path direction.

Figure 2: Overview of the accident site area.
