**COMPLAINT**

1. This action arises out of the wildfire known as the "Hobo Fire," that ignited on United States Forest Service lands approximately four miles north of Helena, California, near Barney Gulch Road within the Forest Direct Protection Area within Trinity County.

2. The Hobo Fire started when electrical equipment owned, maintained, and operated by defendant Trinity Public Utilities District ("TPUD") contacted, or caused electrical current to contact, surrounding vegetation.

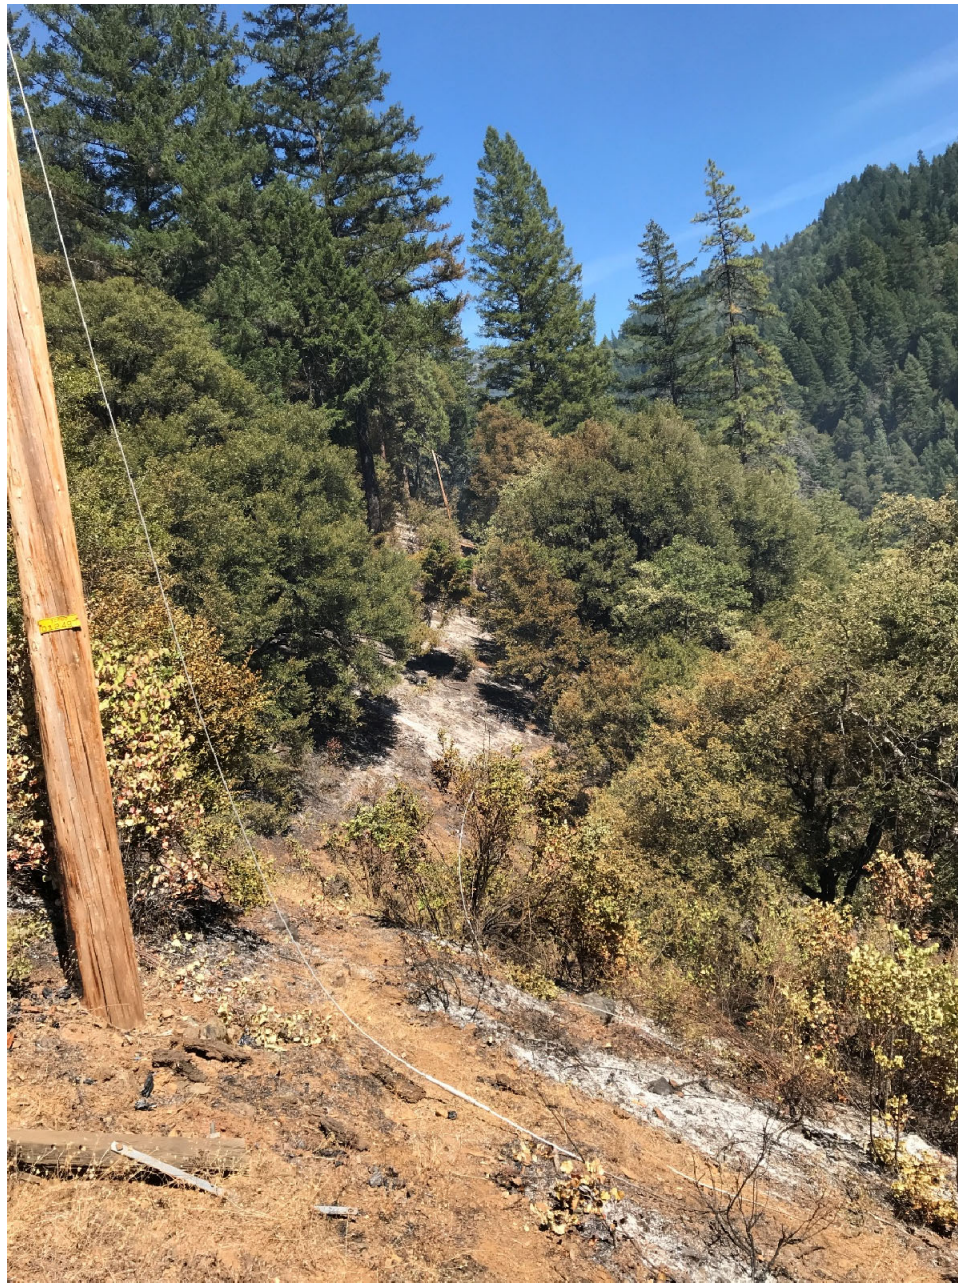
**Figure 1: A portion of the downed TPUD south line between poles #012497 and #012498**

16 19. Investigators continued identifying fire pattern indicators within the general origin area until they  
17 identified the specific origin area. Within the specific origin area, the Investigators observed that the  
18 southern-most electrical powerline, which spans between TPUD utility poles #012497 and #012498, was  
19 downed. A portion of this downed line was touching the ground and laying across a bush that was fully  
20 consumed by the fire as shown in Figure 1.

20. At the beginning of the downed line, there was visible sooting on the east side of the line as it lay in a north-south fashion, amidst overgrown vegetation that had not been appropriately cleared. Another bush touching the downed line had a char line which was consistent with an electrical resistance scar, a likely result of electricity attempting to conduct itself through the vegetation. The electrical resistance scar ended in the approximate upper two thirds of the stem of the bush. The majority of the lower one

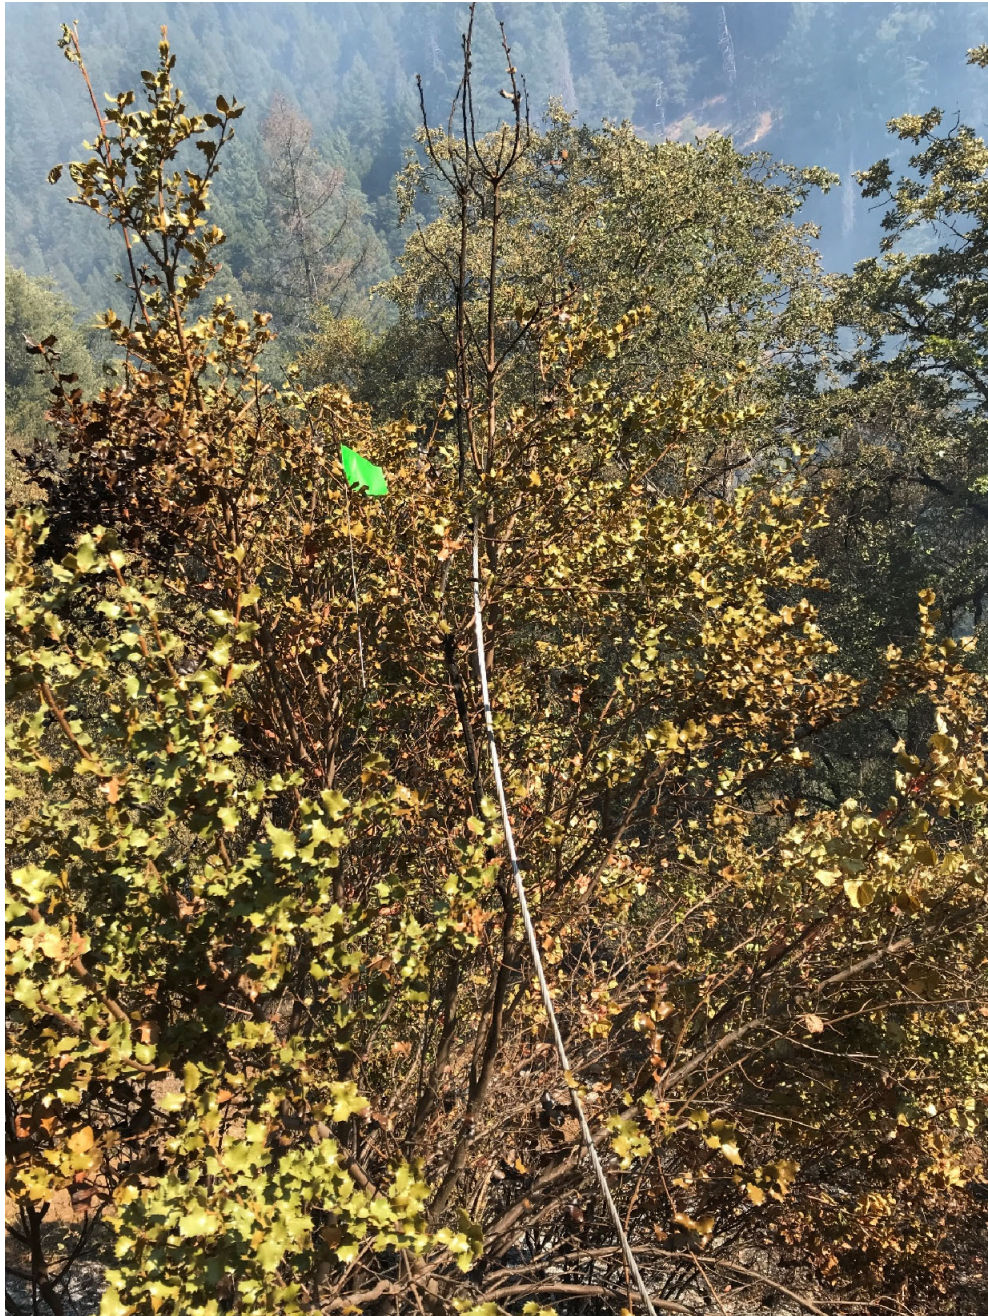
**Figure 2: The downed TPUD powerline on bush with electrical resistance scar**

1 third of the stem appeared to be charred from low intensity ground fire. From the end of the electrical  
2 resistance scar to the top of the ground fire char, the bush appeared to have no visible fire damage.  
3 Having a break in damage on the stem indicated the electrical resistance scar was the result of a charged  
4 powerline coming into contact with the bush.

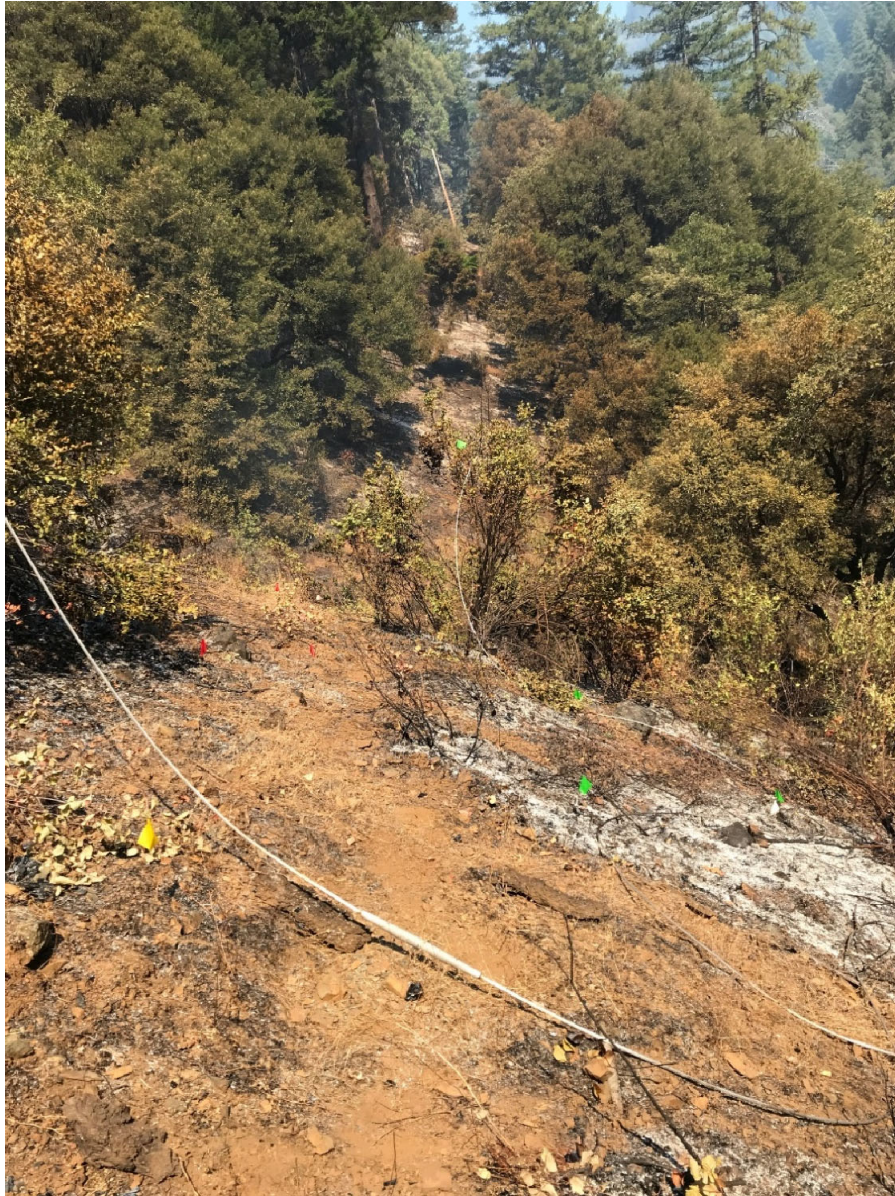
**Figure 3: Downed TPUD powerline with green flags marking probable ignition sources**

21. The Forest Service identified two probable ignition areas, where a competent heat source came into direct contact with readily combustible vegetative fuels, resulting in separate ignitions, as shown in Figure 3 below. The first ignition area was the stem of the bush in contact with the downed TPUD powerline. The second was the frayed metal fragments and melted metal from the downed TPUD powerline where it contacted the vegetation ground fuel. Figure 3 below shows both probable ignition sources.

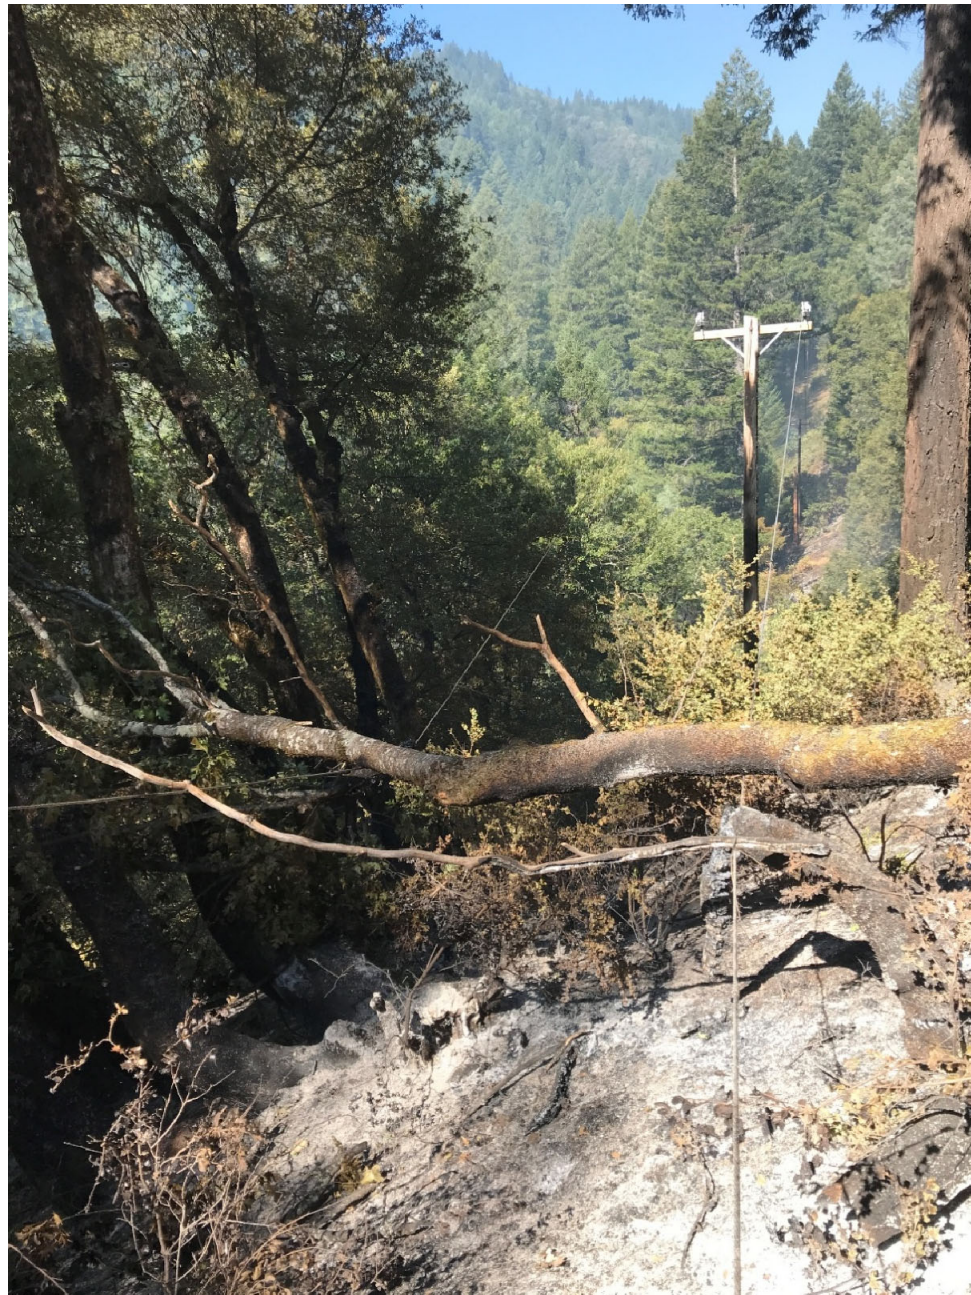
**Figure 4: Fallen oak tree across TPUD powerlines in general origin area**

1 22. The Investigators examined the previously identified oak tree which had fallen across two  
2 parallel sections of powerlines east of TPUD pole #012498 (shown in Figure 4, below). The tree's  
3 canopy still contained a notable amount of green foliage, while the base of the oak tree, which was  
4 separated from its root system, was visibly compromised by rot. The entire bole of the tree was decayed  
5 and absent, with the exception of a ring of barkwood that was a few inches thick in most places. The  
6 portions of the tree that came into contact with the TPUD powerlines displayed signs of heat transfer, in  
7 that the convex shape of the powerline was embedded as a concave shape within the charred portions of  
8 each of the oak limbs. The Investigators determined that the oak tree fell prior to the two ignition areas  
9 within the specific origin area, based on the visible fire pattern indicators that surrounded the oak tree,

10 and that the fallen oak tree compromised the integrity of the entire utility infrastructure, which directly  
11 contributed to the ignition of the Hobo Fire.

24. After gathering witness statements and evaluating fire pattern indicators in the surrounding area, the Forest Service concluded that the TPUD powerlines were the probable cause of the Hobo Fire. The fallen oak tree should have been removed based on clear indications of rot, but it was left in place and

1 fell onto TPUD powerlines. The fallen oak tree compromised the integrity of the utility infrastructure,  
 2 which caused charged powerlines and metal fragments to fall between TPUD utility poles #012497 and  
 3 #012498, onto vegetation that should have been cleared but was not. In sum, the Hobo Fire ignited  
 4 when electrical equipment owned, maintained, and operated by TPUD contacted, or caused electrical  
 5 current to contact, surrounding vegetation.
