## OWNER-ENGINEER AGREEMENT

**Re: Proposal for the Brookside Road Bridge over the Housatonic River  
Superstructure Replacement**

| CITY/TOWN<br><b>GREAT BARRINGTON</b> | B.I.N.<br><b>04K</b> | BR. DEPT. NO.<br><b>G-11-008</b> | 8.-STRUCTURE NO.<br><b>G11008-04K-MUN-NBI</b> | INSPECTION DATE<br><b>JUN 8, 2021</b> |

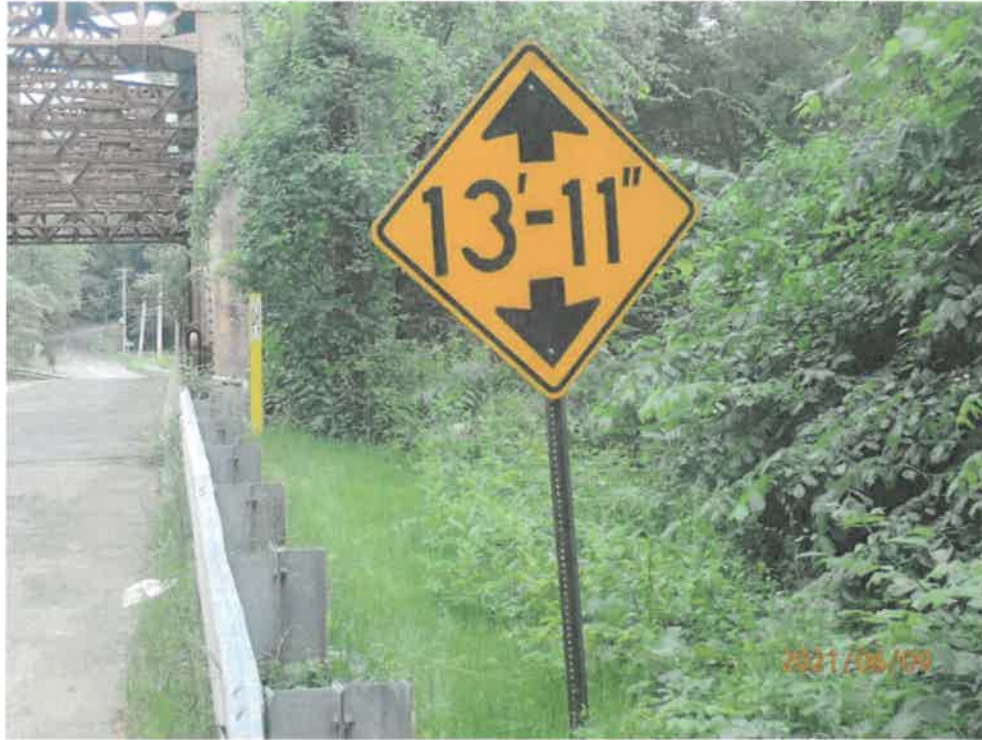
The minimum vertical clearance of 14'-2" was measured at Panel Point U6 over the double yellow lines. There are At-Bridge and Advance clearance posting signs of 13'-11" located along both bounds (**see Photos 1 and 2**).

**Photo 1: West Approach At-Bridge Clearance Posting**
