School District of Bloomer Facility Audit

June
2019

BLOOMER HIGH SCHOOL

FACILITY ANALYSIS

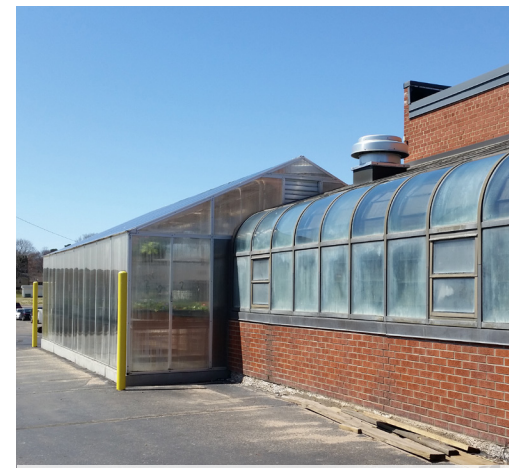
- Lack of an auditorium or another large presentation area
- Attached add-on food service refrigeration building
- Add-on extended greenhouse
- A patchwork of additions and corridors from past expansion
- Limited space in classrooms
- Inadequate storage space for adjacent areas of use
- Inappropriate storage in mechanical areas
- Outbuilding

Greenhouse extension

The first recommendation is to consider building a new high school. This option allows for the existing site and building to be used while the new construction is completed. The planning and design for the new building can remedy all of the space concerns while also improving the educational delivery and operational efficiencies. Identification of the funding for this option is a priority for the capital costs to complete.

The second recommendation in lieu of the first is to plan, design, and engineer in detail another renovation and remodel of the building and site. This option requires a large amount of transitional space for construction work to be completed or a long construction schedule with multiple phases over several years to complete. As with the other option, identification of funding for all phases to complete the renovation and remodel is a priority.

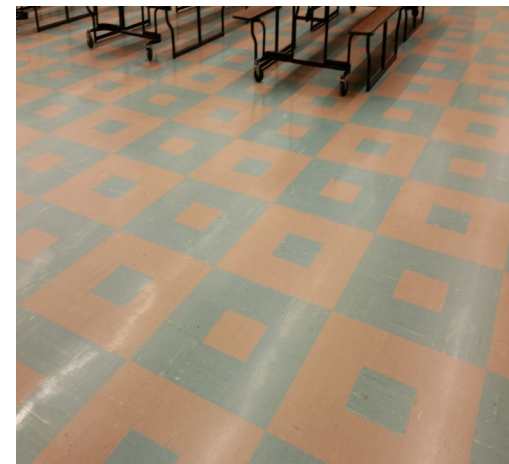
The mechanical/HVAC/plumbing systems are undersized and create uncomfortable accommodations for those attending events in the area. The ceiling, floor, and wall finishes are old, stained, and dingy in appearance. The floor tiles appear to contain asbestos. The stage storage space is small, cluttered, and unorganized.

Commons floor

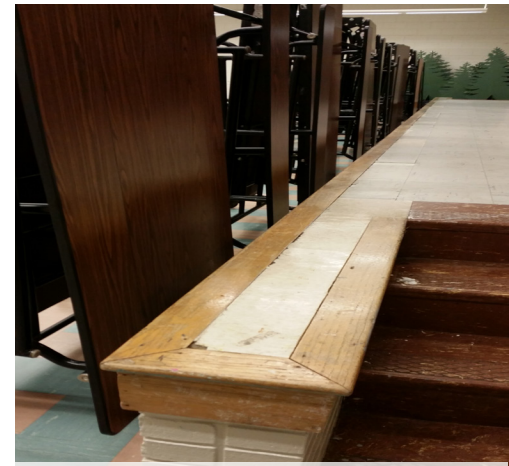
Stage edge, steps, and floor

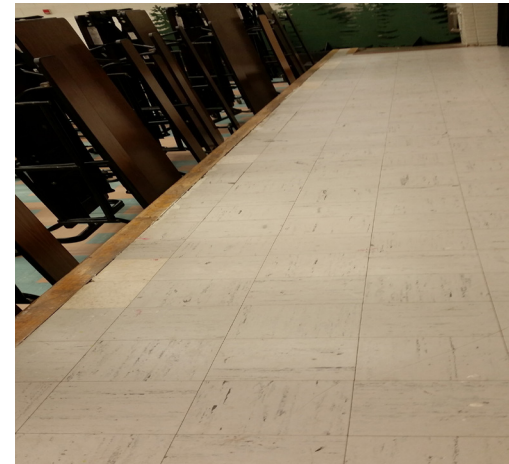
Commons stage

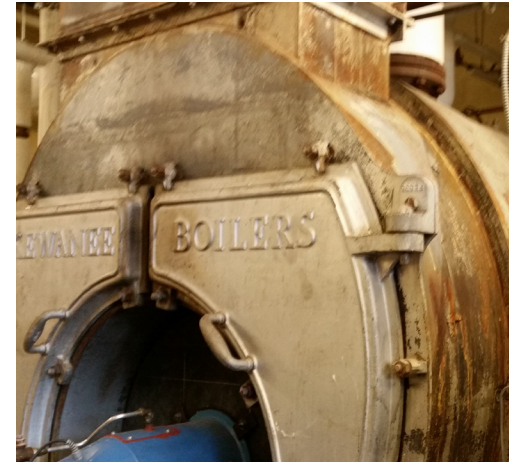
Kewaunee boiler

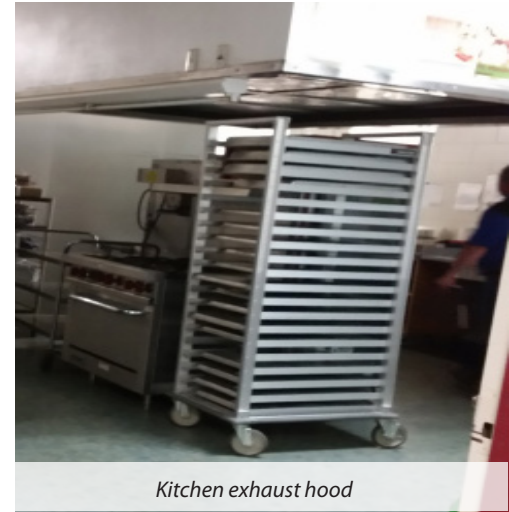
Kitchen exhaust hood

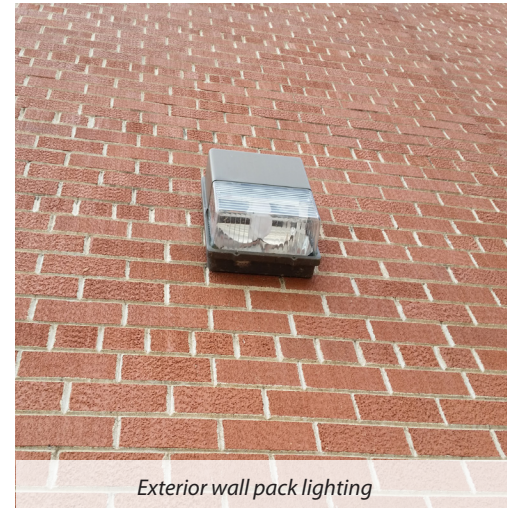
Exterior wall pack lighting

Specialty lighting for the stage, in the kitchen areas, in labs, greenhouses, gym, shops, and building exterior should also be replaced with new LED fixtures or retrofitted to LED.

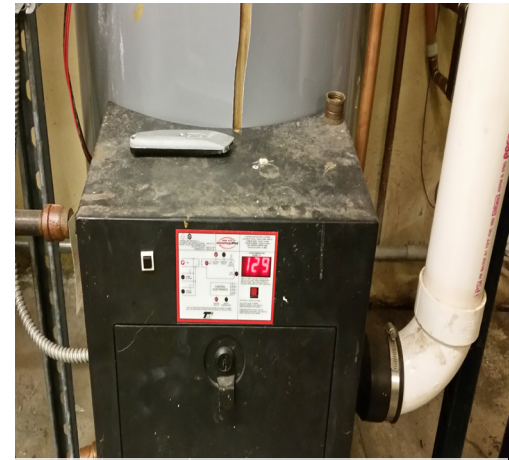
Domestic water heater temp control

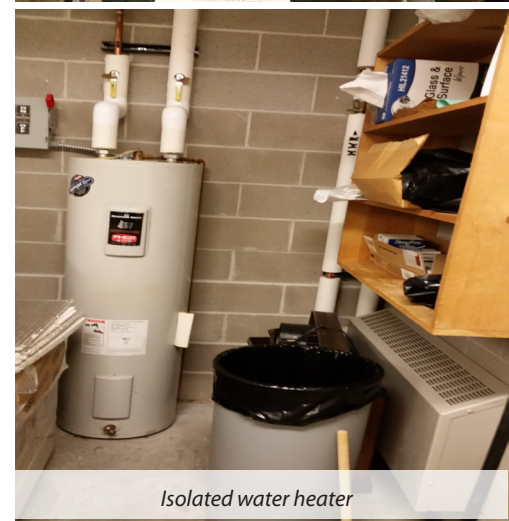
Isolated water heater

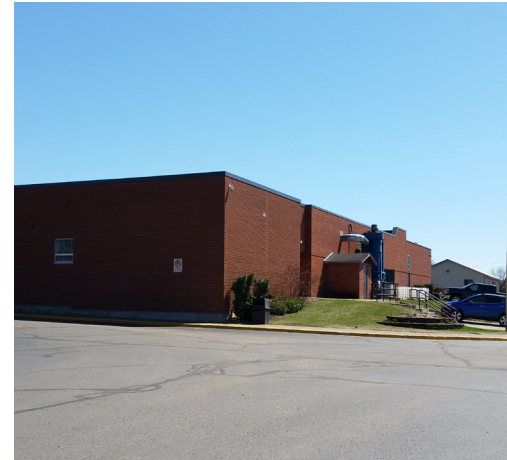
No marked walkways from main parking

- Add additional parking lots with pedestrian walkways.
- Include lot drainage system to protect new parking areas and to minimize additional runoff to fields and other site activity areas.
- Update door hardware to ADA compliant for rooms 160 and 160A through 160E.
- Update or replace fire alarm system.
- Install chain link fencing and locked gates around the dumpster, gas supply meter and distribution tree, electrical transformer, and emergency generator areas.
- Remove all inappropriately stored items as noted in the "Inadequate Space" section of this report.

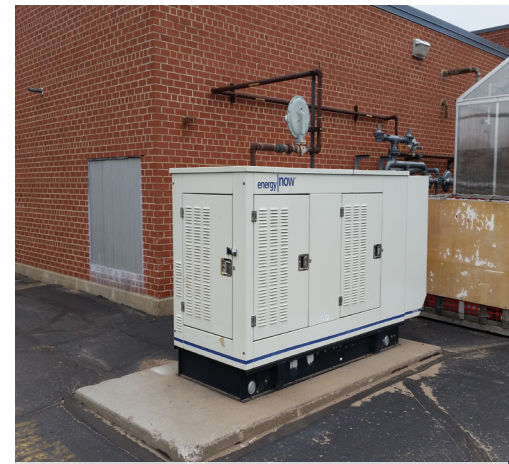
The fire alarm system is an Edwards Systems Technology EST2 addressable fire alarm system and is approximately twenty years old. The fire suppression protection is limited and only includes the kitchen exhaust hood and the small area in Tech Ed. The dumpster, generator, gas supply connection, and electric system main transformer are not secured and located next to parking and drive areas. Bollards are on two sides of the transformer with the front facing the driveway and the back unprotected next to the building.

Unsecured generator

For securing the external utility and hazardous work areas, the recommendation is to fence with locked gate the unsecured dumpster, gas supply meter and distribution tree, electrical transformer, and emergency generator areas. The second recommendation is to remove all non-electrical system storage from the main electrical room.

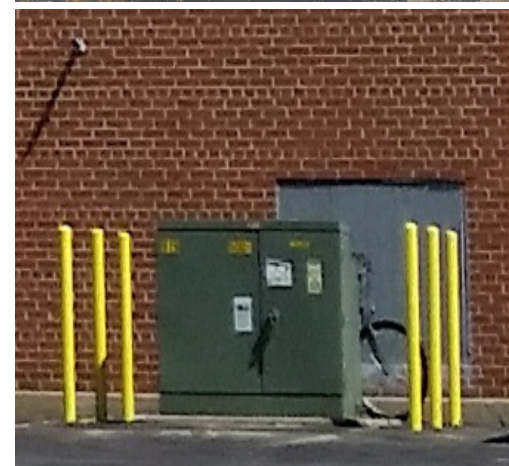
Unsecured electrical transformer

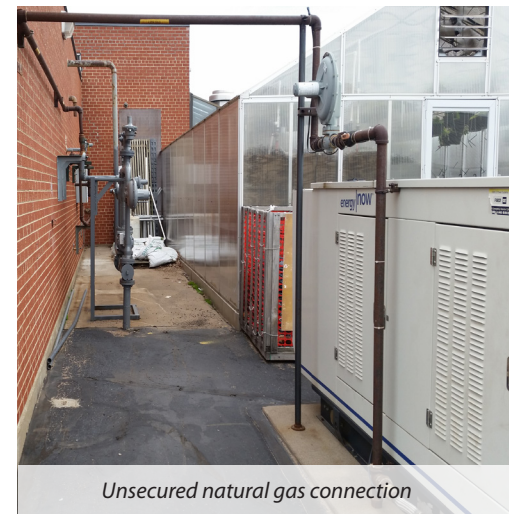
Unsecured natural gas connection

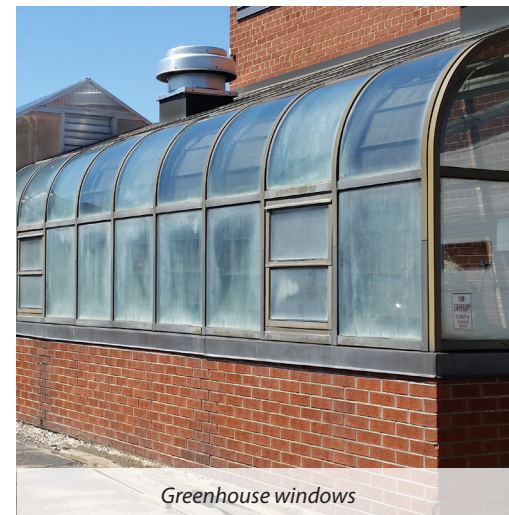
The high school window systems in different parts of the building are failing. The IMC (instructional media center) windows, room 128, and the greenhouse are examples of the insulating area between the glass panes filling with moisture, clouding the view, and staining the internal glass surfaces. The glazing sealant around windows in rooms 120, 122, and 123 have failed, causing similar problems. The roofing on the building is primarily in two age groups. Approximately half of the roofing is over sixteen years old. The other half of the roof area is nine years old. Failing seams and water ponding roofing problems are anticipated to increase as this older roofing ages. Replacement is anticipated for half of the roof area in the next five to ten years.

Greenhouse windows

The failed windows and window systems should be repaired or replaced. The tempered air leaking in and out of the window insulation area is causing occupant discomfort during the heating season, blocks window views, and looks dirty. The failed windows are also wasting energy. The cracked concrete exit door thresholds should also be repaired or replaced. The cracked thresholds allow for water infiltration into the door frames causing premature door replacement needs and potential door exiting failures. The water and air infiltration also create occupant safety hazards, occupant discomfort, and wastes energy.

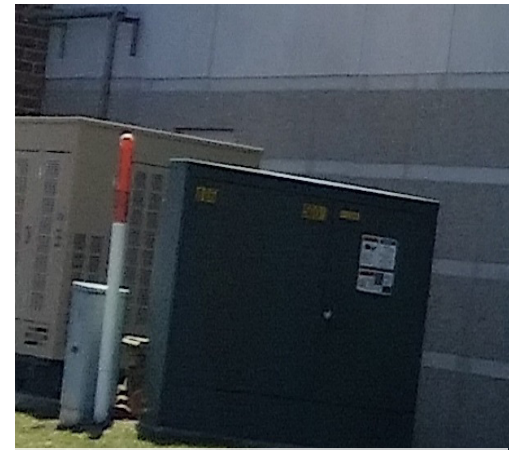
Unsecured transformer & generator

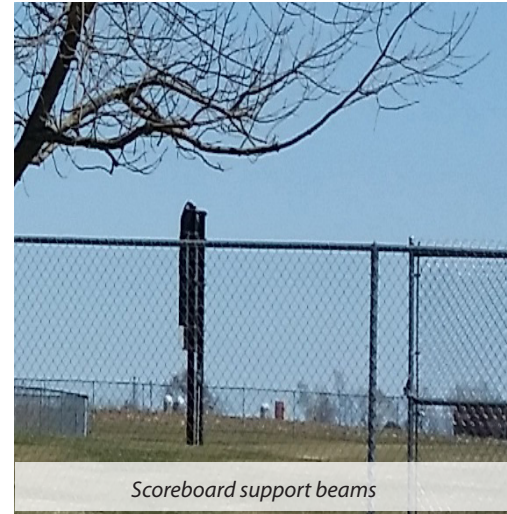
Scoreboard support beams
