Babb Fire

AKV-221- Incident #NES-2151

Wildland Fire Investigation Report

September 7, 2020

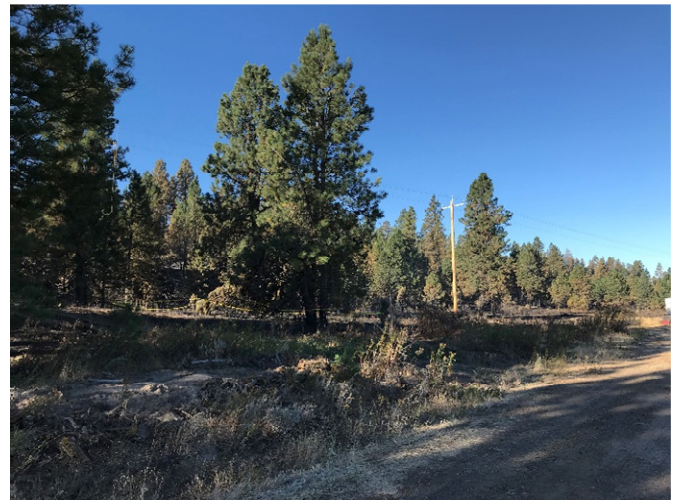
1

IMG0051 looking east/northeast at Ponderosa Pine tree that had a branch fail.

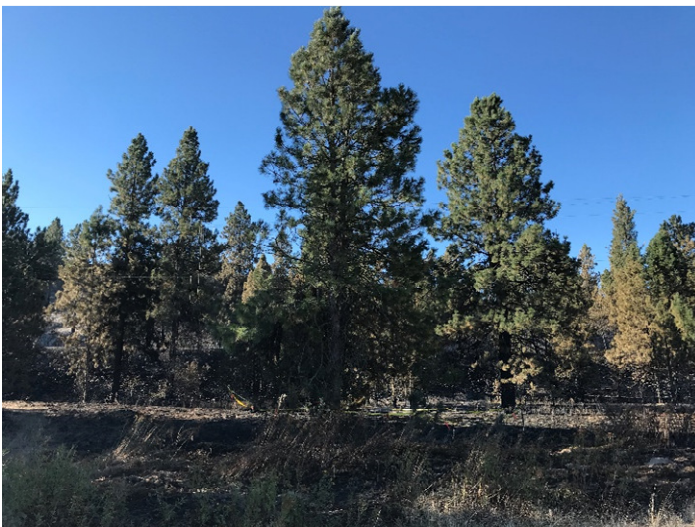
2

IMG0052 view of tree looking southeast from dirt access road off Morrow Rd.

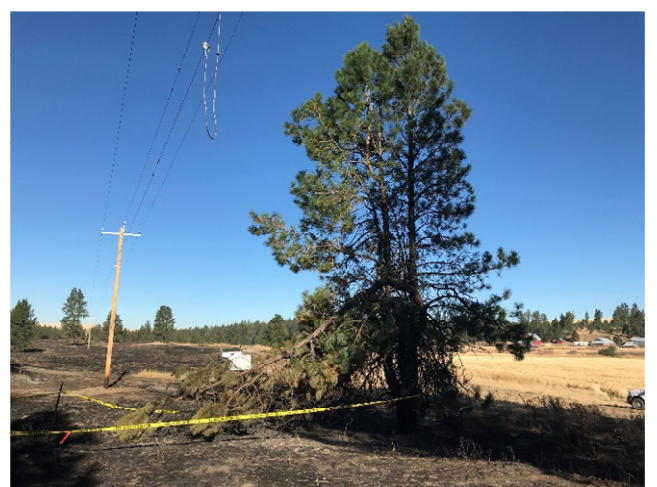
7

IMG0059 view of tree and power lines with new splices looking north/northeast

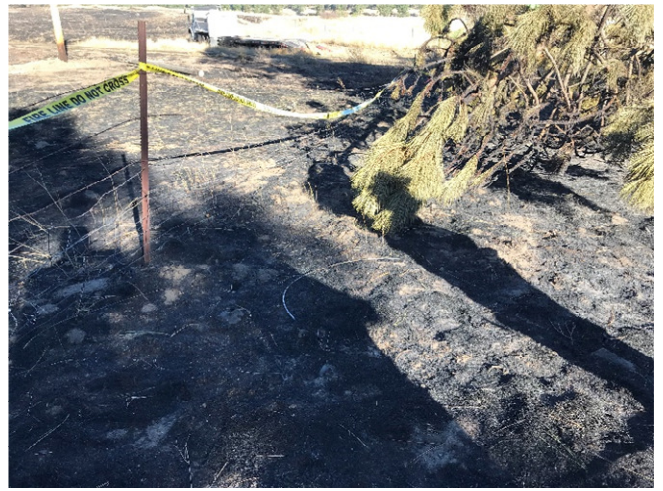
9

IMG0061 closer view of failed branch

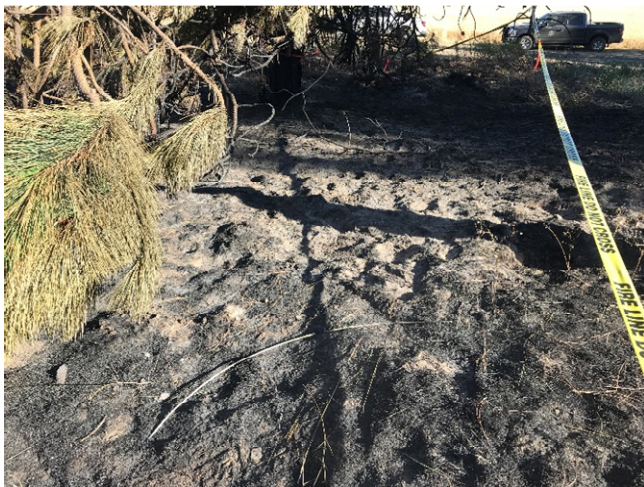
10

IMG0062 conductor left by Avista maintenance crew

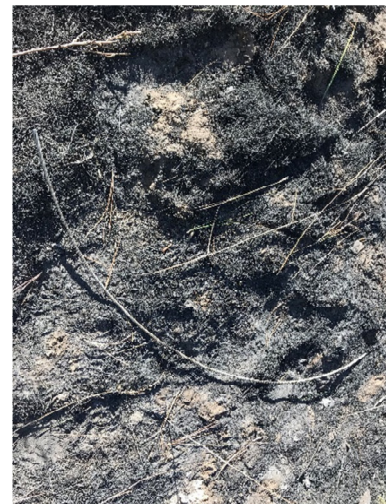
11

IMG0063 Conductor left by Avista maintenance crew

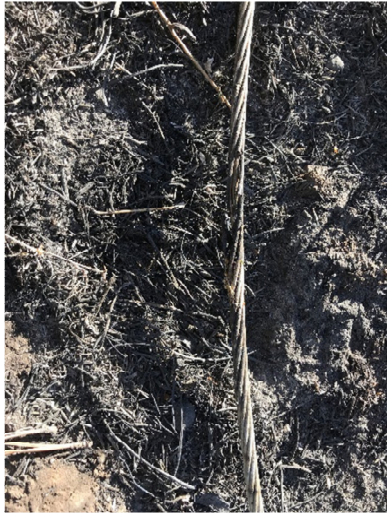
12

IMG0064 Close up of IMG0063

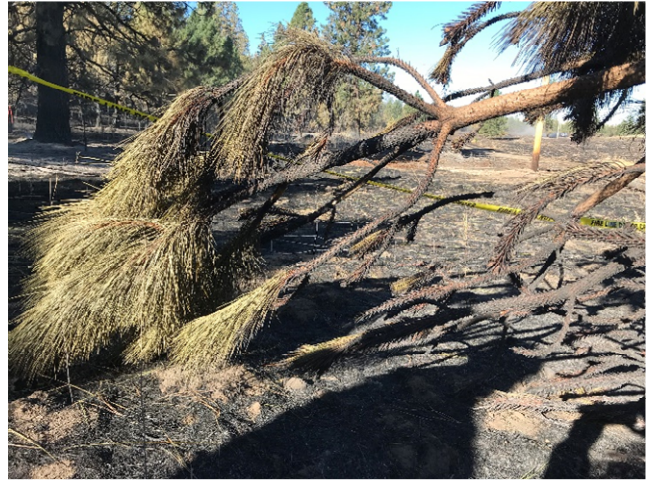
13

IMG0065 closer view of IMG0063

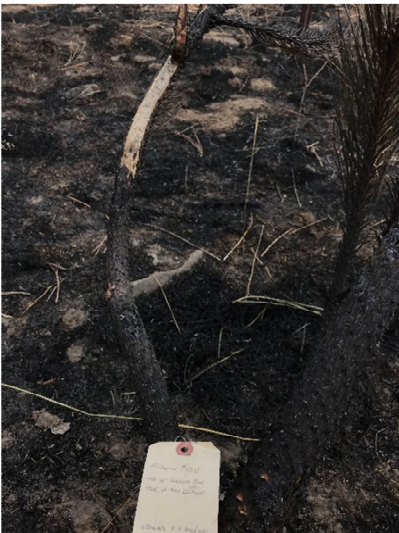
18

IMG0073 marks perpendicular to branch below tag

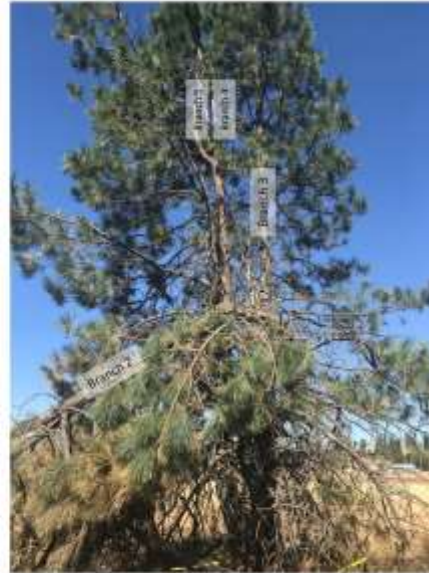
Drawing (not to scale) of the main branches of the ponderosa pine whose branch failed and struck the powerline that ignited the Babb Road Fire, facing NW. Branch 2 is the branch that failed and hit the powerline. Branch 2 fell on Branch 1, breaking that branch. Branch 1 was dead at the tip.

Branch 2 was the branch that initially failed, striking the powerline. This branch was 54 feet 10 inches in length, from the tip to the base of the tree. Branch 2 hit branch 1 when it failed, breaking that branch as well. There is no evidence that branch 1 hit the powerline.

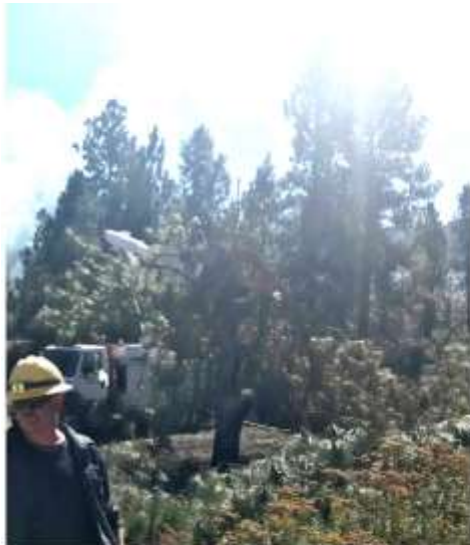
Image 3. View of the tree facing SW, after the adjacent tree, and branches 3, 4, and 5 were removed.

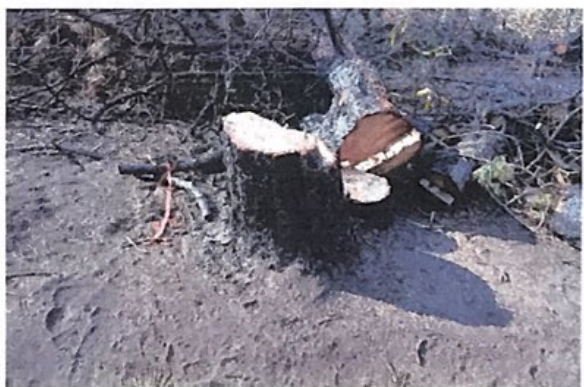
15
DSC 015 – Looking West at the stumps

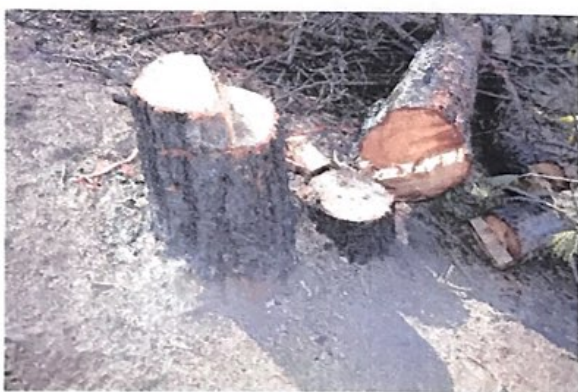
16
DSC 016 – looking West at the stumps

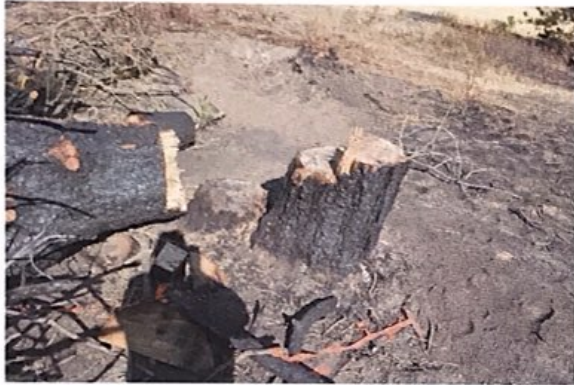
17

DSC 017 – Looking East at the stumps

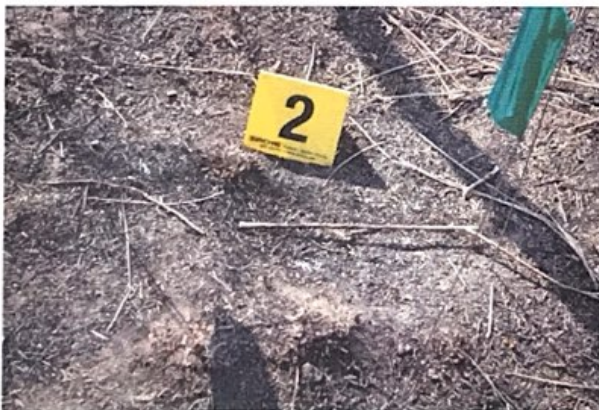
7

DSC 027 – Looking at the Aluminum droppings

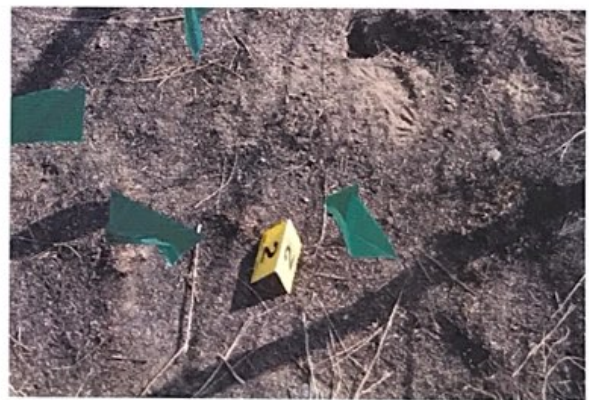
8

DSC 028 – Looking at the Aluminum Droppings

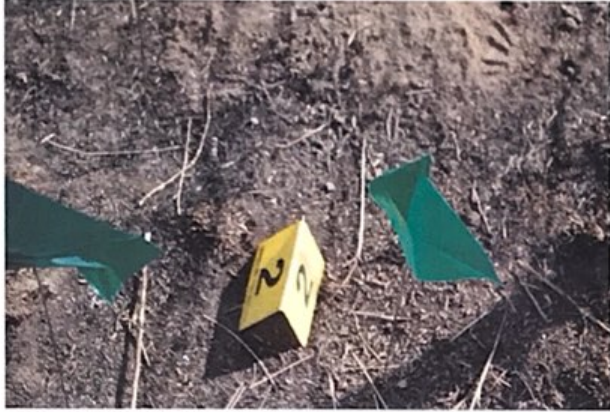
9
DSC 029 – Aluminum Droppings

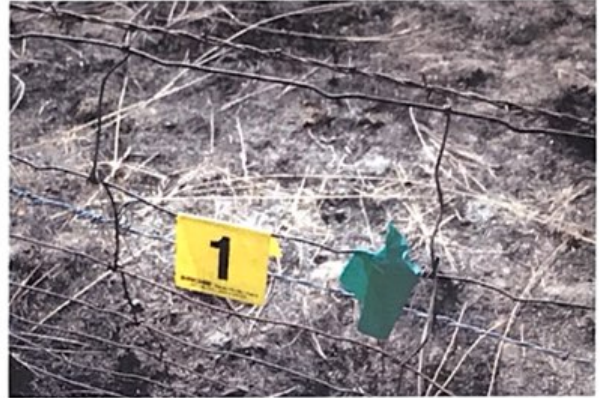
10
DSC 030 – Aluminum on the fence wire

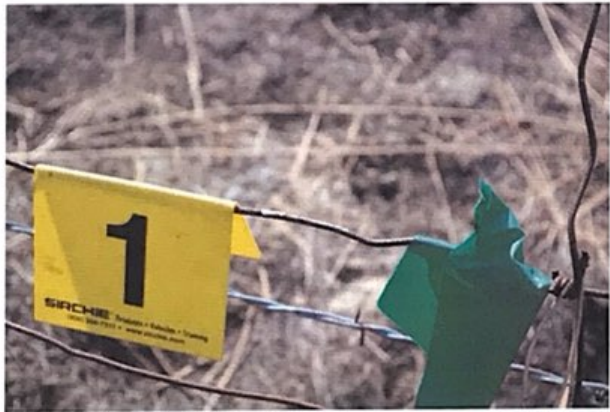
11
DSC 031 – Aluminum on the wire fence

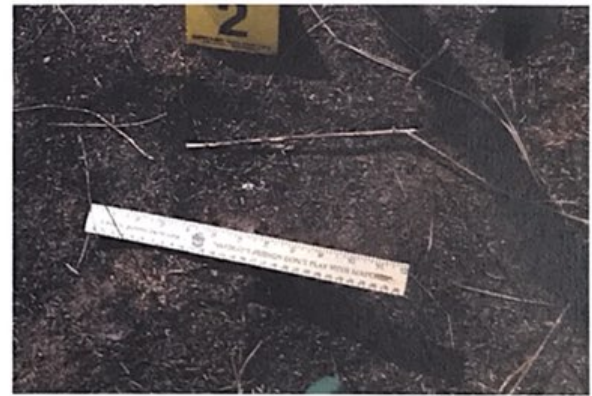
12
DSC 032 – Aluminum Dropping on the Ground

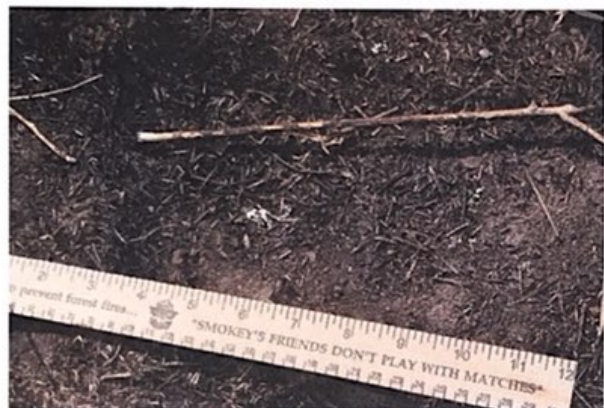
13
DS 033 – Aluminum Dropping on the Ground

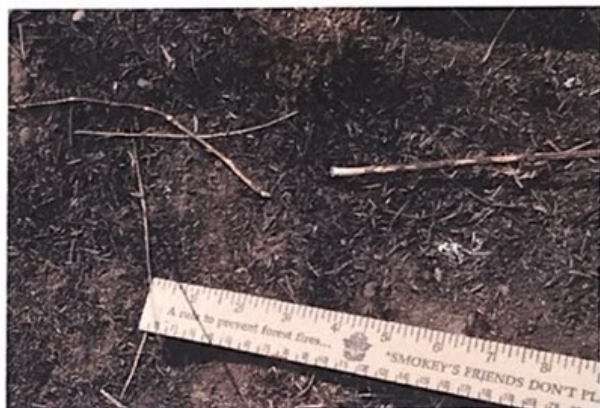
14
DSC 034 – Aluminum on the Ground

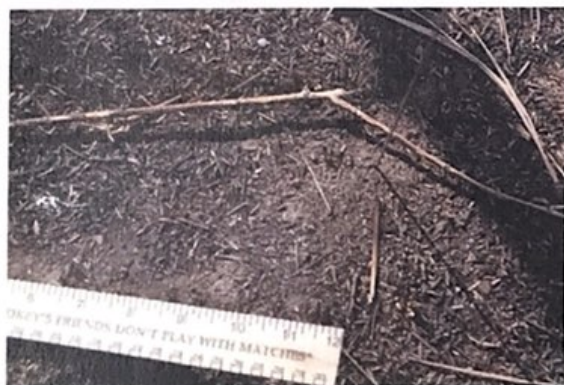
15
DSC 035 – Aluminum on the Ground

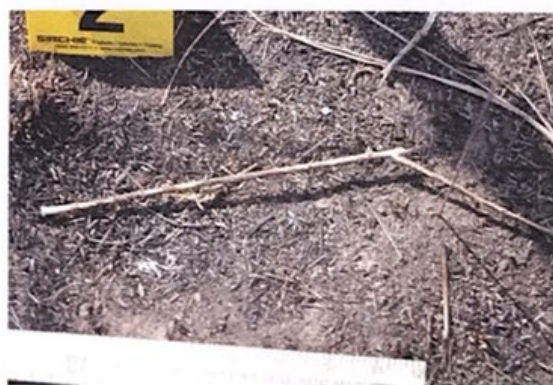
16
DSC 036 – Aluminum on the Ground

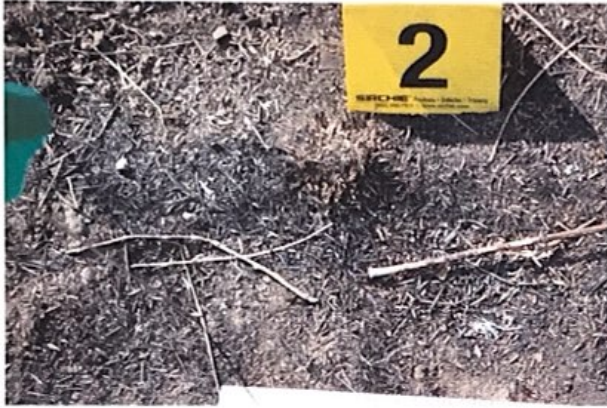
17
DSC 037 – Aluminum on the Ground

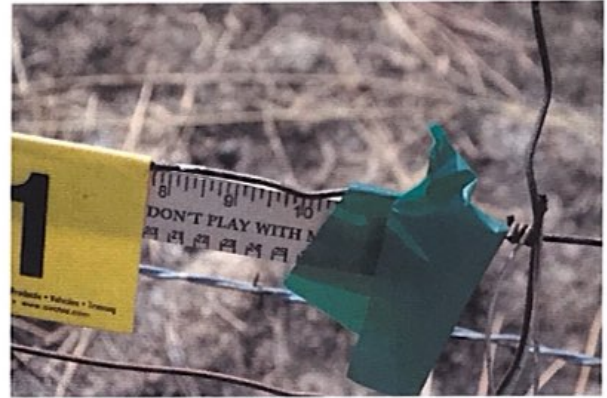
18
DSC 038 – Aluminum on the wire fence

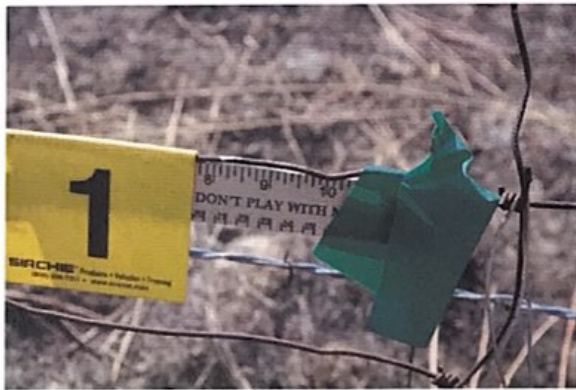
19
DSC 039 – Aluminum on the wire fence

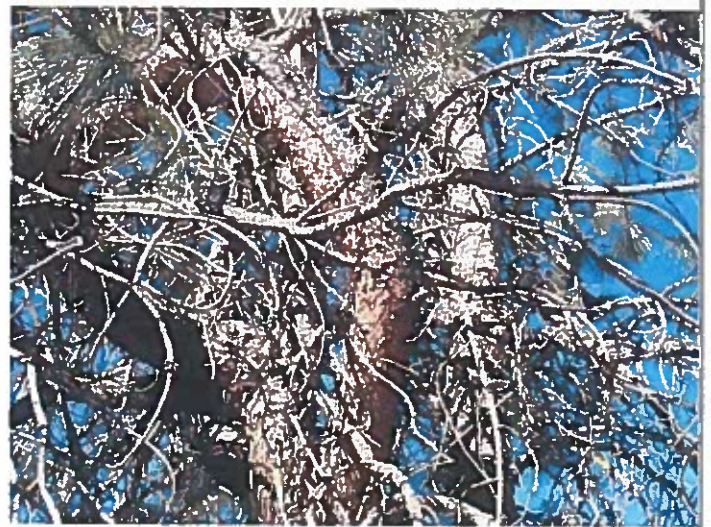
12-017

Photo taken looking at the east side of the tree and is showing the defect in the limb that failed.

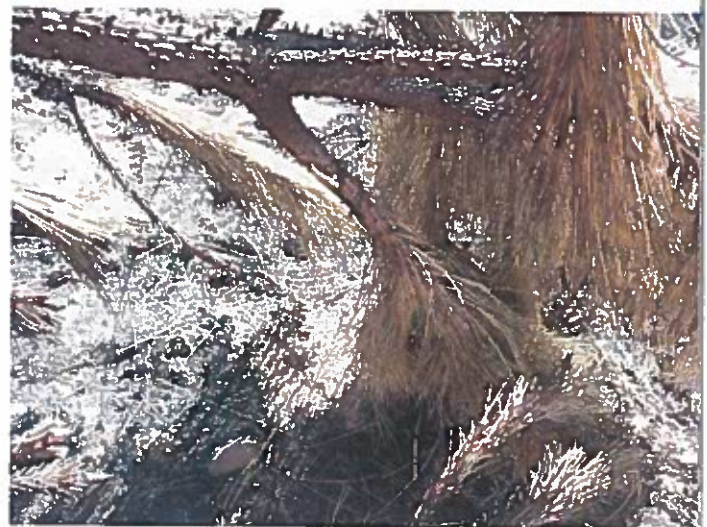
16-021

Photo is a close view of the end of the failed limb. This is the area, of the tree, that contacted the power lines.

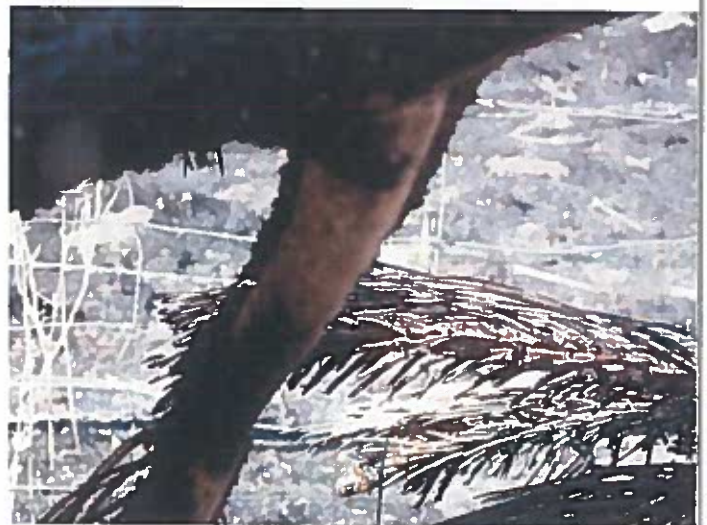
20-025

Photo is a close up view of the scar from the power line.
