PROPERTY INSPECTION REPORT

601 Main St
Inspection Prepared For: Kirk Beattie
Agent: Warren Clement - Re / Max Innovative Bayside Laconia

Date of Inspection: 4/24/2024

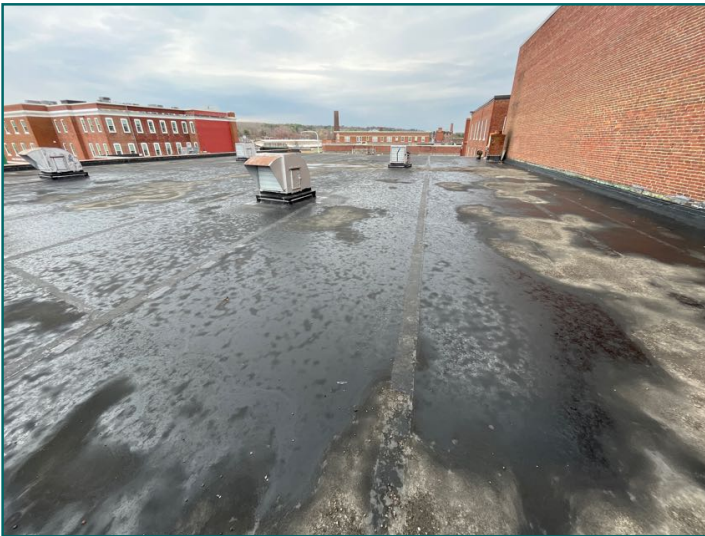
Rear / upper roof surface

1.2. There are areas of lifting and or damage to roof surfaces, recommend assessment and repairs as needed by a qualified roofing contractor.

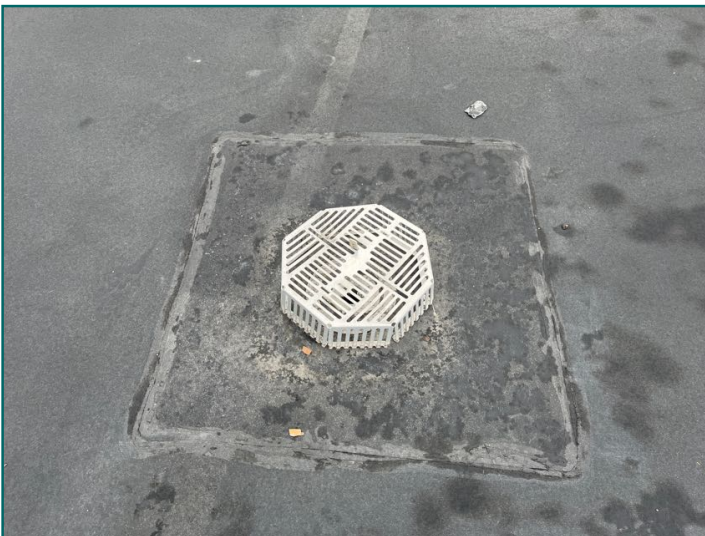
4.2. One or more of the roof top gutter screens are missing or damaged. Recommend installation of drain screens to help prevent clogging and ponding on roof, and regular maintenance of drains and gutter system.

Internal roof drains throughout

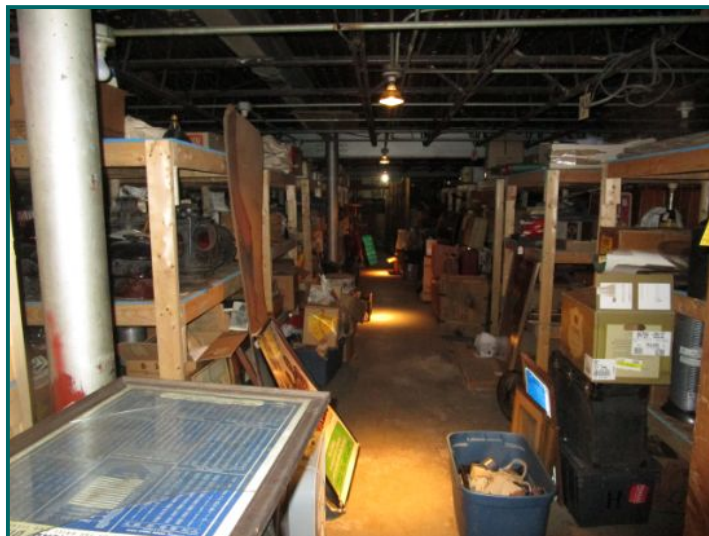
Limited visibility in basement space due to stored items / cluttered conditions

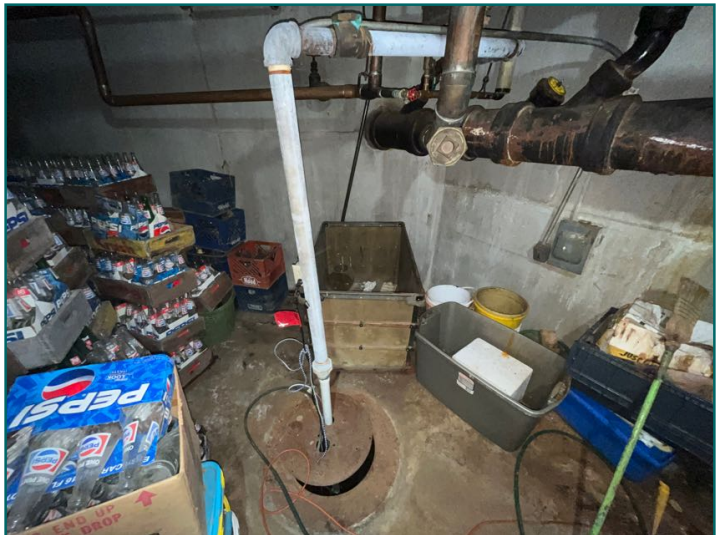
Sump pump at front of basement drains into sewer system

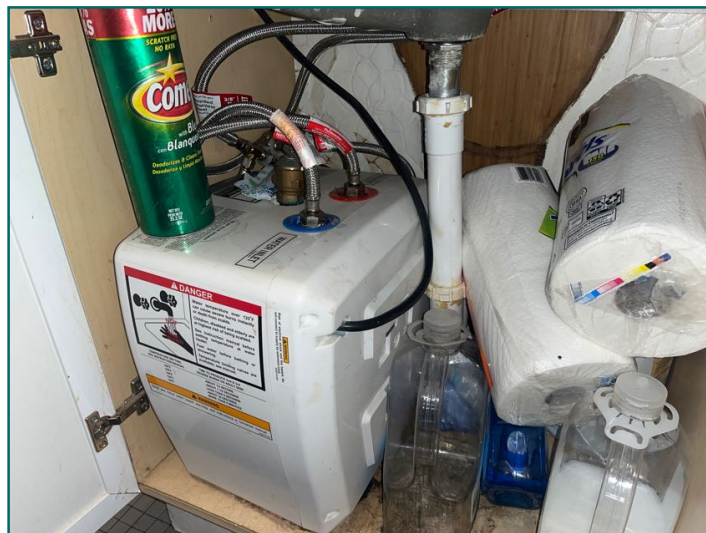
Electric water heater in first floor bathroom, age not determined

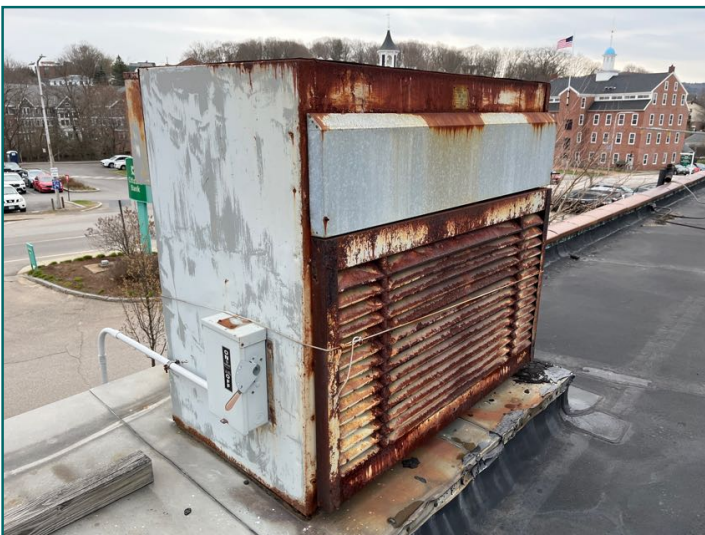
Right side RTU age not determined, shut down no longer in use

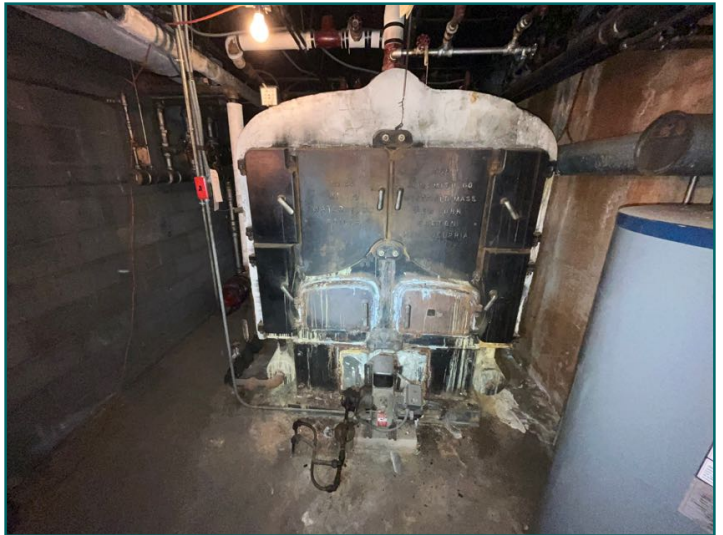
Boiler in basement, age not determined

1.8. Oil boilers and furnaces require annual maintenance. Last maintenance is not recorded. Recommend inspection maintenance and cleaning by a certified oil heating company. Recommend inspection of oil tank during each annual boiler service.

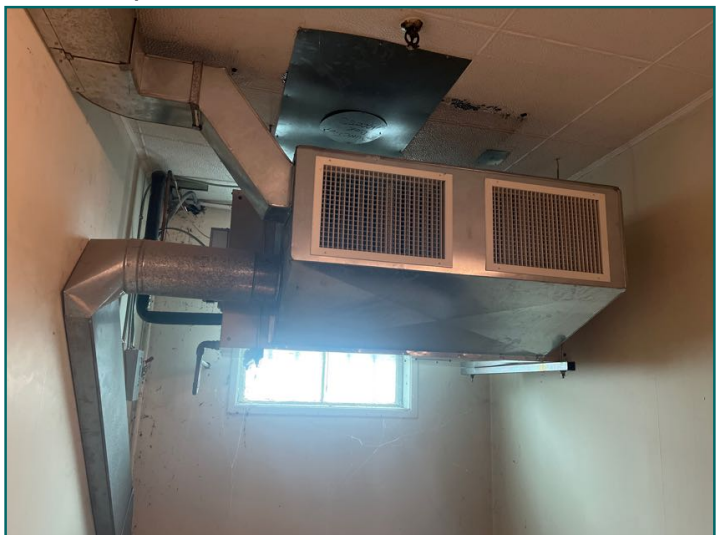
Air handler at rear stairwell, age not determined

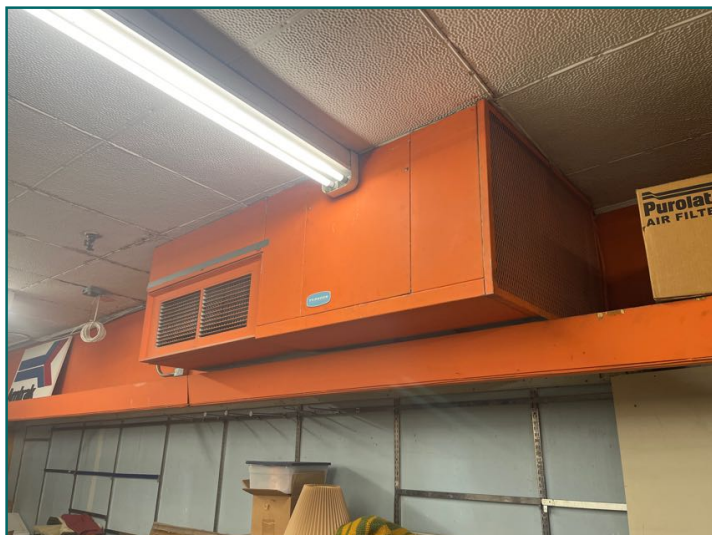
Air handler at rear second floor, age not determined

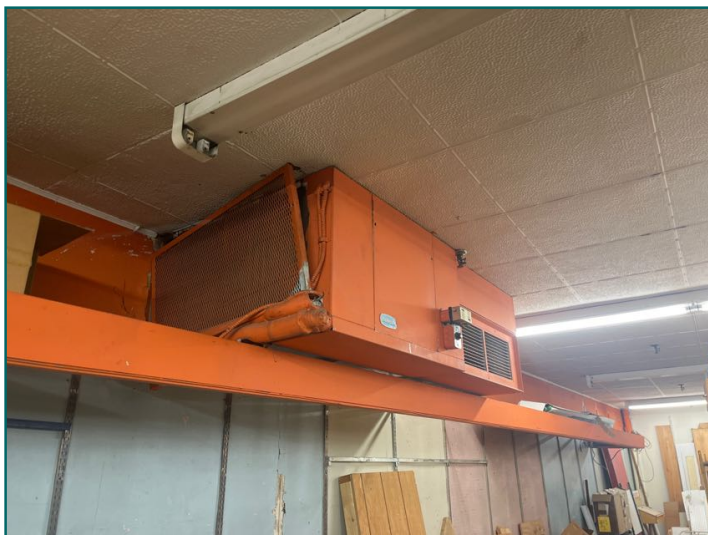
Air handler at rear second floor, age not determined

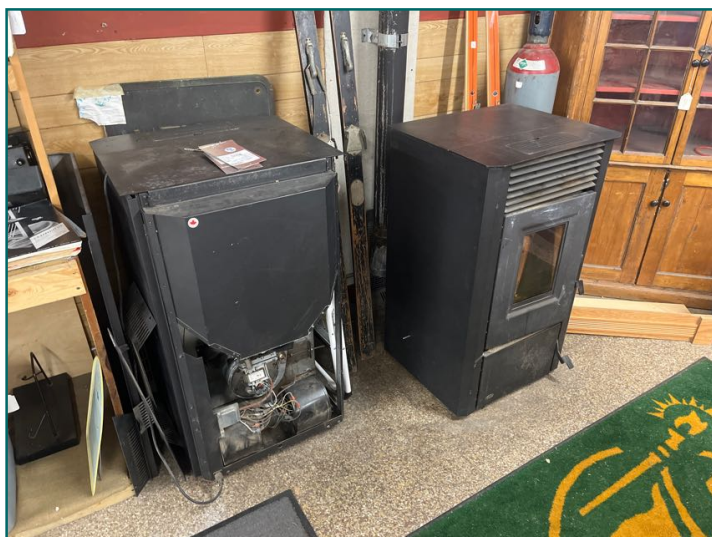
Pellet stoves at rear first floor

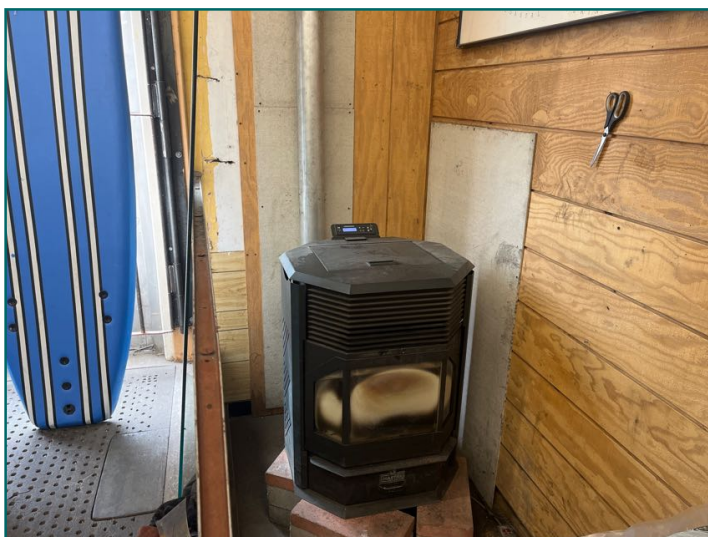
Pellet stove at right side

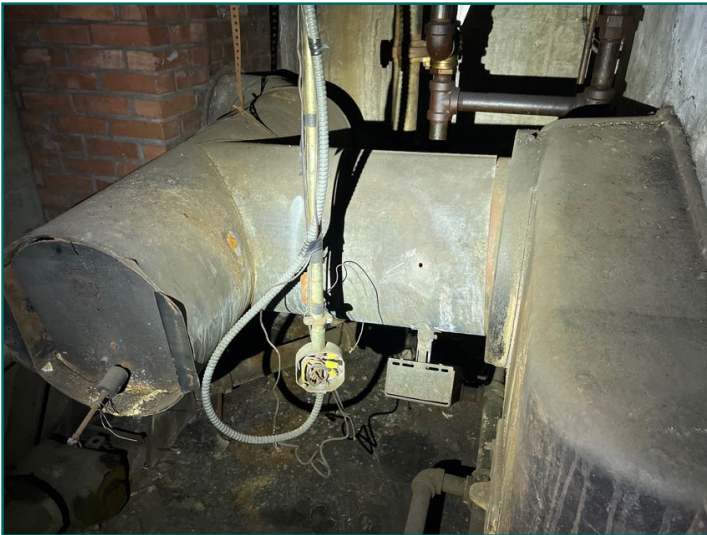
Boiler vent termination

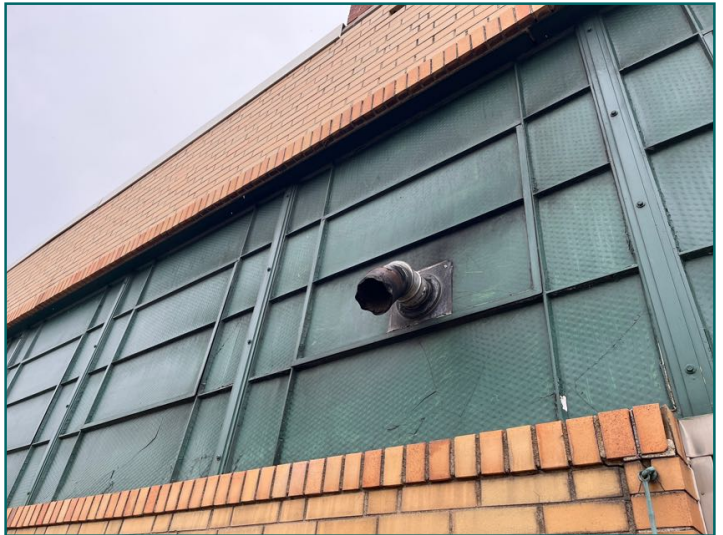
Pellet stove vent termination at right side

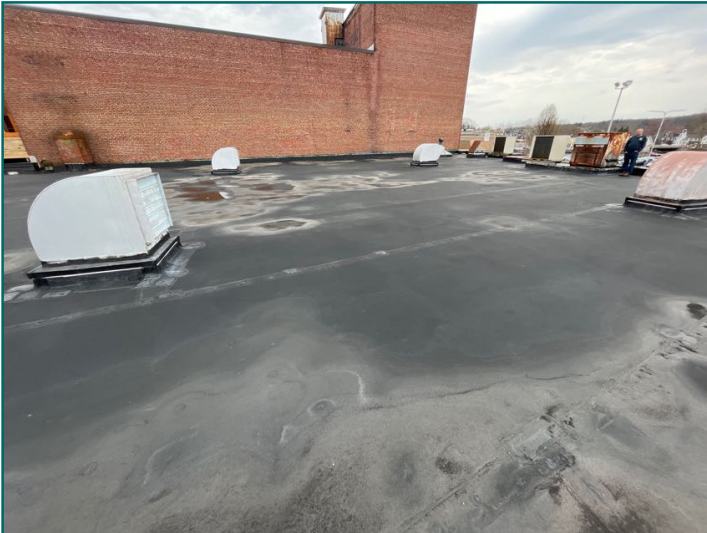
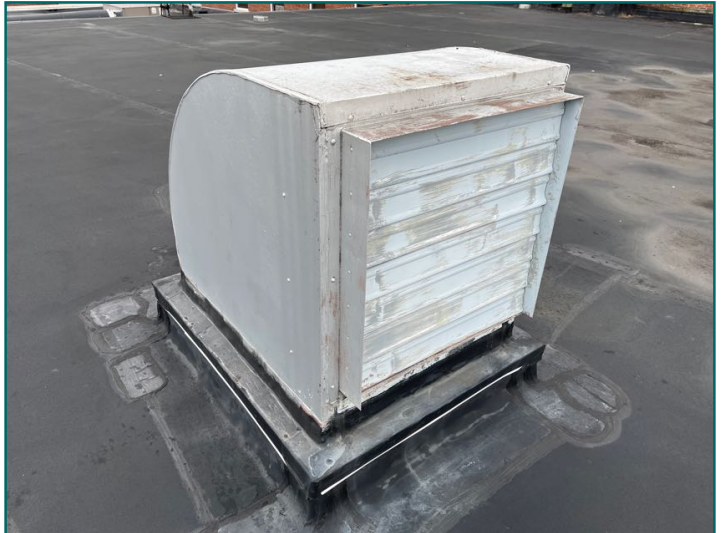
HVAC vent terminations on roof

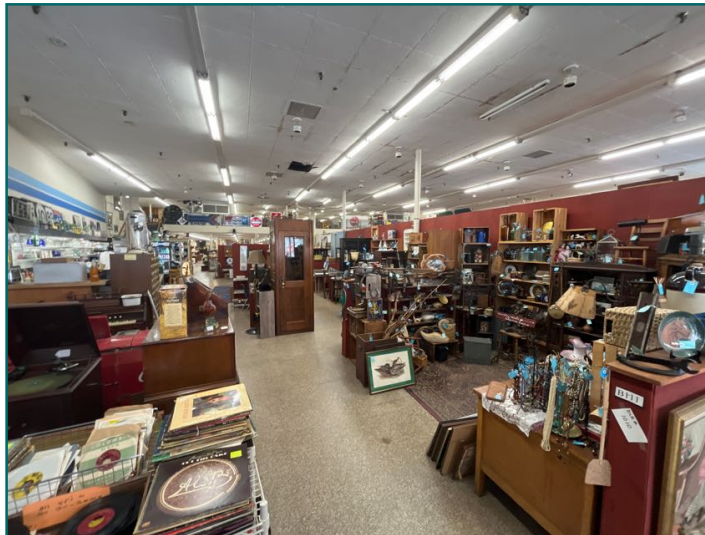
3.2. Cluttered conditions in one or more area of the building limiting visibility and access to interior surfaces and components.

Limited visibility throughout due to stored items / cluttered conditions

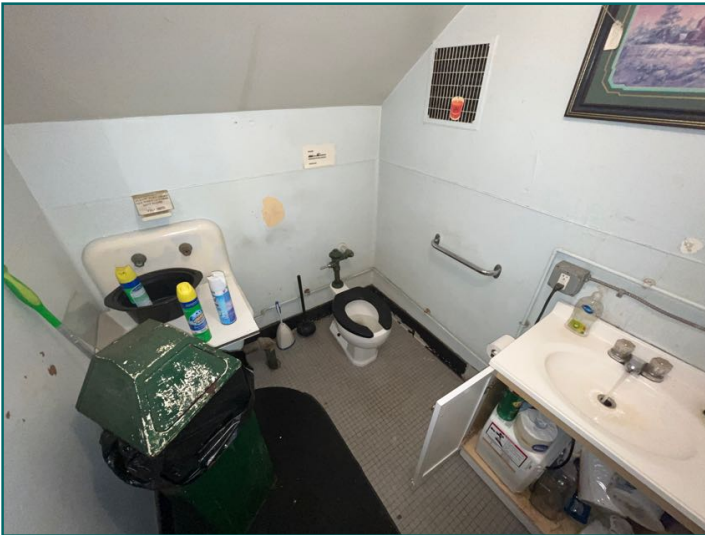
First floor front left bathroom

7.2. Water was shut off to one or more plumbing fixture Unable to test. Recommend, licensed plumber turn on water and assess all plumbing components.

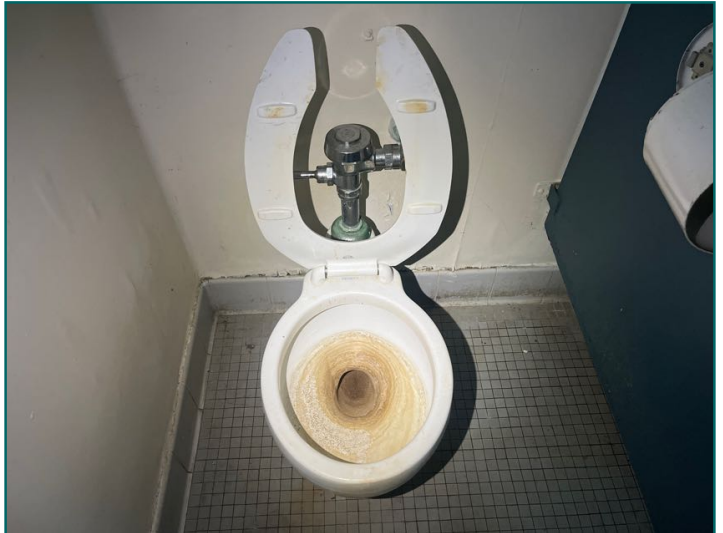
toilet not functioning in second floor bathroom

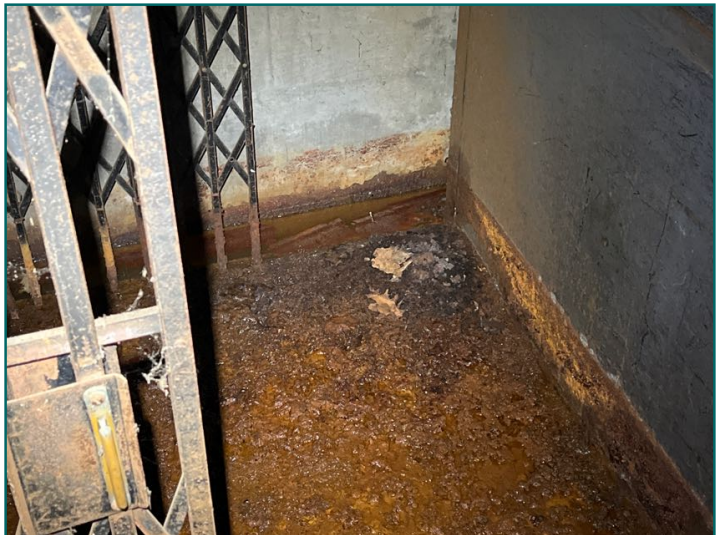
9.2. Elevator shaft is filled with ground water, recommend evaluation and repairs by a qualified contractor.

Elevator / elevator shaft are filled with water

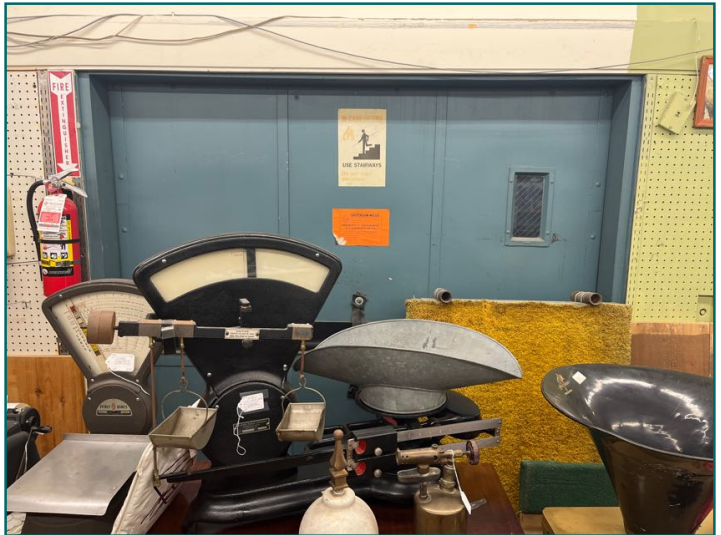
Elevator doors are blocked at one or more area, could not assess
