| <b>Report Title:</b> | Safe Drinking Water Act Compliance Inspection Report | | |
| <b>Inspection Date(s):</b> | Tuesday, July 26, 2022 – Thursday, July 28, 2022 | | |
| <b>System Name:</b> | City of Richmond | | |

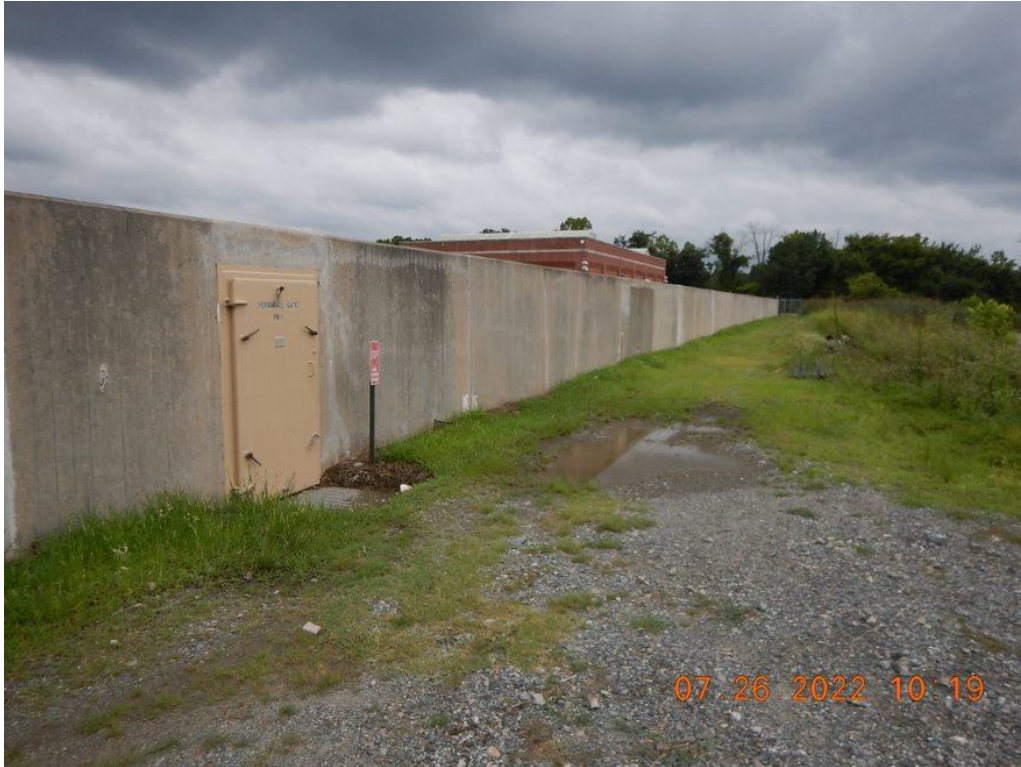
2. Pre-sedimentation Basin, Residuals Settling Lagoon, and Raw Water Basin
- The Superintendent explained that the flood wall is inspected by the United States Army Corps of Engineers (USACE) annually. It was funded by USACE but is owned by the City of Richmond (see *Attachment A: Photo 1*).

**Photograph 1.** Flood wall between treatment plant and the lagoon/pre-sedimentation basin area.

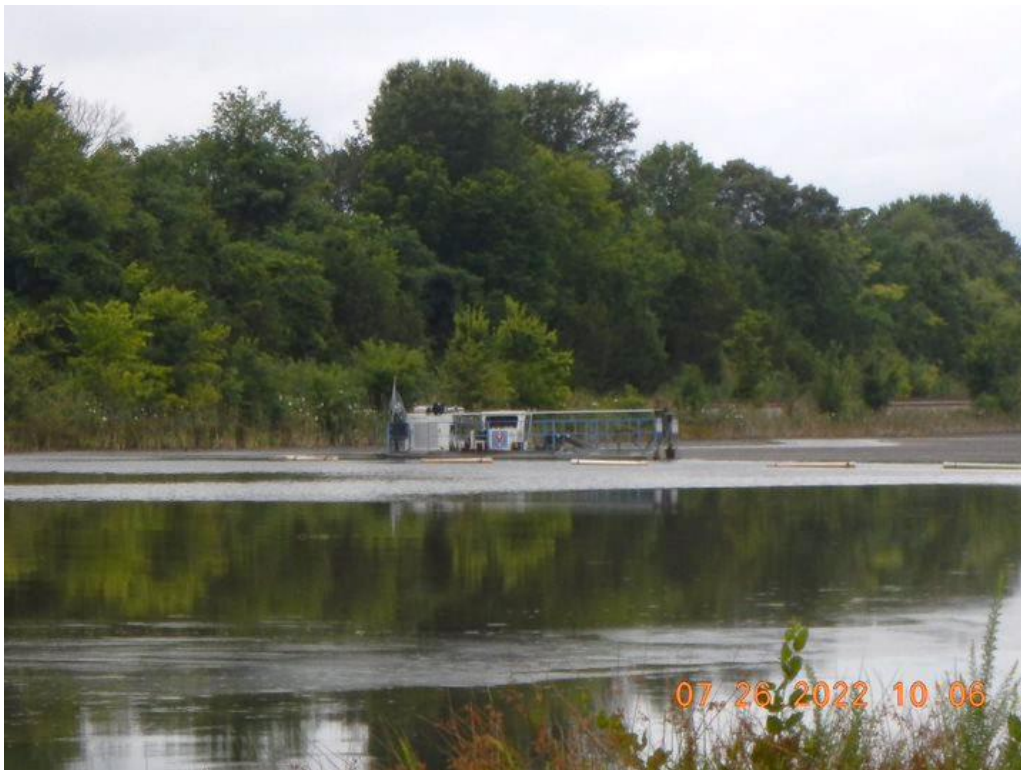
- EPA observed lagoon dredging activities. The Superintendent explained the dredging process started in April 2021 and takes approximately two years to complete. The System uses five-year contracts for lagoon dredging. The Superintendent explained there are no operational impacts to drinking water production during the lagoon dredging process (*Photo 2*).

**Photograph 2.** Lagoon dredging operation.

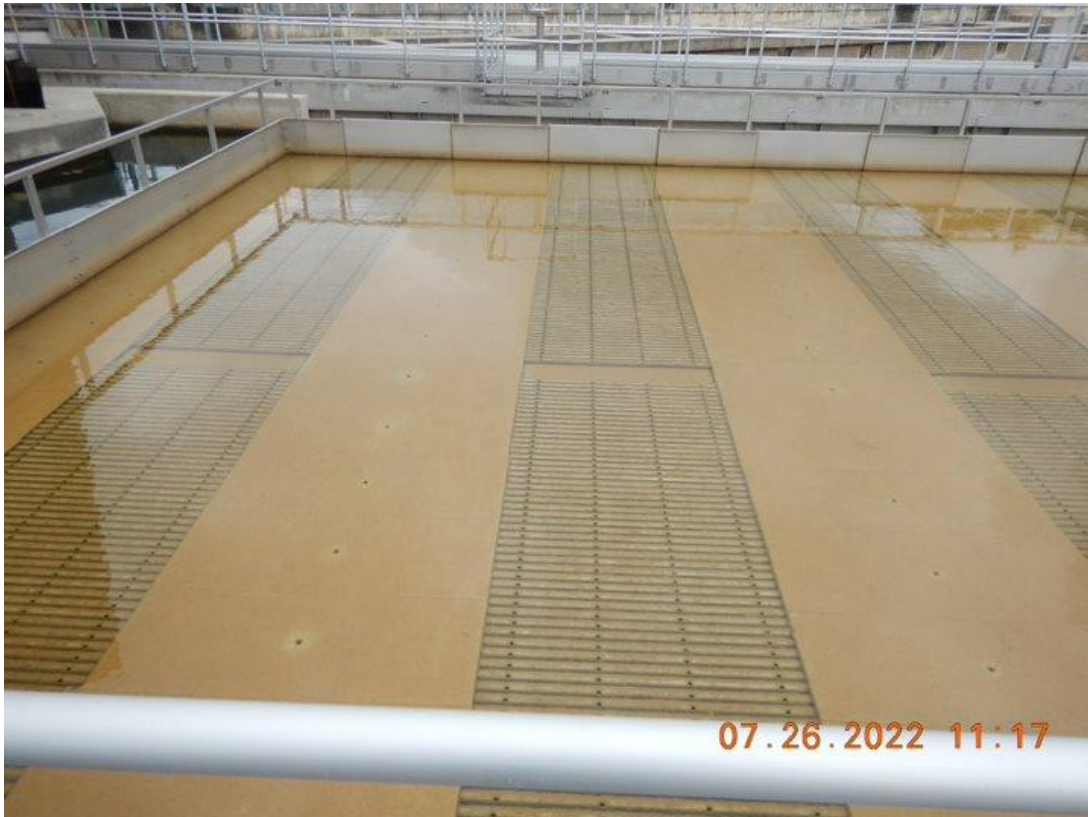
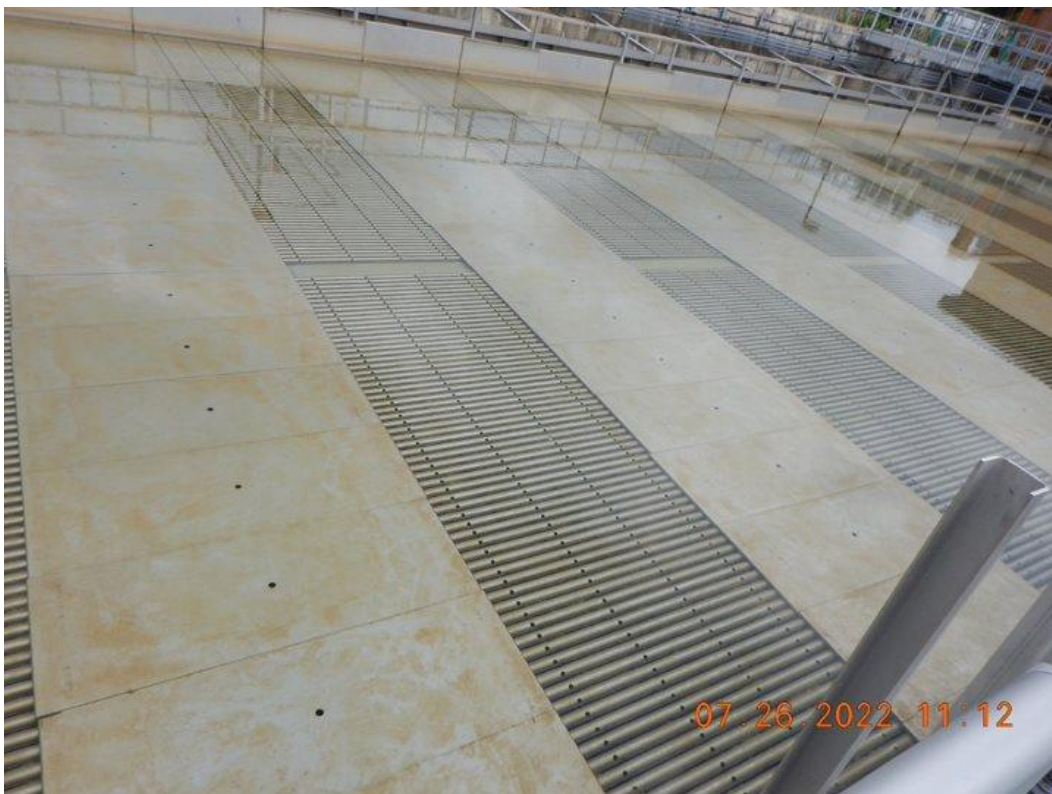
- The Superintendent stated that each sedimentation basin is drained twice/year to be cleaned. The Superintendent also stated that the plate settlers are cleaned in sections weekly with a fire hose. EPA observed more solids collected on the Plant 1 plate settlers than Plant 2 (*Photos 22-23*).
- EPA observed one flocculator in three separate basins that were out of service.
- Flocculator 4-2A had exposed wiring to the motor on the platform above the basin (*Photo 24*); this flocculator is one of the three that was out of service during the inspection.
- The flocculation basins are discussed in more detail with the Sr. Plant Operations Supervisor on Day 3 (July 28, 2022) below.

**Photograph 22.** Plant 1 plate settlers.

**Photograph 23.** Plant 2 plate settlers.

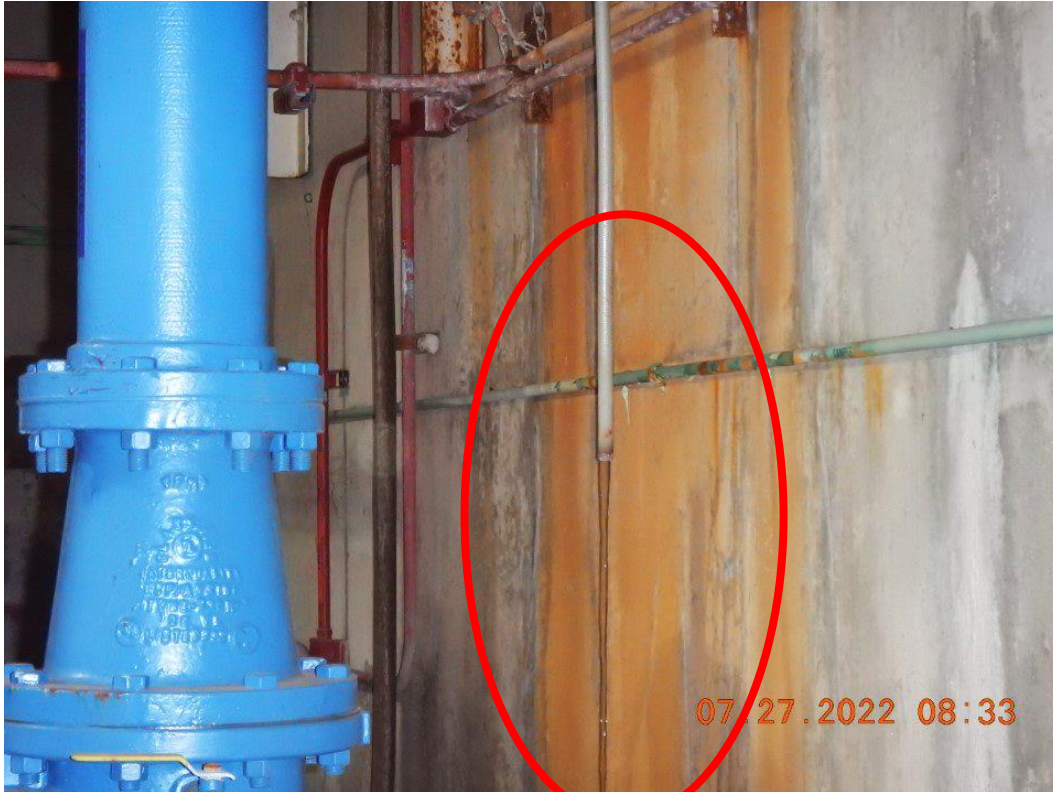
**Photograph 43.** Process water pipe discharging to floor on lower level of Korah 2 and 3 Pump Station

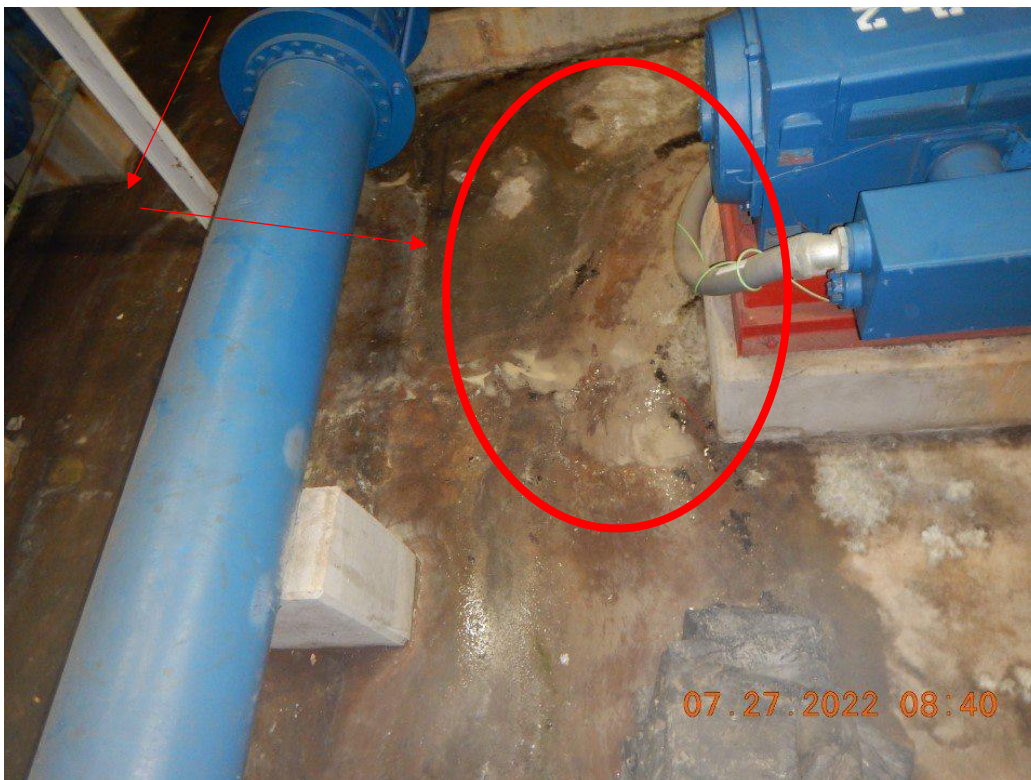
**Photograph 44.** Water flowing across floor near K3-2 pump, and algal growth on floor near pump motor in Korah 2 and 3 Pump Station.

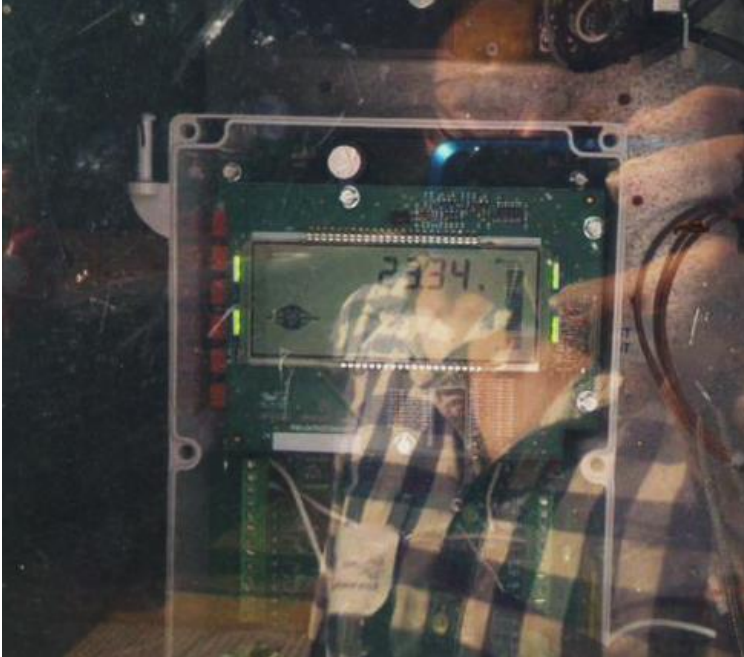
- System Representatives stated that the full capacity of the reservoir is at a water level of 27', and that they usually operate with the reservoir at 18-24'. At the time of inspection, the reservoir level read 23.34' (*Photo 57*).

**Photograph 57.** Level indicator at Byrd Park Reservoir reading 23.34 feet.

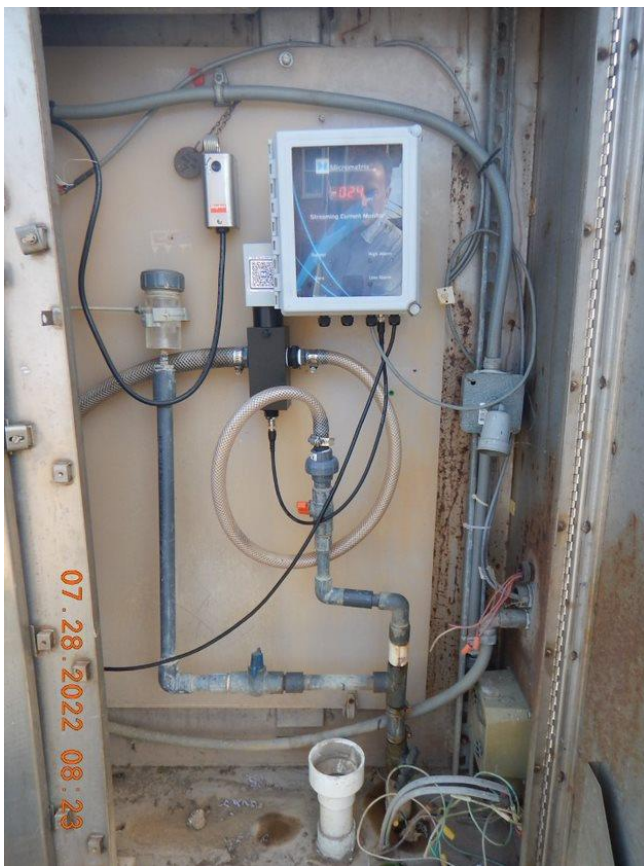
- The Sr. Plant Operations Supervisor explained that the streaming current monitor was newer on Sedimentation Basins 3-4 for Plant 1. The monitor read negative 0.24 mV at the time of the inspection (*Photo 117*).

**Photograph 117.** Streaming current monitor for Plant 1, reading -0.24 mV.

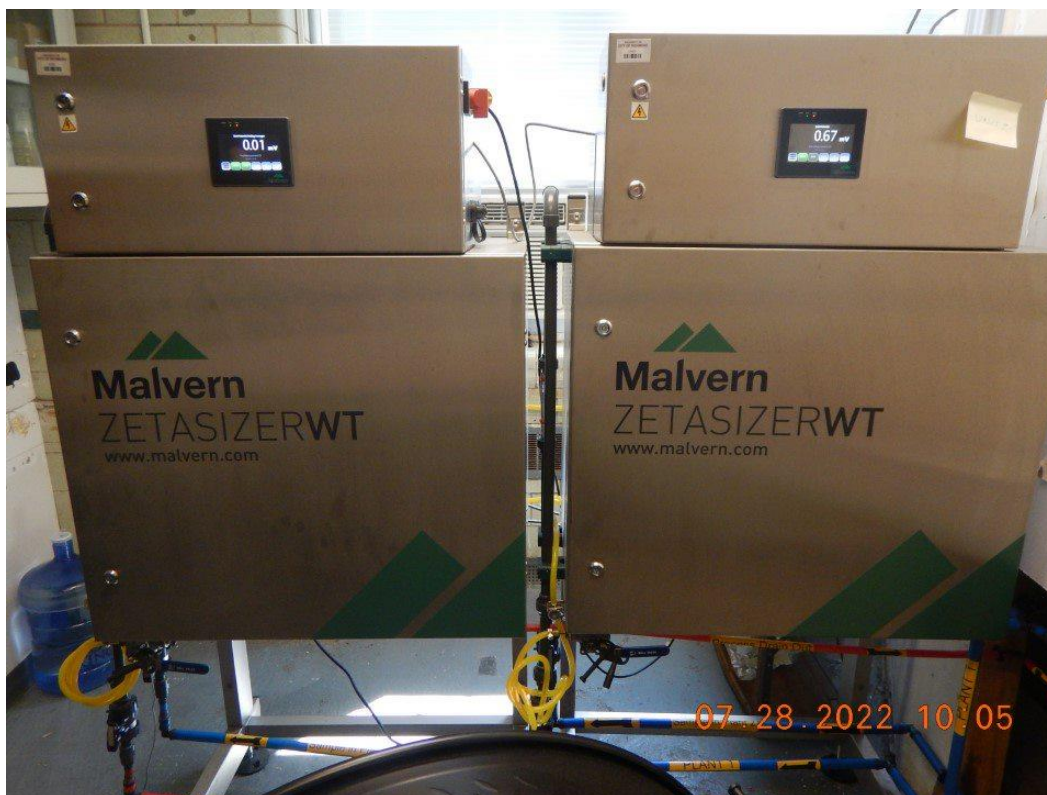
- The Zetasizer is in the process laboratory. The Sr. Plant Operations Supervisor stated it is not on SCADA (*Photo 127*).
  - The Sr. Plant Operations Supervisor explained there are not quick reference guides to explain goals for chemical dosing that is easily available to the operators. They explained there are historical SOPs available for reference.

**Photograph 127.** Malvern Zetasizer in Plant 2 process laboratory.
